Final Reclamation and Stormwater Inspection

Operator: Noble Energy INC - 100322

Location ID: 409315

Inspection Photos
Location Name: Timmerman #44-18
Location ID: 409315

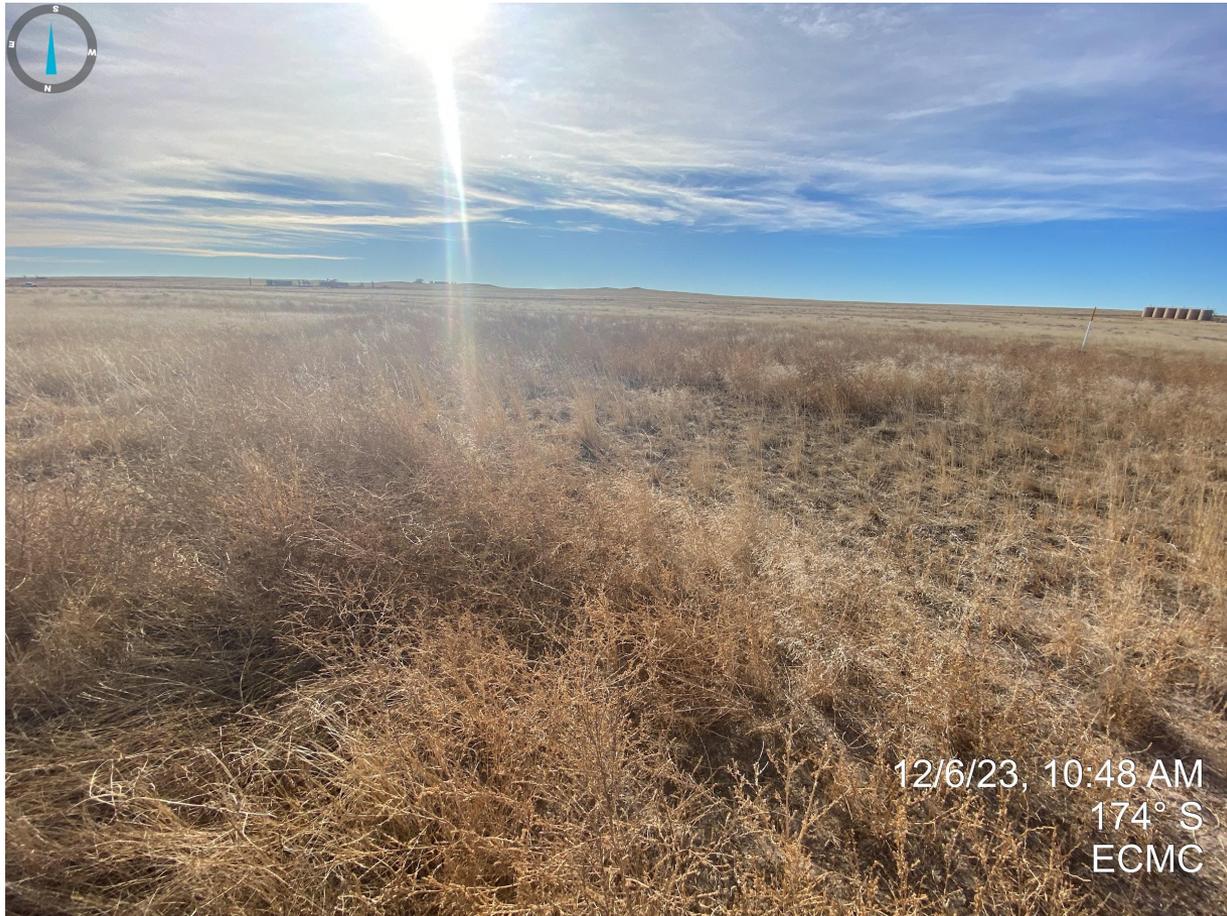
Photo 1. Taken from the northern portion of the former well location. Photo illustrates the presence of weedy debris/undesirable vegetation (e.g. russian thistle and kochia). Additional reclamation activities are required.

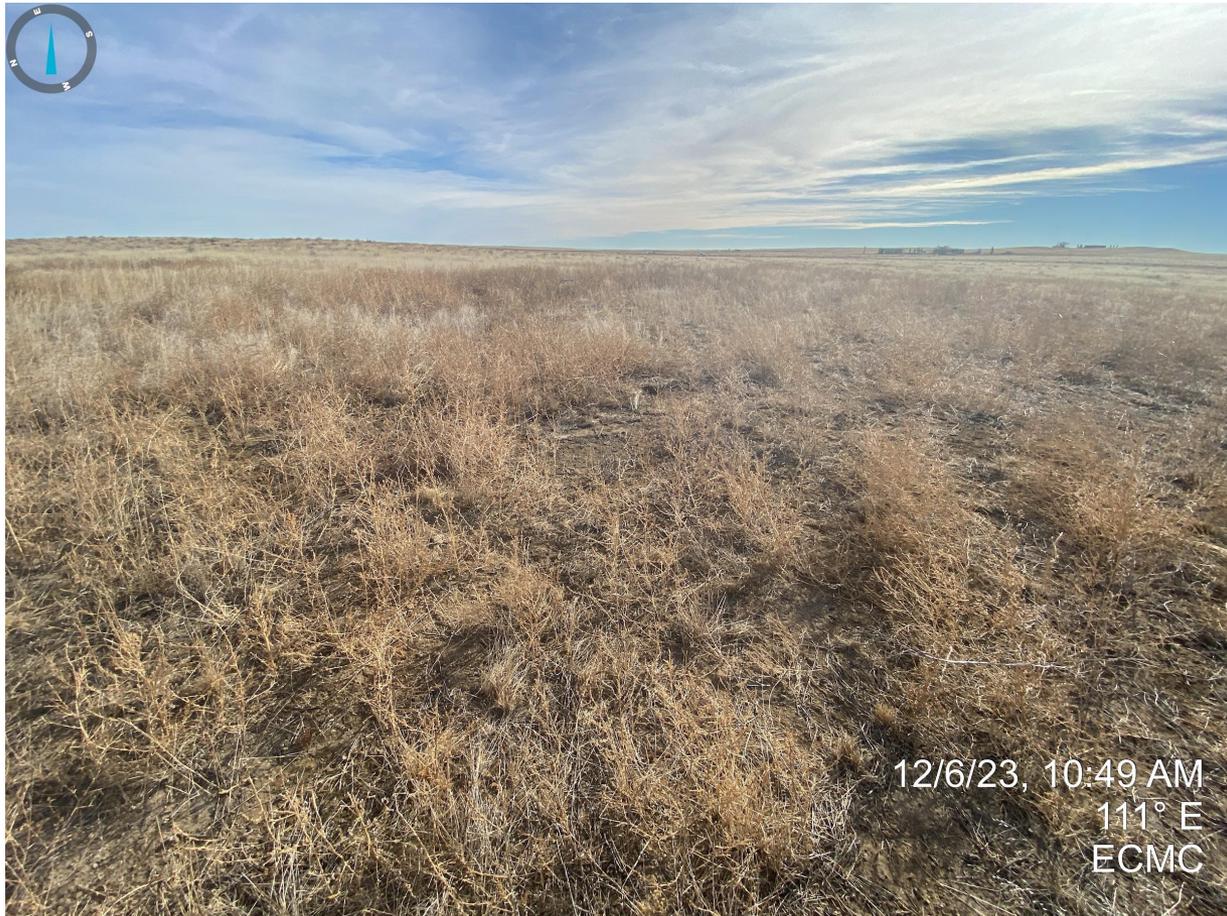
Photo 2. Taken from the western portion of the former well location. See comments in Photo 1.

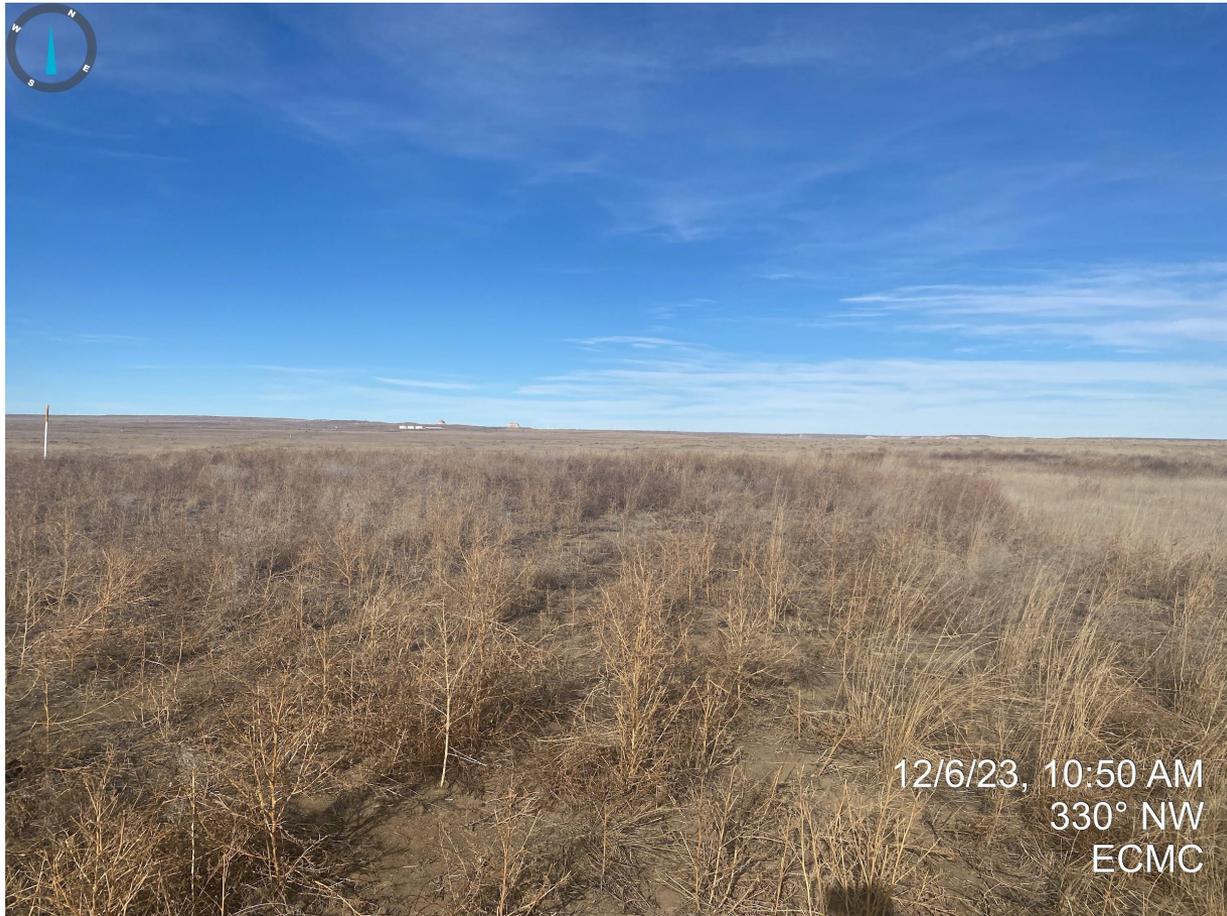
Photo 3. Taken from the southern portion of the former well location, facing northwest. See comments in Photo 1.

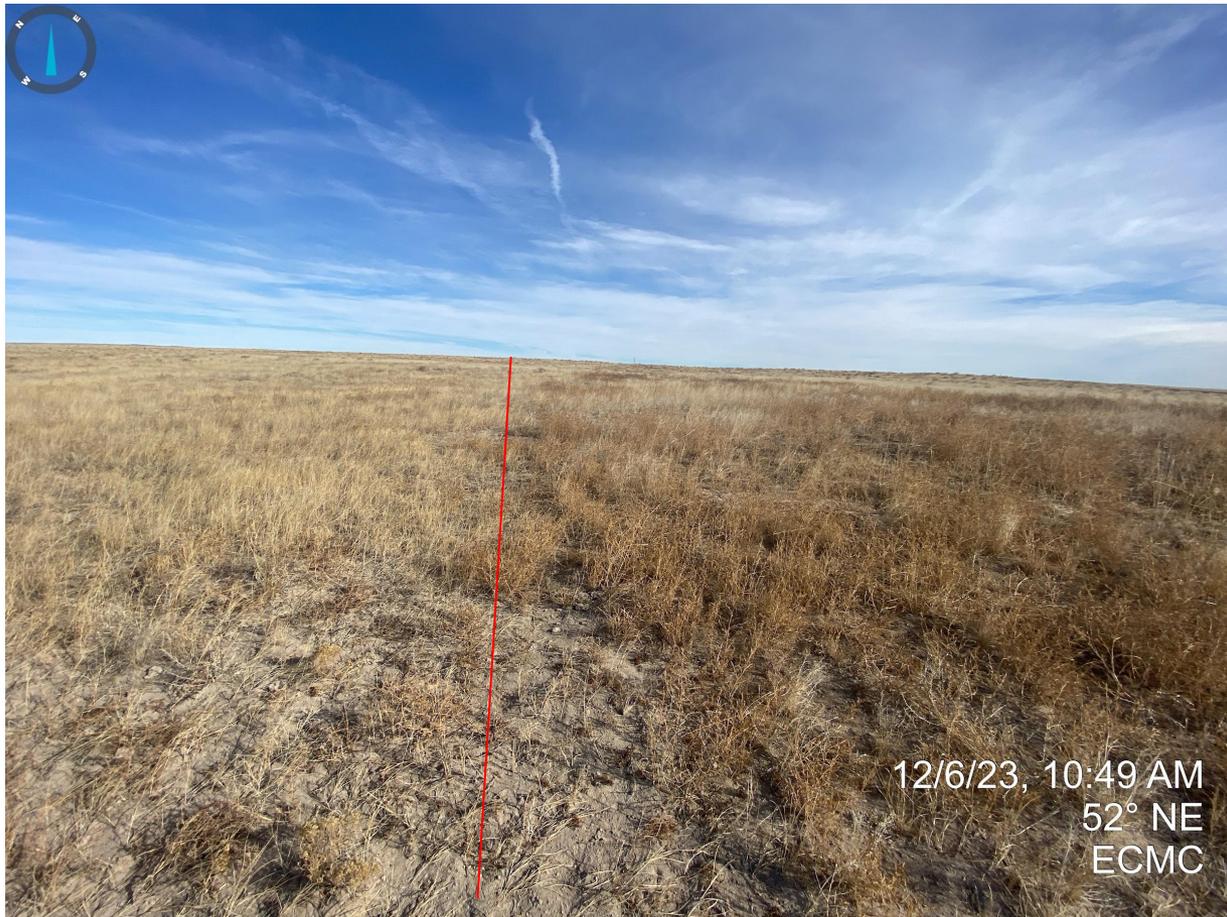
Photo 4. Taken from the northwestern portion of the former well location. Photo illustrates the adjacent reference area (left of red line) and the disturbance area (right of red line) that requires additional reclamation activities. .
