Final Reclamation and Stormwater Inspection

Operator: Noble Energy Inc. - 100322

Location ID: 302903

Inspection Photos
Location Name: Stroh O 2-17
Location ID: 302903

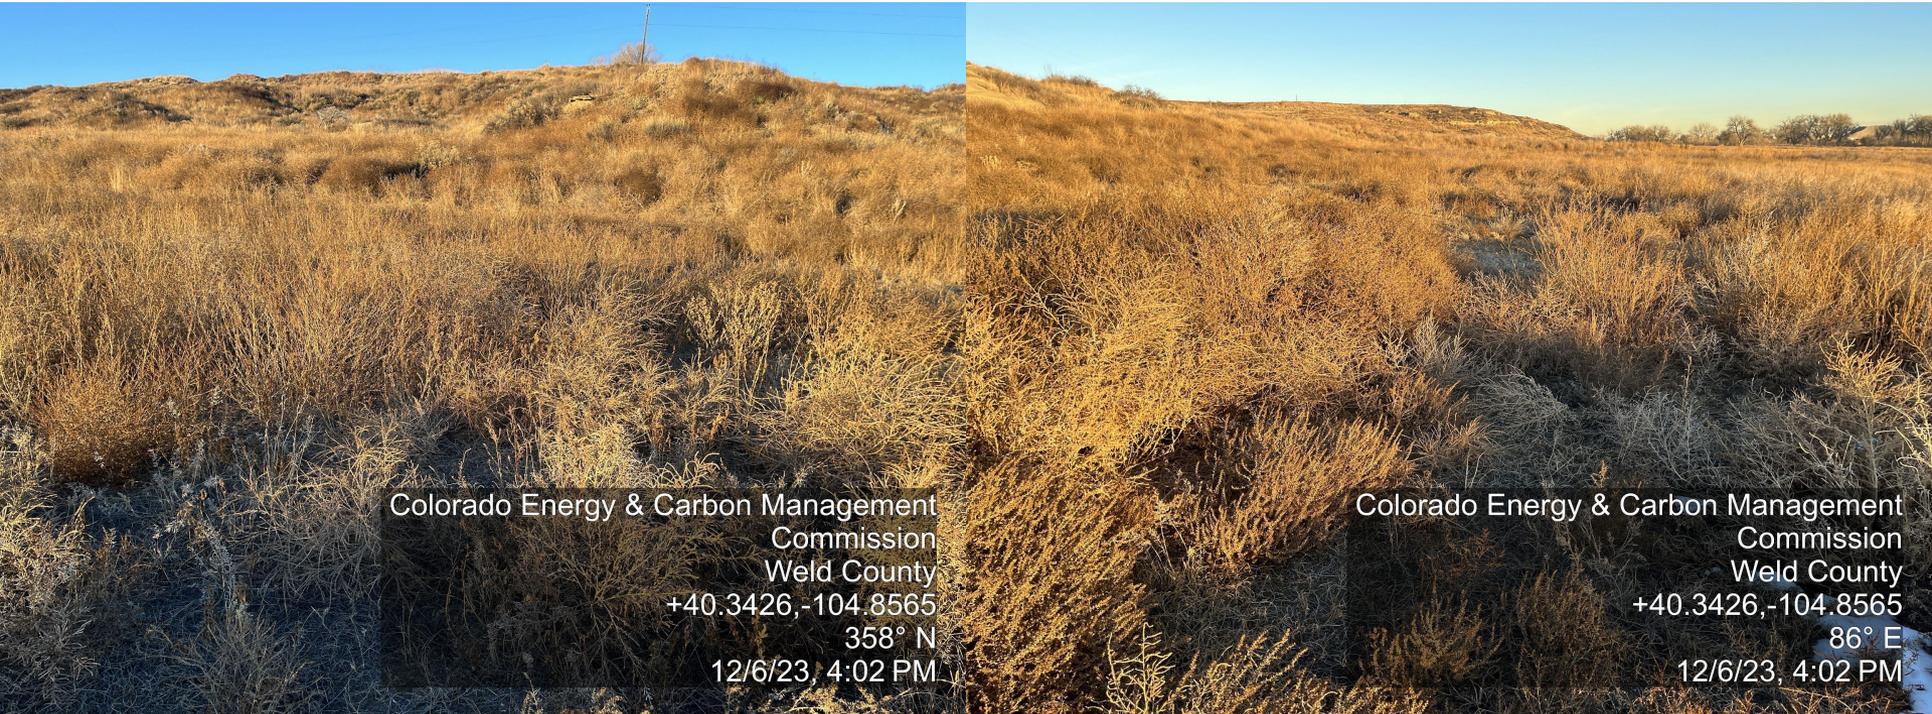
Photo 1. The photo was taken at the well location facing North. The photo illustrates the well location is dominated by russian thistle and kochia.

Photo 2. The photo was taken at the well location facing East. Refer to the comment for photo 1.

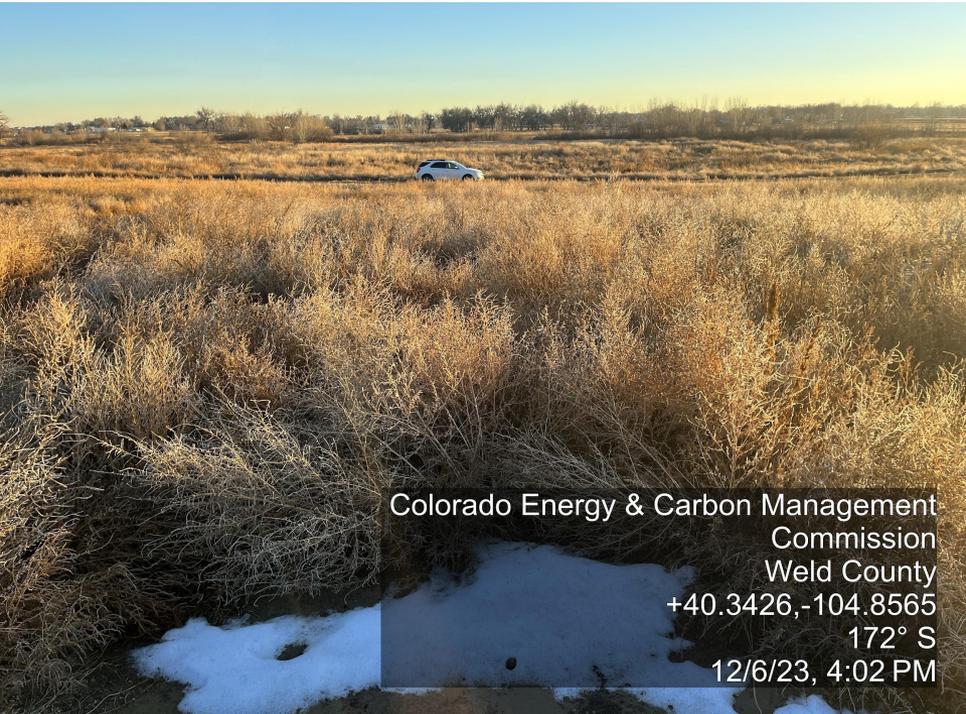
Colorado Energy & Carbon Management
Commission
Weld County
+40.3426,-104.8565
172° S
12/6/23, 4:02 PM

Photo 3. The photo was taken at the well location facing South.
Refer to the comment for photo 1.

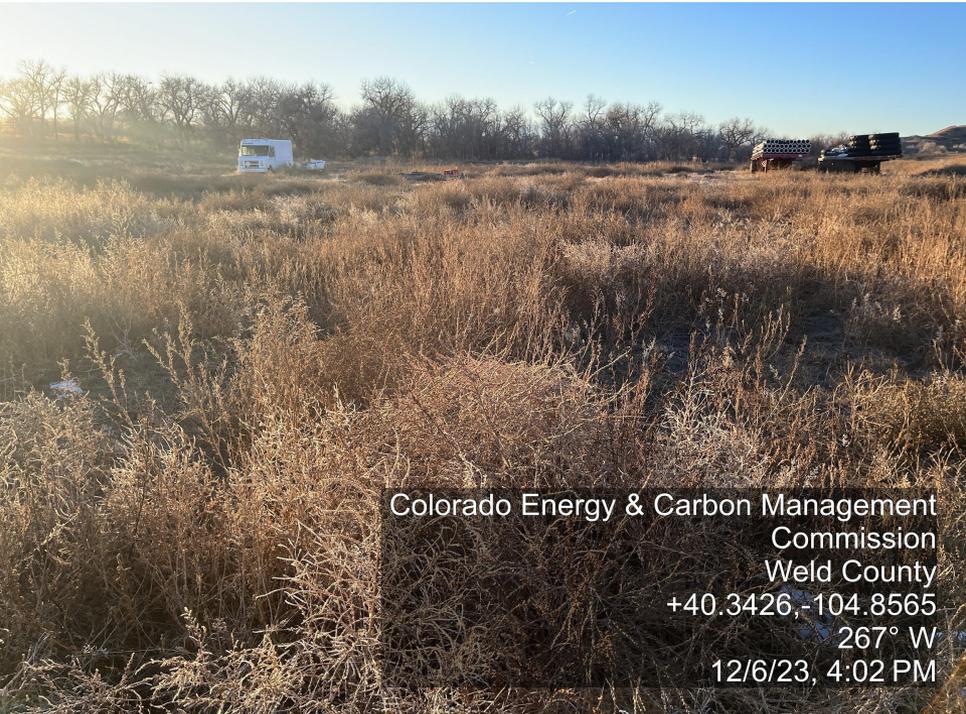
Colorado Energy & Carbon Management
Commission
Weld County
+40.3426,-104.8565
267° W
12/6/23, 4:02 PM

Photo 4. The photo was taken at the well location facing East.
Refer to the comment for photo 1.

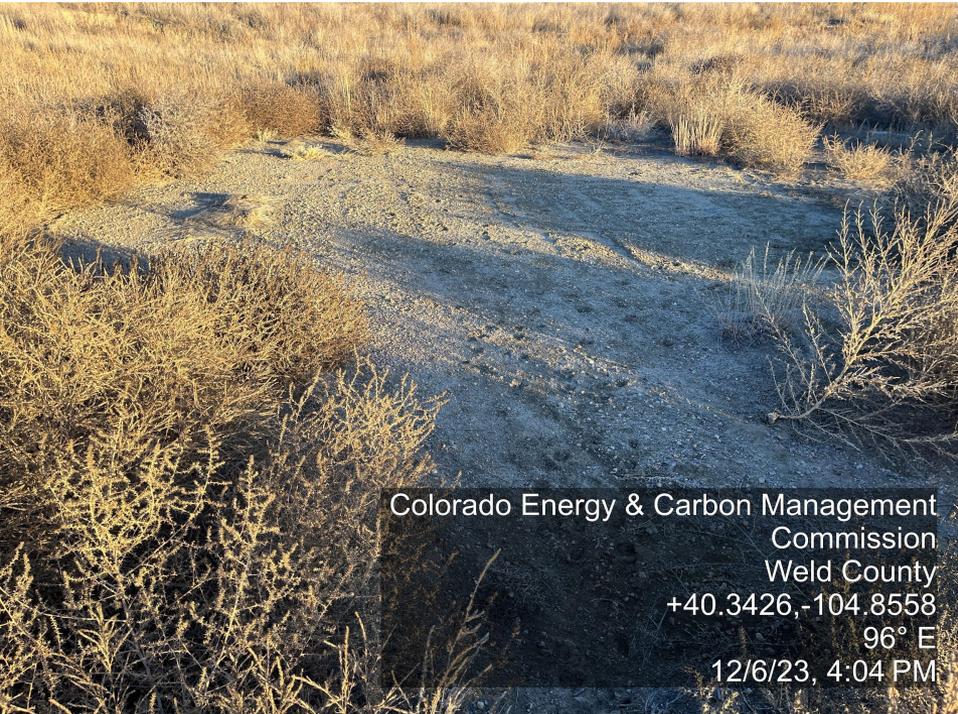
Photo 5. The photo was taken at the tank battery location facing East. The photo illustrates a large area of bare soil amongst the Russian thistle where the tank battery was.

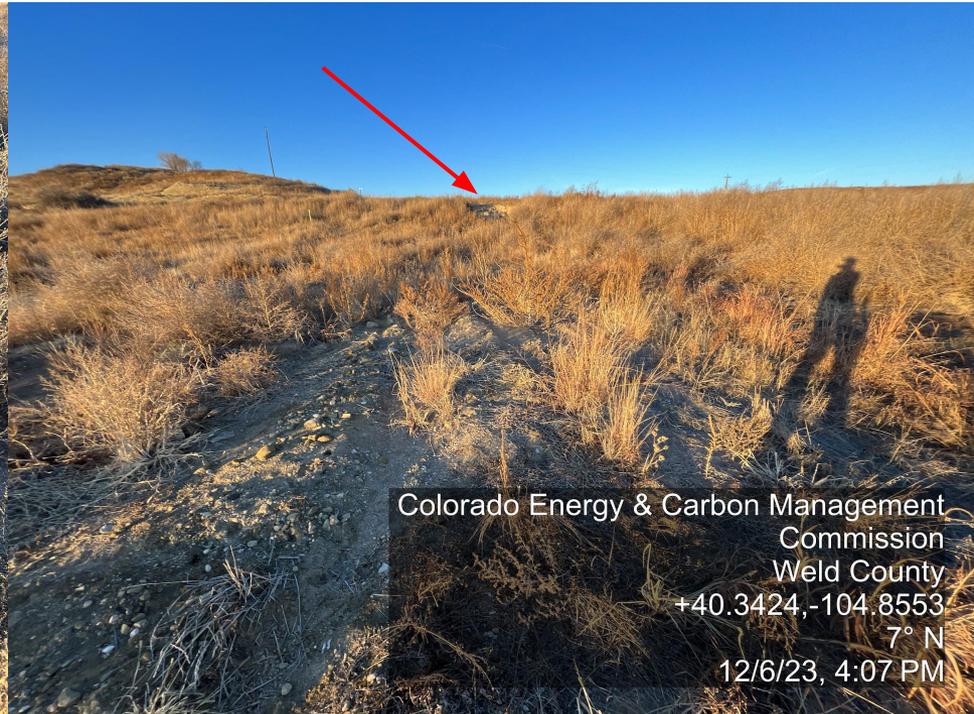
Photo 6. The photo was taken at the tank battery location facing Northeast. The photo illustrates a headcut beginning at the road above the location and moving sediment across the former tank battery.

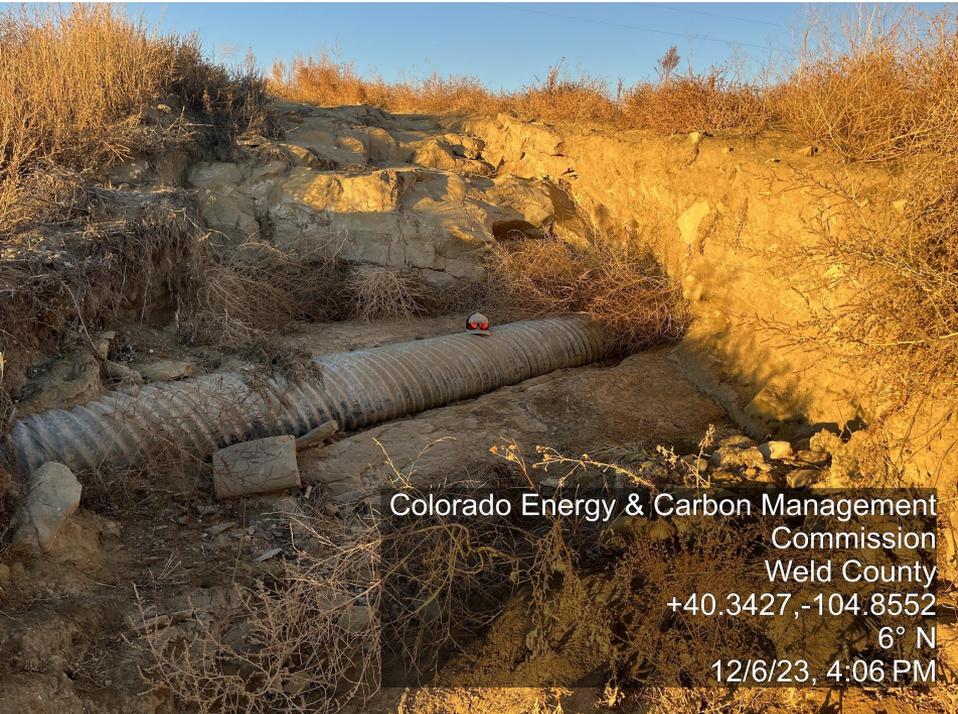
Colorado Energy & Carbon Management
Commission
Weld County
+40.3427, -104.8552
6° N
12/6/23, 4:06 PM

Photo 7. The photo was taken North of the tank battery location facing North. The photo illustrates a large gully erosional feature moving sediment from above the location across the former tank battery area.

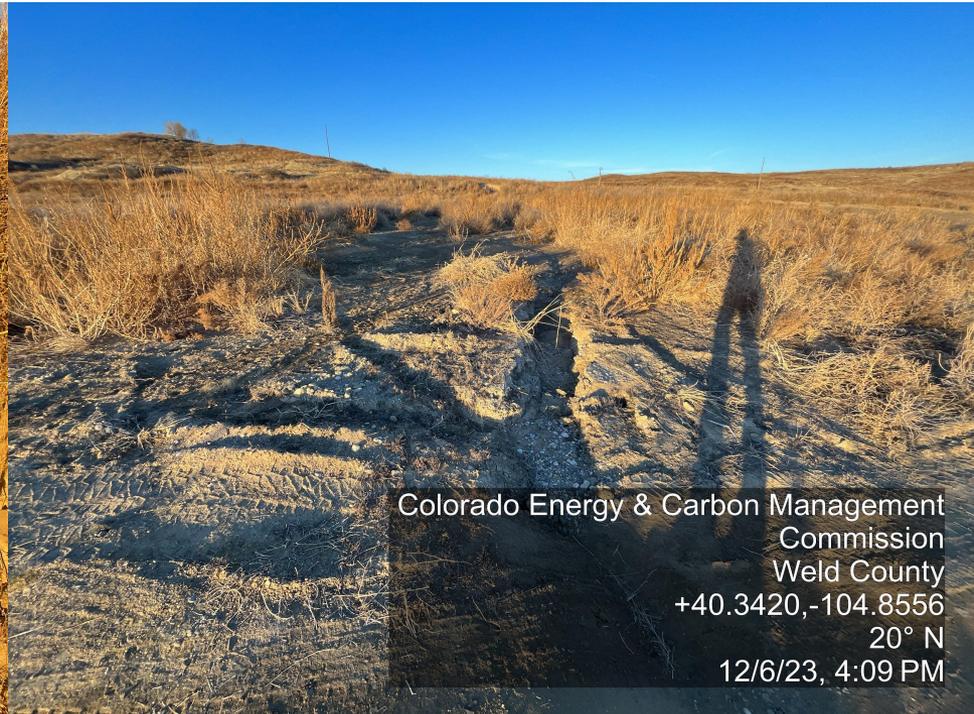
Colorado Energy & Carbon Management
Commission
Weld County
+40.3420, -104.8556
20° N
12/6/23, 4:09 PM

Photo 8. The photo was taken at the tank battery location facing North. The photo illustrates the bottom of the erosional feature cutting across the tank battery location.

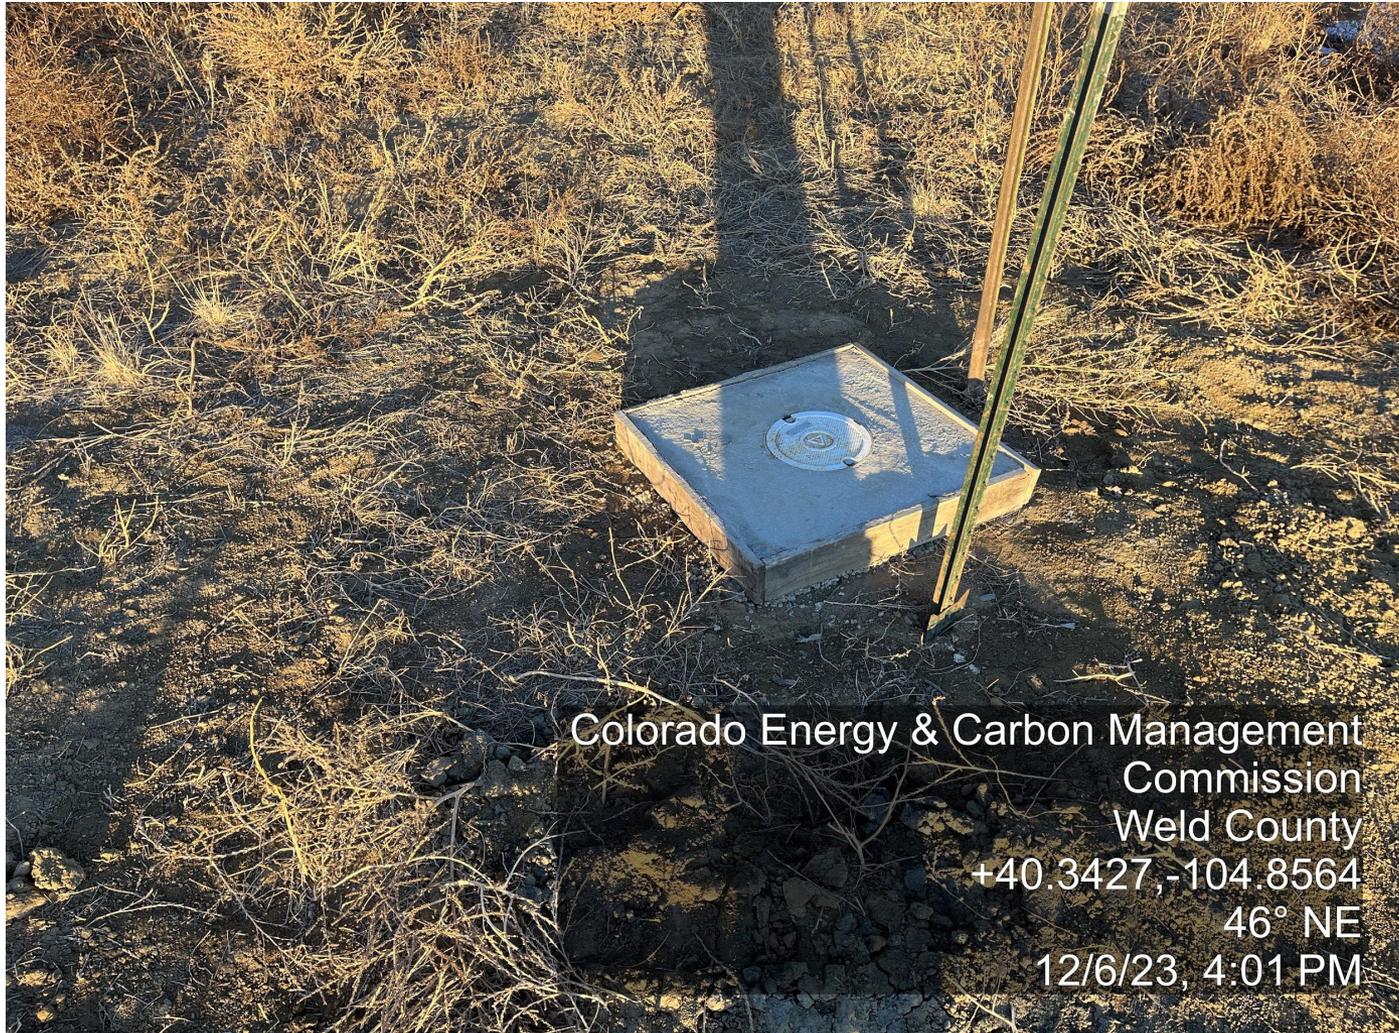
Colorado Energy & Carbon Management
Commission
Weld County
+40.3427, -104.8564
46° NE
12/6/23, 4:01 PM

Photo 9. The photo was taken at the well location facing Northeast. The photo illustrates the a water sampling well drilled for sampling for Remediation project #28300.
