Inspection Photos

Operator: CAERUS PICEANCE LLC #10456

Location ID: 334935

Inspection Doc: 696205499

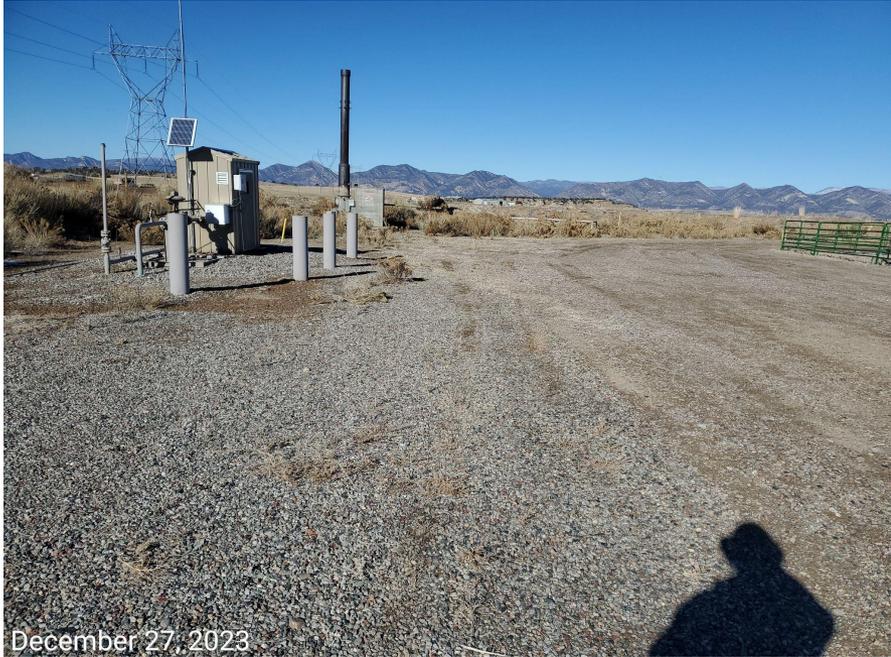
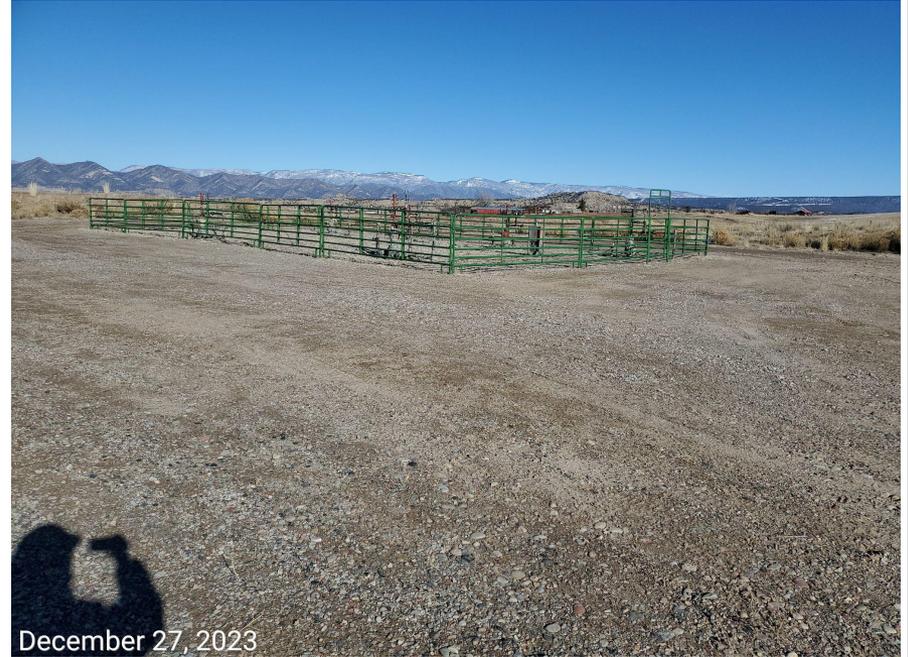
Photo 1: Photos taken from the west end of the working pad surface. Photos provide an overview of the Location from north, northeast, southeast to south.

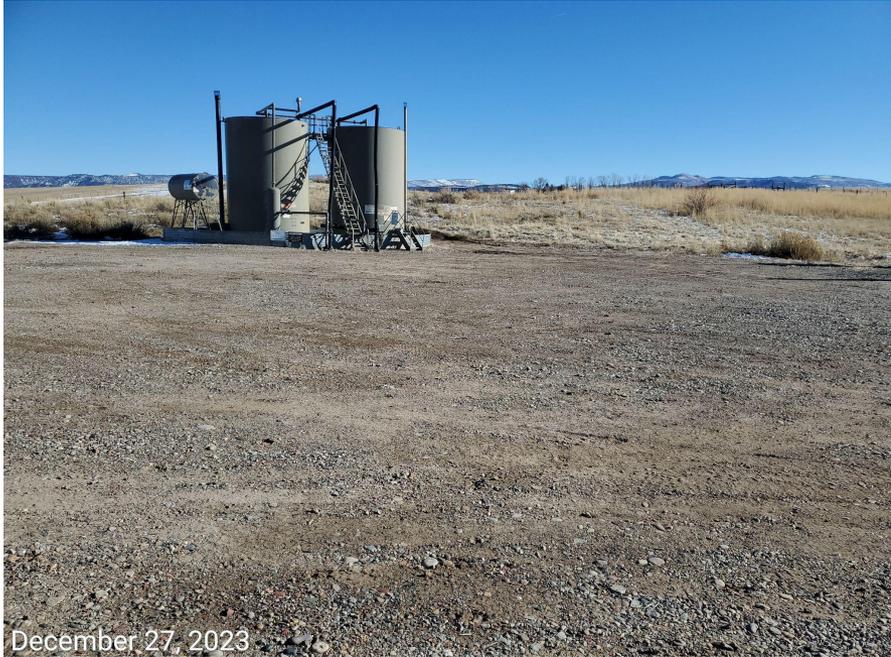
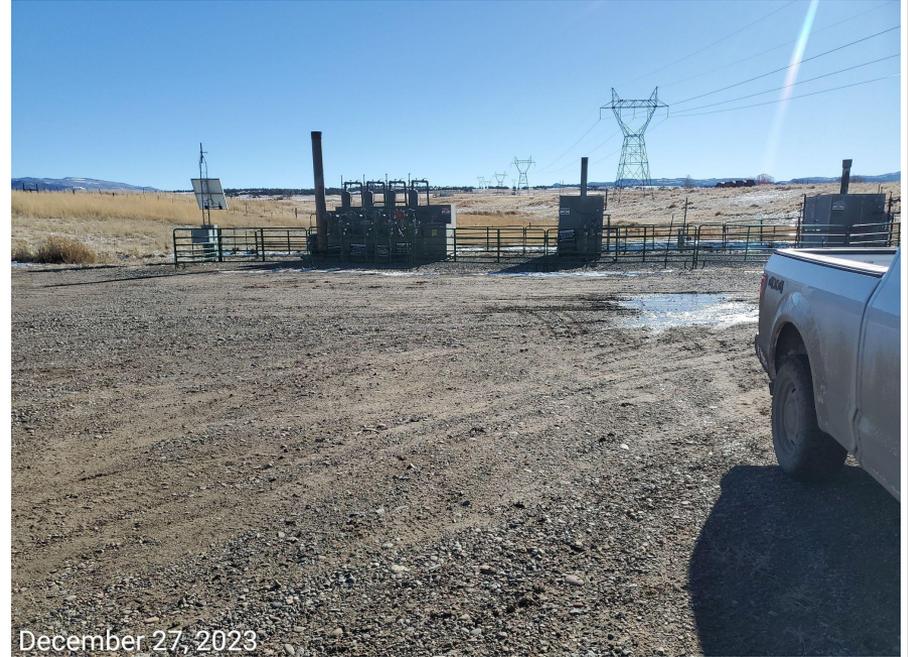
Photo 2: See comments under photo 1.

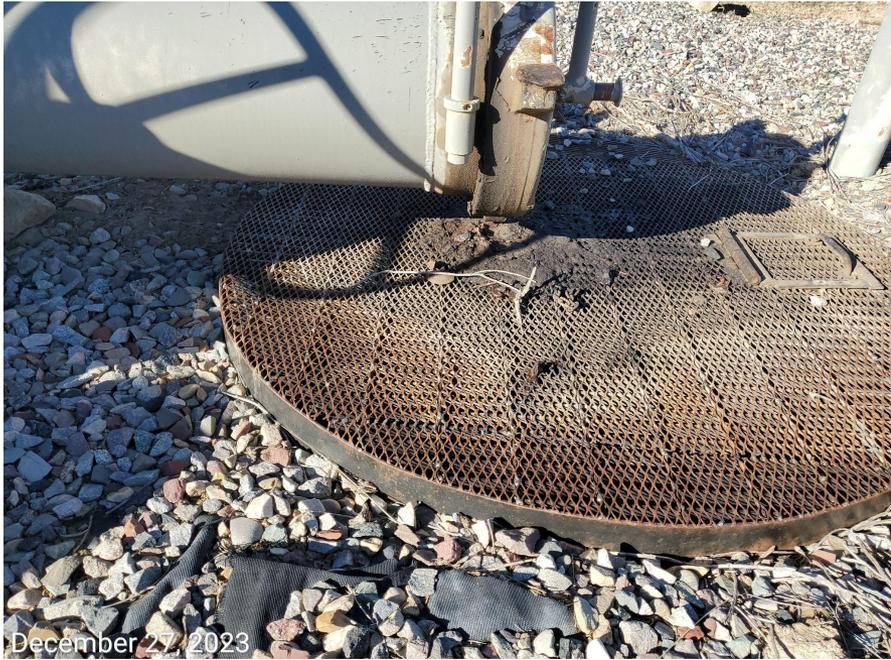
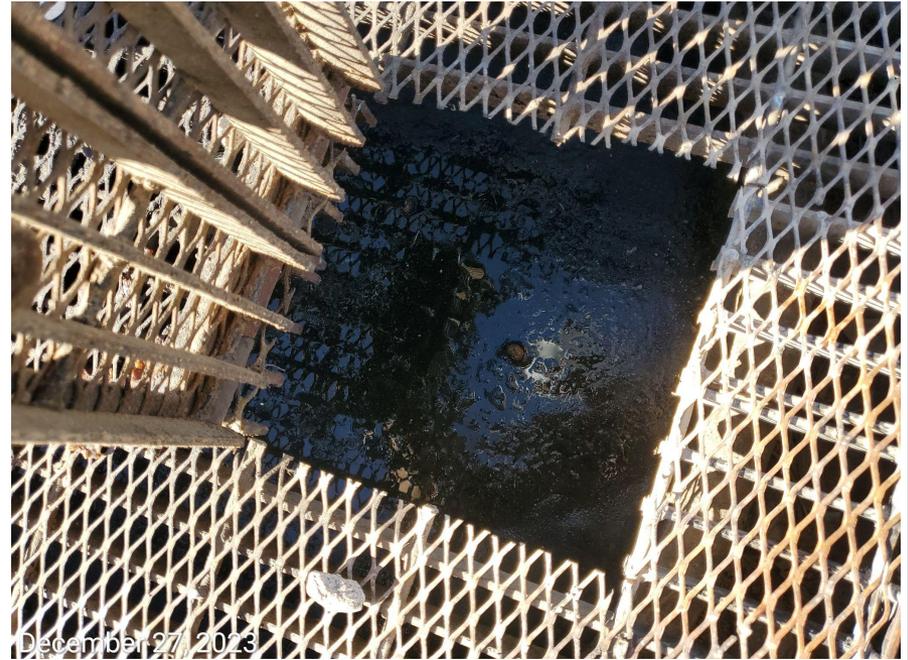
Photo 3: Photo taken from the pipeline equipment on the west end of the Location. Leak evident at equipment. Photo right shows fluids spilled into containment.

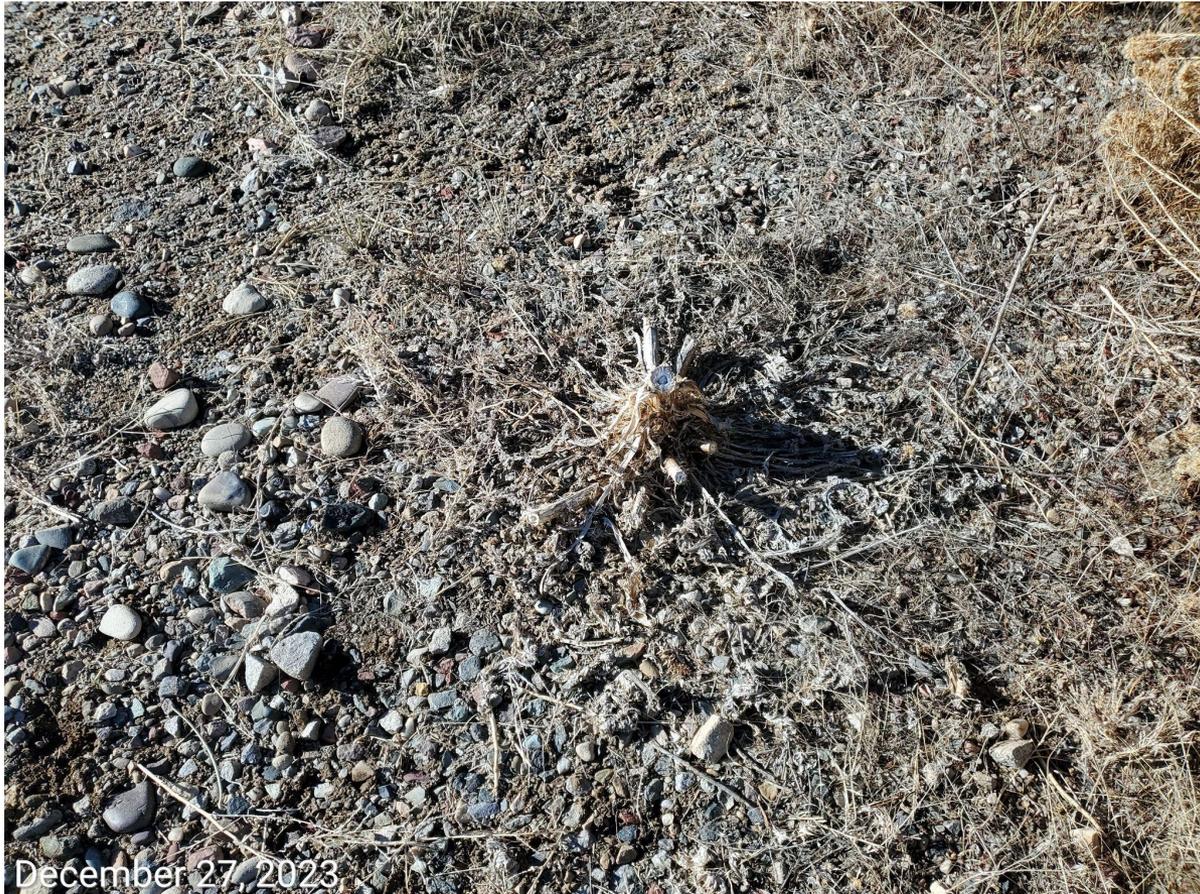
Photo 4: Photo example of what appears to be Musk or Bull thistle remnants observed on the Location. Management efforts by Operator apparent on the Location.

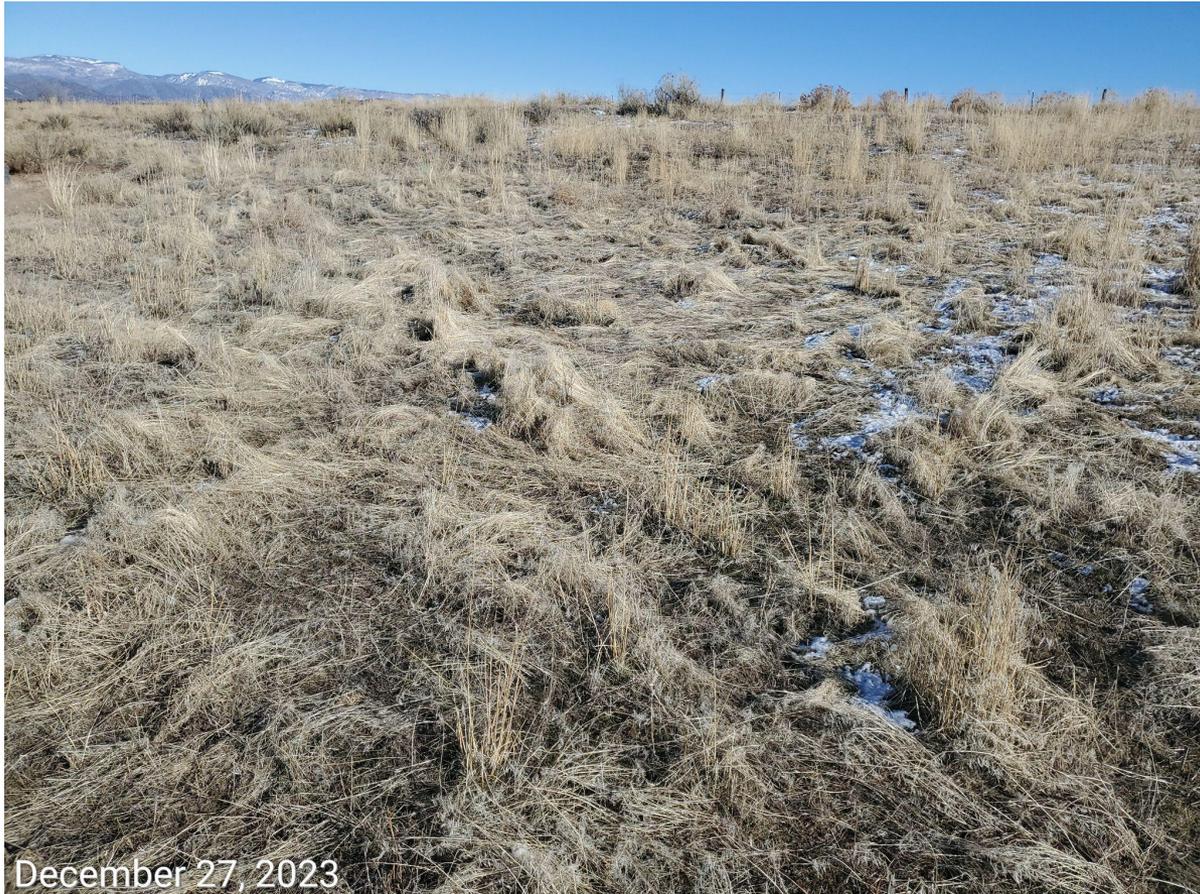
Photo 5: Photo example showing interim areas on the southern end of the Location that do not appear to be progressing towards 1003 standards; vegetation observed is predominantly undesirable plant species such as cheatgrass.

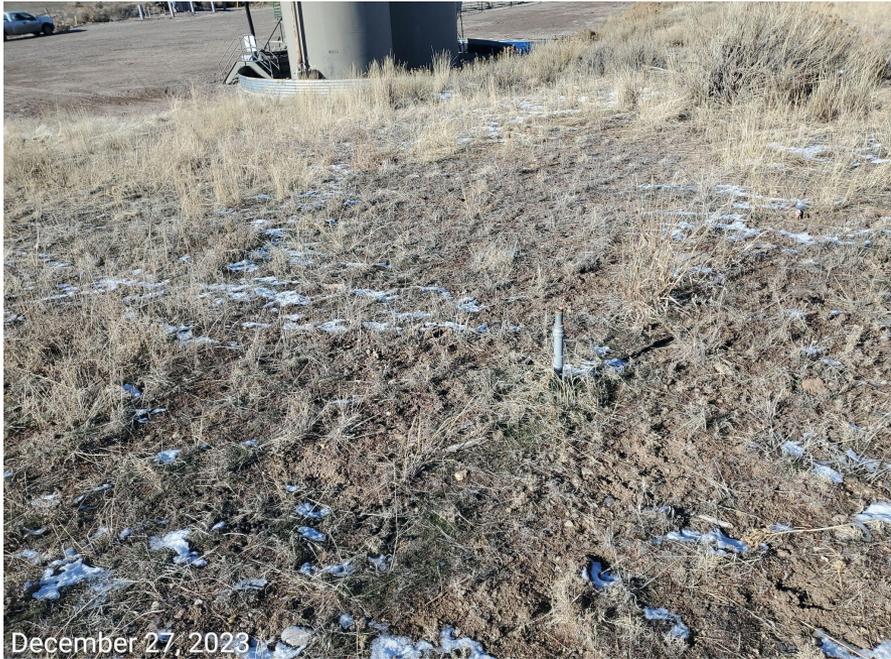
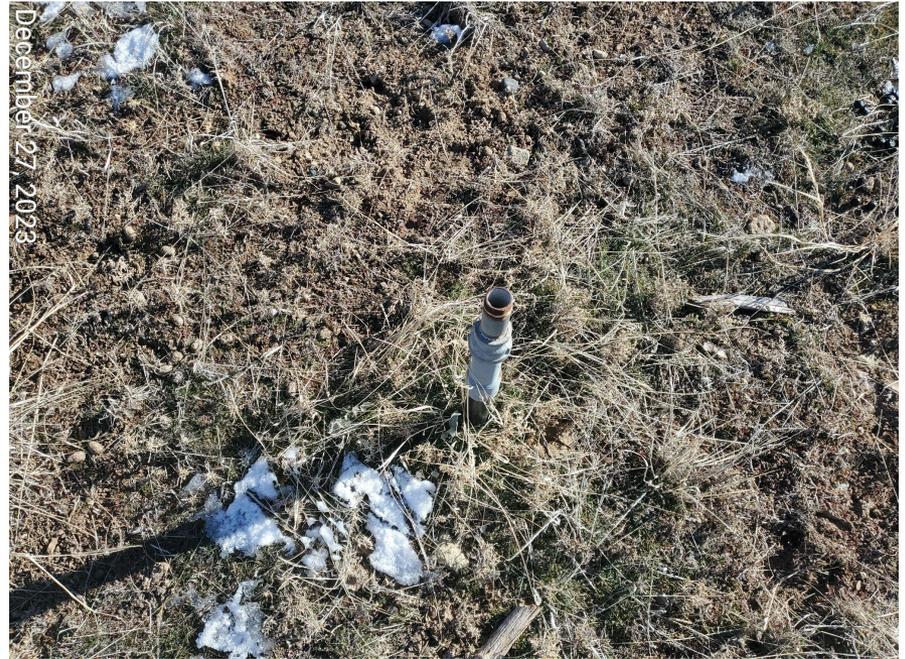
Photo 6: Photo show uncapped riser on the southeastern interim areas of the Location. Riser is considered unused equipment and requires removal.
