**Operator: BONANZA CREEK ENERGY OPERATING COMPANY LLC**

**Location Name: Crow Valley 31-18 Pad**

**Loc ID: 440344**

**Inspection: 697505024**

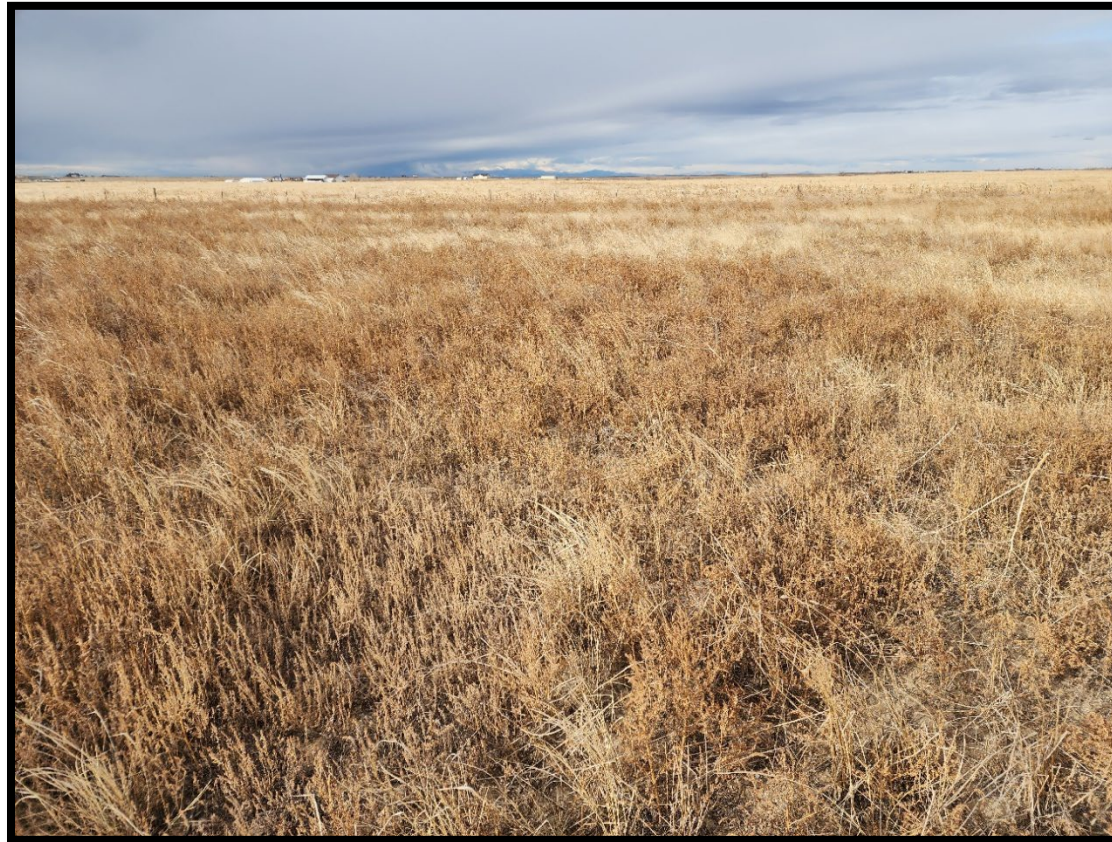
**Exhibit G**

**CA:** This location does not comply with Rule 1004. Reclamation rules require reclamation activities to be conducted within twelve months of plugging on non-cropland. Well was plugged 06/08/2021. The well location has some evidence of reclamation activities with evidence of few perennial grasses germinating on location. Operator has failed to reclaim the access road and the well location area is dominated by Russian thistle, kochia and bare soil patches. Comply with Rule 1004. Reseed disturbance areas using a seed mixture requested by the surface owner, or a mixture prescribed by the local county NRCS. Establish vegetation with total perennial, non-invasive uniform plant cover of at least eighty (80) percent of reference area levels. Ensure erosion controls are implemented to stabilize the seeded soil. Operator shall continue to monitor and manage this site until the location meets Rule 1004 standards, including stormwater and weed management.

**CA Resolution:** ECMC Inspector noted that they were unable to access the site and used historical data to assist with the inspection. Operator then reported that the location has been reclaimed (re-seeded and bare areas addressed) and shared photos from the EcoPoint Assessment completed on November, 8<sup>th</sup> 2023 to show that the location is in compliance with Rule 1004.
