Inspection Photos

Operator: CAERUS PICEANCE LLC #10456

Location ID: 334619

Inspection Doc: 696205503

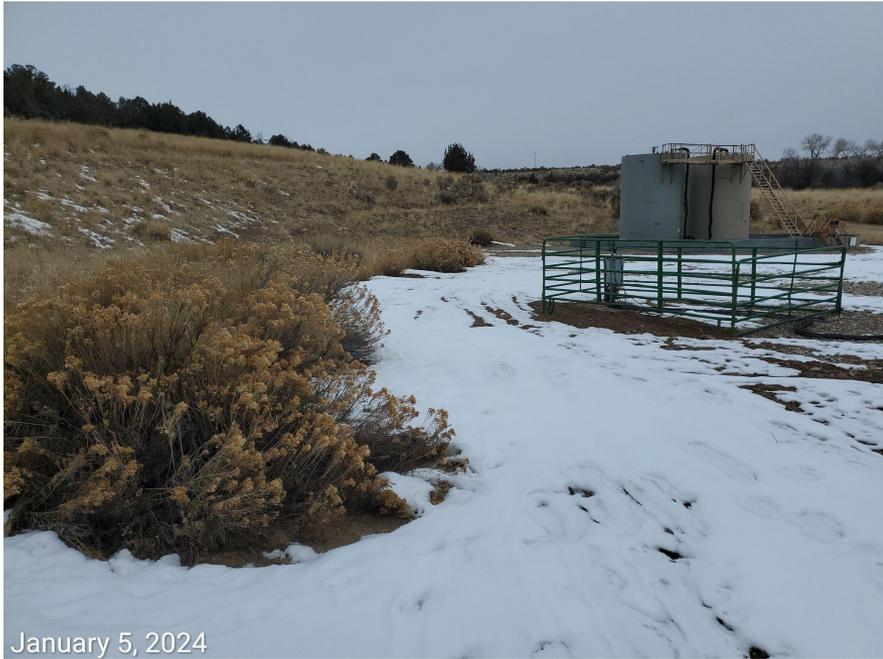
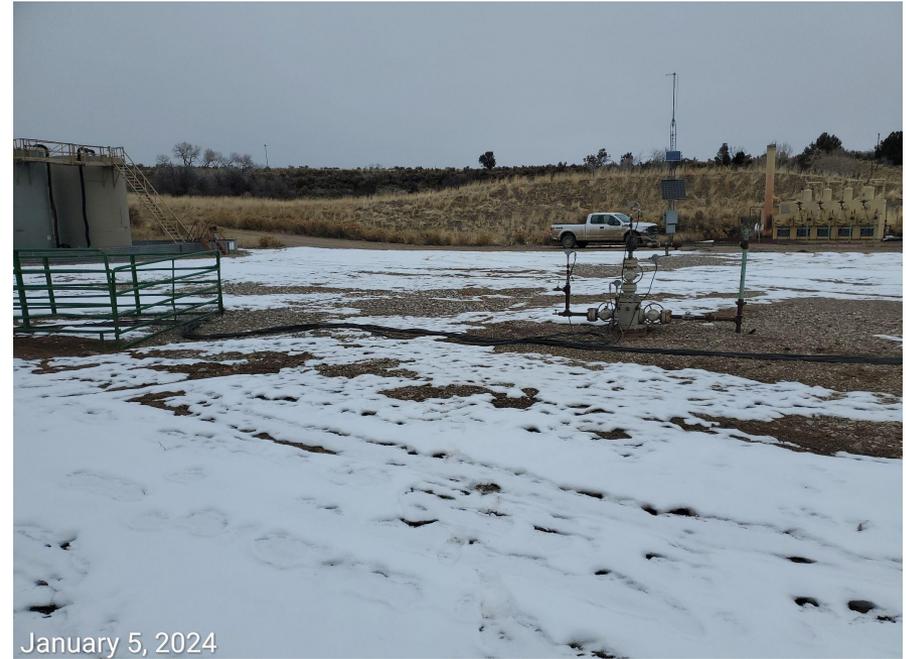
Photo 1: Photos 1-2 taken the western end of the working pad surface. Photos provide an overview of the Location from northwest, north, east to southeast.

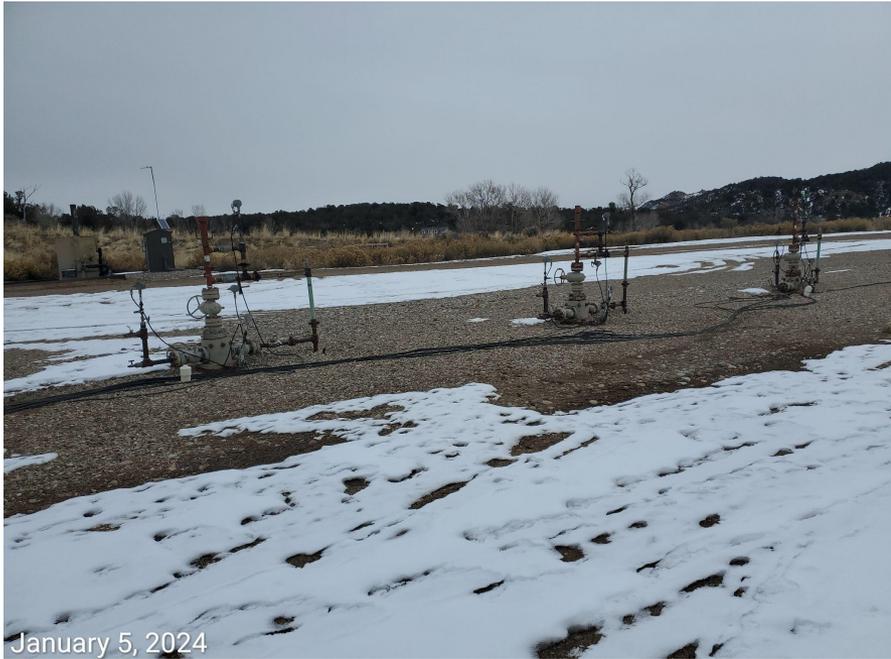
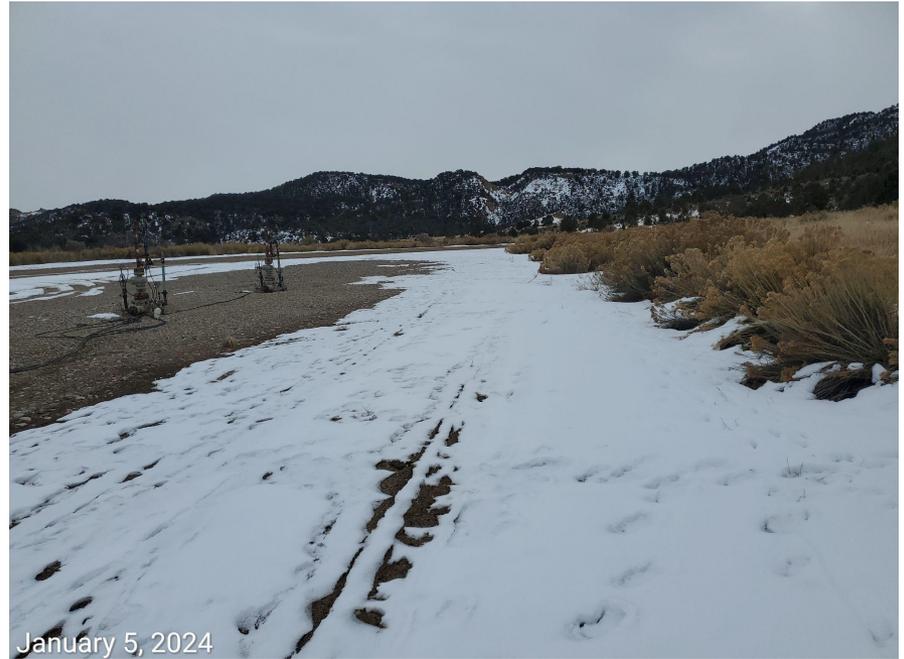
Photo 2: See comments under photo 1.

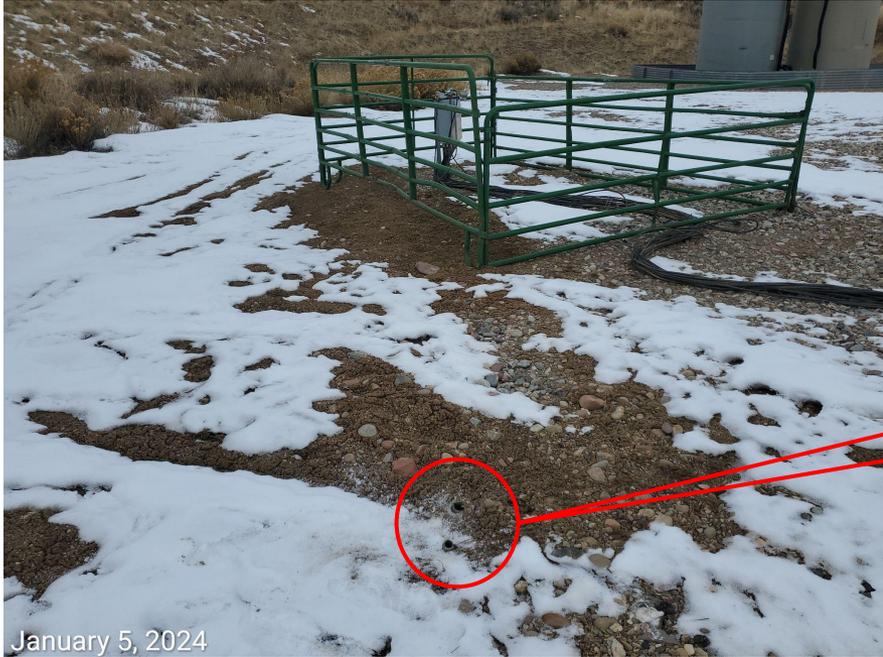
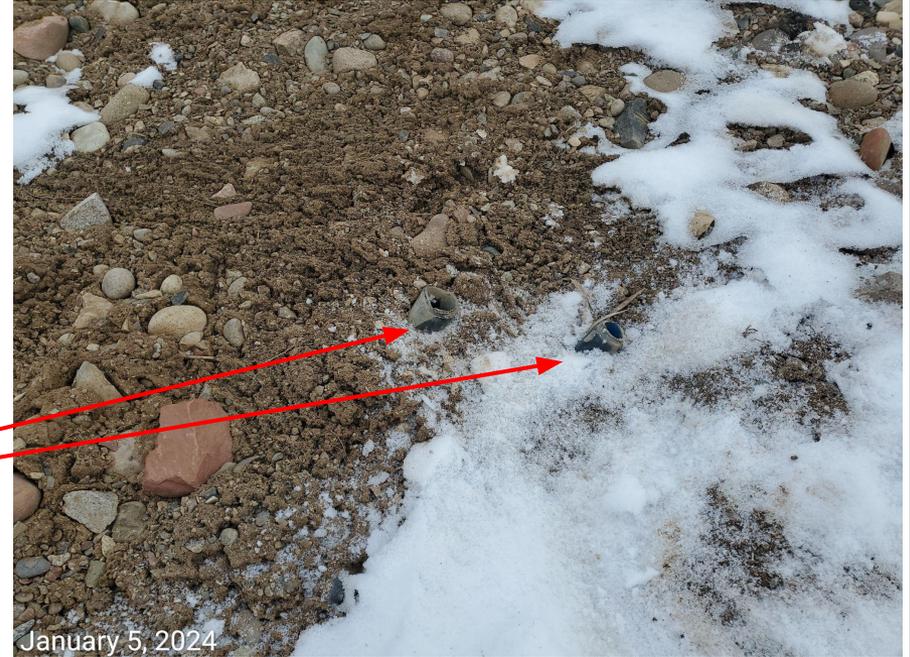
Photo 3: Photo taken from the west end of the working pad surface, next to the electrical equipment. Photo shows unused/uncapped pipe equipment remaining at the WPS surface.

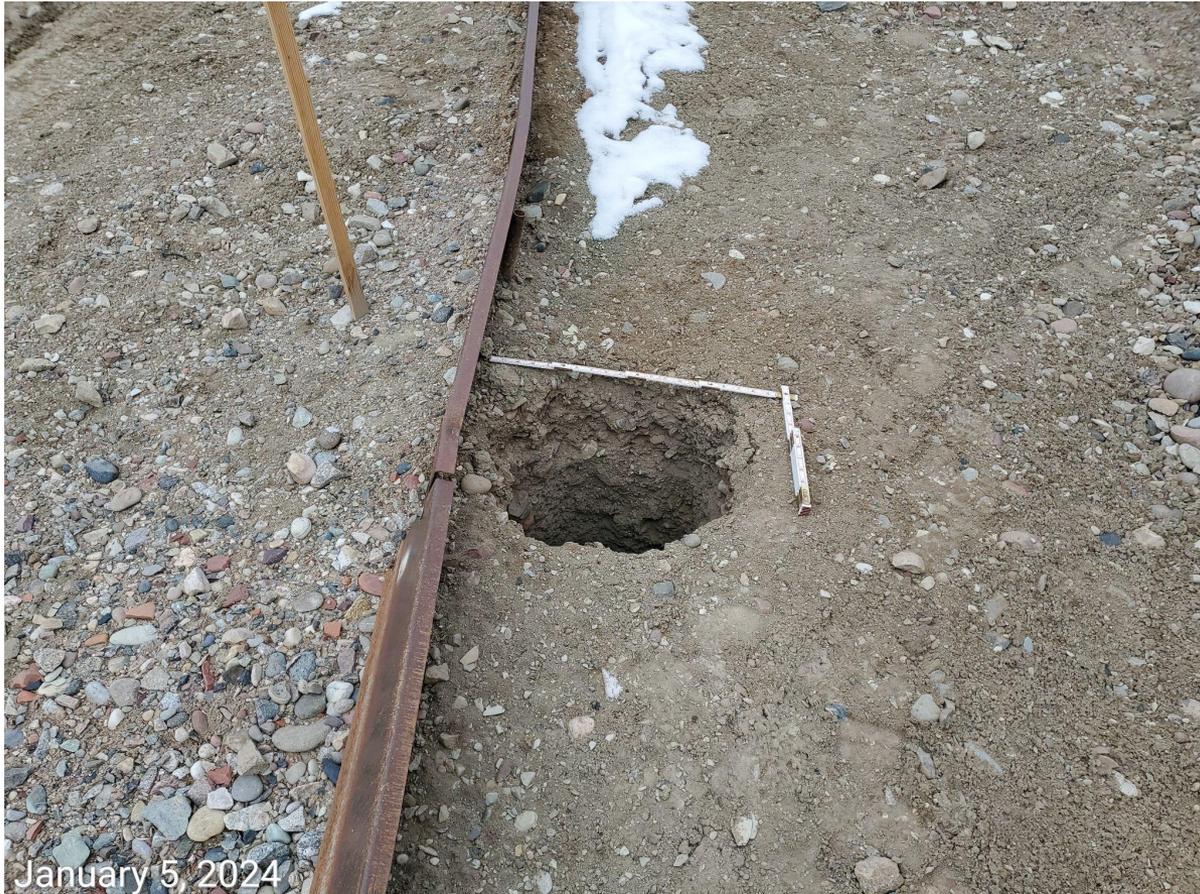
Photo 4: Photo taken from the separator equipment on the east end of the Location. Photo shows sinkhole. Sinkhole is ~1.5' wide and 2.5' deep.

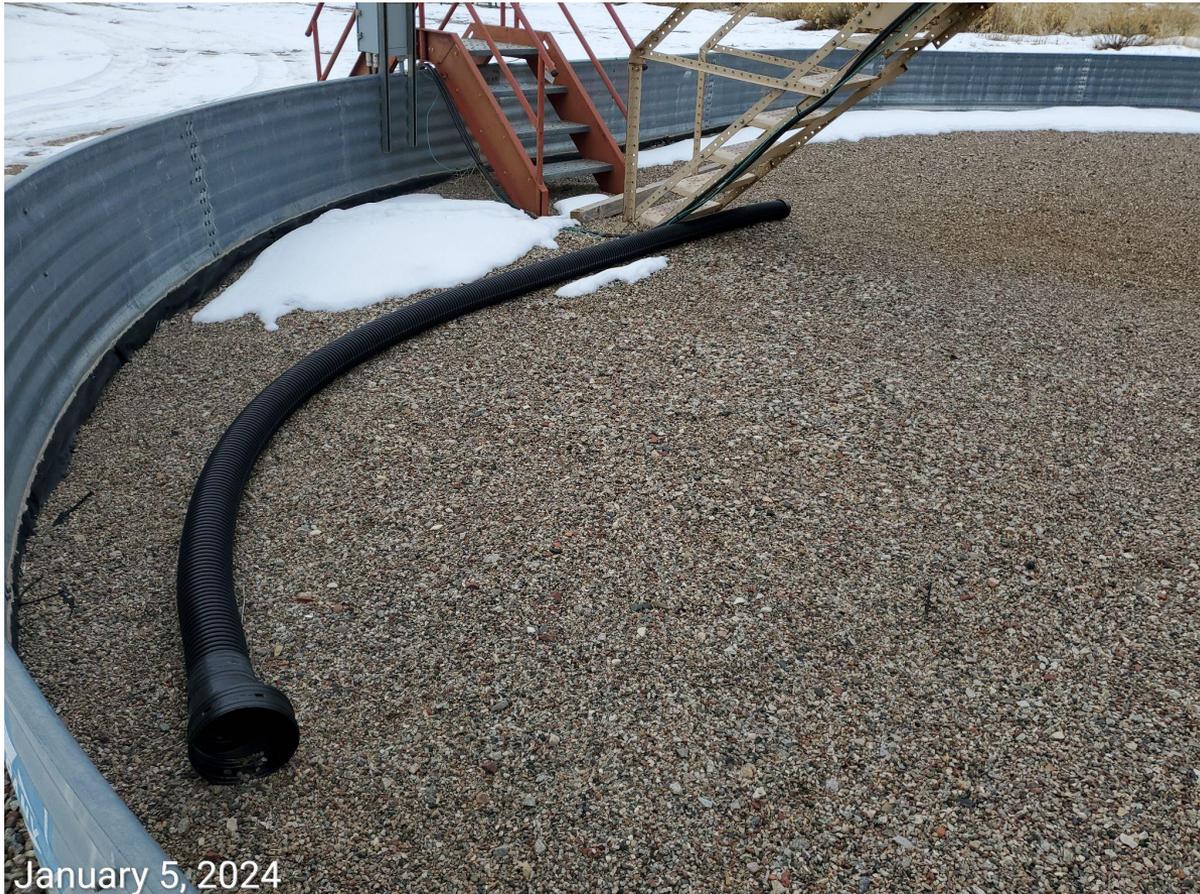
Photo 5: Unused flowline heating insulator.

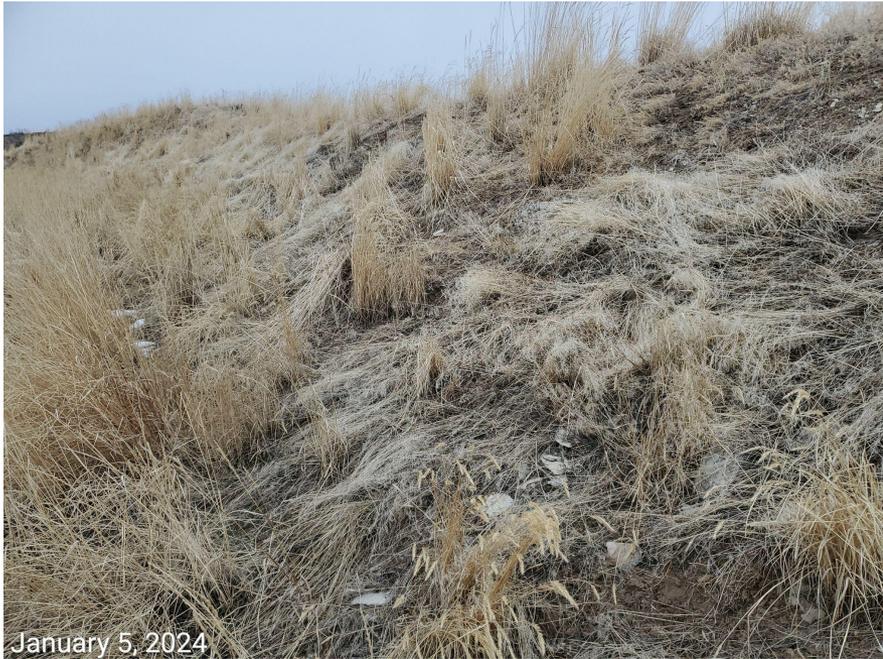
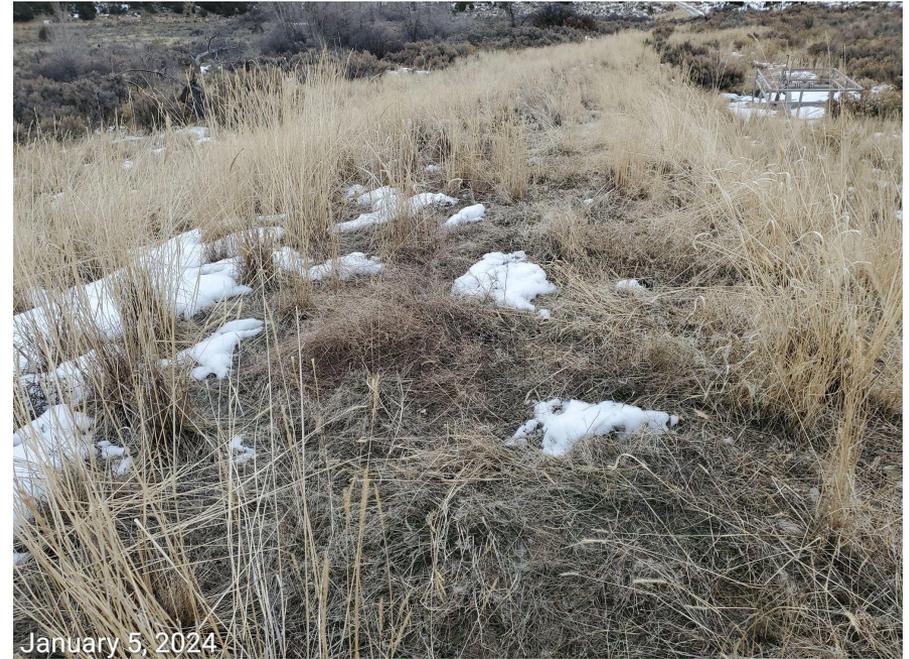
Photo 6: Photo taken from the stockpile berm on the east end of the Location. Though desirable perennial vegetation is apparent, uniform establishment has not been achieved with Undesirable Plant Species, such as cheatgrass, being dominant along the slopes and top of the berm.

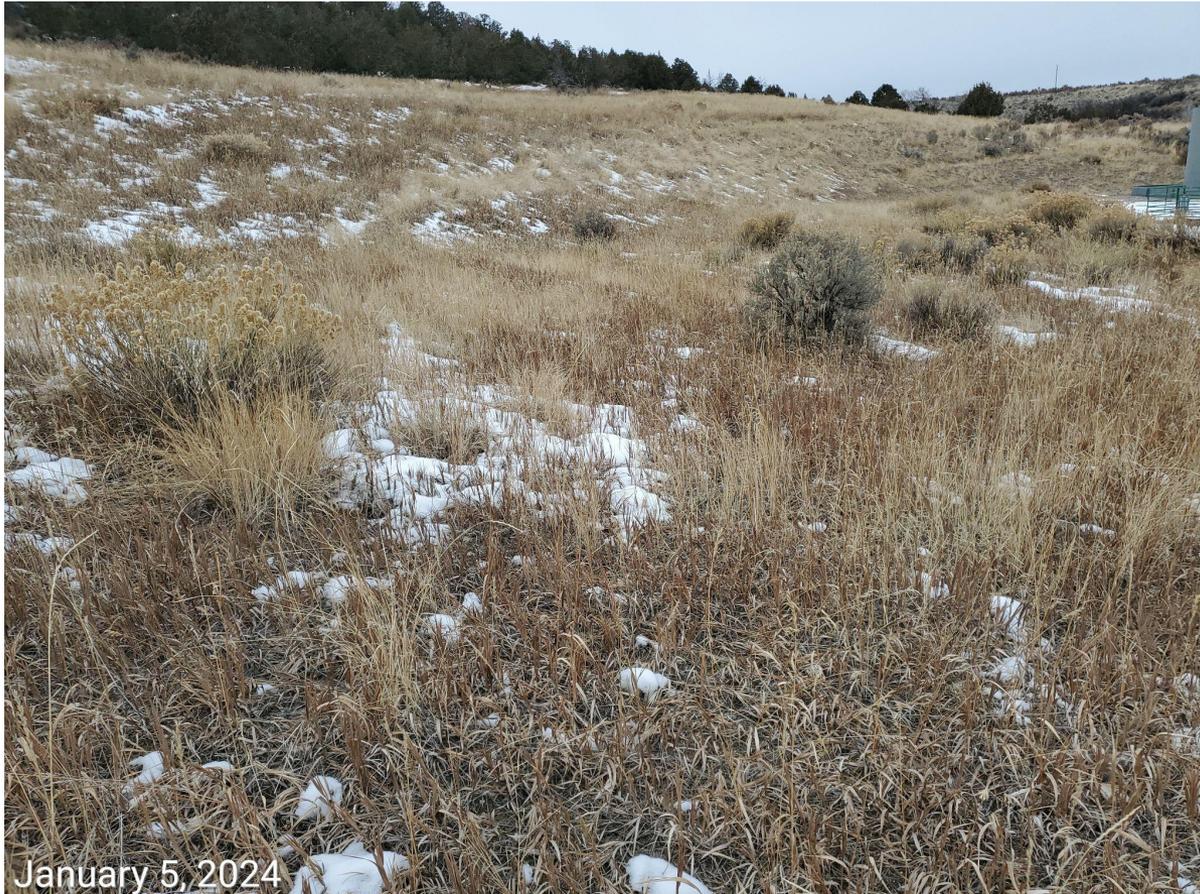
Photo 7: Photo taken from the western interim areas of the Location. Photo example of areas where Reclamation has met 1003 Standards.
