Inspection Photos

Operator: CAERUS PICEANCE LLC #10456

Location ID: 334610

Inspection Doc: 696205507

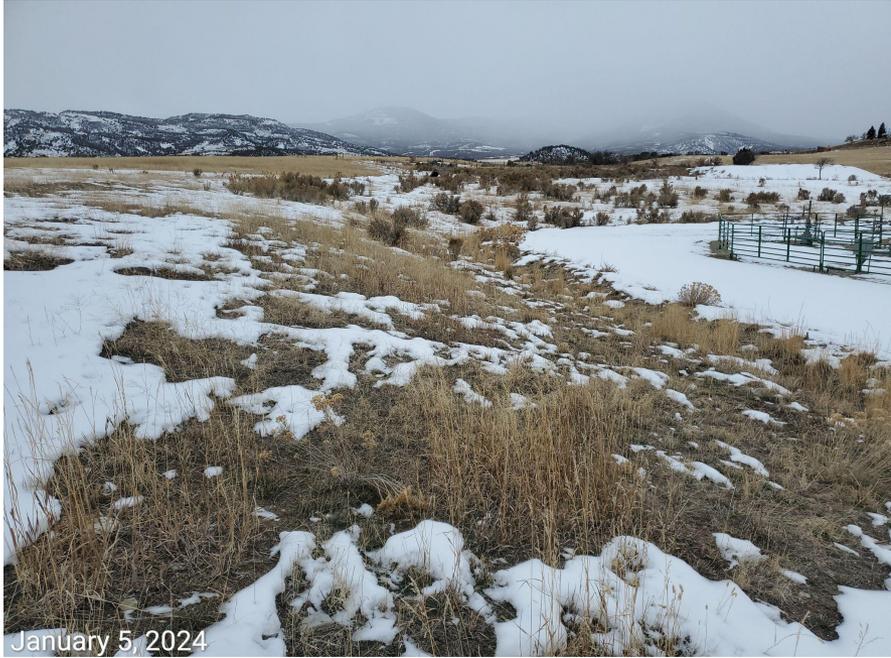
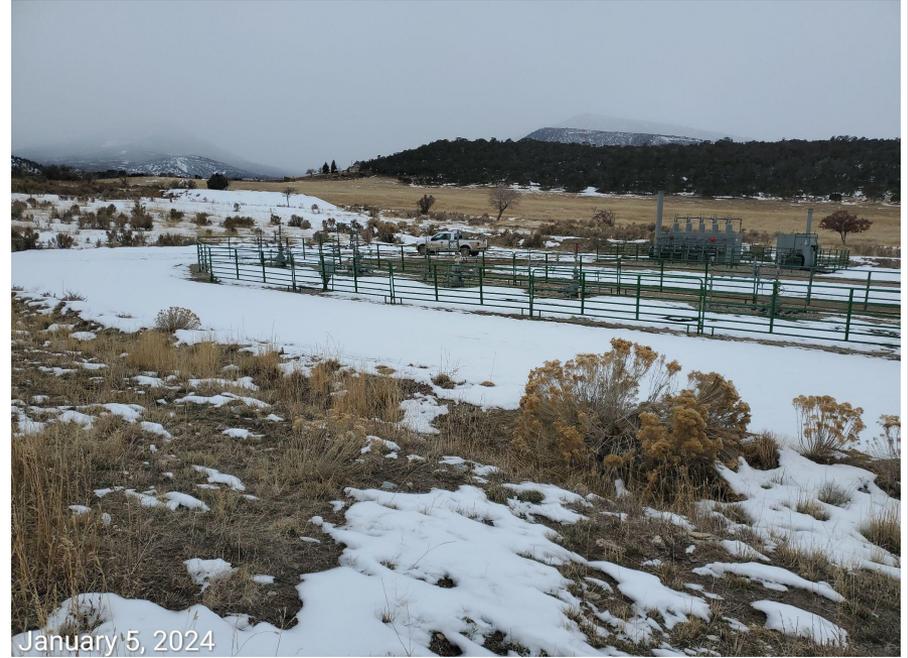
Photo 1: Photos 1-2 taken from the eastern interim areas of the Location. Photos provide an overview of the Location from south, southwest, northwest to north.

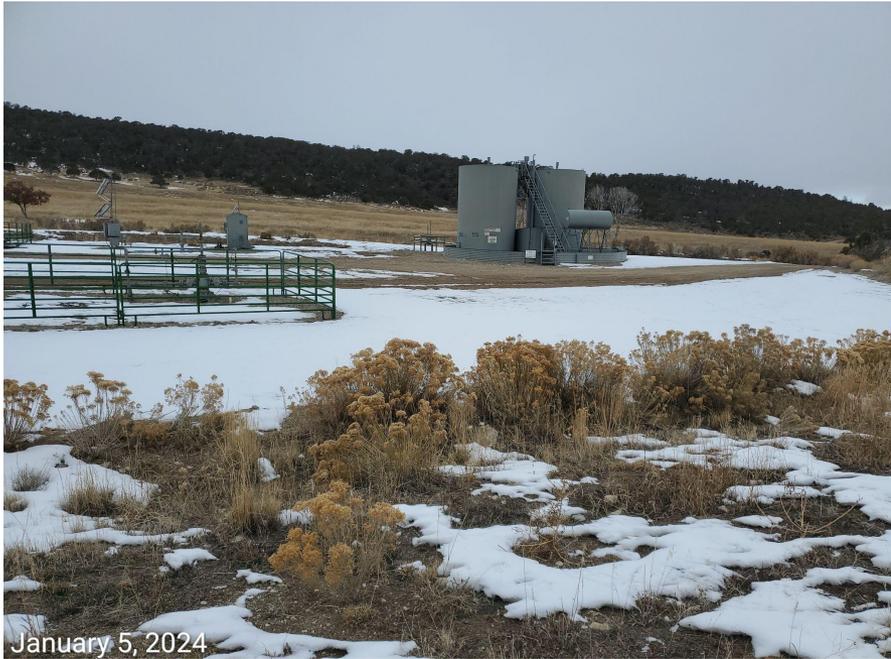
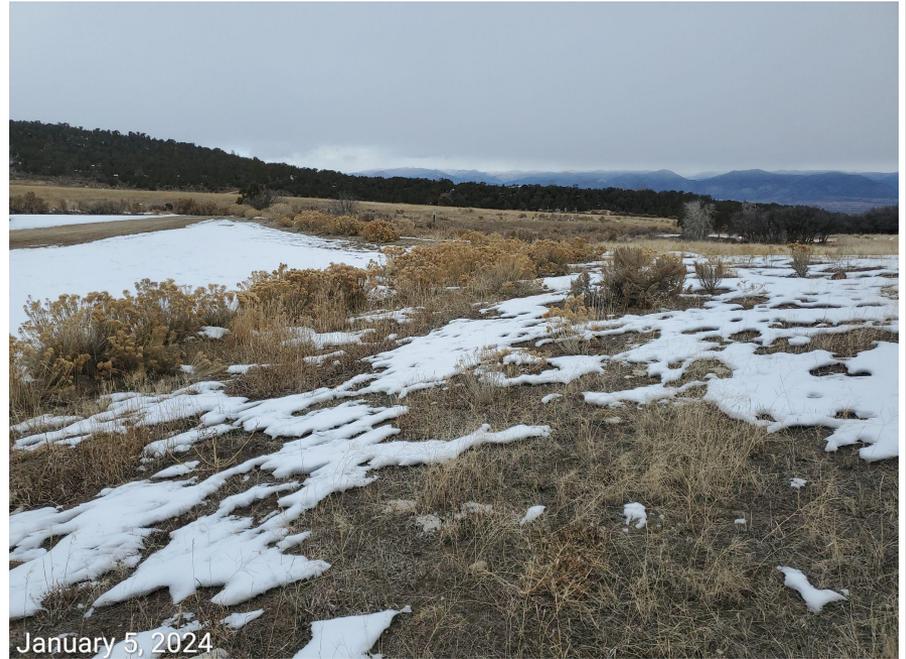
Photo 2: See comments under photo 1.

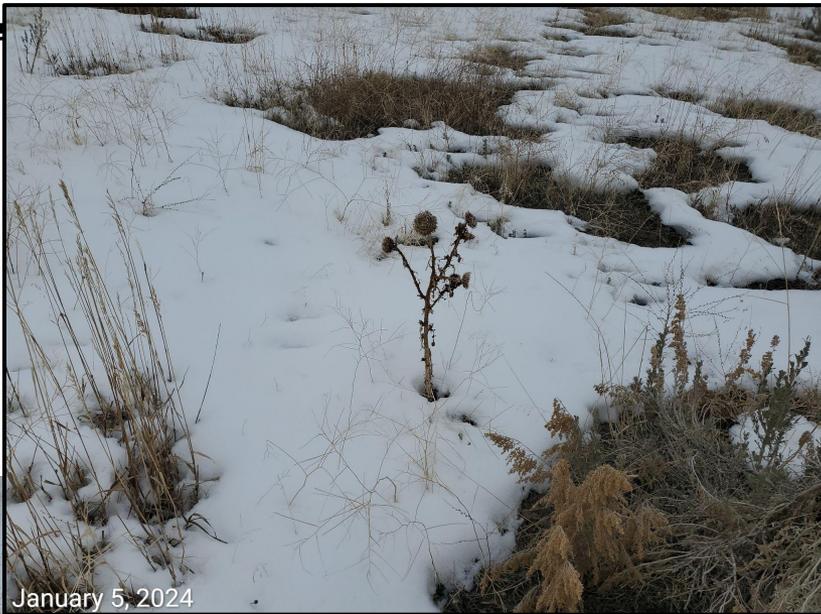
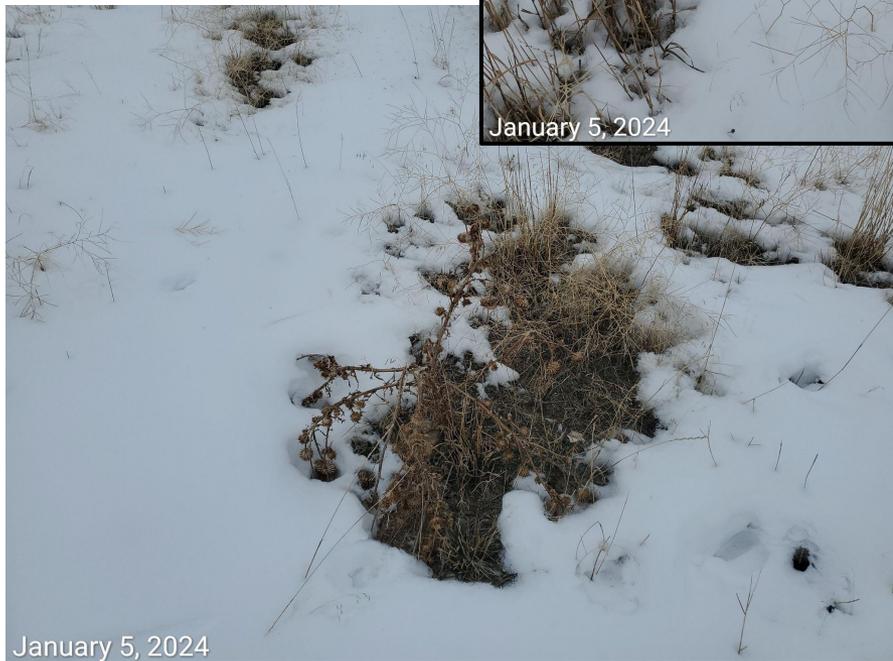
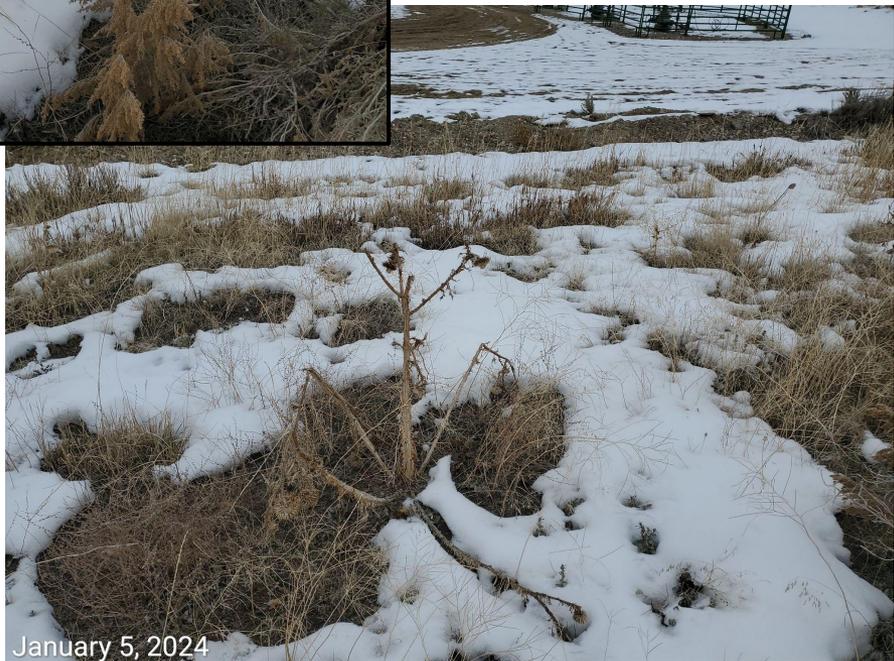
Photo 3: Photos examples of Noxious Weeds observed within the interim areas of the Location.

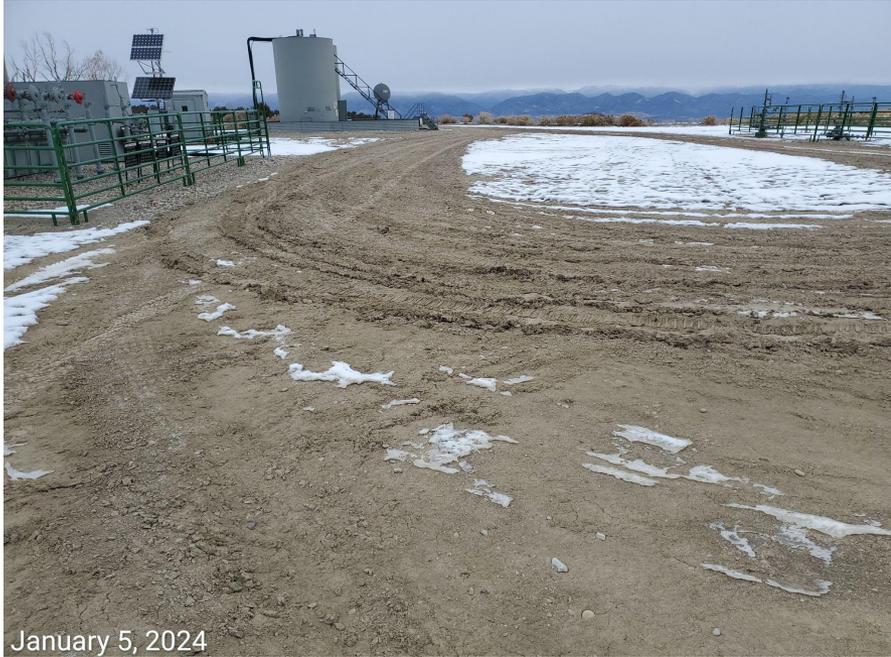
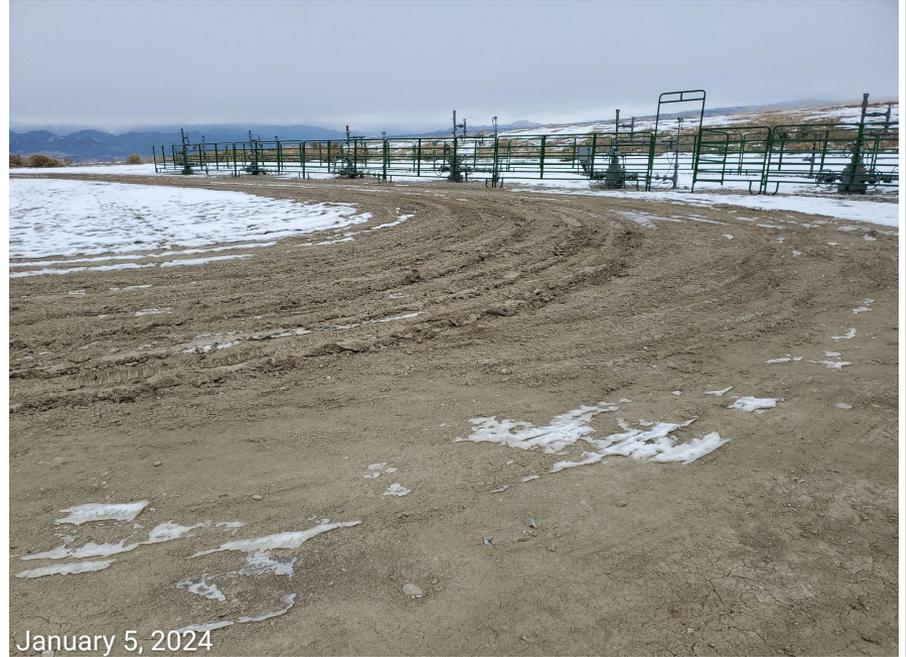
Photo 4: Working Pad Surface lacks stabilization; BMPs to minimize erosion, degradation and sediment transport missing or insufficient.

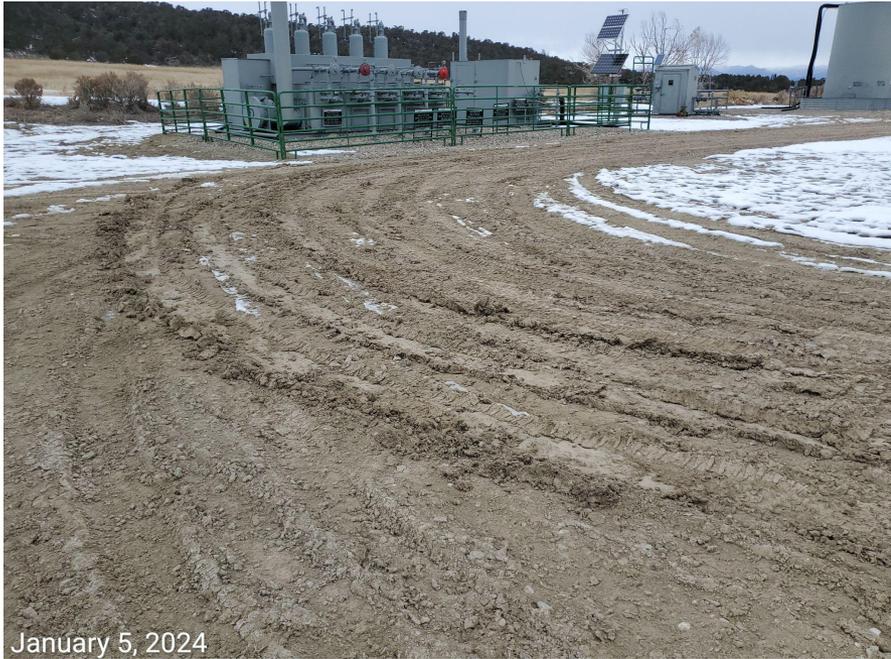
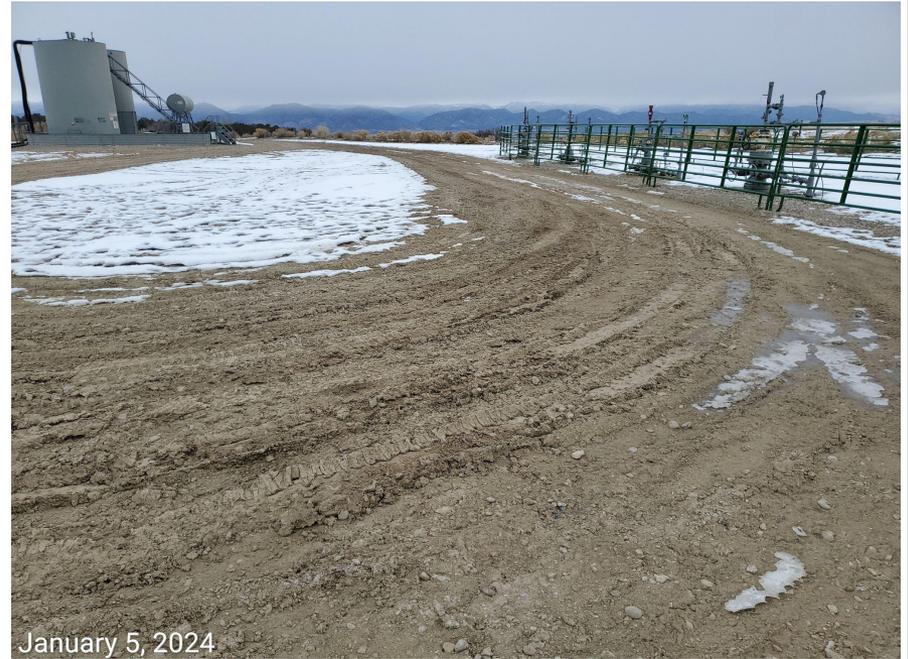
Photo 5: Working Pad Surface lacks stabilization; BMPs to minimize erosion, degradation and sediment transport missing or insufficient.

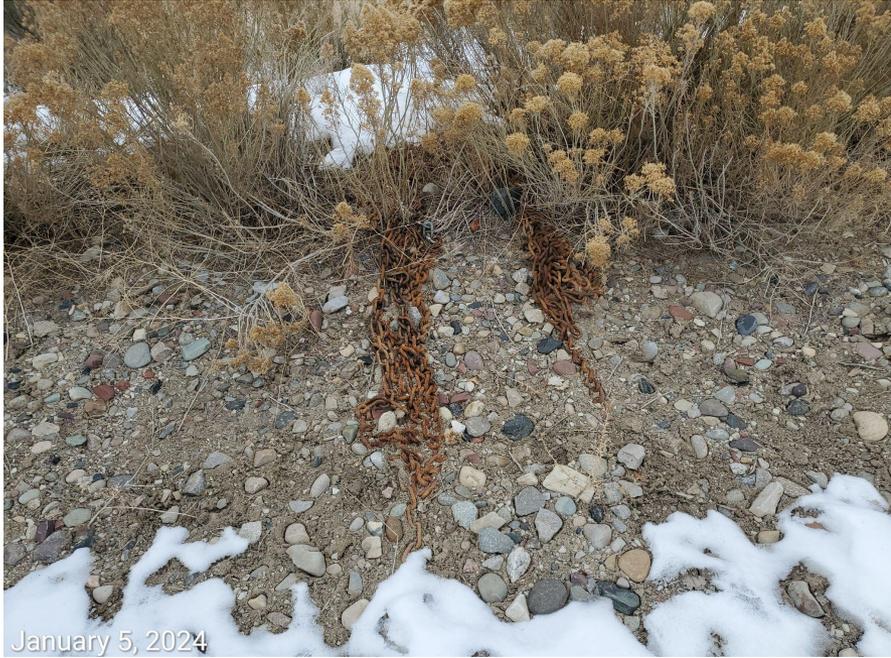
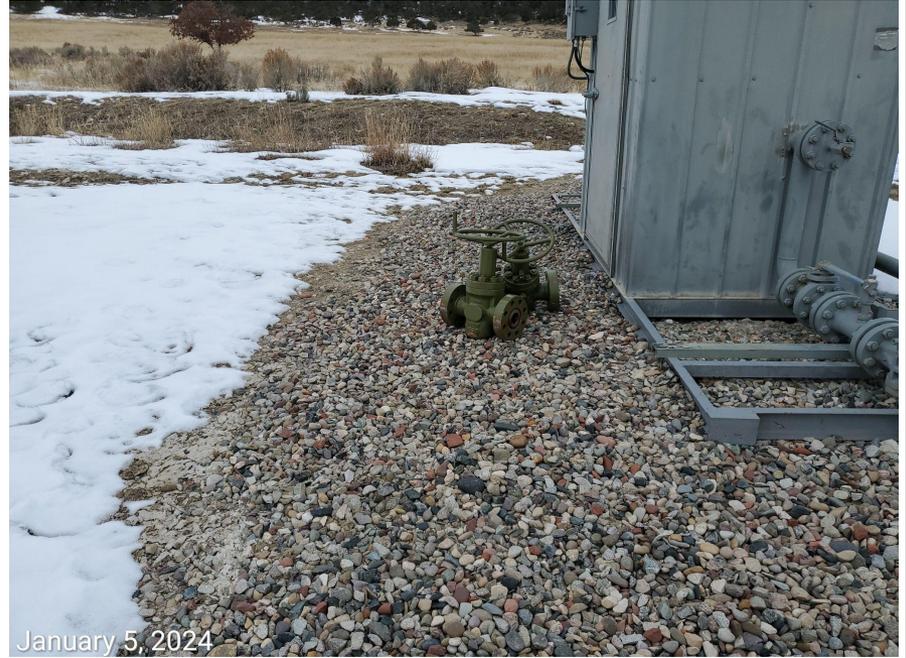
Photo 6: Unused equipment.

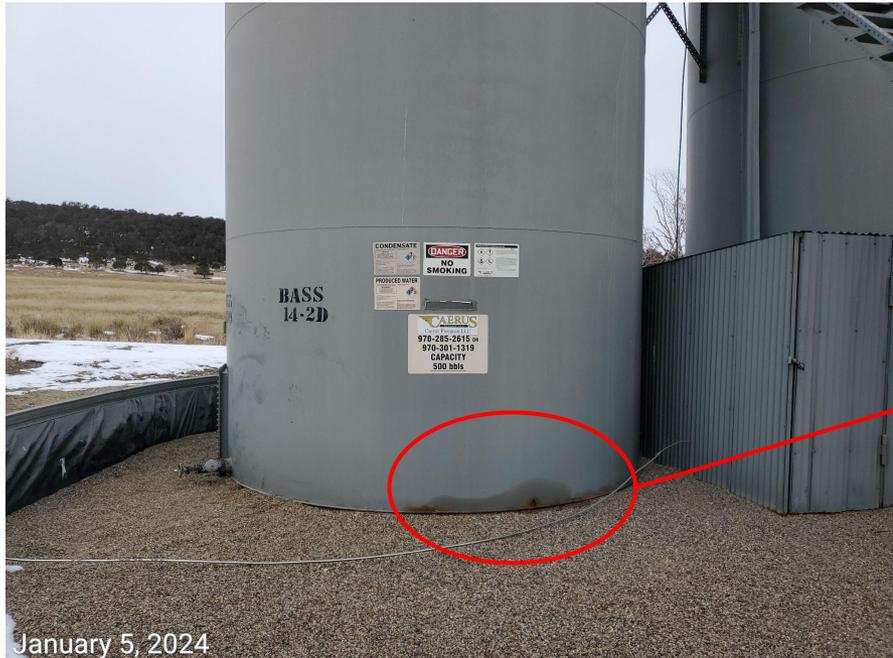
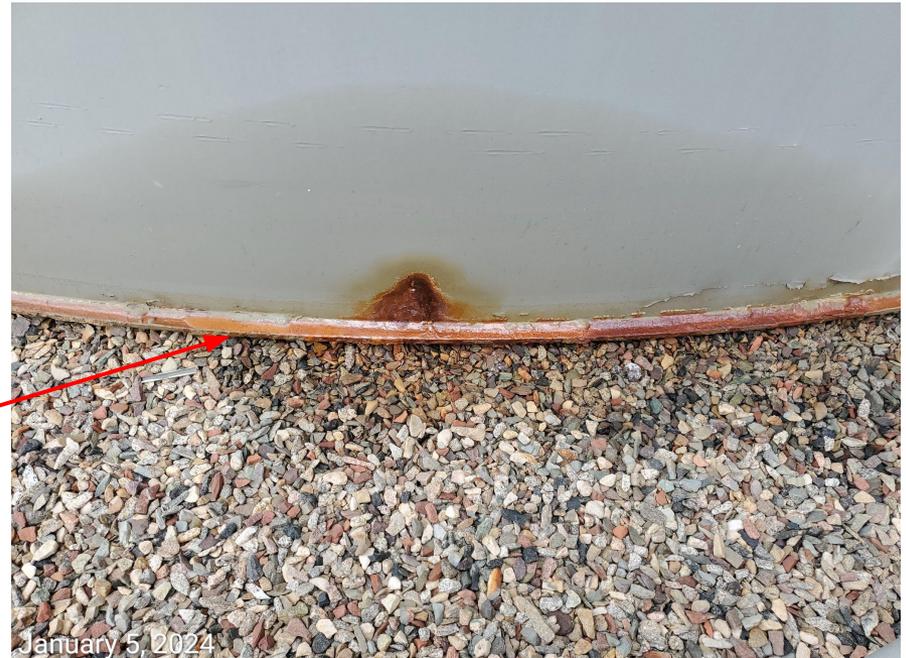
Photo 7: Corrosion observed at the base of the southern Produced Water / Condensate Tank; fluids appear to be leaking from these areas.

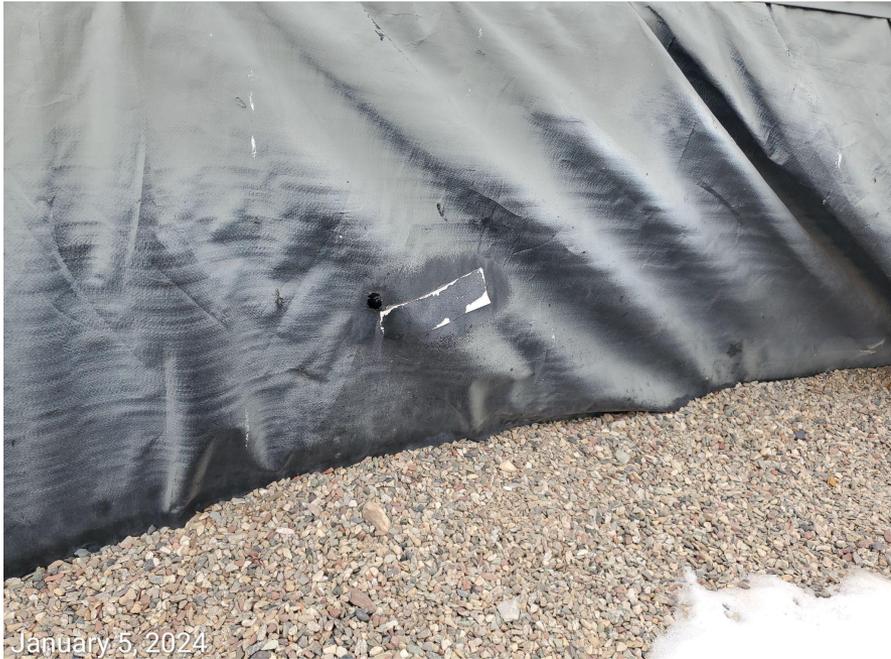
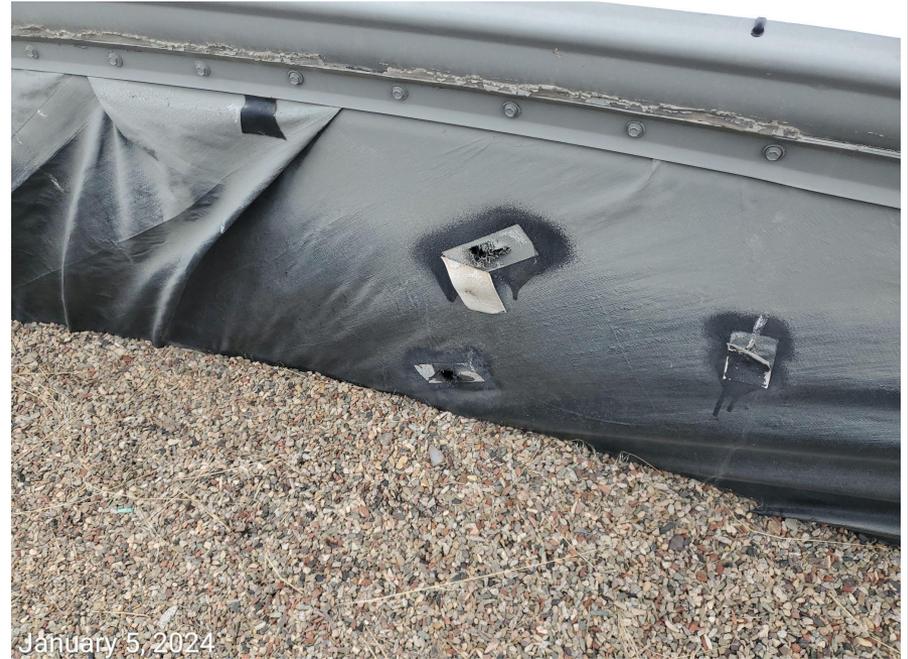
Photo 8: Photos examples showing holes observed within the liner at the tank battery.
