# Inspection Photos

API: 043-06194

Operator: **INCREMENTAL OIL & GAS (FLORENCE) LLC**

Inspection Date: 1/18/2024

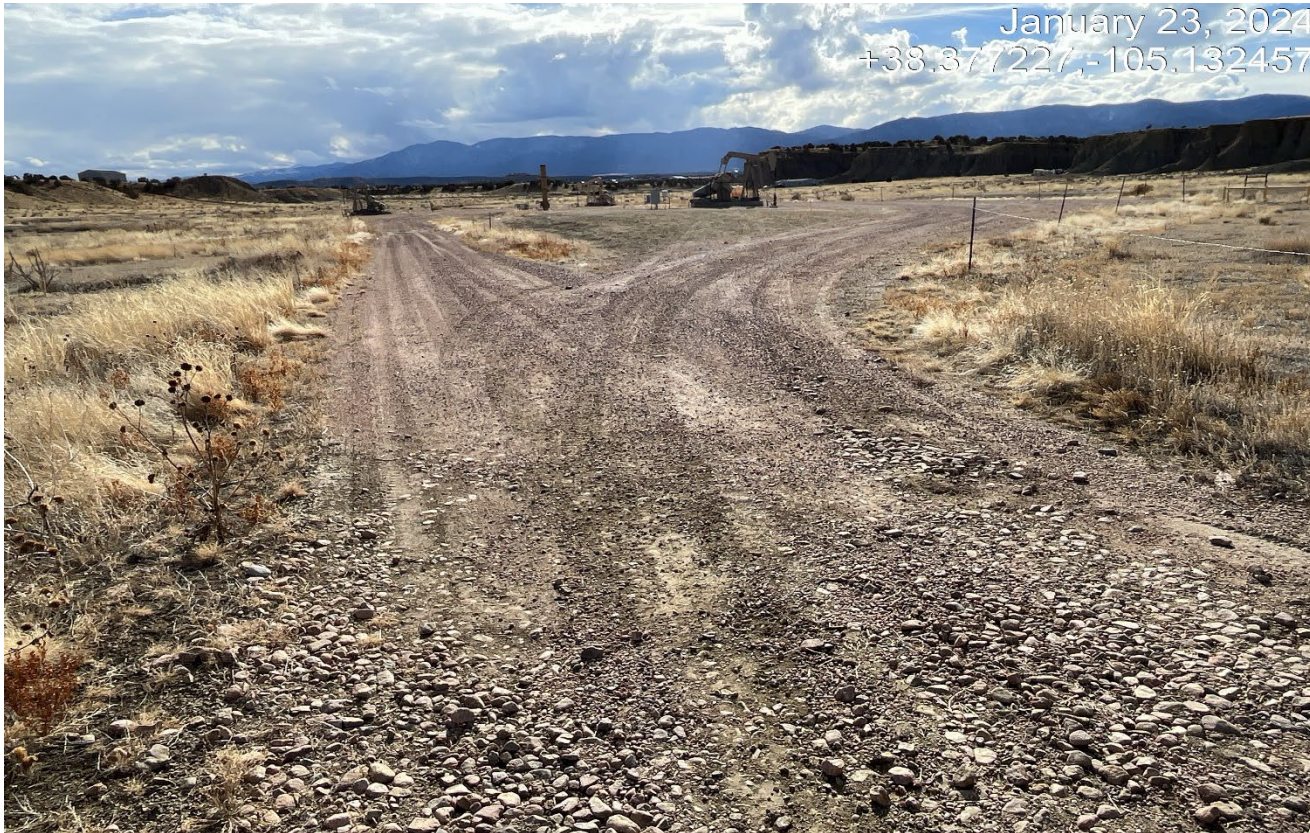
**Photo 1.** Facing southwest toward the wellsite location.

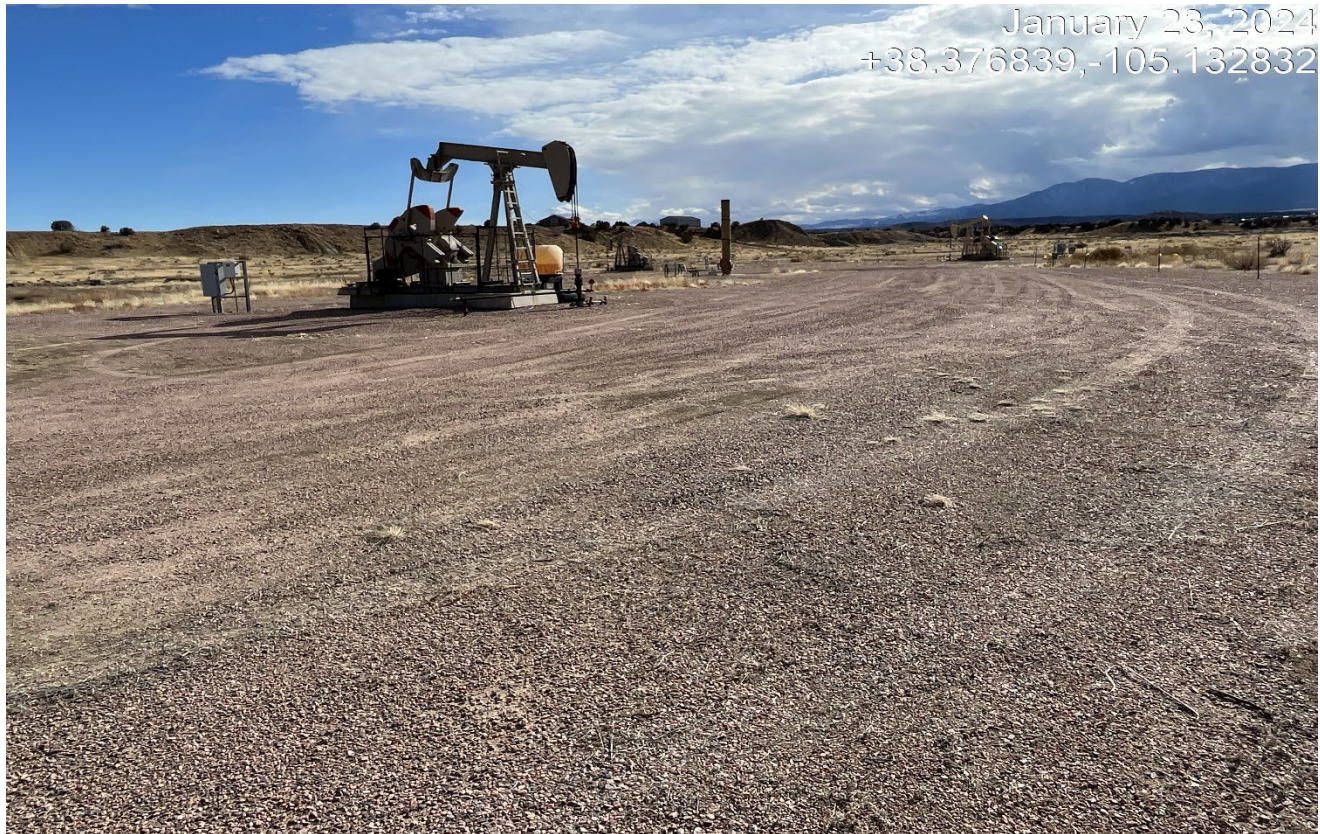
**Photo 2.** Facing southeast toward the wellsite.

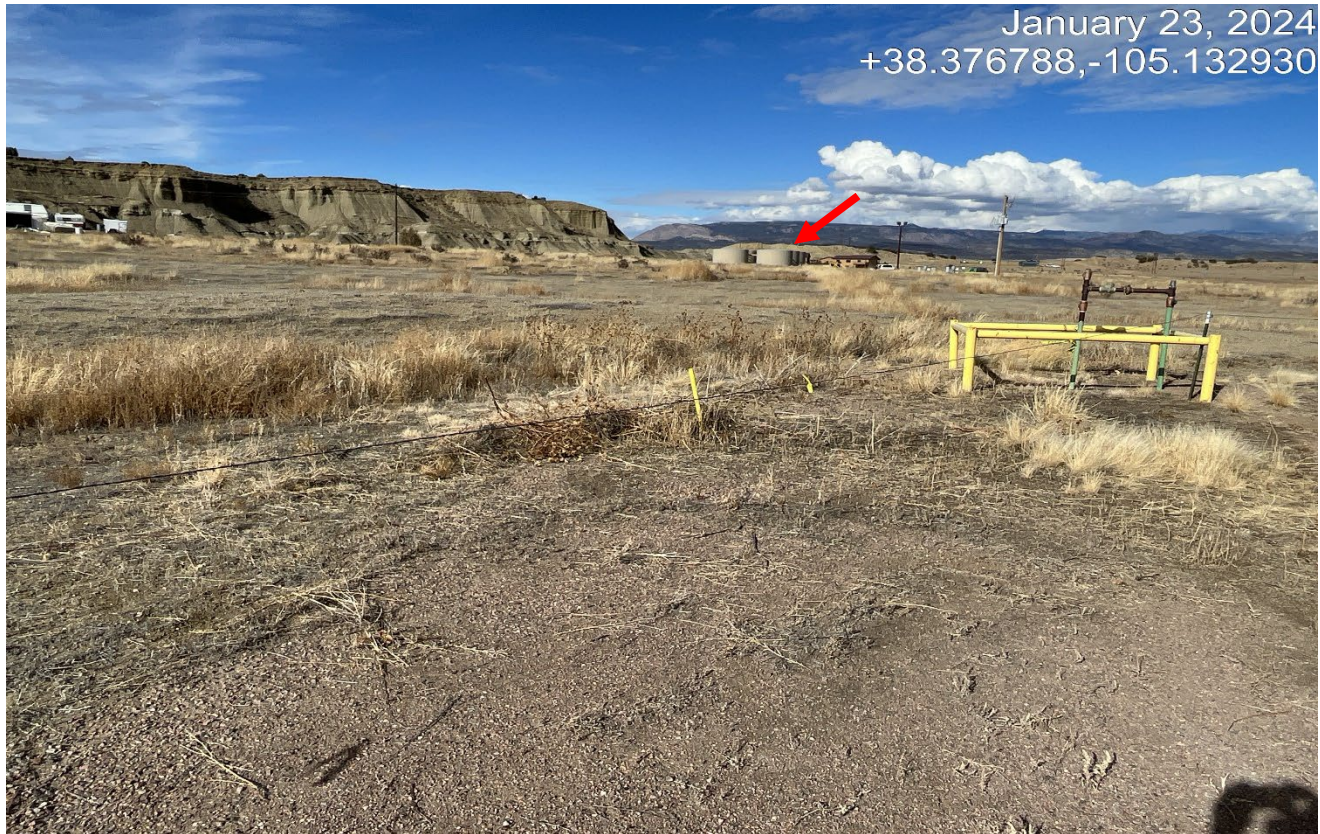
**Photo 3.** Facing back northwest. There is an offsite tank battery shown at red arrow.

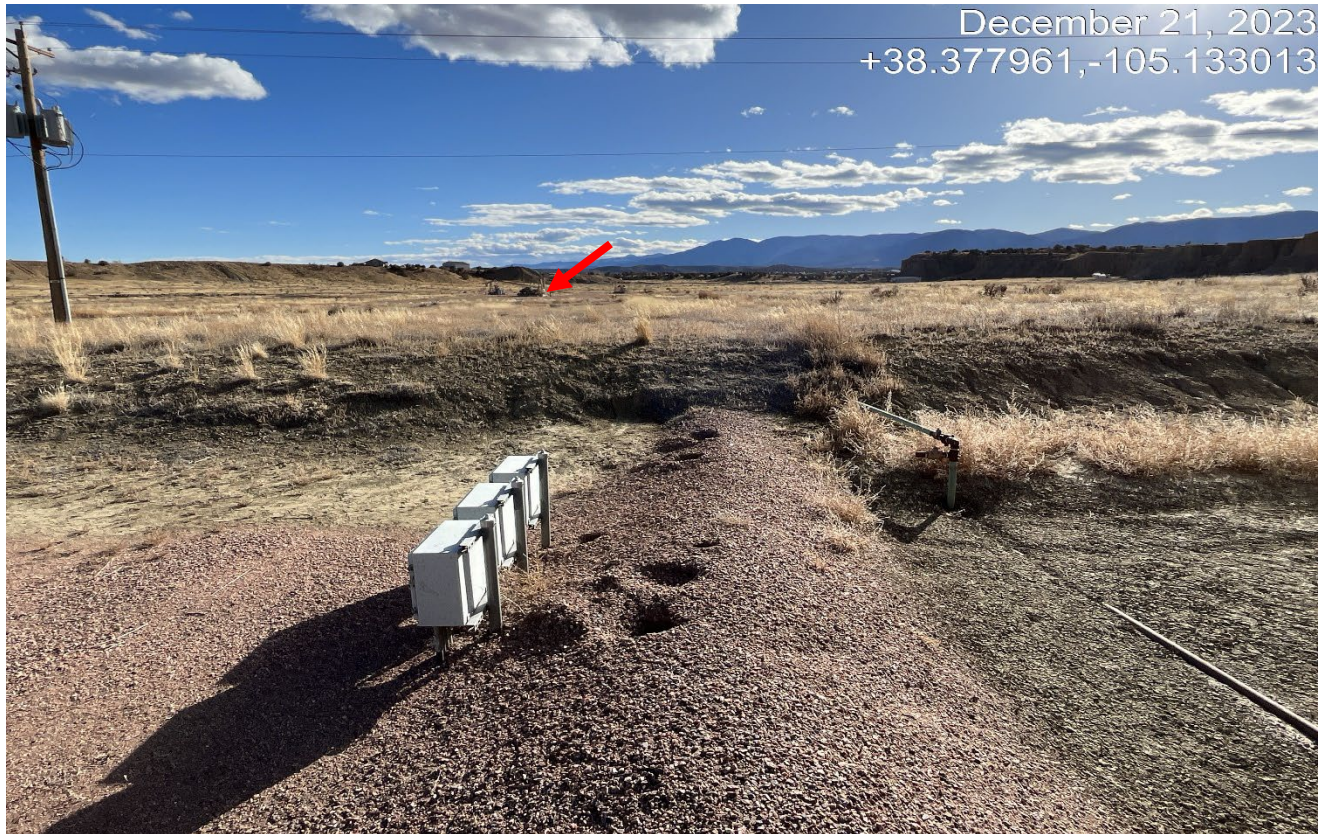
**Photo 4.** Standing at the tank battery facing south. The well is shown at red arrow. The flowline does not appear to be registered.

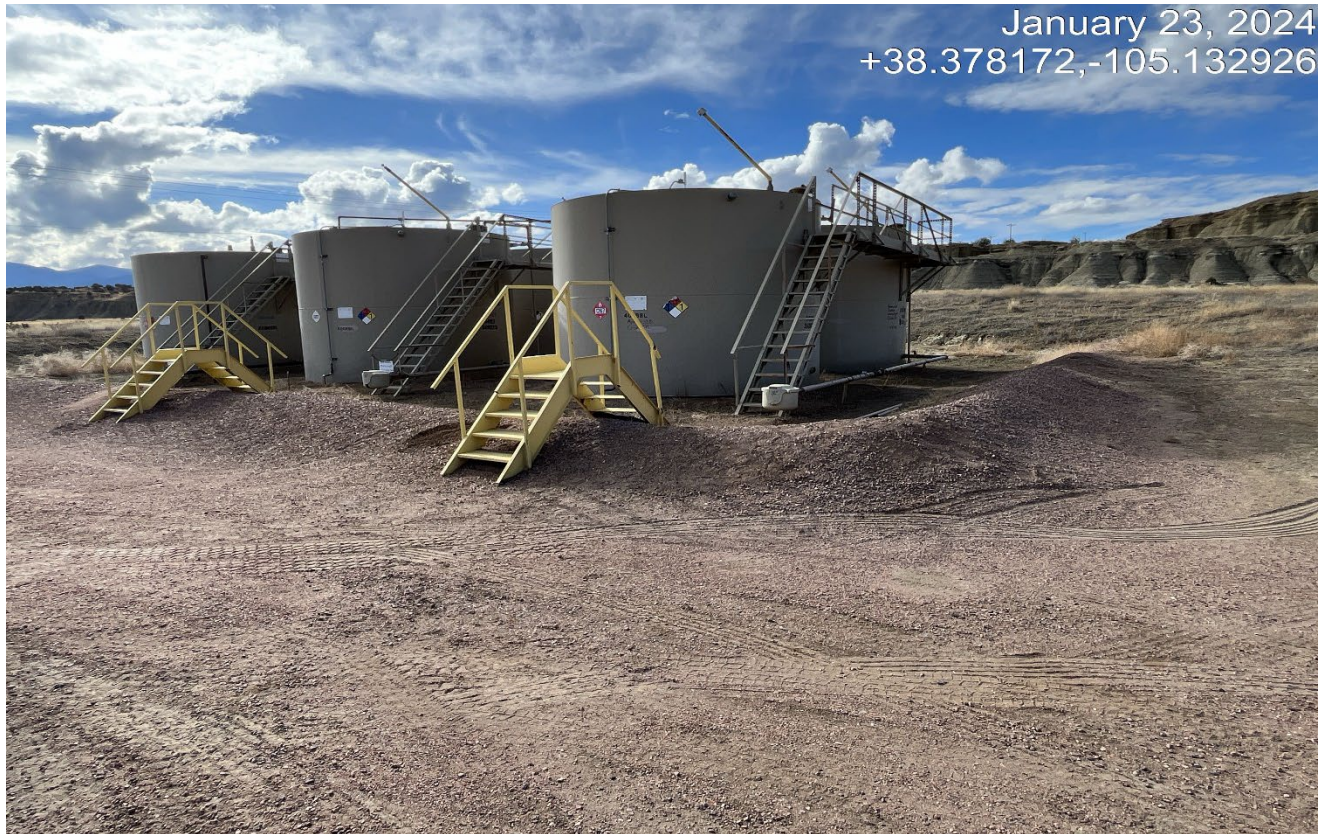
**Photo 5.** Facing southwest toward the offsite tank battery which has 6 tanks. There is not a proper sign posted at the tank battery.

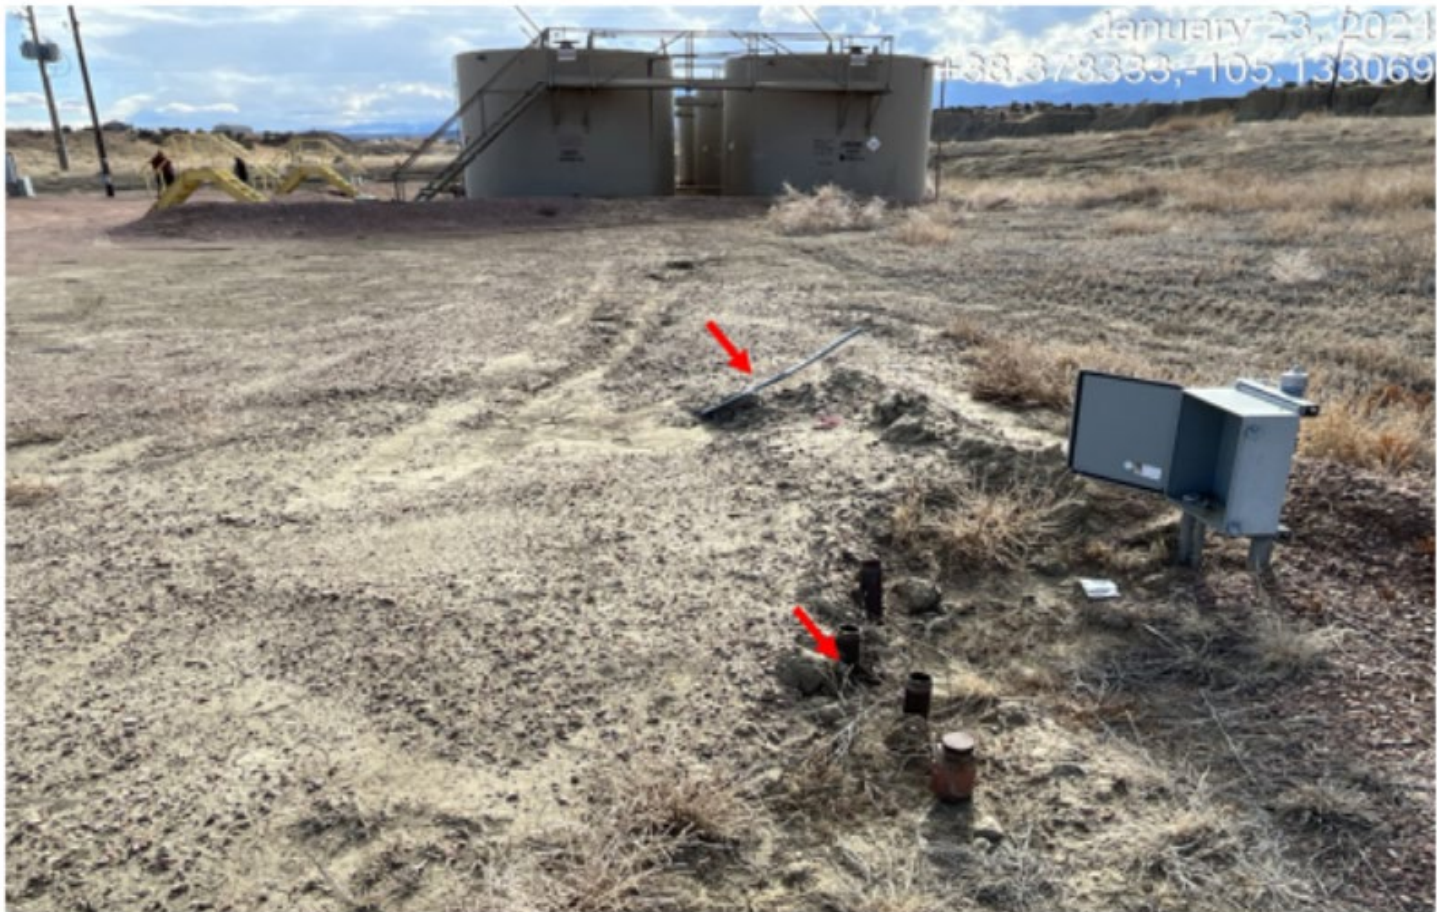
**Photo 4.** Facing south at the west side of the location. There is an exposed electric line at red arrow and multiple open pipe risers. All risers and utilities need to be removed. Previous corrective action was not completed.
