Construction and Stormwater Inspection

Operator: BAYSWATER EXPLORATION & PRODUCTION LLC- 10261

Location ID: 484898

Inspection Photos
Location Name: Onyx/Pad
Location ID: 484898

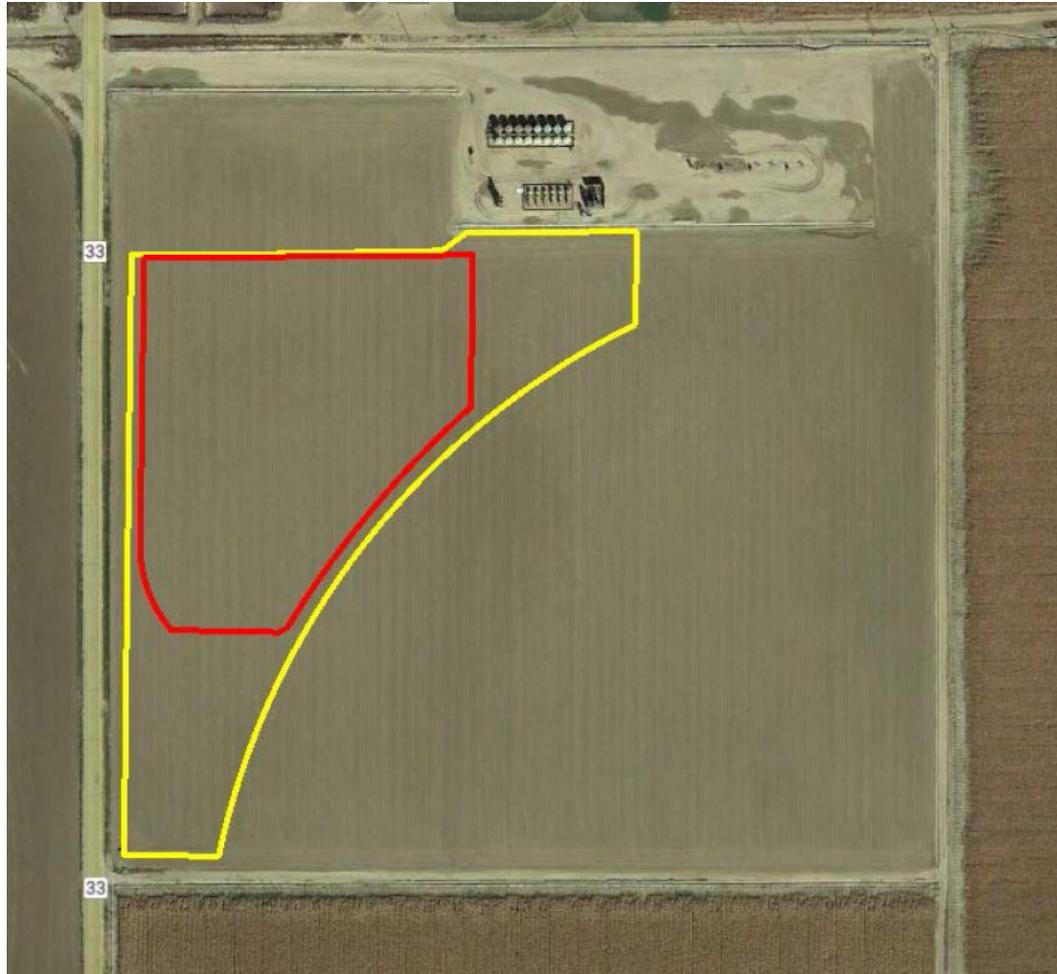
Photo 1. Google Earth aerial imagery from 10/14/2017 prior to the construction of the Onyx Pad. Imagery illustrates the Onyx pad outline and demonstrates the location was within agricultural production (flood irrigation); therefore, there should be a plow layer.

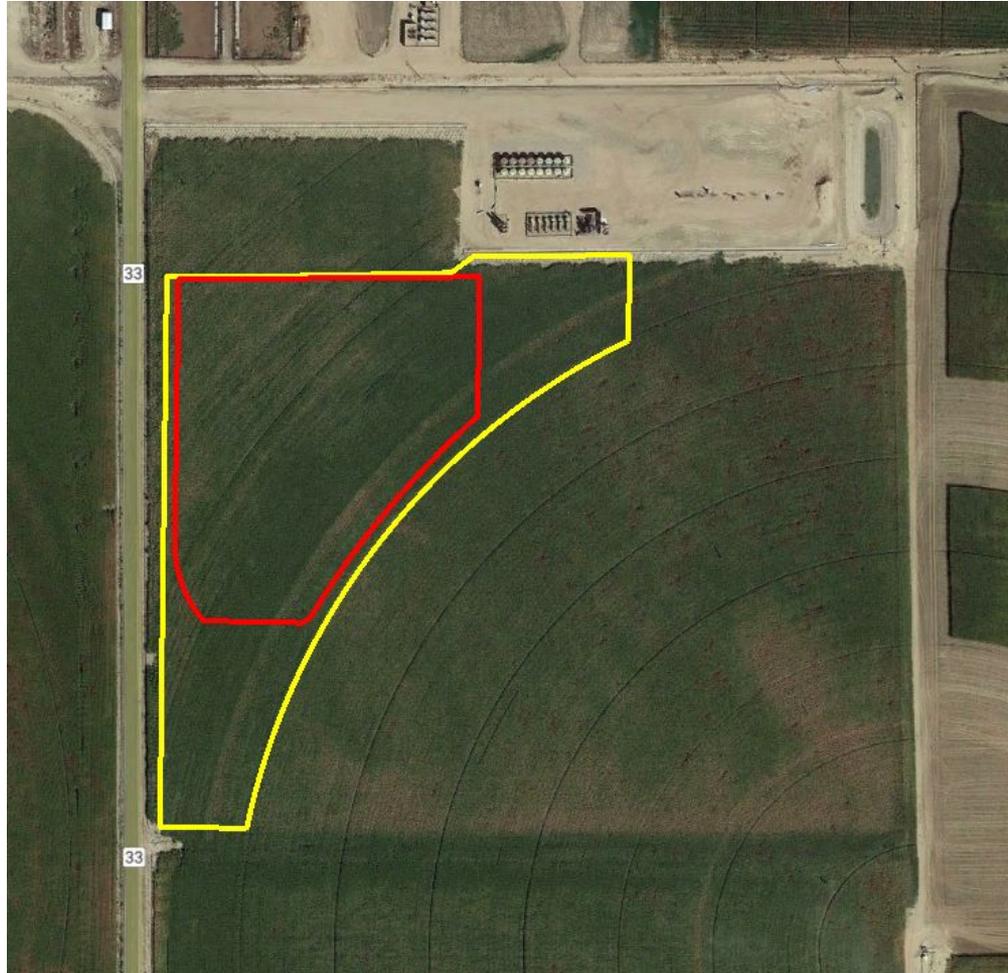
Photo 2. Google Earth aerial imagery from 9/12/2018 prior to the construction of the Onyx Pad. Imagery illustrates the Onyx pad outline and demonstrates the location was within agricultural production (pivot irrigation); therefore, there should be a plow layer.

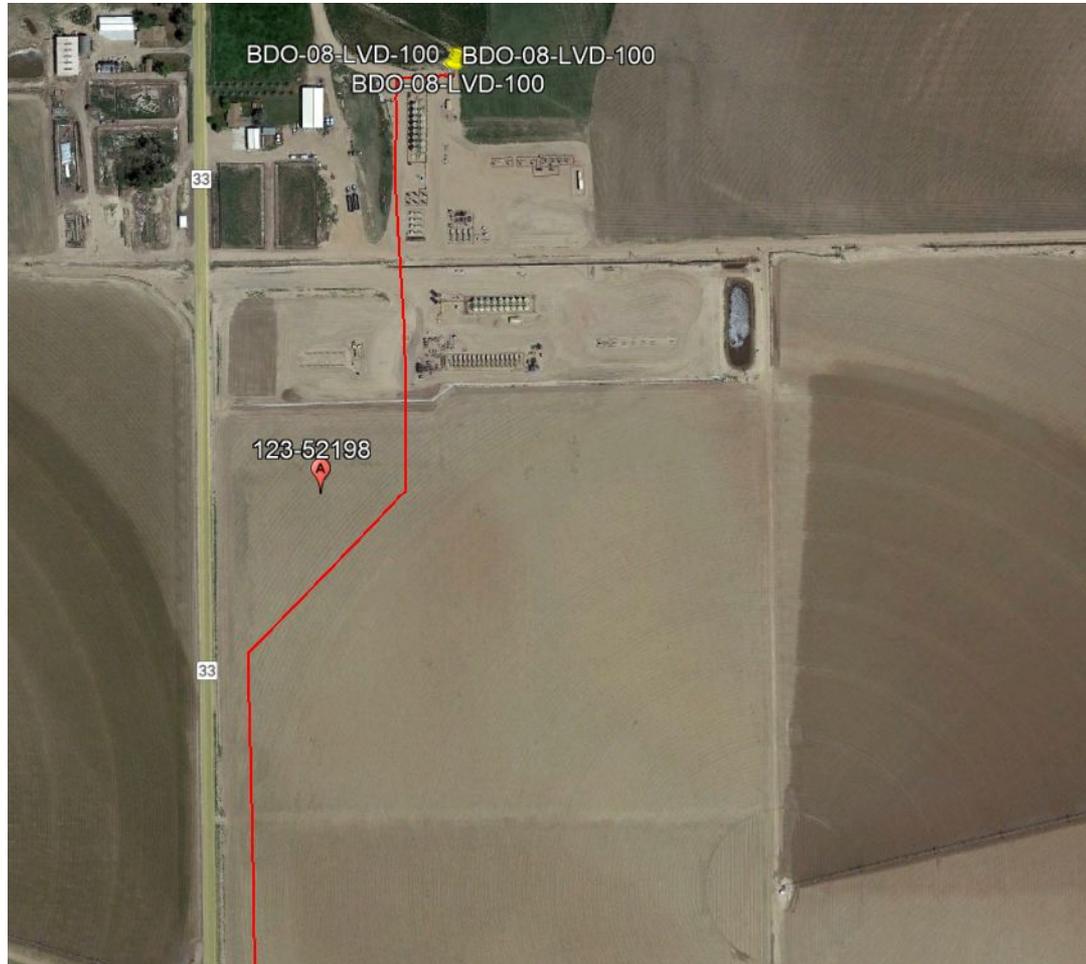
Photo 3. Google Earth aerial imagery from 6/11/2021 prior to the construction of the Onyx Pad but after the 8" crude oil gathering line was installed. Imagery illustrates the path of the crude oil gathering line and that the landowner was conducting agricultural practices, likely tilling to a depth of 12" (plow layer).
