# Final Reclamation Inspection

Operator: EXTRACTION OIL & GAS INC - 10459

Location ID: 321507

Inspection Photos  
Location Name: GREEN-61S68W 17SESE  
Location ID: 321507

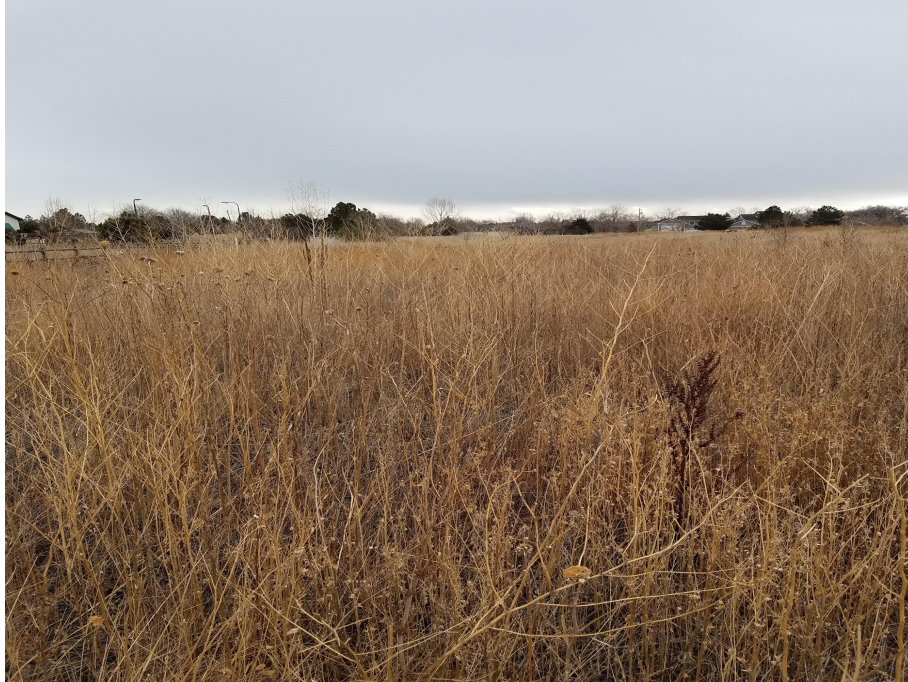
**Photo 1.** Photo taken from the tank battery location, facing East. Photo illustrates 5'-6' unmanaged weeds which are not reflective of reference areas.

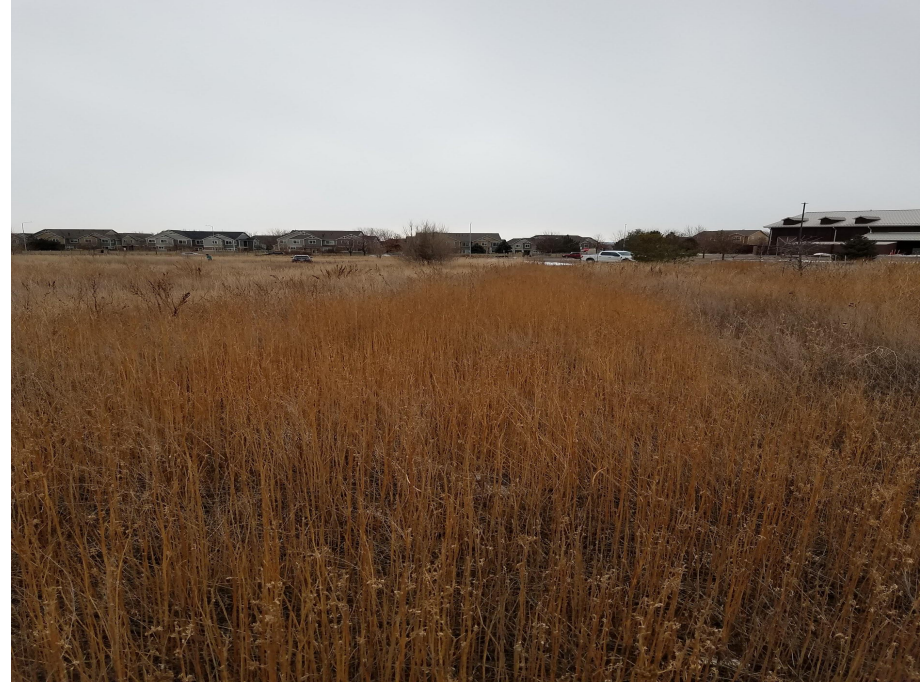
**Photo 2.** Photo taken from the north well location access road, facing South. Photo illustrates unmanaged weeds along the access road.

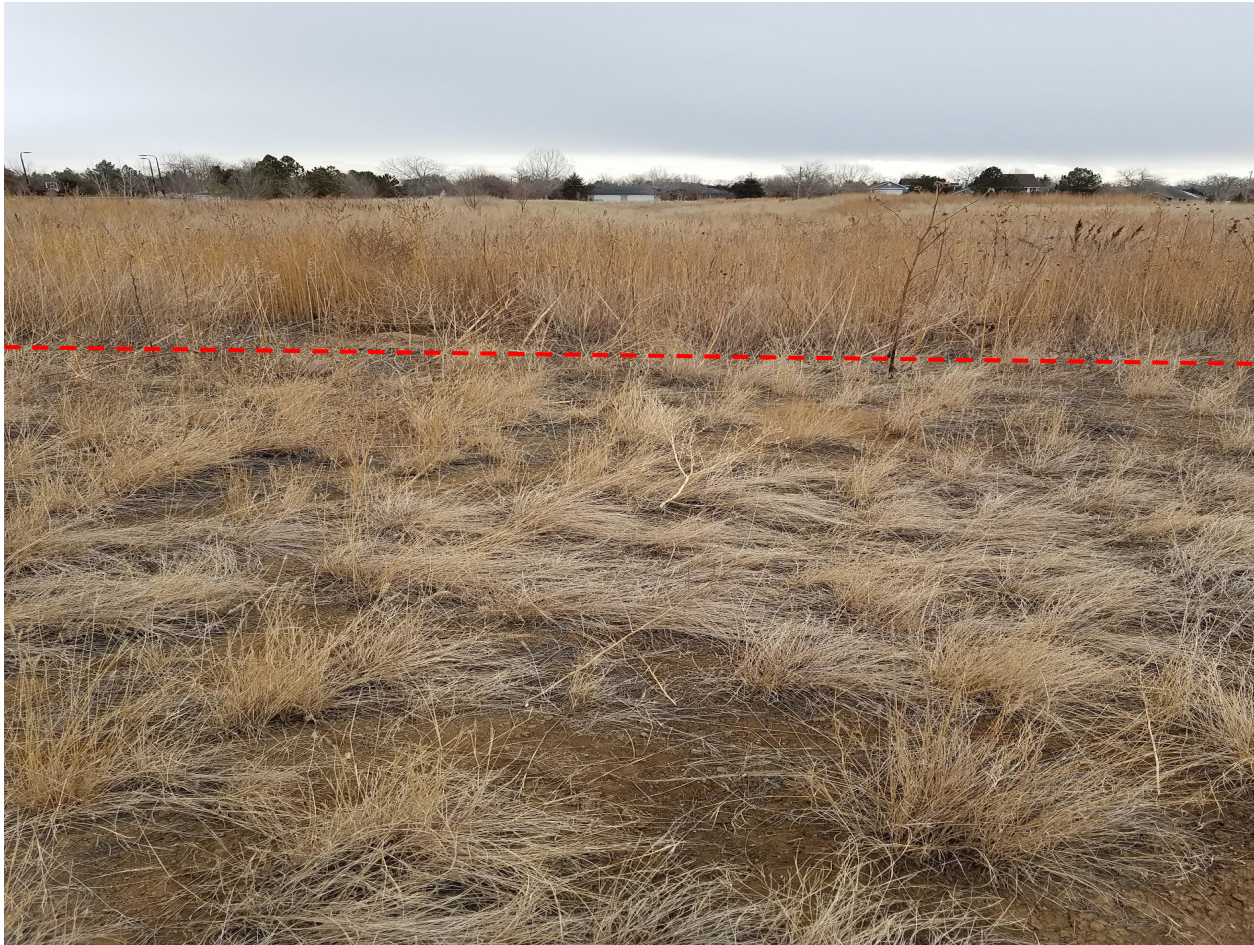
**Photo 3.** Photo taken from a portion of the access road, facing East. Reference area vegetation is below the red-dashed line; the weedy access road above the red-dashed

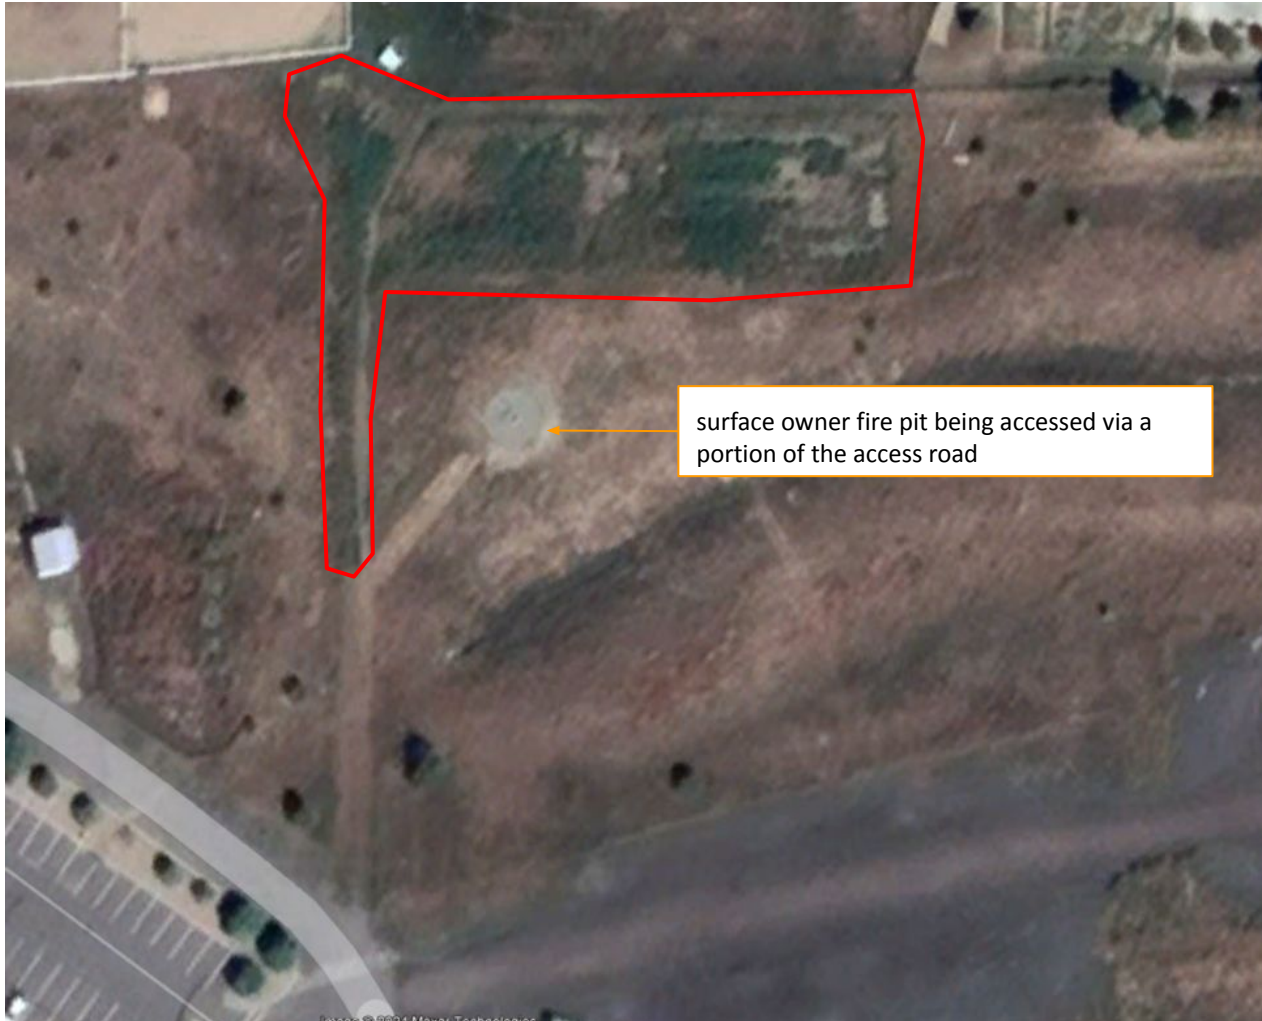
**Photo 4.** Google Earth aerial imagery from 9/21/2021. There has been some land use change along a portion of the access road that is not the responsibility of the Operator. Operator is responsible for the red outlined area.
