Inspection Photos

Operator: CAERUS PICEANCE LLC #10456

Location ID: 335780

Inspection Doc: 696205598

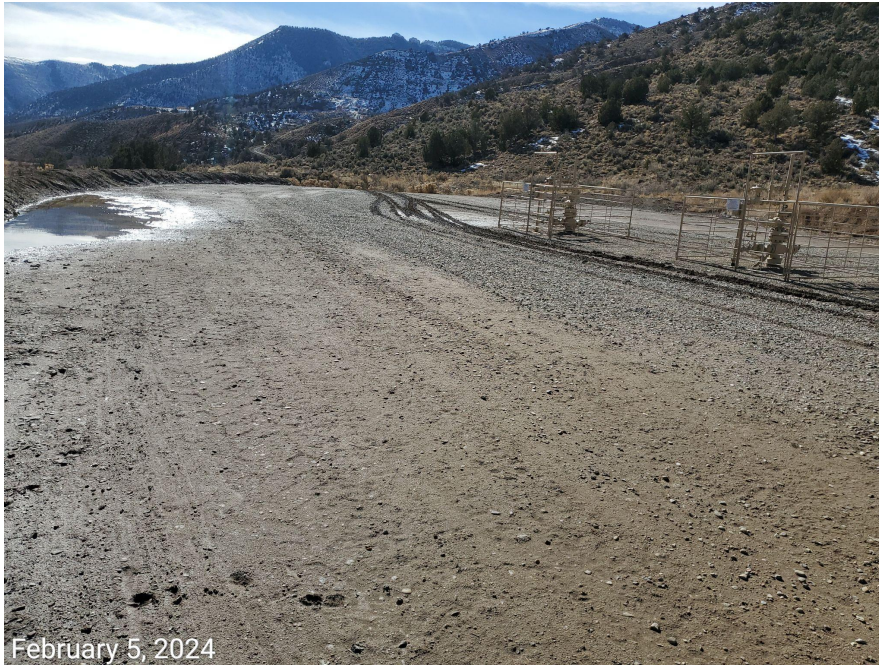
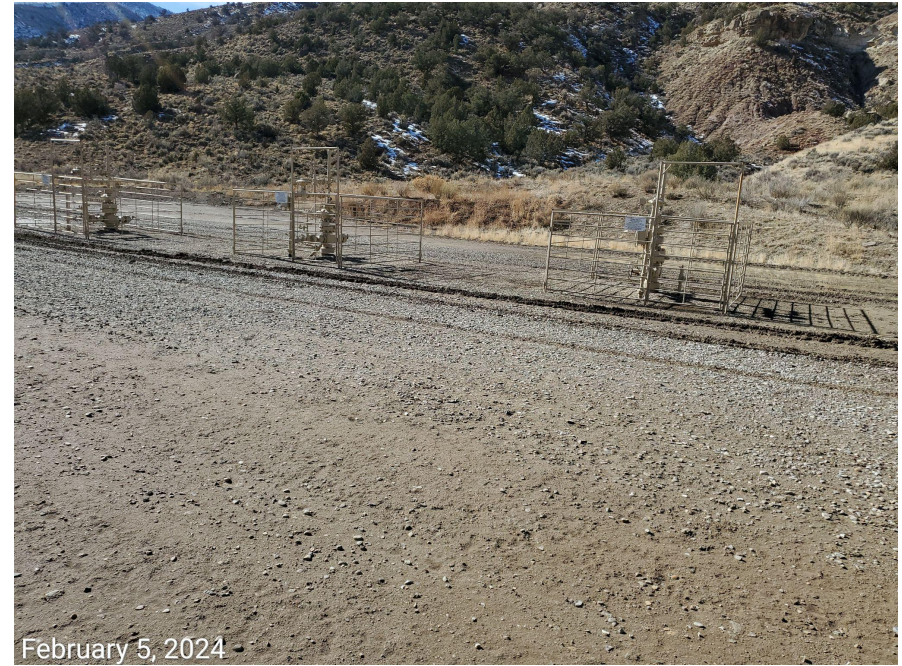
Photo 1: Photos 1-2 taken from the east end of the Location. Photos provide an overview of the Location from south, southwest, northwest to north.

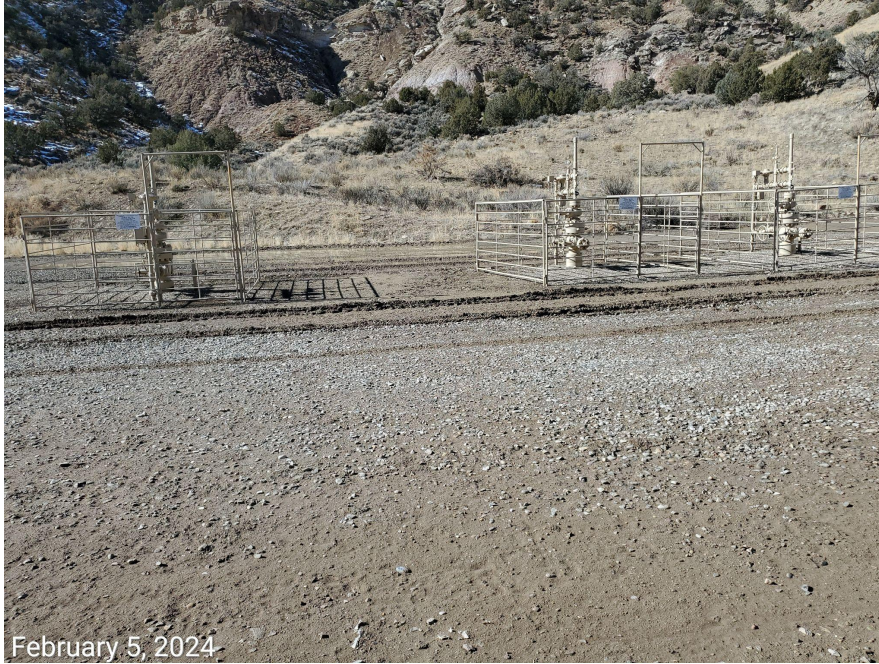
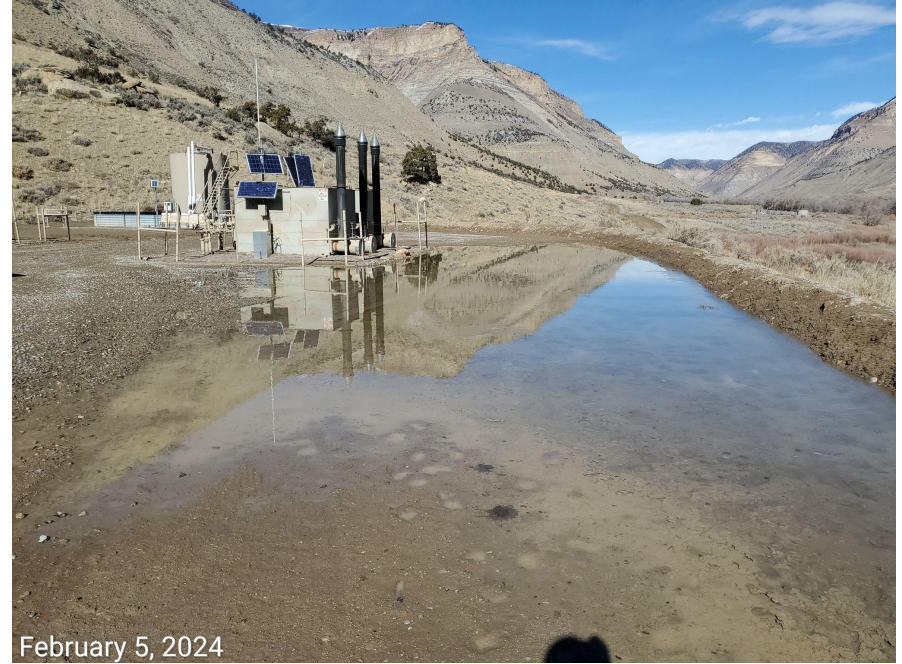
Photo 2: See comments under photo 1.

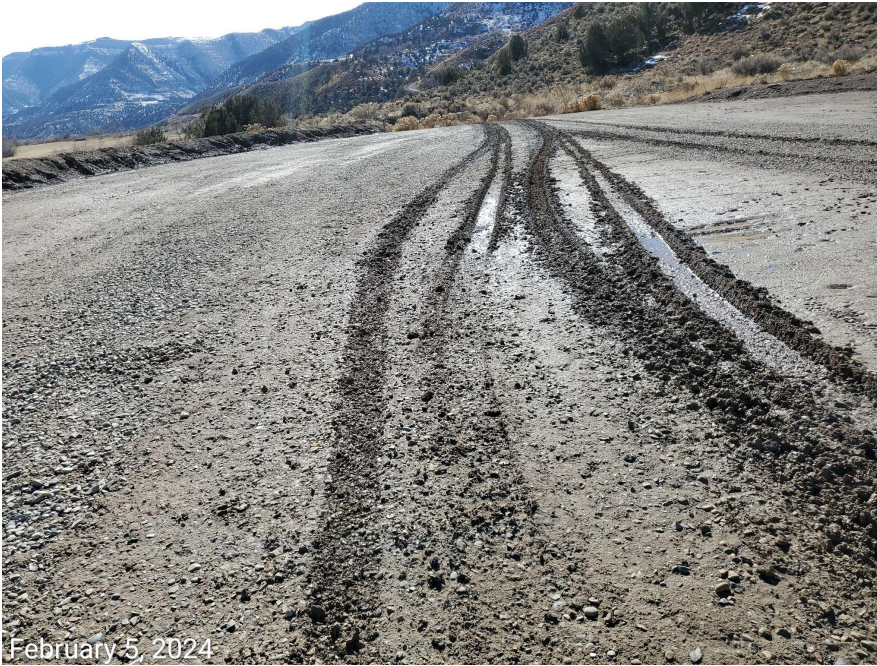
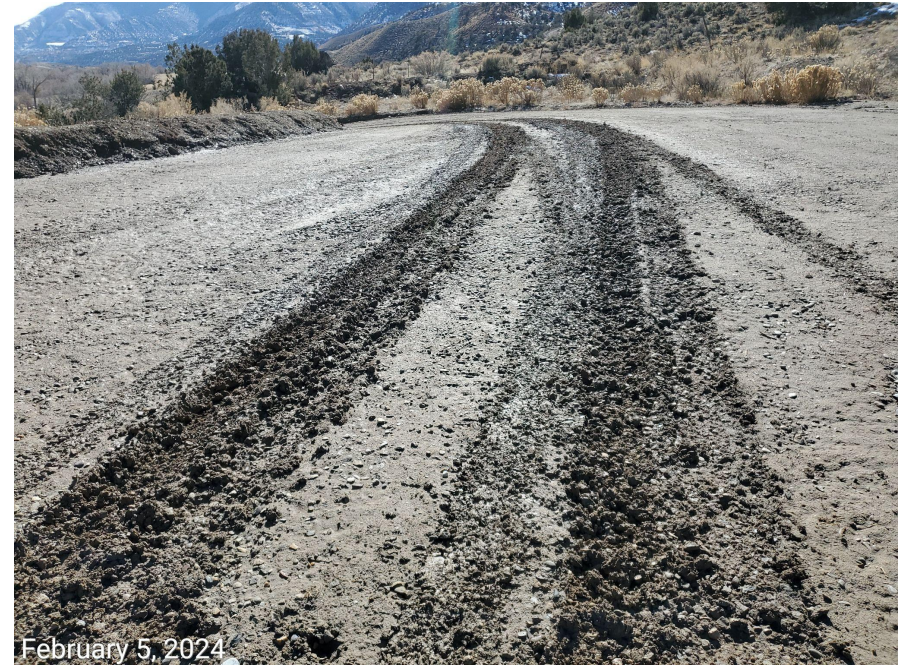
Photo 3: Photos examples showing BMPs to stabilize the working pad surface, and to minimize erosion, degradation and sediment transport have not been maintained in proper functioning condition.

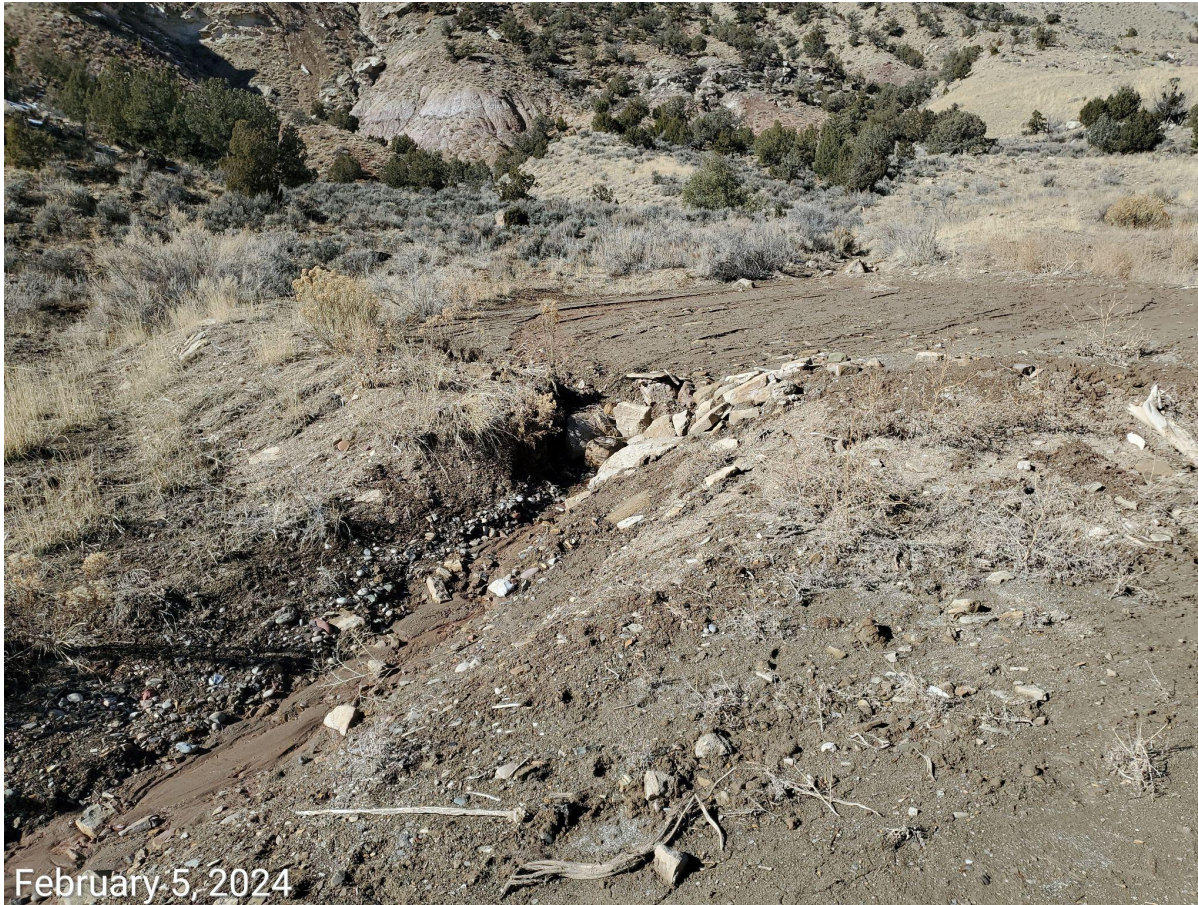
Photo 4: Photos taken from the sediment trap on the southwest end of the Location. Photo shows work to repair or maintain BMP does not appear to have been performed; outlet at BMP remains in disrepair; degradation at outlet has persisted. Sediment trap remains filled with sediment.

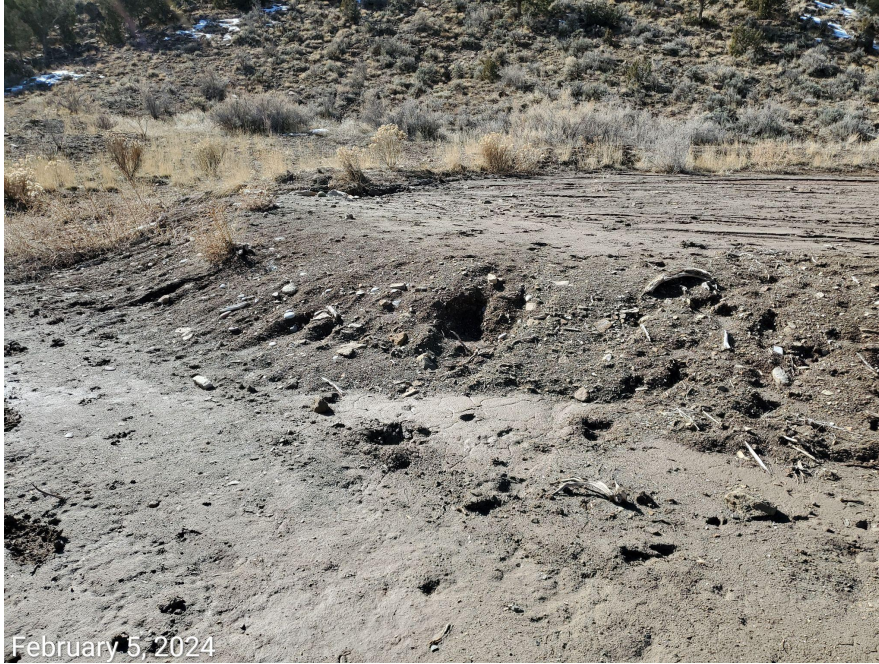
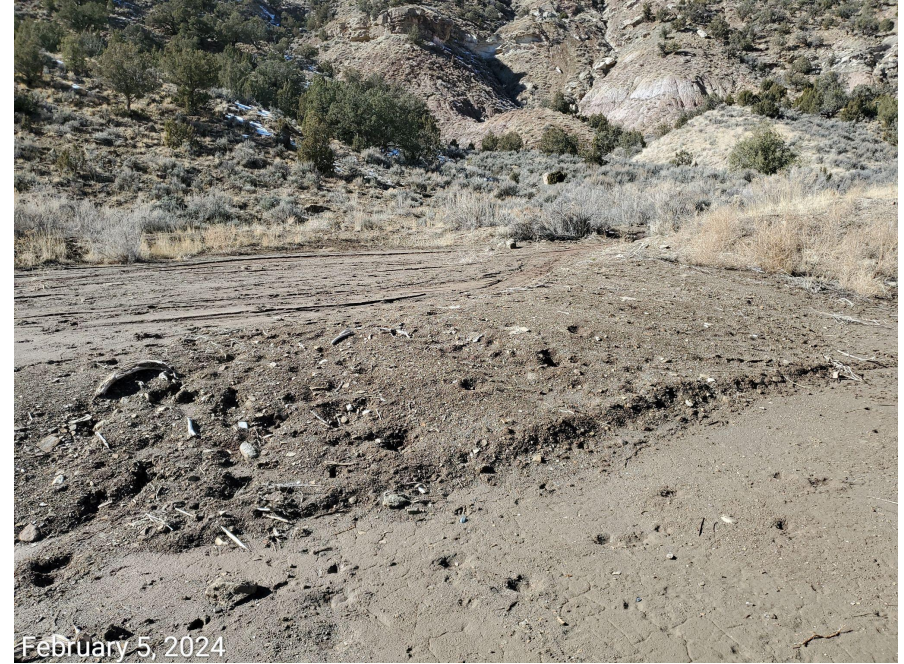
Photo 5: Photos taken from the sediment trap on the southwest end of the Location. Photo shows work to repair or maintain BMP does not appear to have been performed; sediment trap remains filled with sediment.

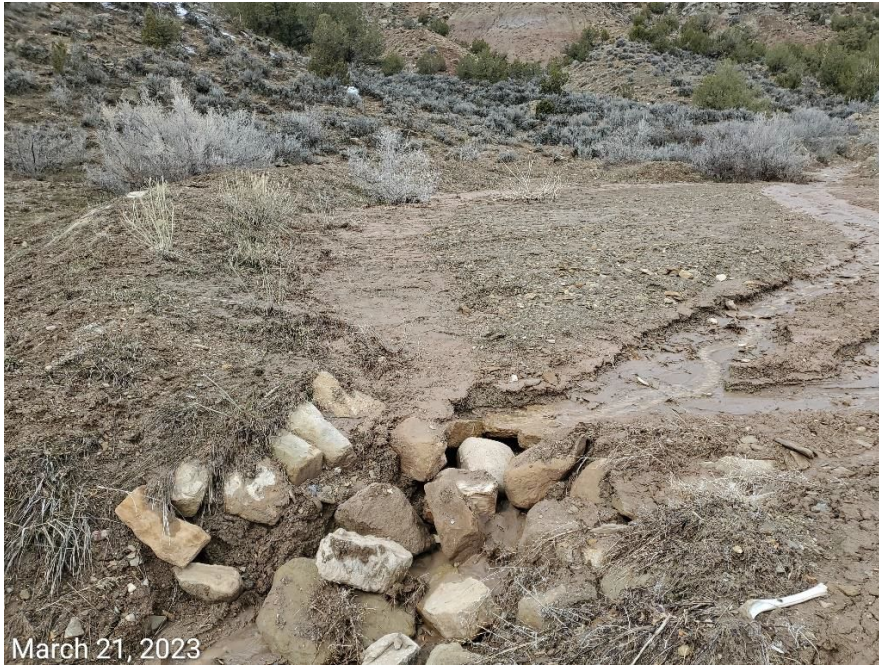
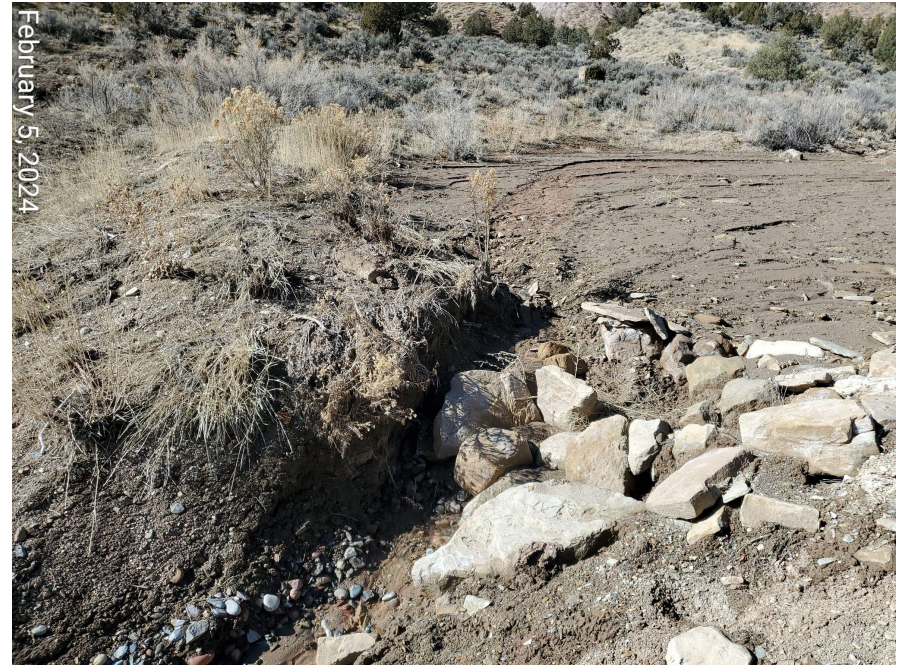
Photo 6: Photo left taken from the 3/21/2023 inspection. Photo right dated 2/5/2024. Photos used for comparison to show work to repair or maintain BMP does not appear to have been performed; degradation at inlet has persisted. Sediment has not been removed from trap.

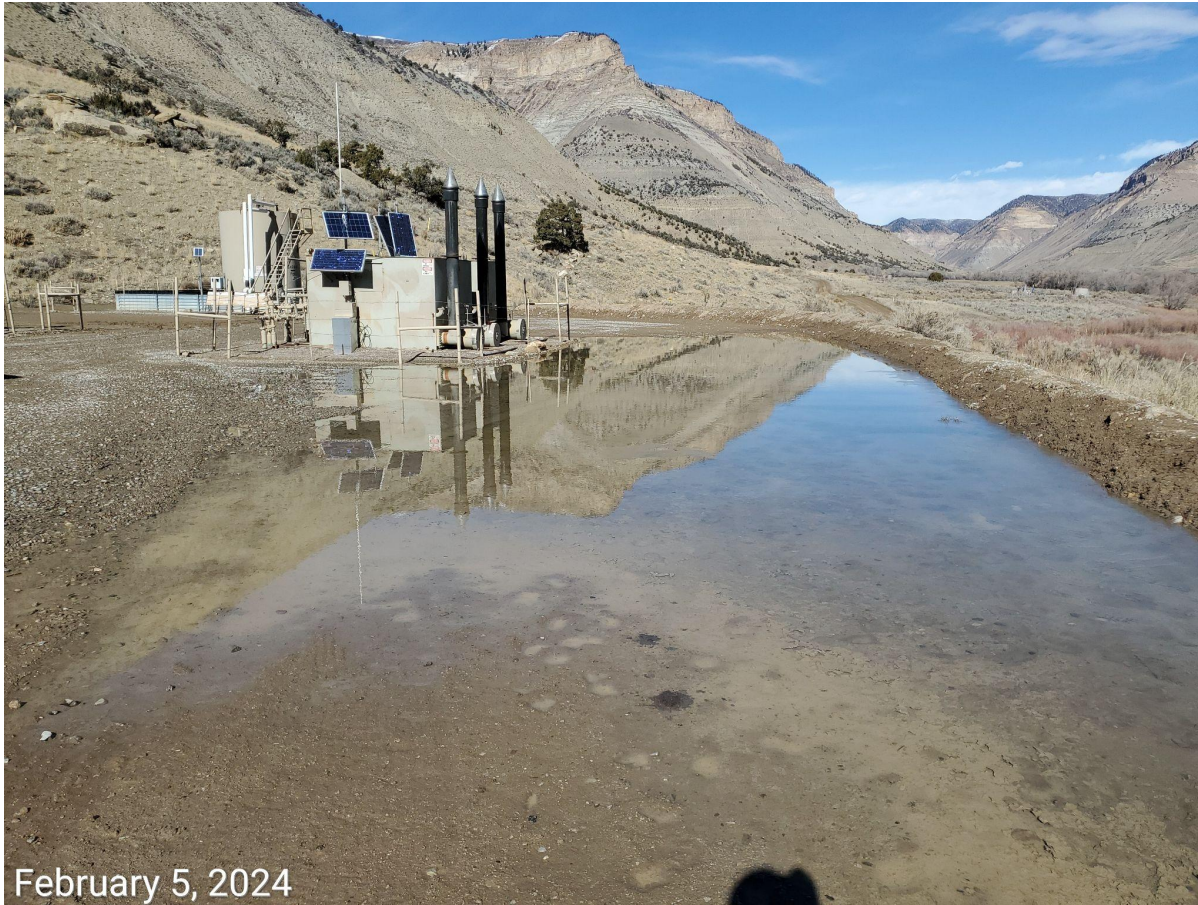
Photo 7: Photo taken from the northeast end of the working pad surface. It appears that, in lieu of installing an engineered outlet to allow for proper stormwater discharge from the Location, Operator has repaired the berm along the east end of the Location. This has resulted in continued stormwater ponding on the Location, as well as the destabilization/degradation of the working pad surface.

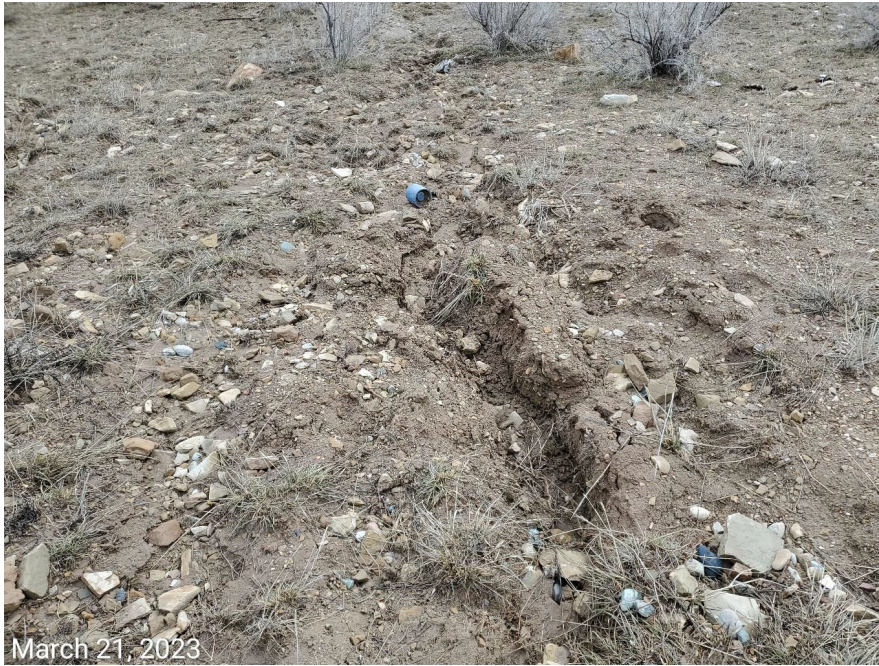
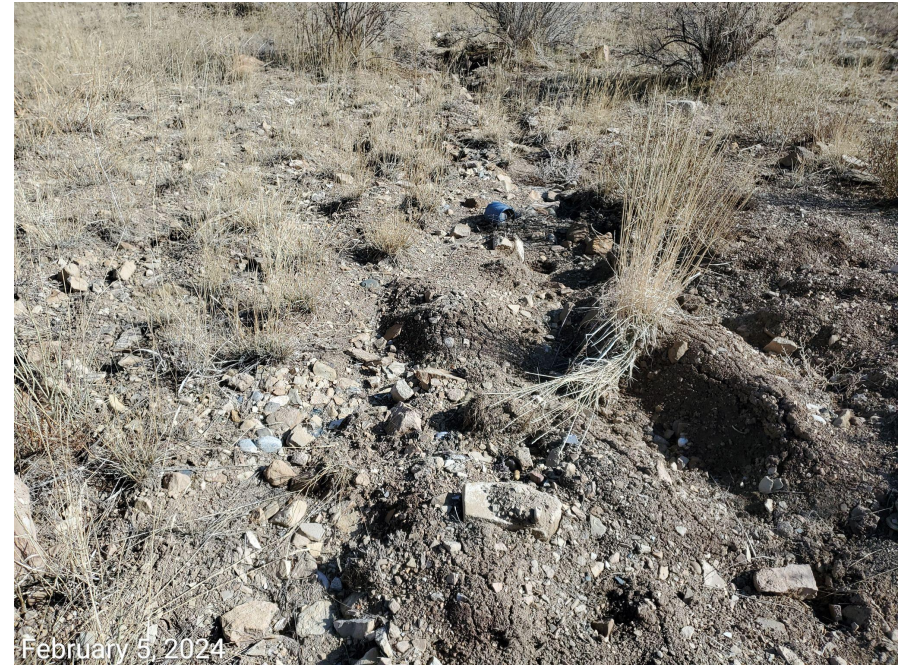
Photo 8: Photo left taken from the 3/21/2023 inspection. Photo right dated 2/5/2024. Photos show erosion degradation on the eastern interim areas due to stormwater runoff from the pad. Inspection #696204788 required Operator to repair degradation on the slopes, stabilize and conduct additional reclamation. Photos used for comparison to show work to address the corrective action does not appear to have been performed; erosion degradation remains apparent and appears to have persisted.

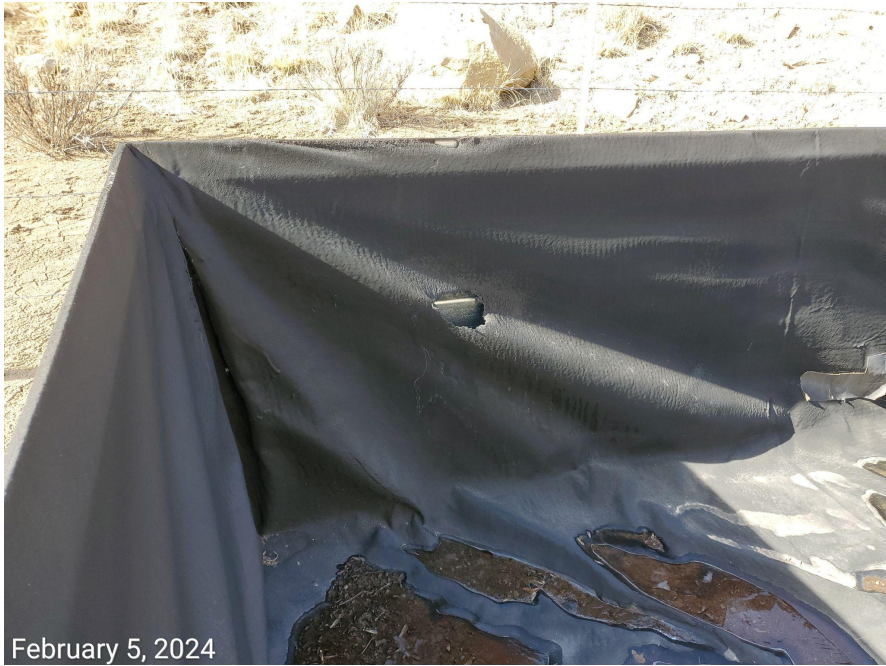
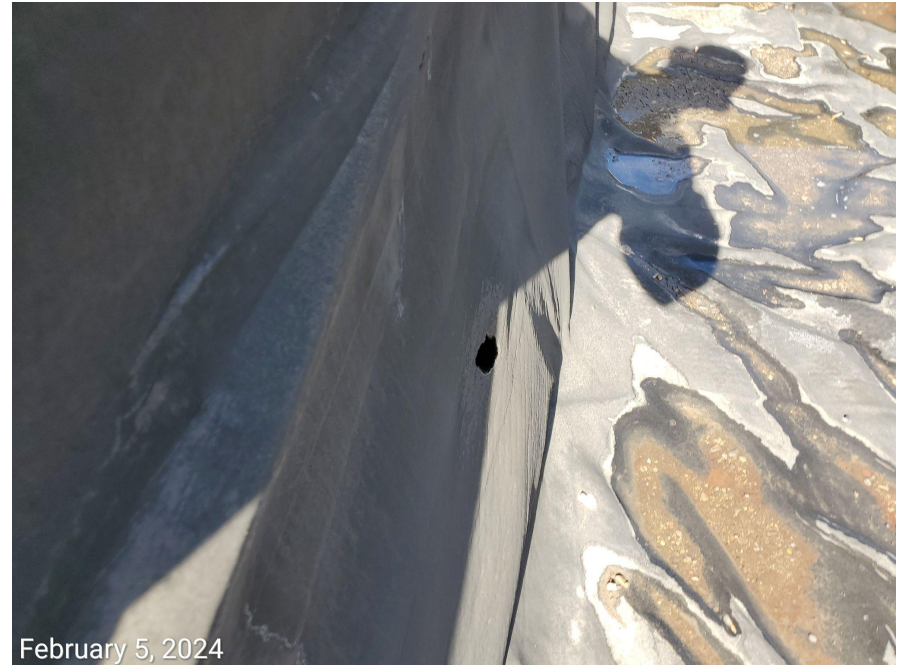
Photo 9: Photo 9-12 taken from the tank battery facility of the Location. Photos show holes/tears remain apparent throughout the entire liner. Work to repair and ensure containment remains impervious to contain a spill or release has been inadequate.

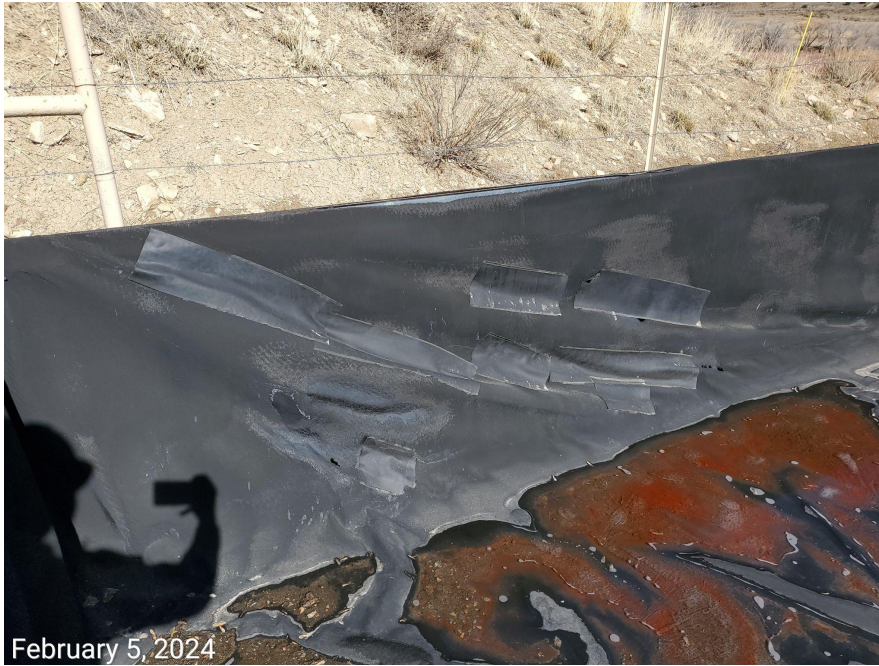
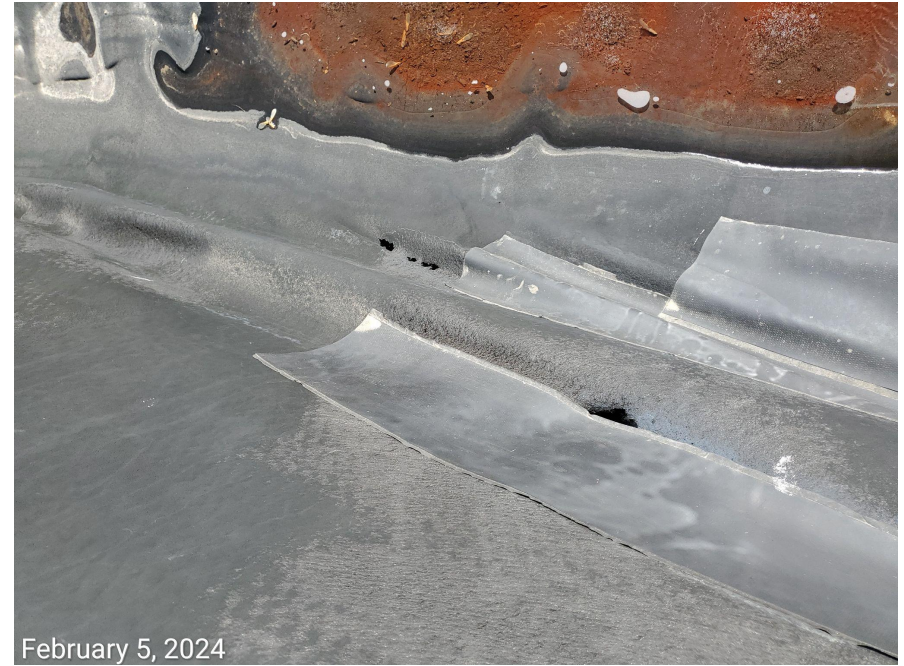
Photo 10: See comments under photo 9.
