Inspection Photos

Loc: 321584

Operator: CITATION OIL & GAS CORP

Inspection Date: 2/7/2024

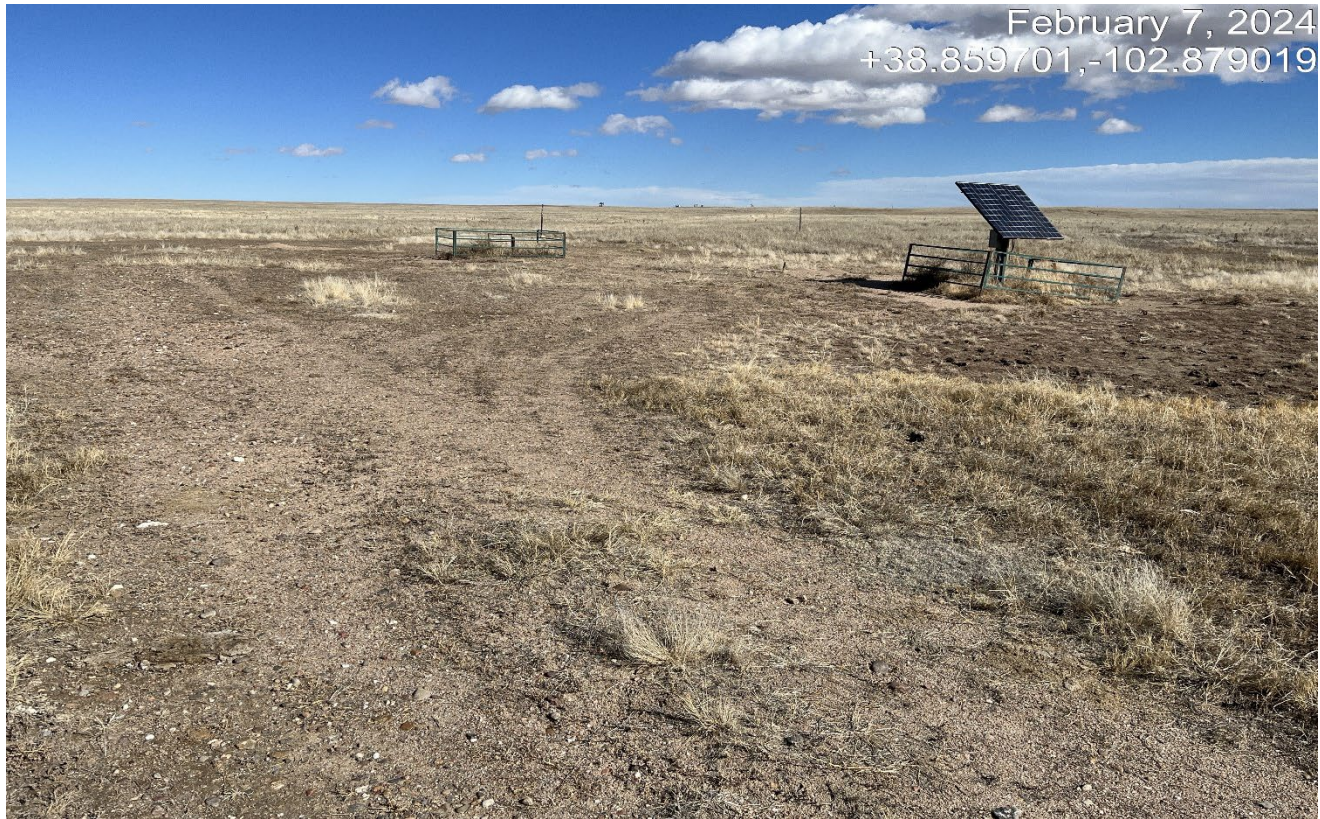
Photo 1. Facing northeast toward the wellsite location.

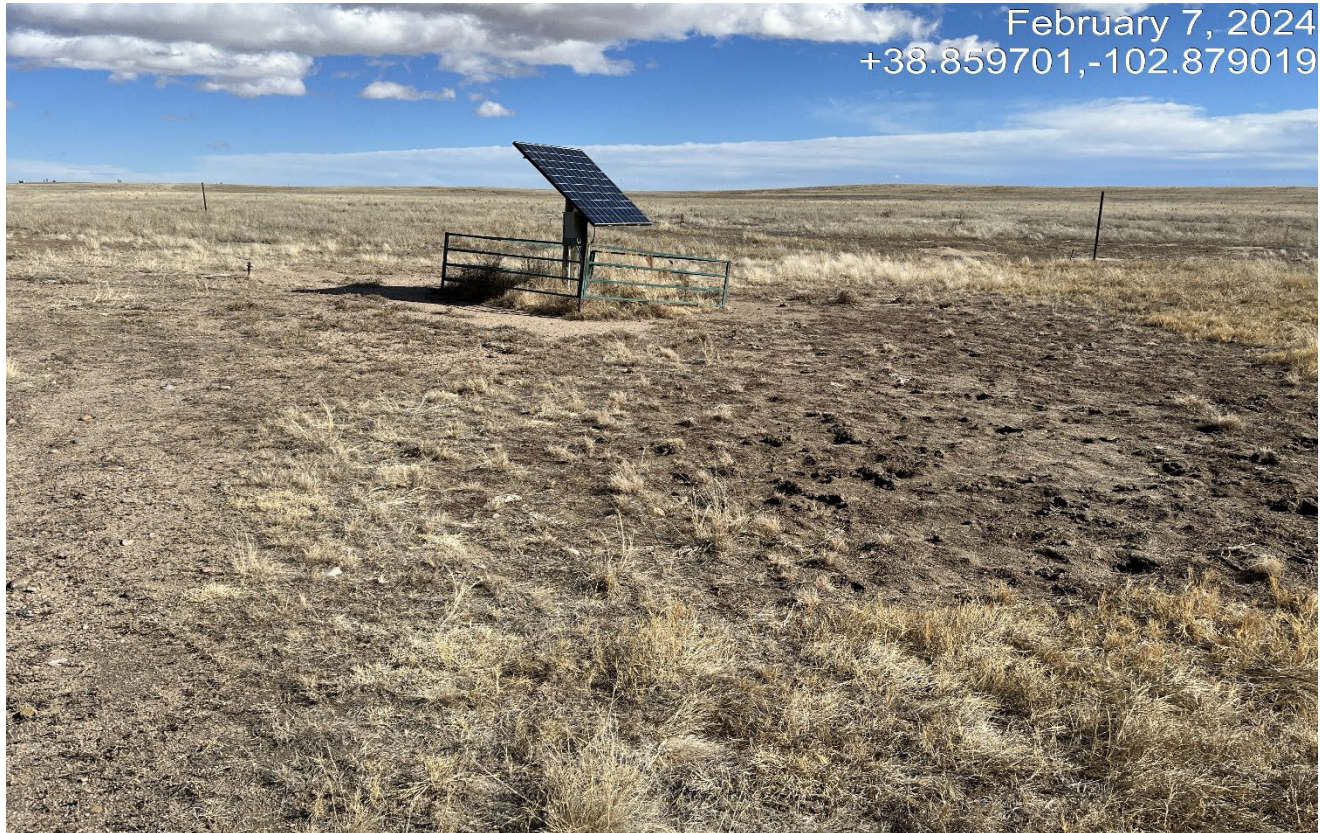
Photo 2. South side of the location facing east. This are to the right of the solar panel has ne vegetation growth and needs to be reclaimed.

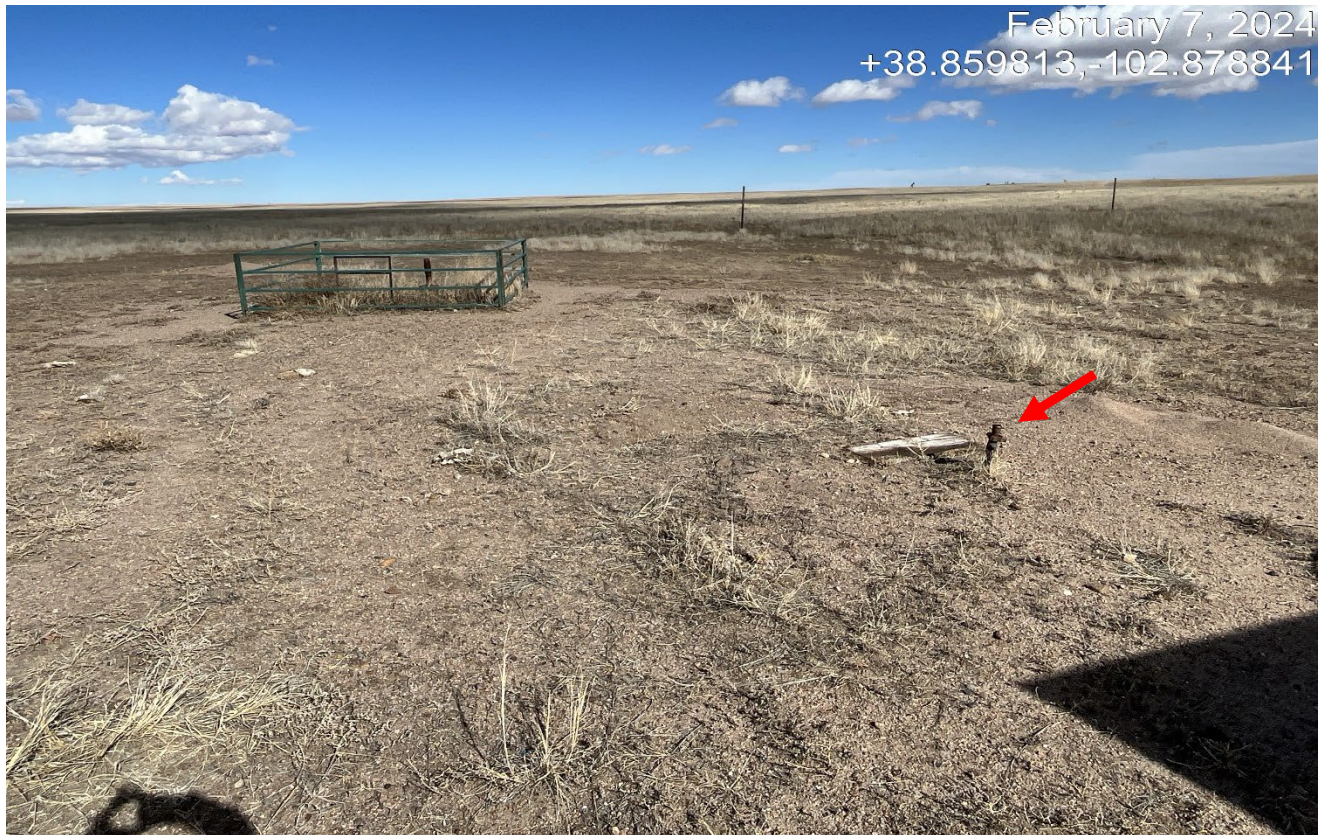
Photo 3. Facing northeast toward the well. There is an unmarked/unused pipe riser shown at red arrow.

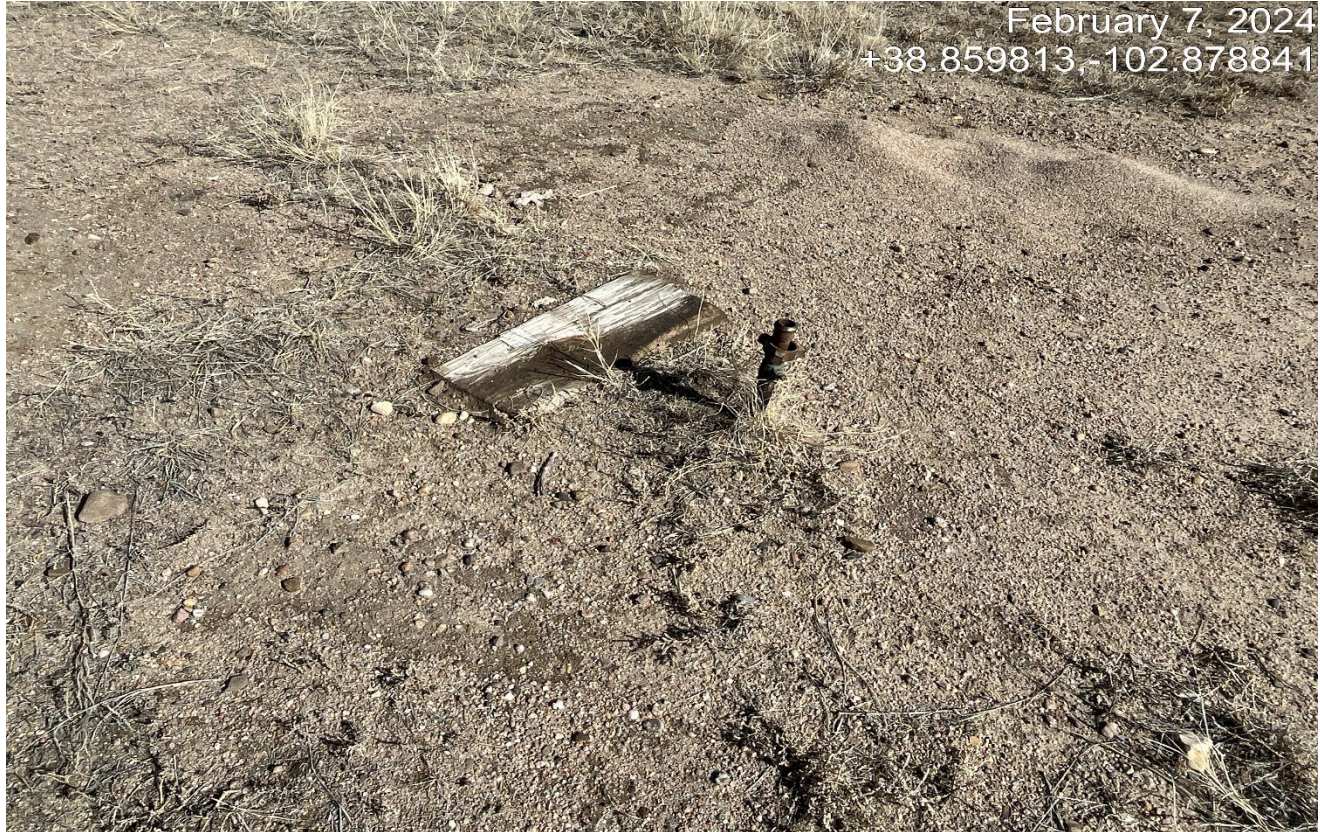
Photo 4. The pipe riser is not capped and is is unused which needs to be removed.

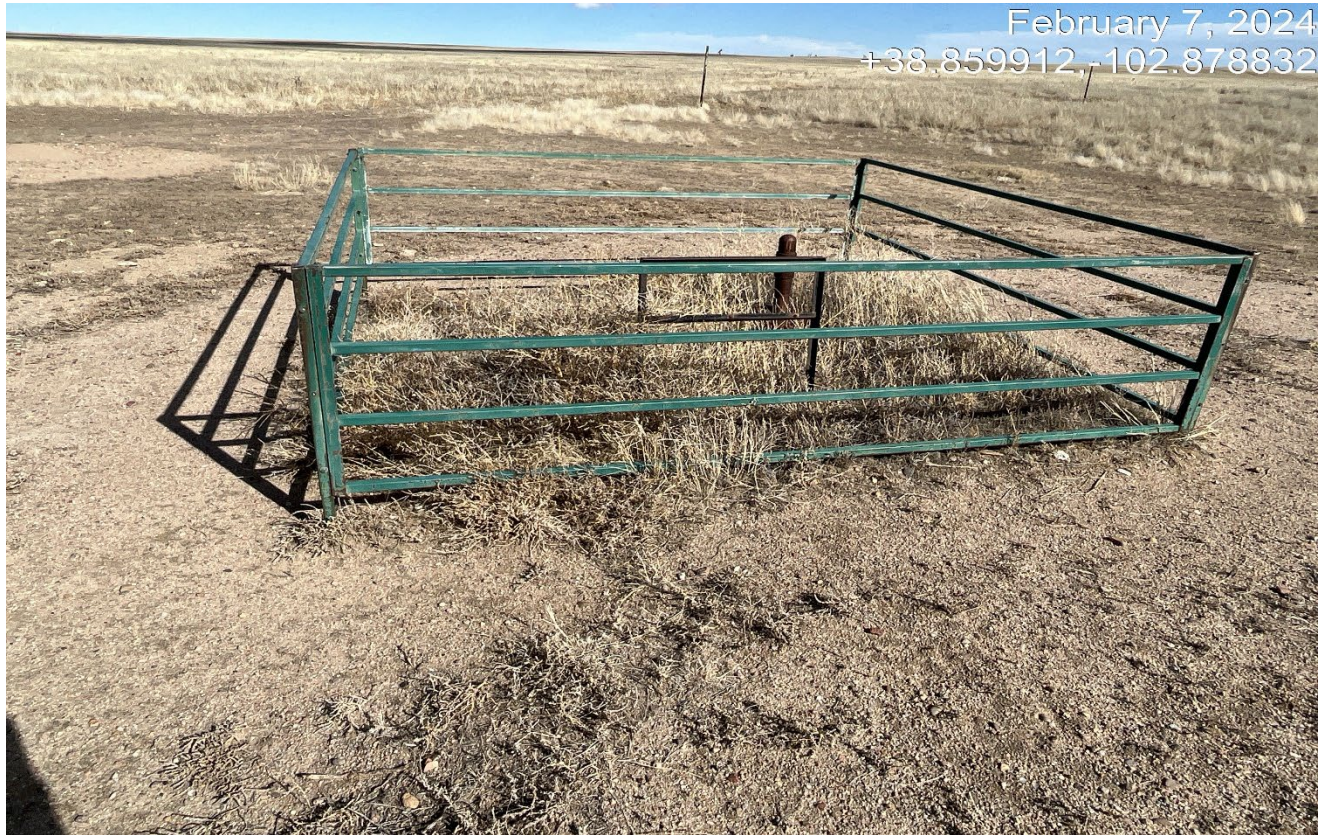
Photo 5. Facing toward the wellhead which has not produced for a very long time. There is no well sign posted at the wellhead.

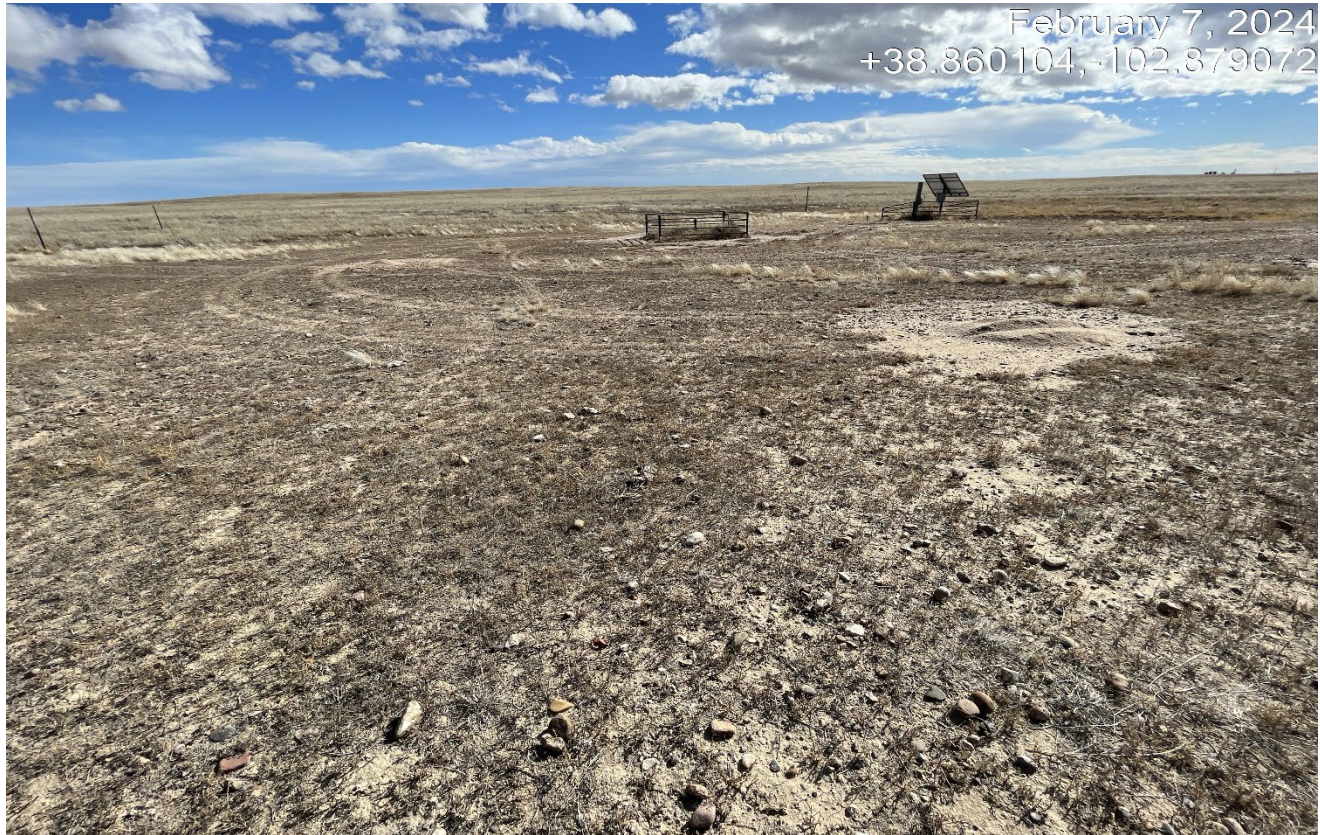
Photo 6. Facing southeast at the location. Unused areas of the location are not reclaimed and consists of undesirable weeds.

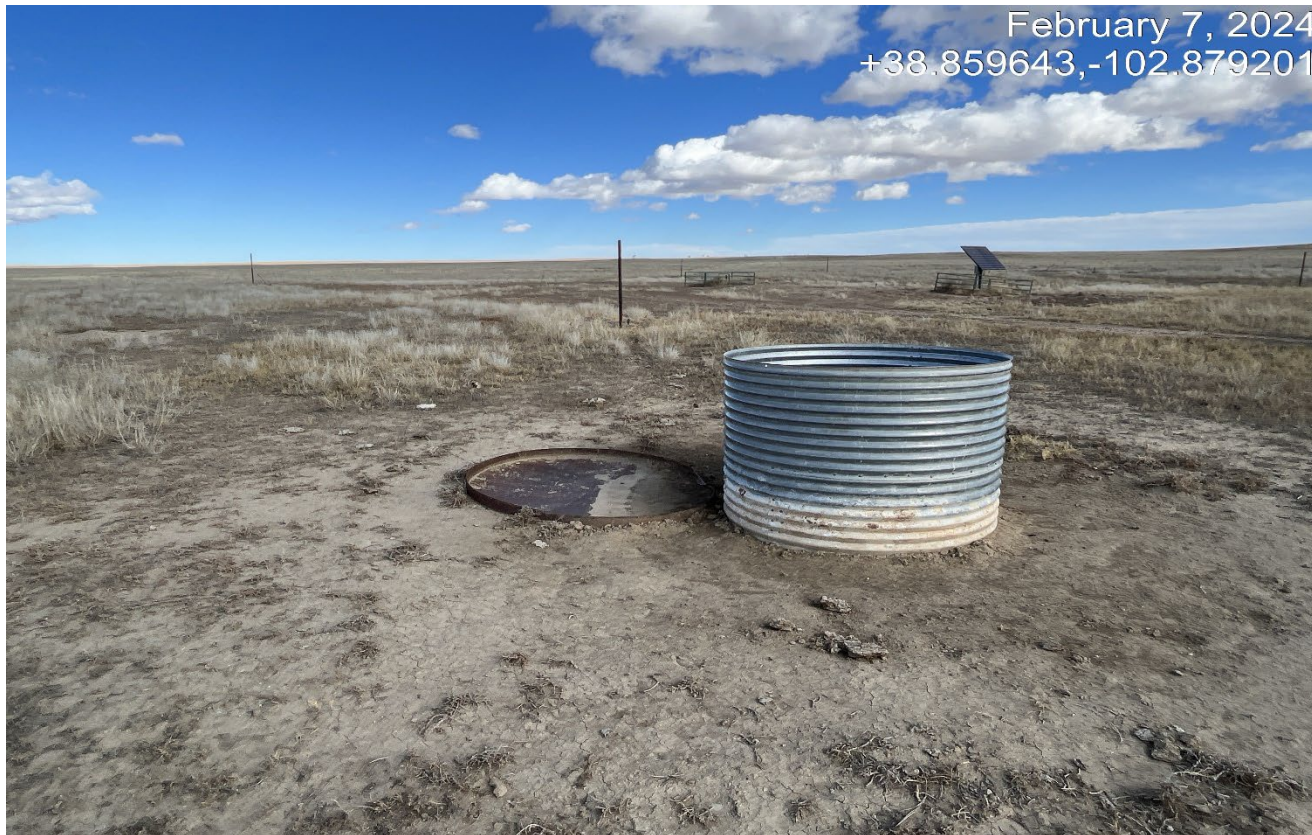
Photo 7. Southwest side of the location facing northeast. There is a pipeline cellar with the lid off laying on the ground.
