**Operator: BONANZA CREEK ENERGY OPERATING COMPANY LLC**

**Location Name: Antelope O-31**

**Loc ID: 471040**

**Inspection: 713900289**

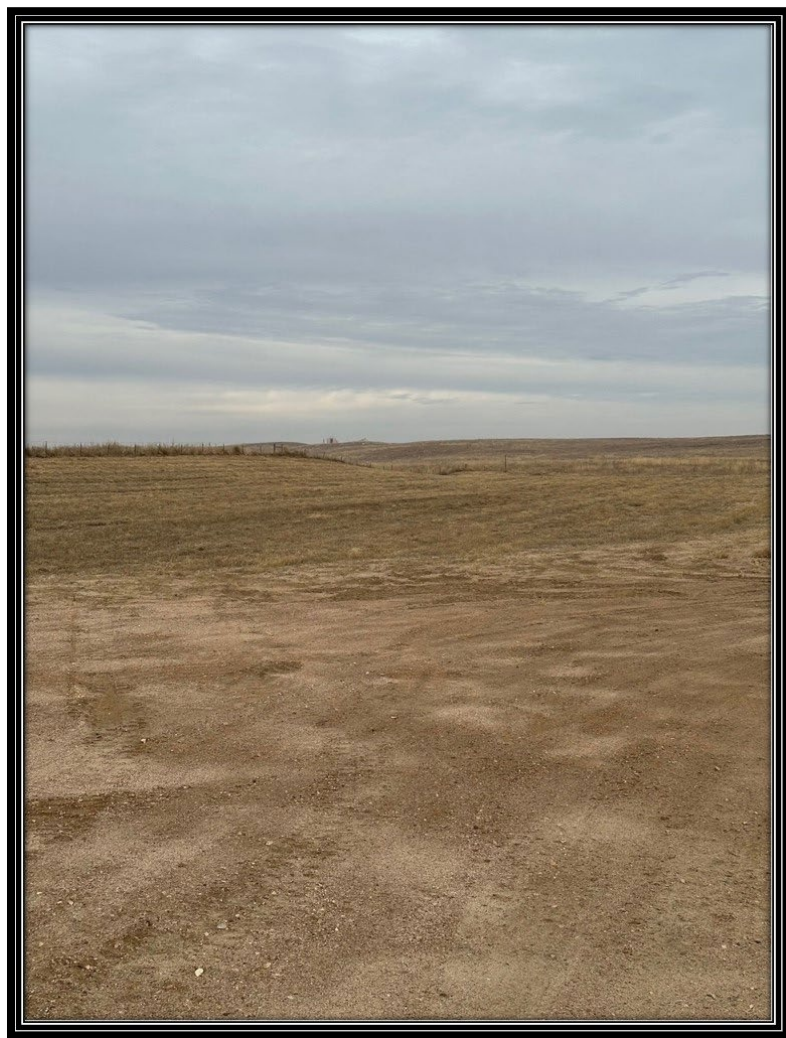
**Exhibit A**

**CA:** Weed debris in the form of tumbleweeds were observed along the perimeter fence line. Tumbleweeds are a troublesome annual non-native weed that easily breaks off at the stem. Operator failed to control and manage weeds to prevent weed waste and prevent the spread of seeds onto adjacent lands. Comply with Rule 606 to remove weed debris. The corrective date is the date the location was observed out of compliance, as it should be in compliance at all times.

**CA Resolution:** Operator has reported that reclaimed areas have been mowed to help maintain the location and identified weeds have been removed to comply with Rule 606. Reseeding of the location will be scheduled in the near future.
