Interim Reclamation and Stormwater Inspection

Operator: Noble Energy Inc. - 100322

Location ID: 328481

Location Name: Centennial State G34-689 Pad

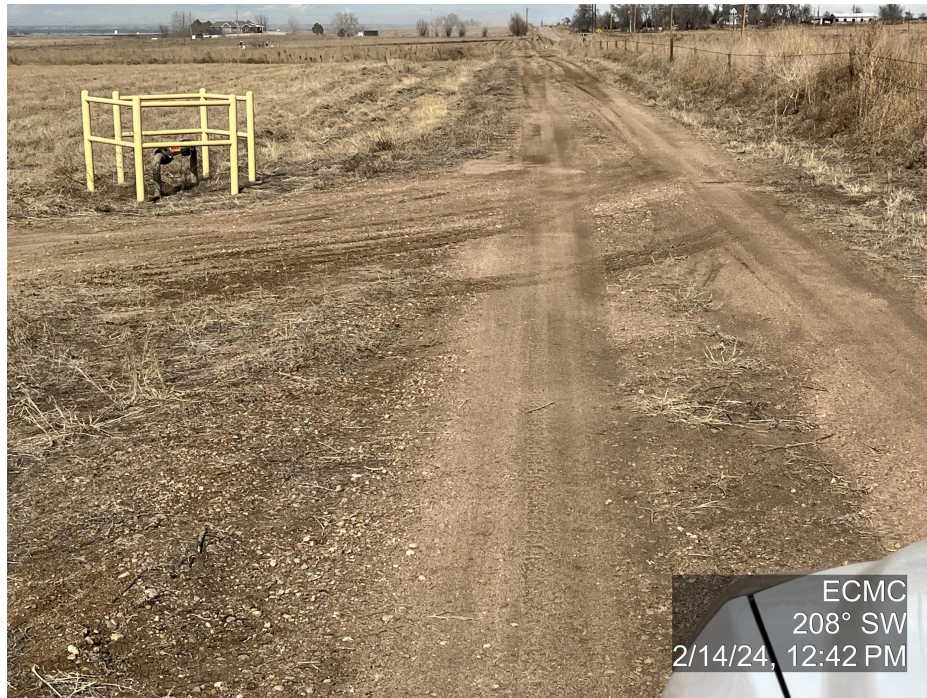
Photo 1. The photo was taken along the well location access road facing Southwest. The photo illustrates the access road has no stormwater issues.

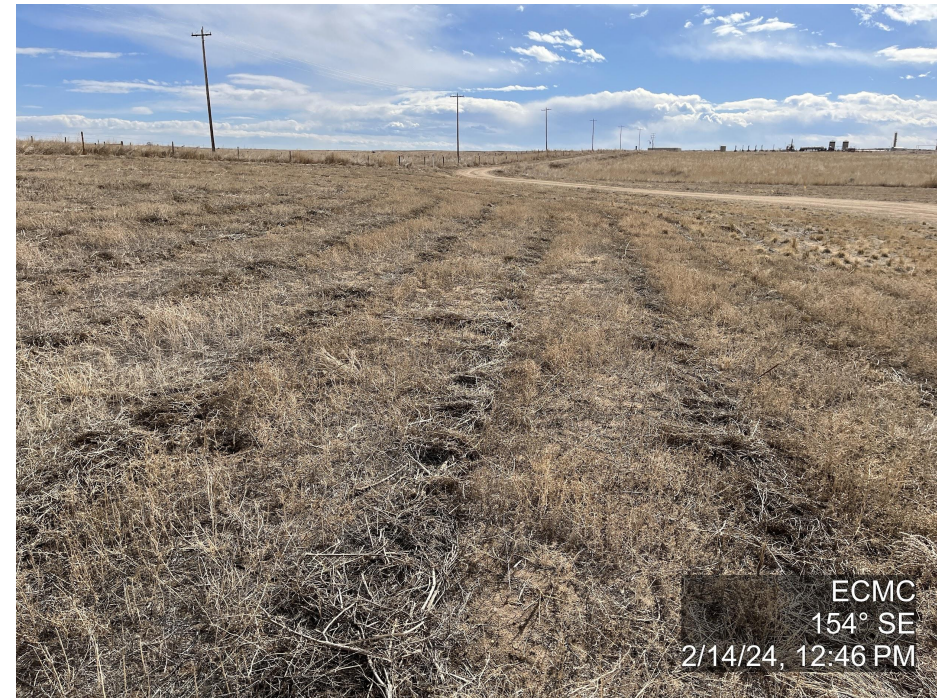
Photo 2. The photo was taken at the well location facing Southeast. The photo illustrates the interim area around the wellheads has been mowed.

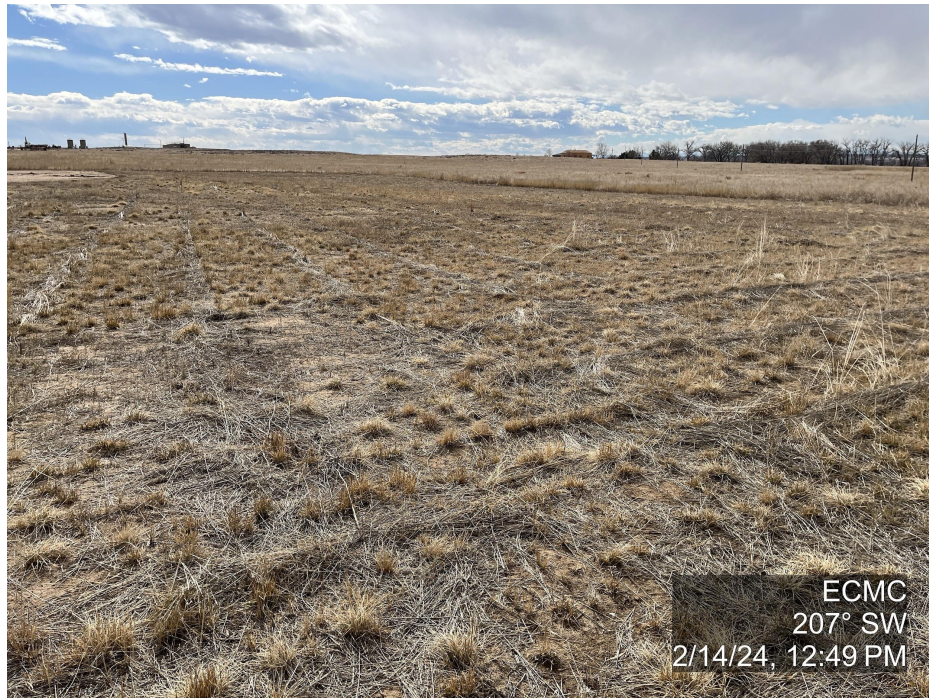
Photo 3. The photo was taken at the well location facing Southwest. Refer to the comment for photo 2.

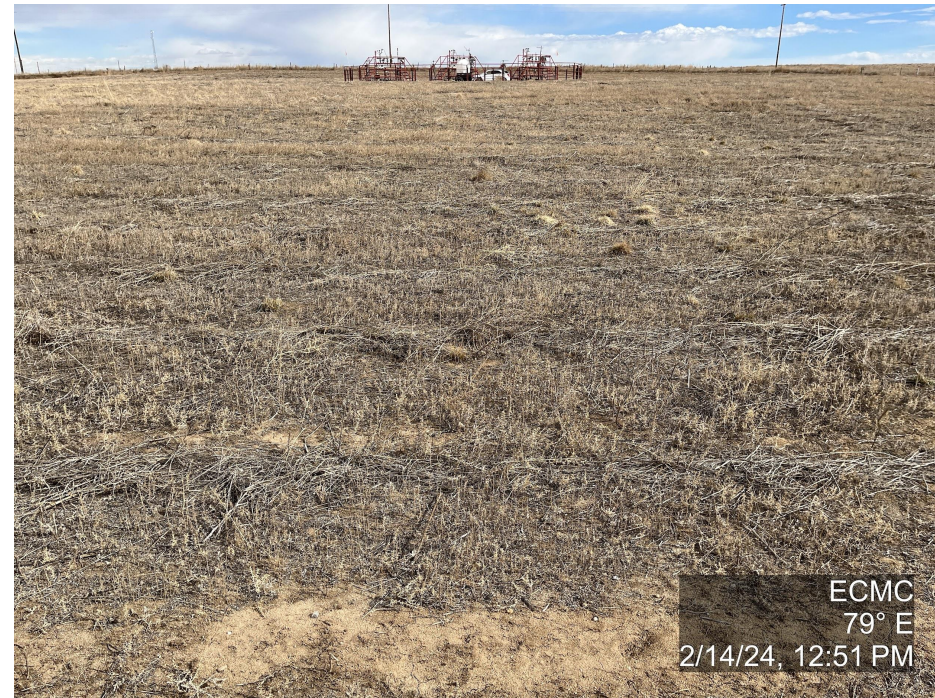
Photo 4. The photo was taken at the well location facing East. Refer to the comment for photo 2.

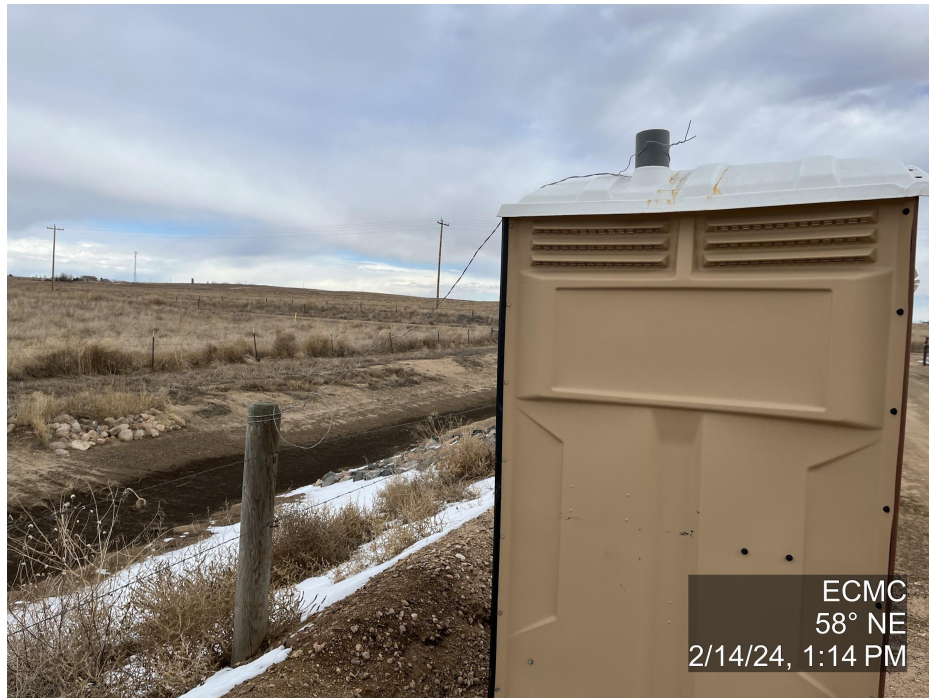
Photo 5. The photo was taken at the tank battery location facing Northeast. The photo illustrates the portable bathroom is secured by a piece of wire attached to the bathroom vent.

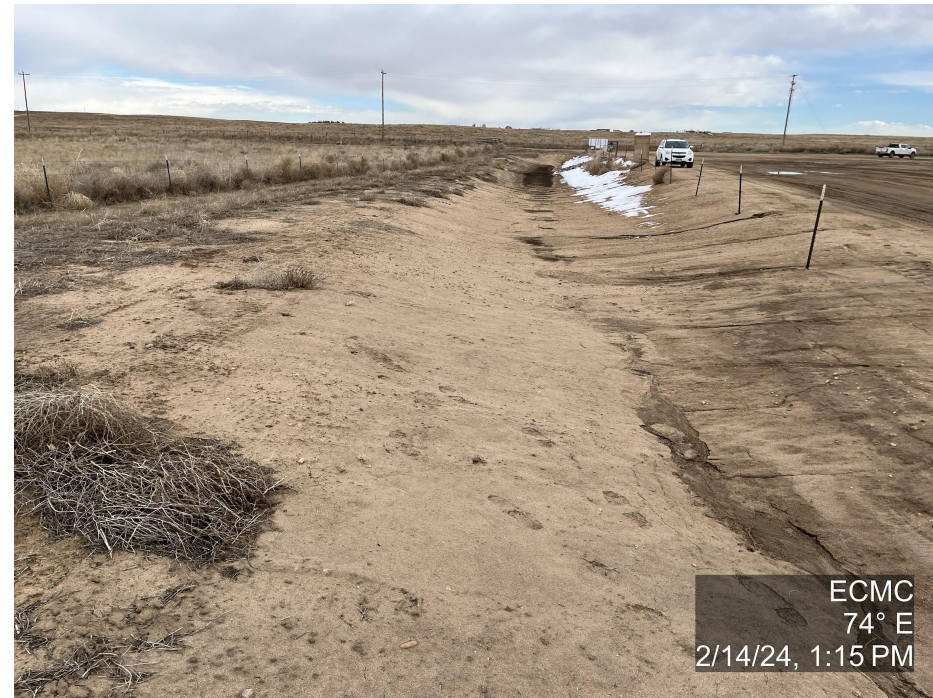
Photo 6. The photo was taken at the tank battery location facing East. The photo illustrates the sediment trap on the North side of the facility.

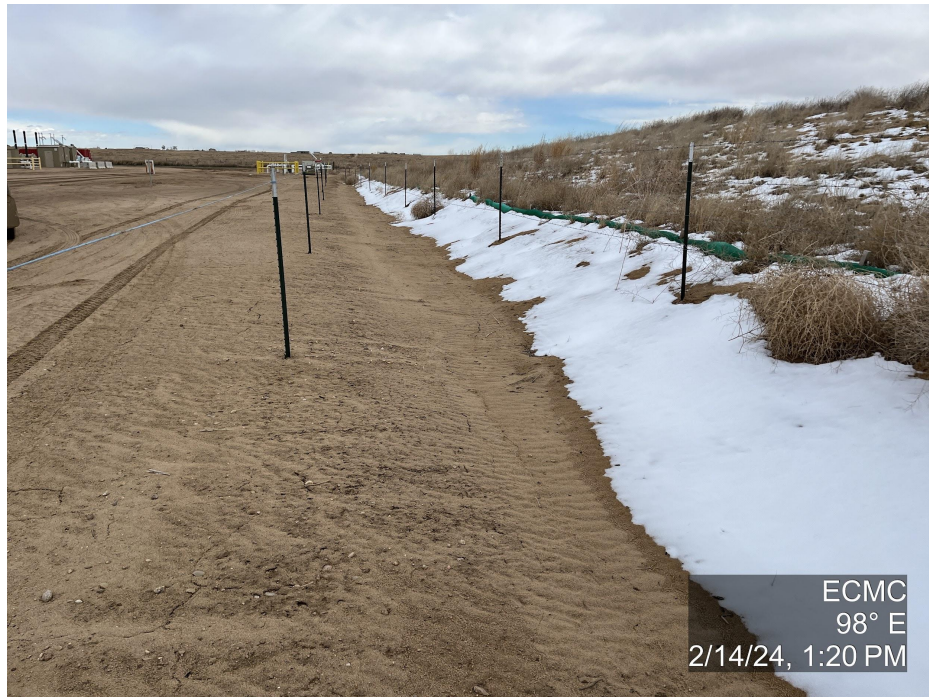
Photo 7. The photo was taken at the tank battery location facing East. The photo illustrates the Southern boundary fence and stormwater BMP.

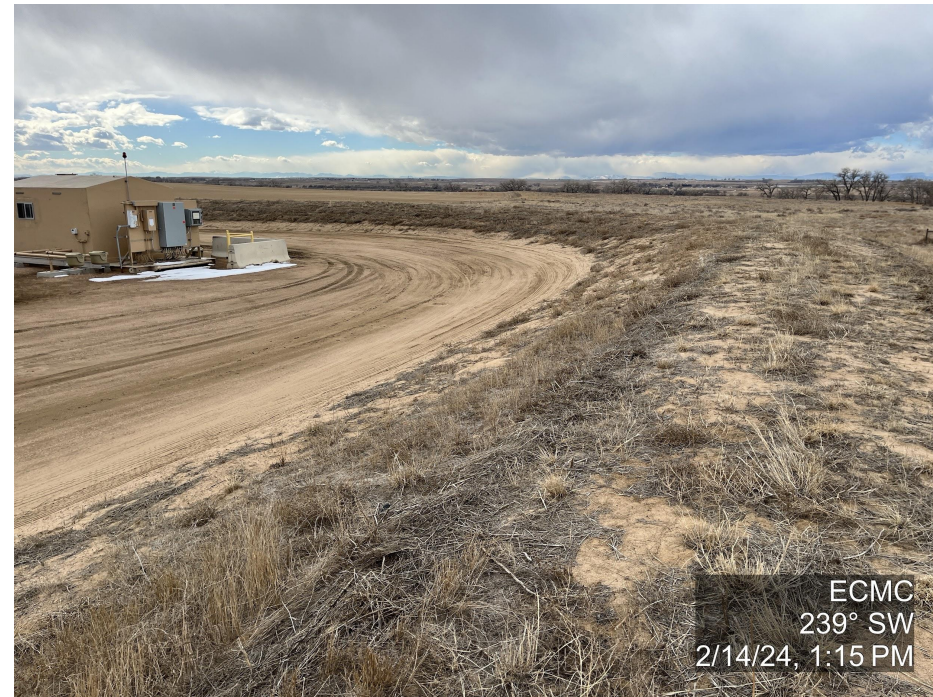
Photo 8. The photo was taken at the tank battery location facing Southwest. The photo illustrates the topsoil stockpile is vegetated successfully and has been mowed.

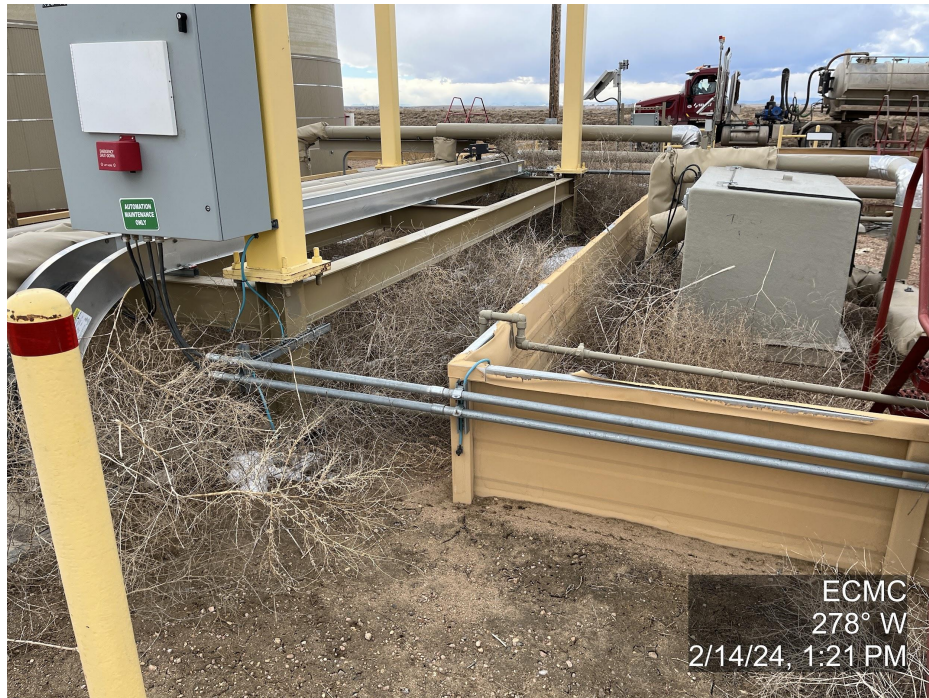
Photo 9. The photo was taken at the tank battery location facing West. The photo illustrates tumbleweeds building up around equipment.

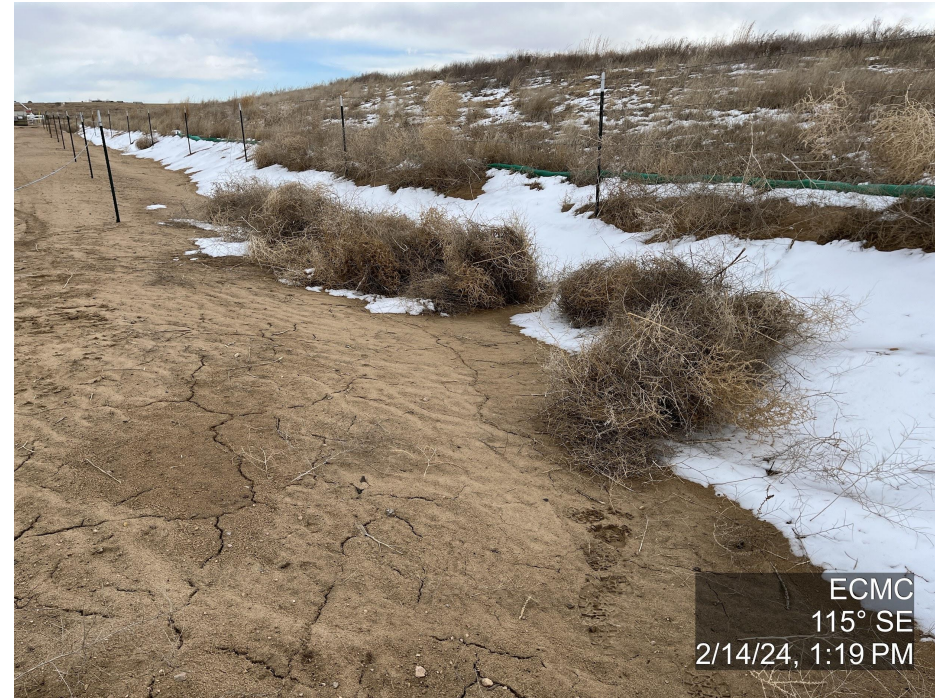
Photo 10. The photo was taken at the tank battery location facing Southeast. The photo illustrates another area where tumbleweeds have built up.
