Inspection Photos

Operator: CAERUS PICEANCE LLC #10456

Location ID: 335729

Inspection Doc: 696205616

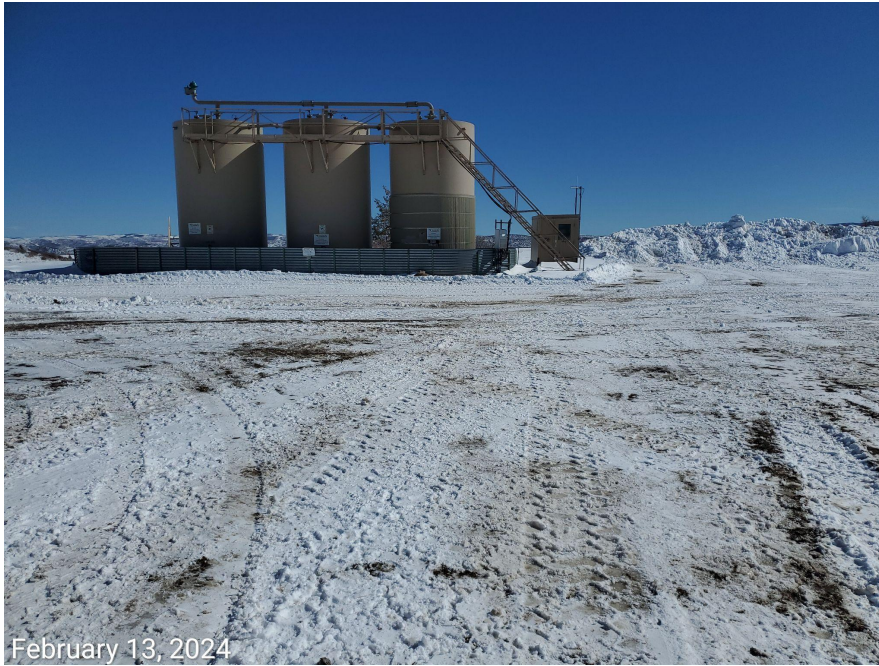
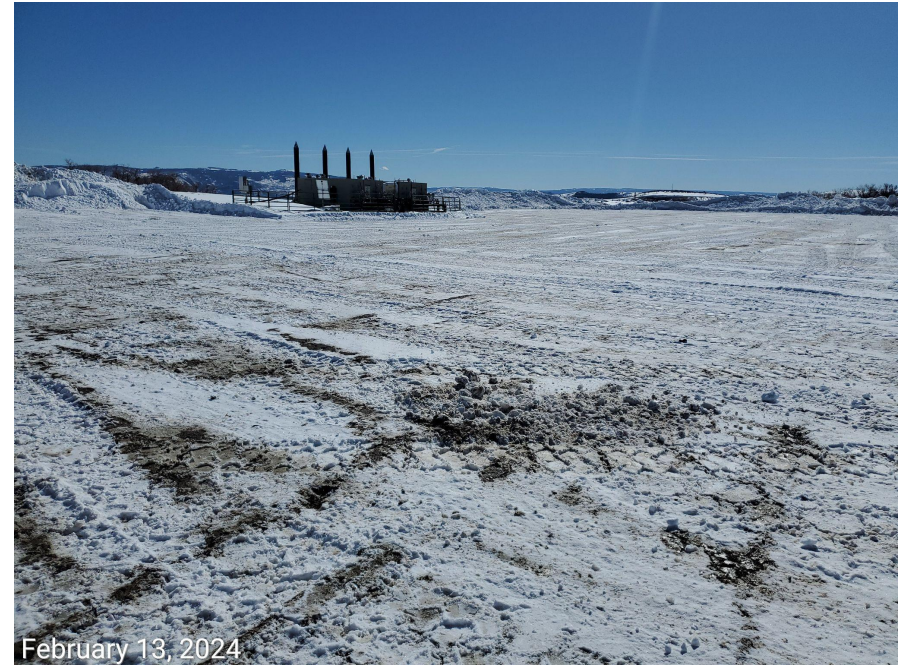
Photo 1: Photos 1-2 taken from the north end of the Location. Photos provides an overview of the Location from east, southeast, southwest to west.

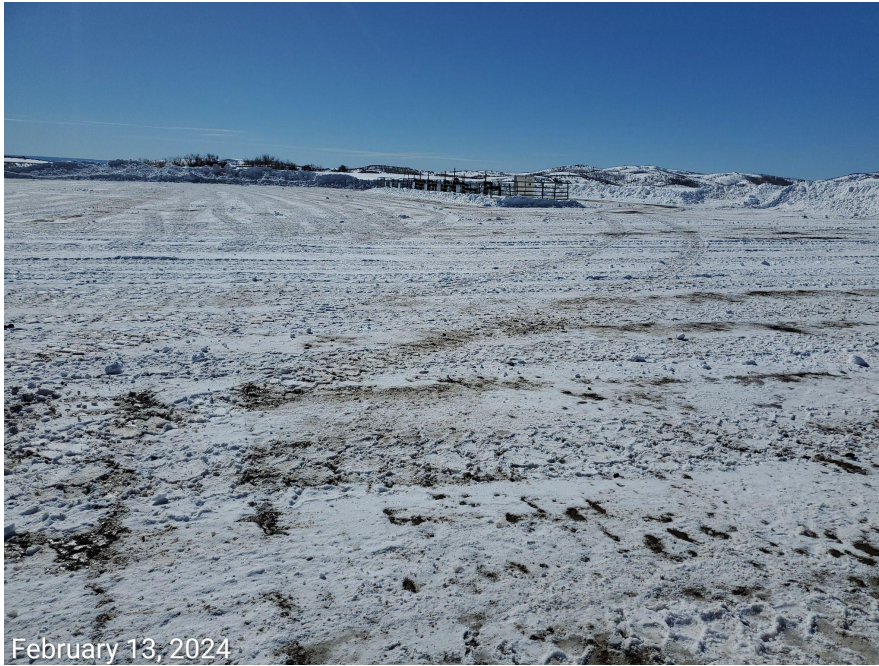
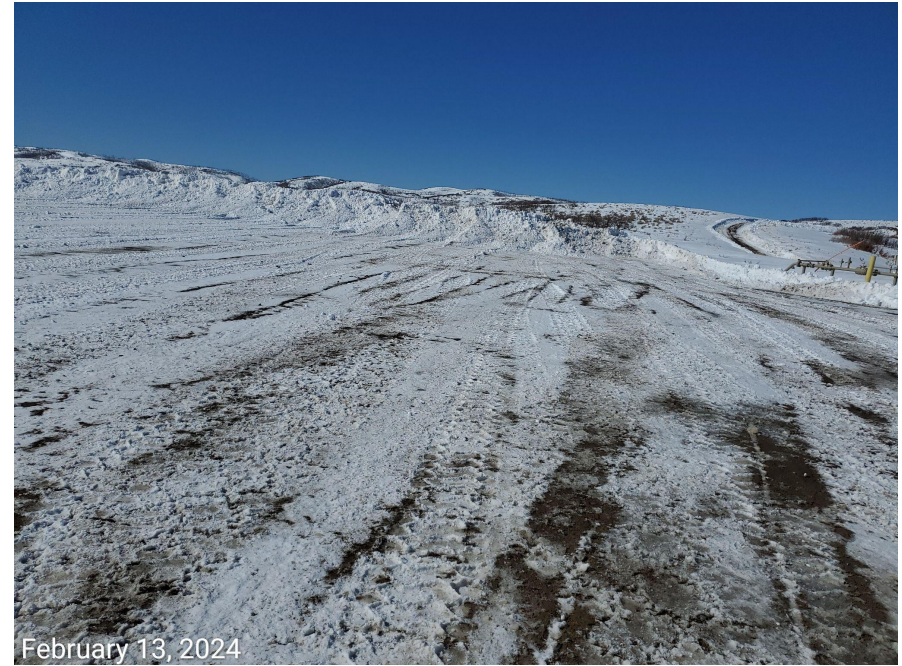
Photo 2: See comments under photo 1.

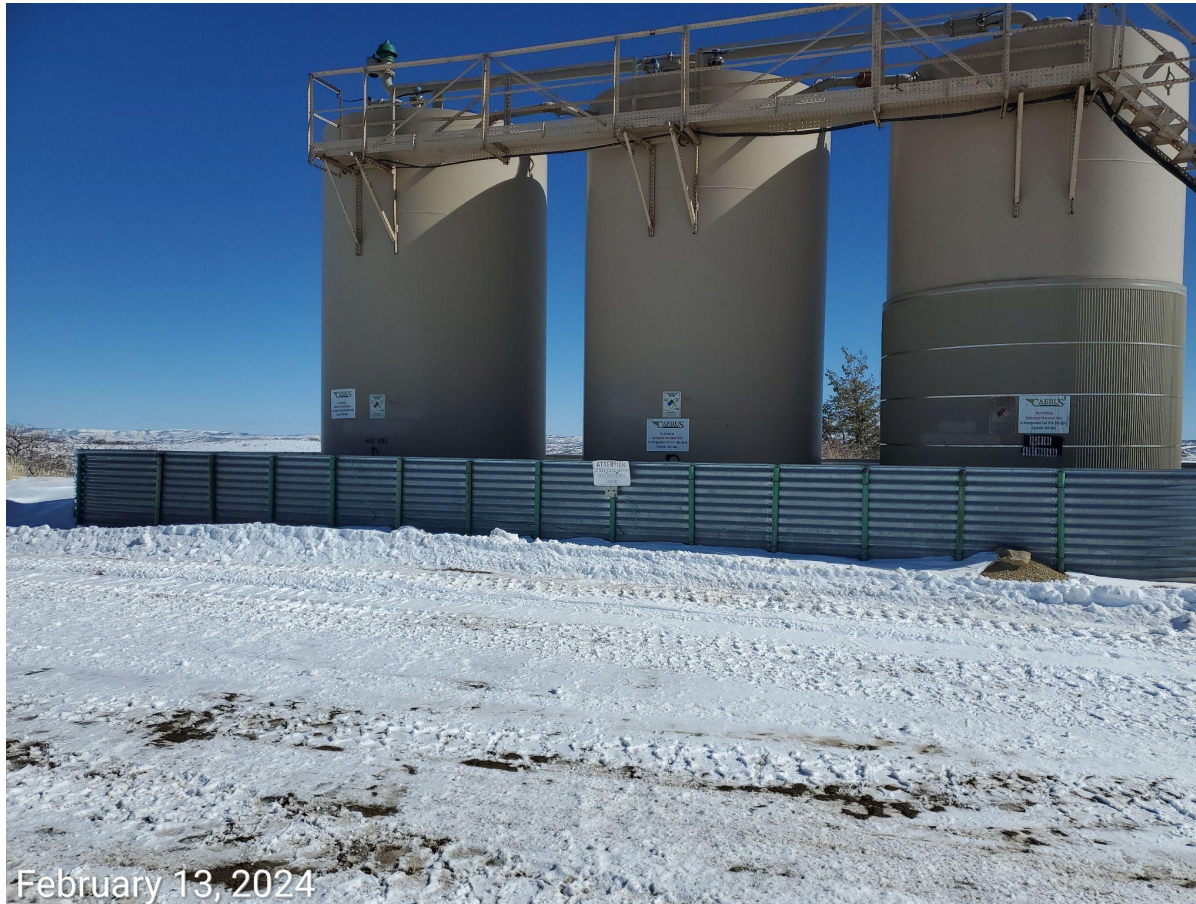
Photo 3: Signage not observed at the tank battery facility; signage missing, or not conspicuously posted at the battery facility.

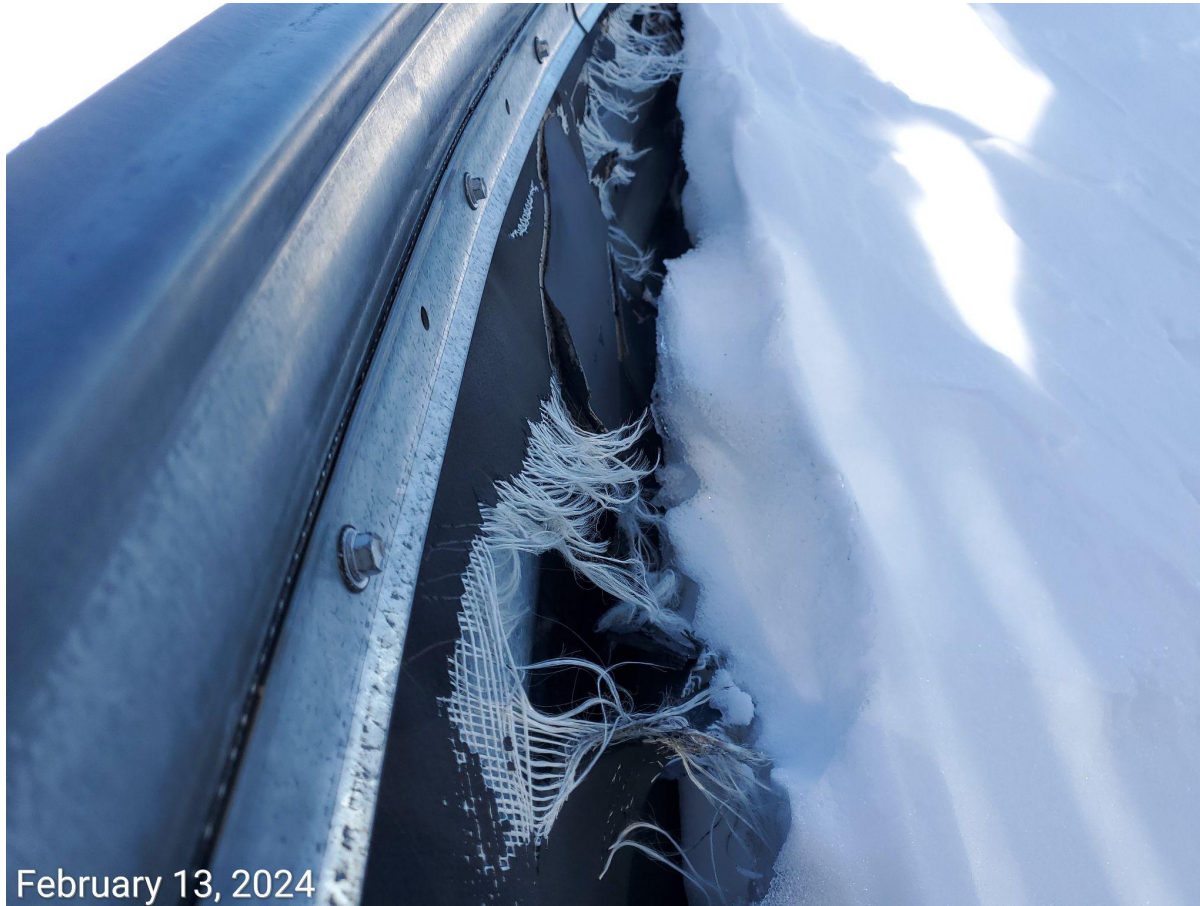
Photo 4: Tears observed in liner at the tank battery facility containment BMP.
