**Operator: CIVITAS NORTH LLC**  
**Location Name: Hunt 8-60 17B**  
**Loc ID: 457475**  
**Inspection: 696305977**

**Exhibit A**

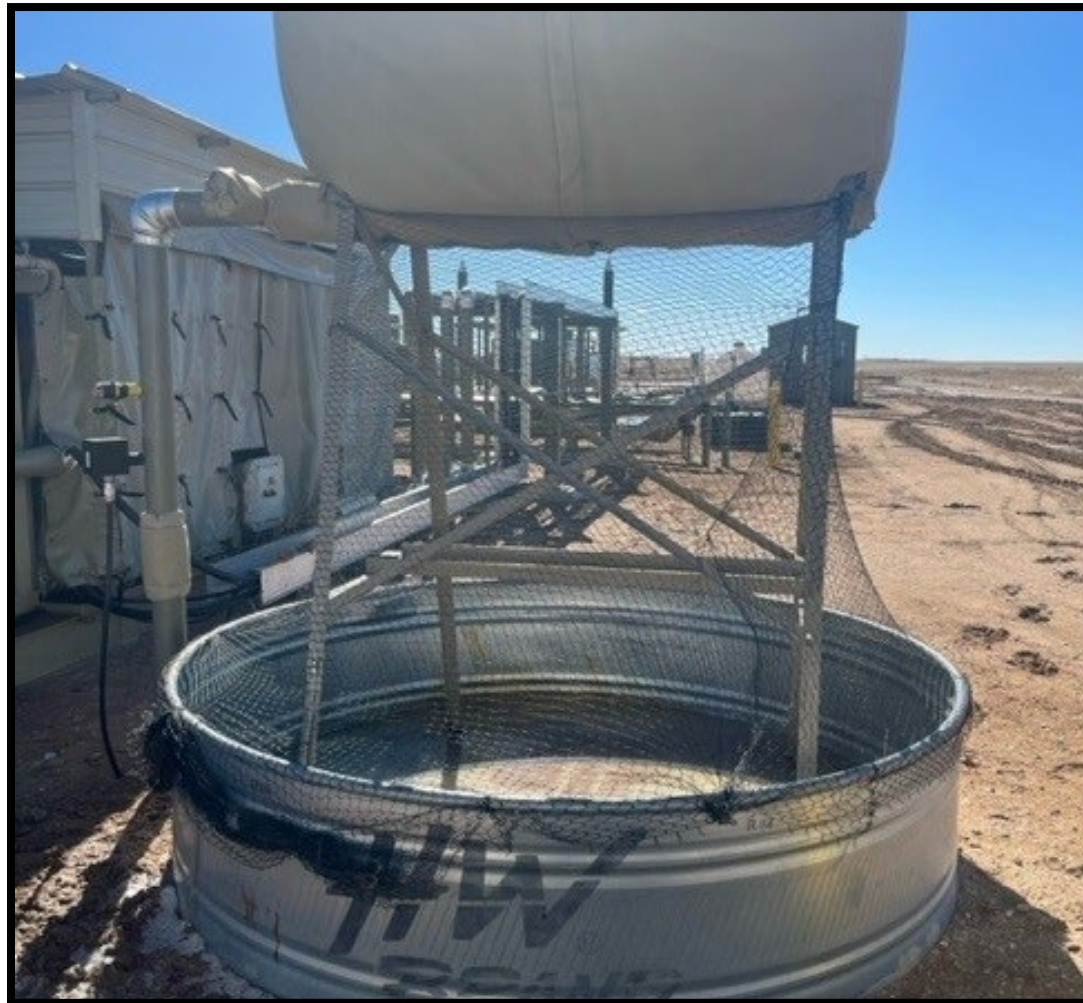
**CA:** Day Tank Containment Netting in disrepair - need to cover whole opening. See photos. Install or repair wildlife protection equipment. Prevent any unauthorized discharge (specify condition if it is E&P waste, improper disposal, trash, etc.) Per Rule 902.b.

**CA Resolution:** Operator has appropriately repaired/installed Wildlife Netting at identified Day Tank to comply with Rule 902.b.
