Storm Water Management and Erosion control
Location Name: TEP ROCKY MOUNTAIN LLC Valley Farms I Pad
Location ID: 335553

Section/Township/Range: 13 6S92W

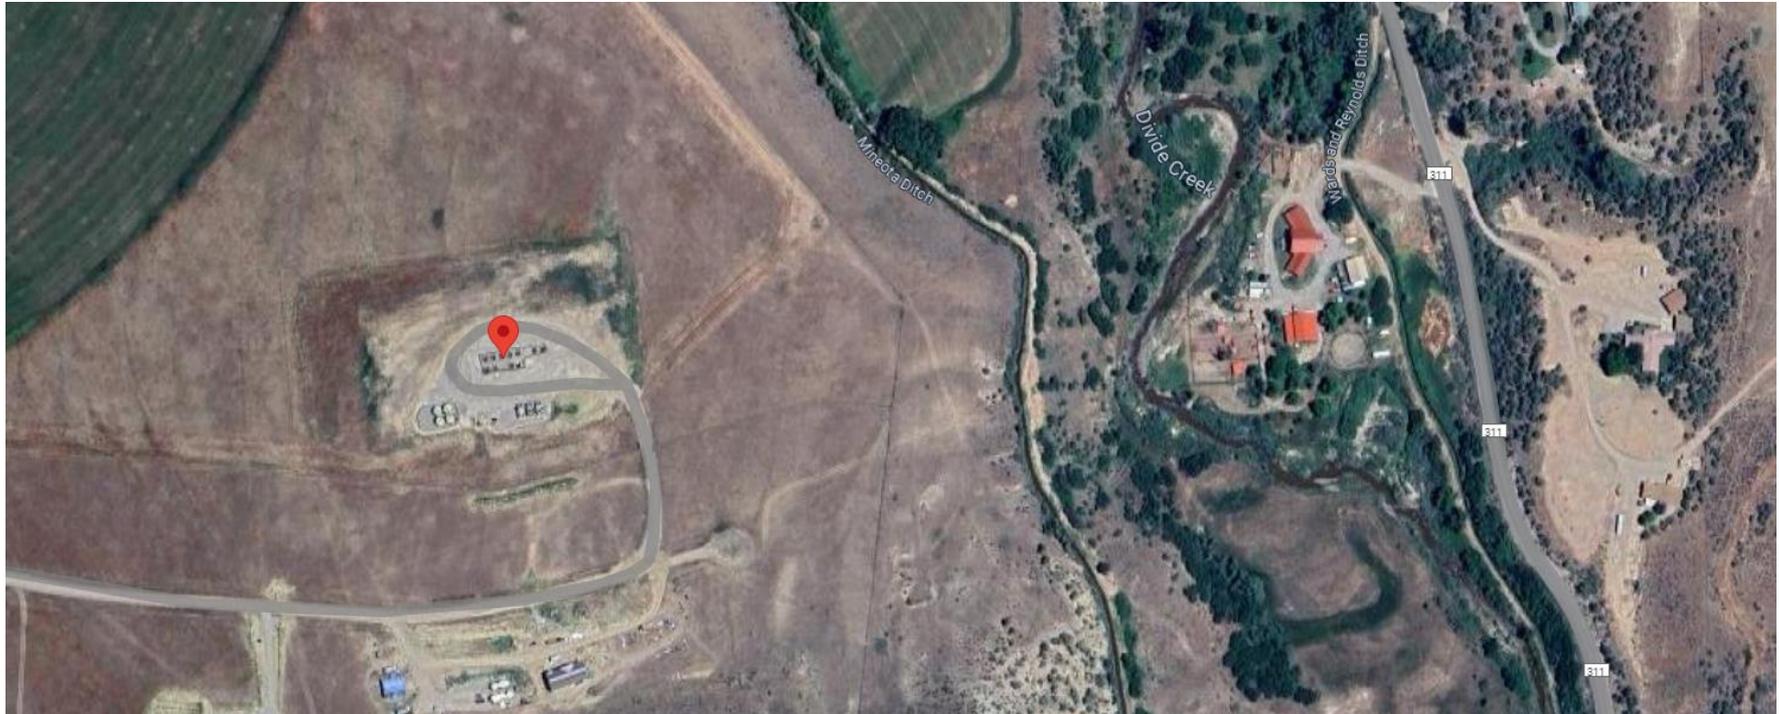
Location Overview: Location is within High Priority/Density/Black Bear Habitat areas & in close proximity to NSO Habitat area & Bald Eagle Roost Site. Location is within Rule 411a Surface Water Intermediate Buffer & in close proximity to Rule 411b Generalized Intermediate & External Buffers. Location is approximately 230 yards from Mineota Ditch & 296 yards from Divide Creek.

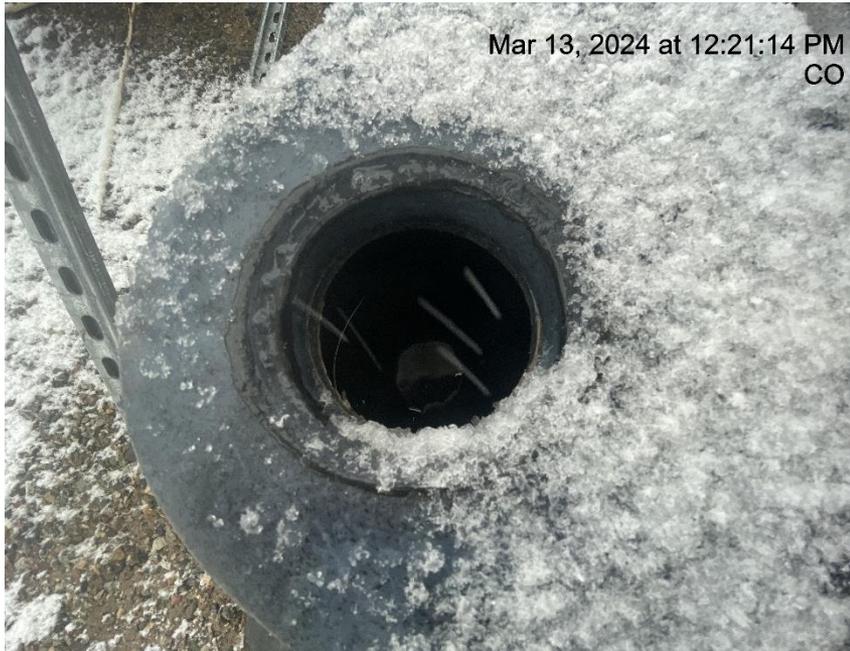
Photo # 9779 Chemical containment approximately $\frac{3}{4}$ full of fluid/Failure to maintain chemical BMP/BMP insufficient to contain possible spill
