# Hale Reclamation Plan, Weld County, Colorado

**Taproot Rockies Midstream, LLC**

**SWCA Environmental Consultants**

# **HALE RECLAMATION PLAN, WELD COUNTY, COLORADO**

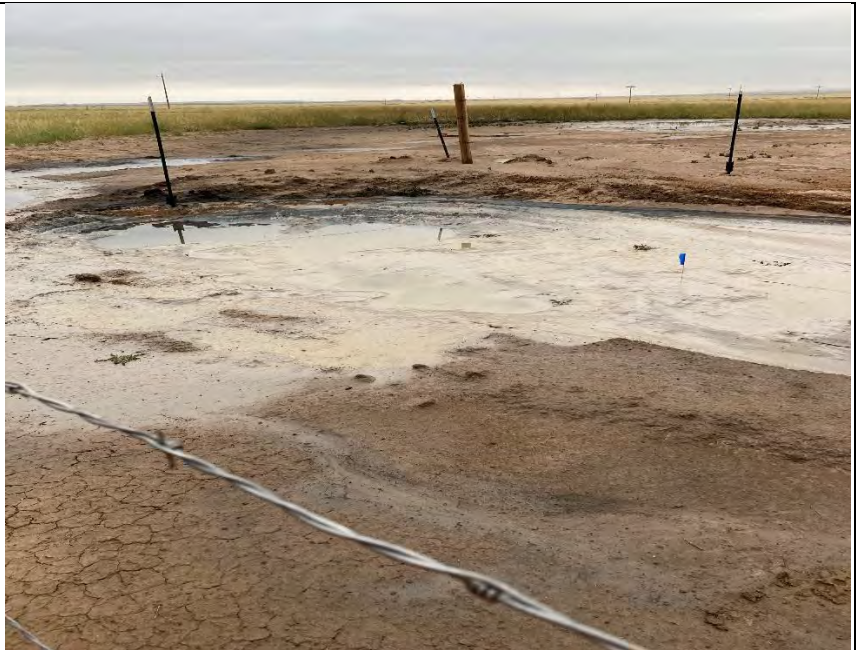
**Photo: B-1**

Initial site conditions

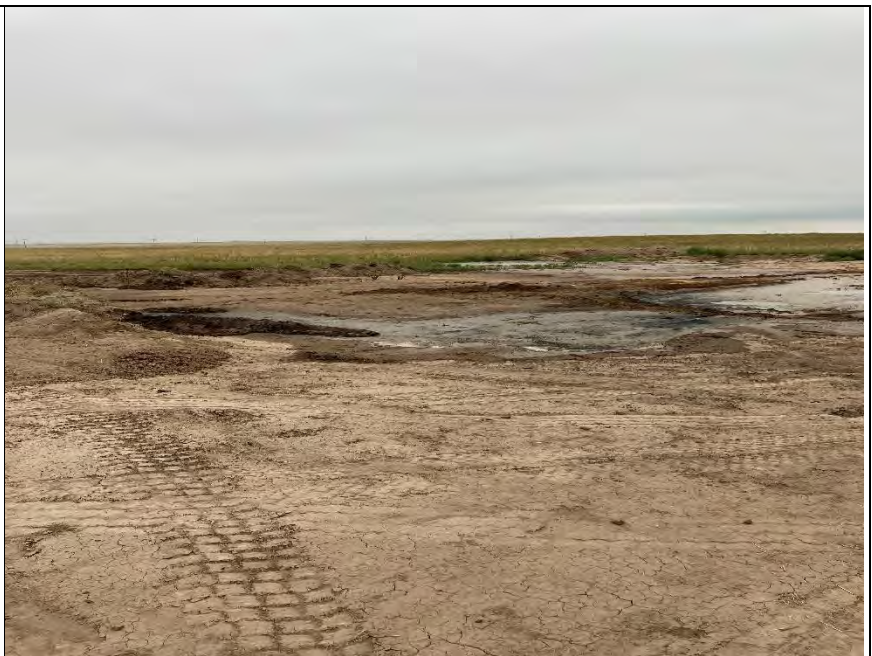
**Photo: B-2**

Initial site conditions

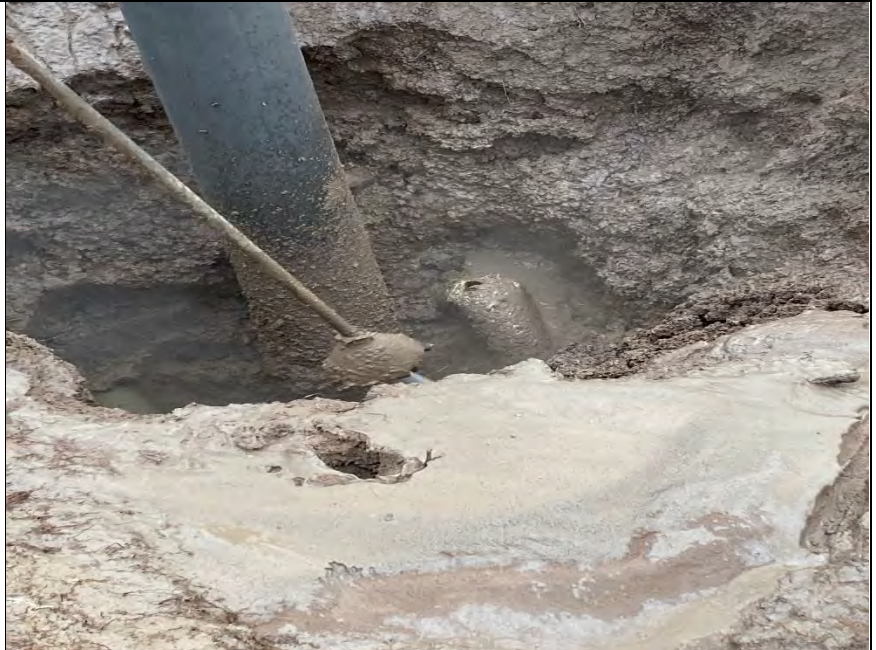
**Photo: B-3**

Hydro Excavation;  
Daylighting pipeline

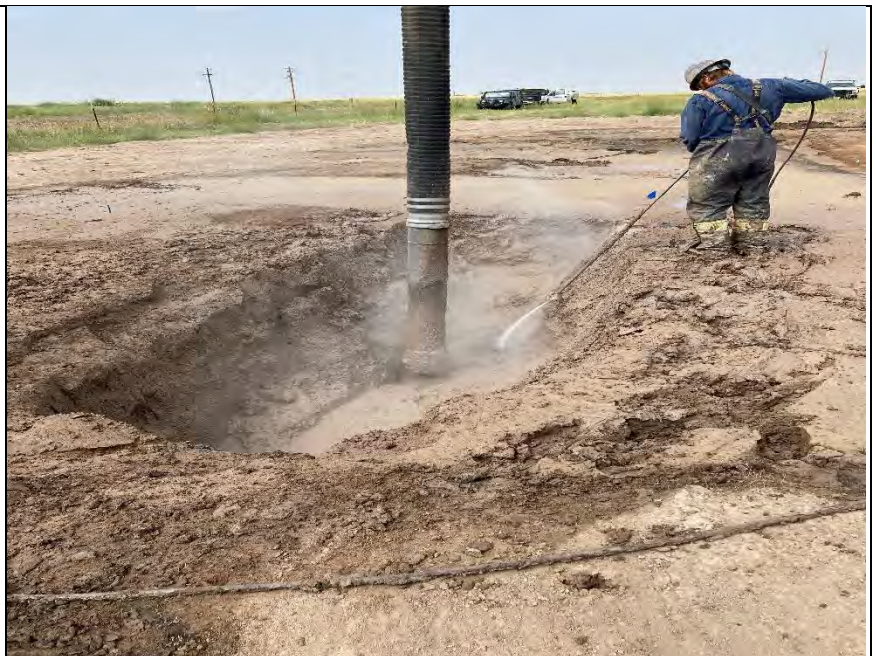
**Photo: B-4**

Hydro Excavation

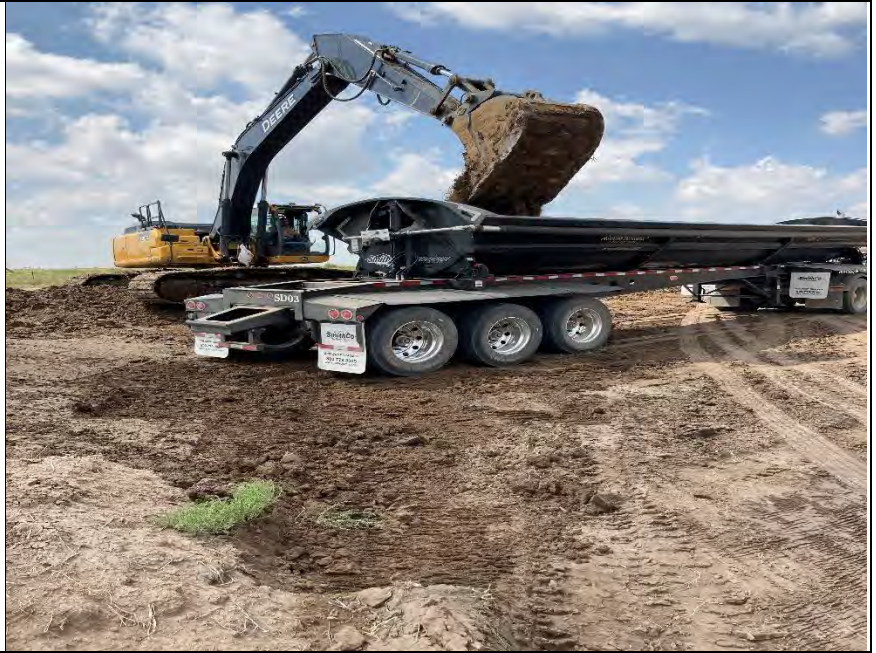
**Photo: B-5**

Loading impacted soil
