# Final Reclamation Inspection

Operator: Simcoe LLC - 10749

Location ID: 307019

Inspection Photos  
Location Name: Eldridge 25-02 2  
Location ID: 307019

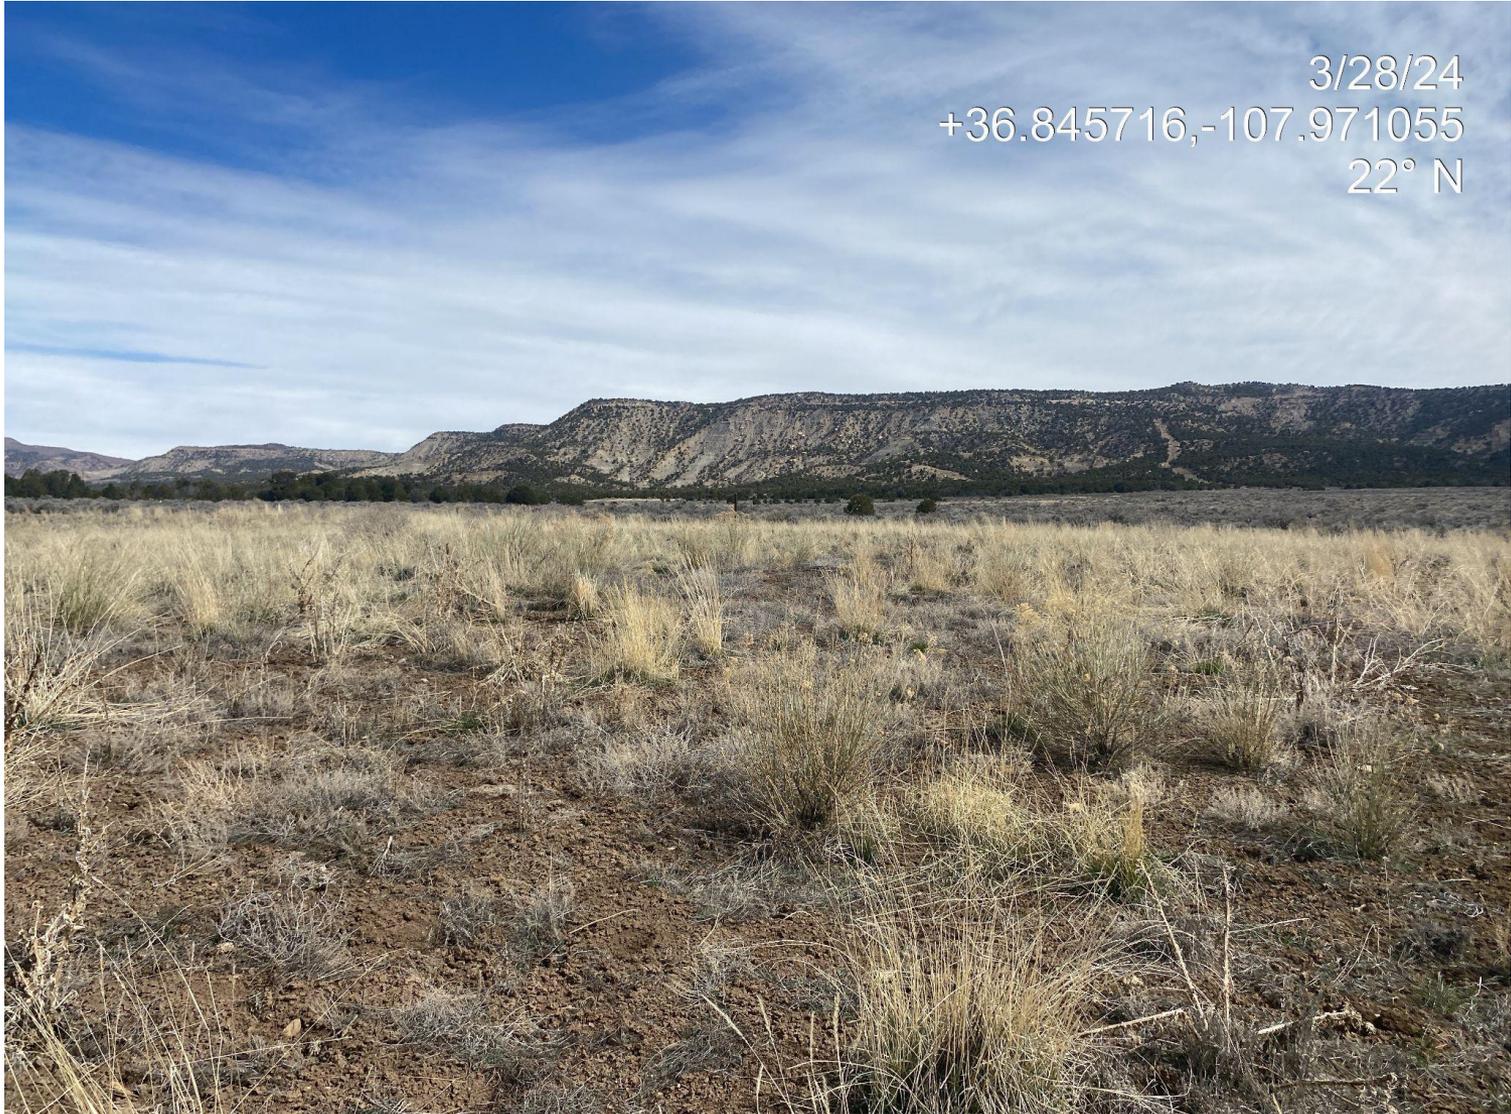
**Photo 1.** Overview of the disturbance taken from the southern edge facing center.

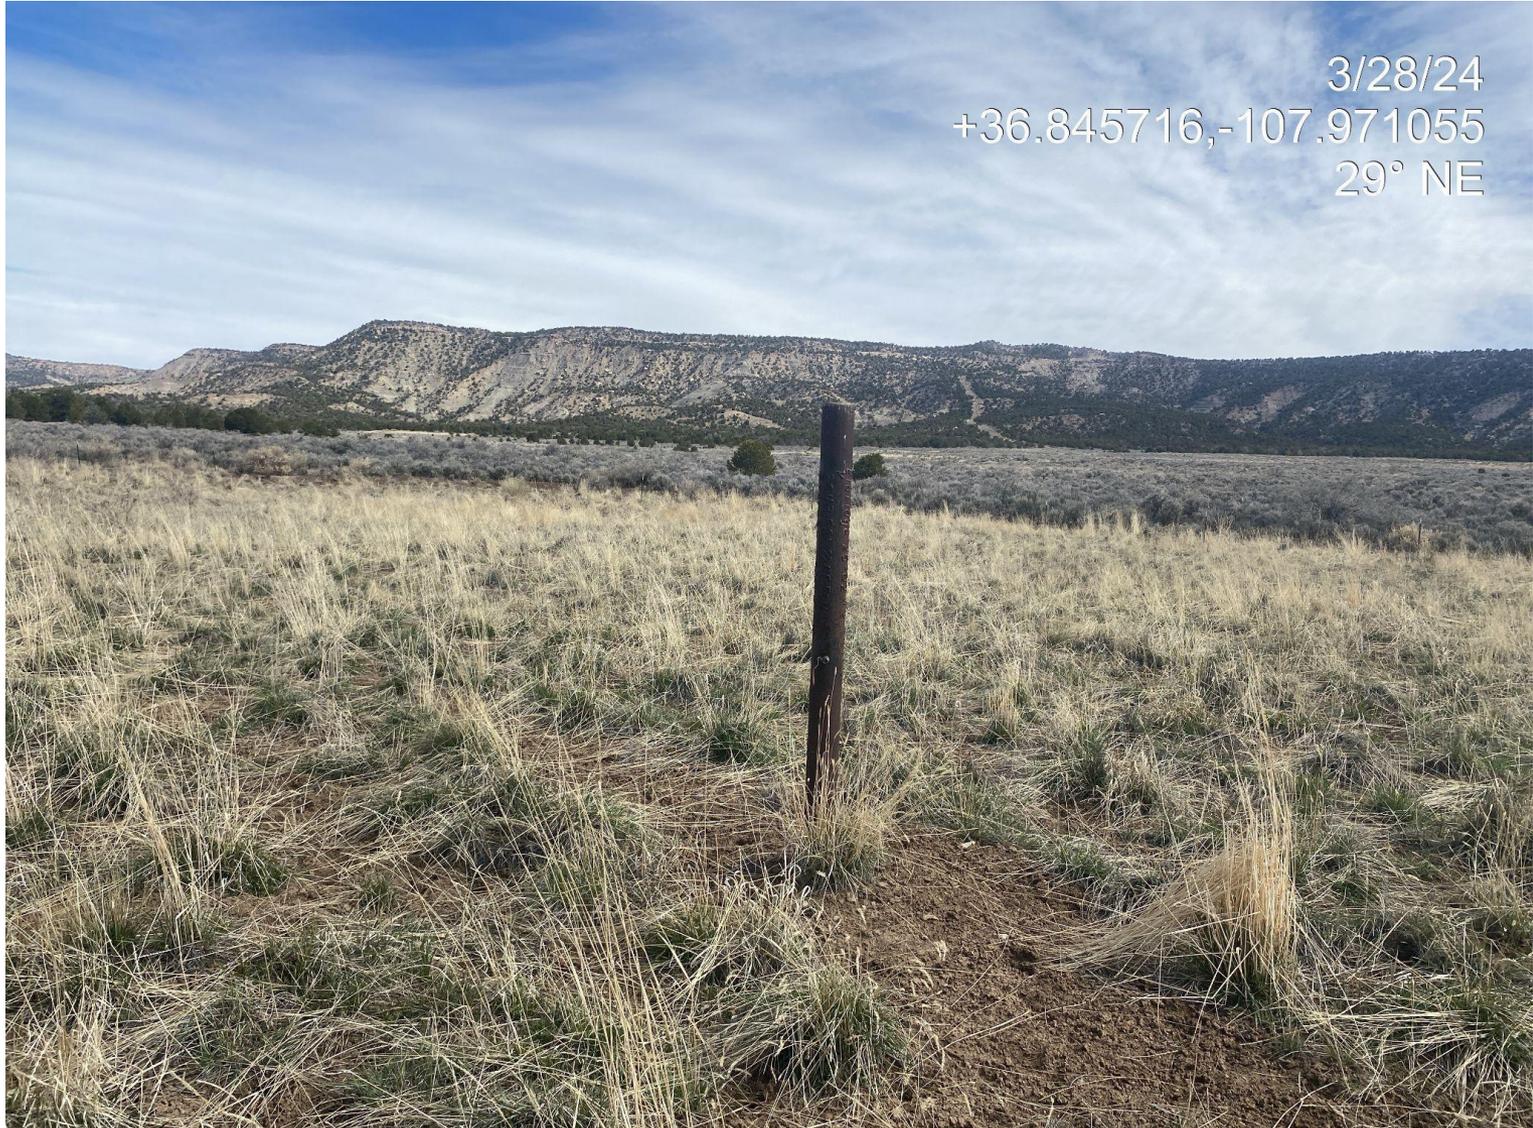
**Photo 2.** View of the well head marker facing north.

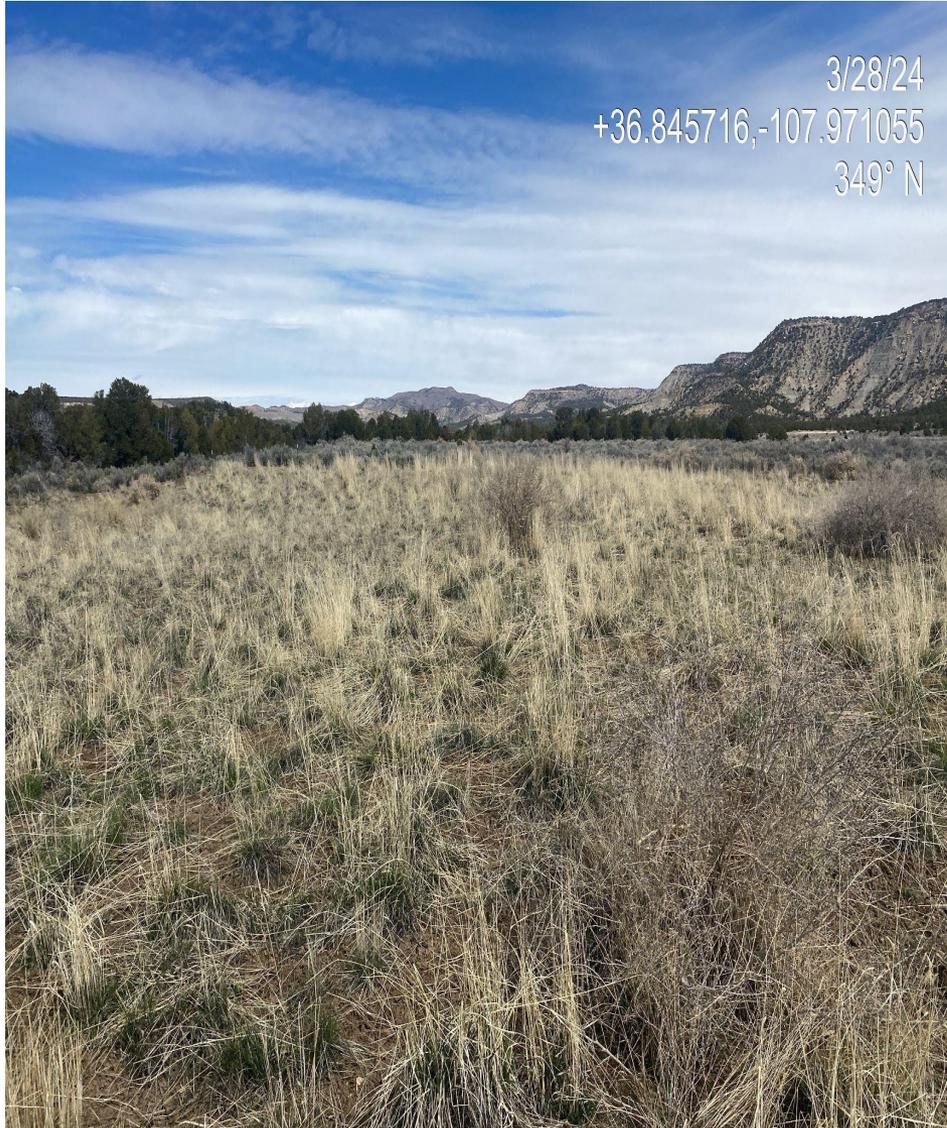
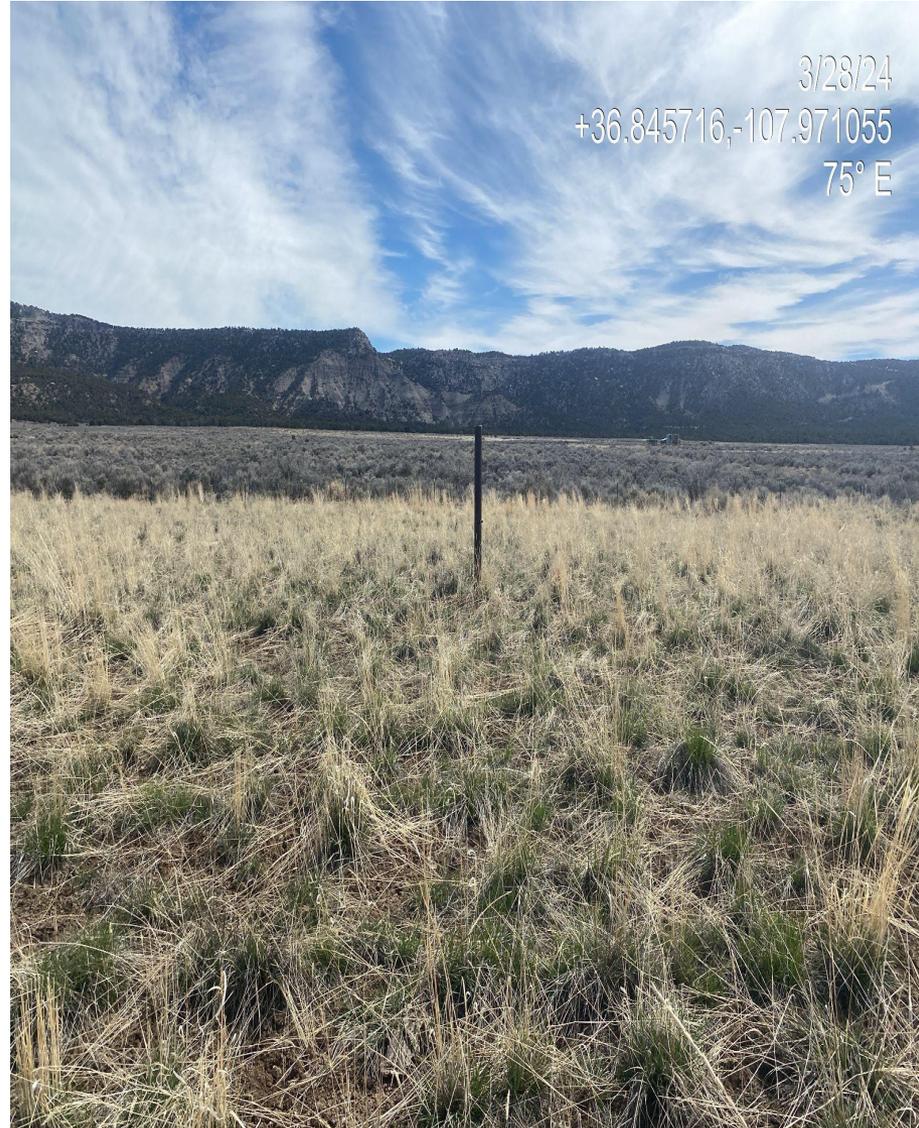
**Photo 3.** Cardinal photos taken from the center of the disturbance. Left photo facing north, right photo facing east.

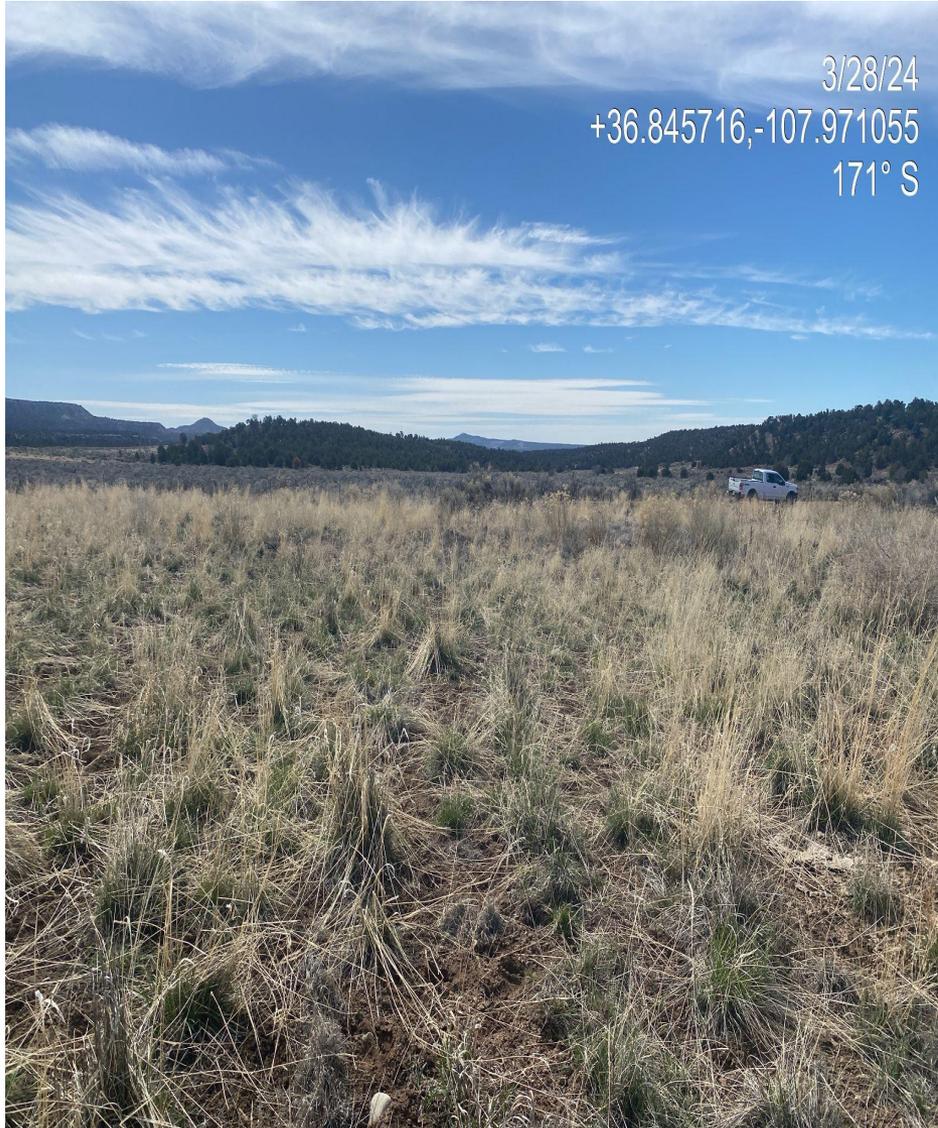
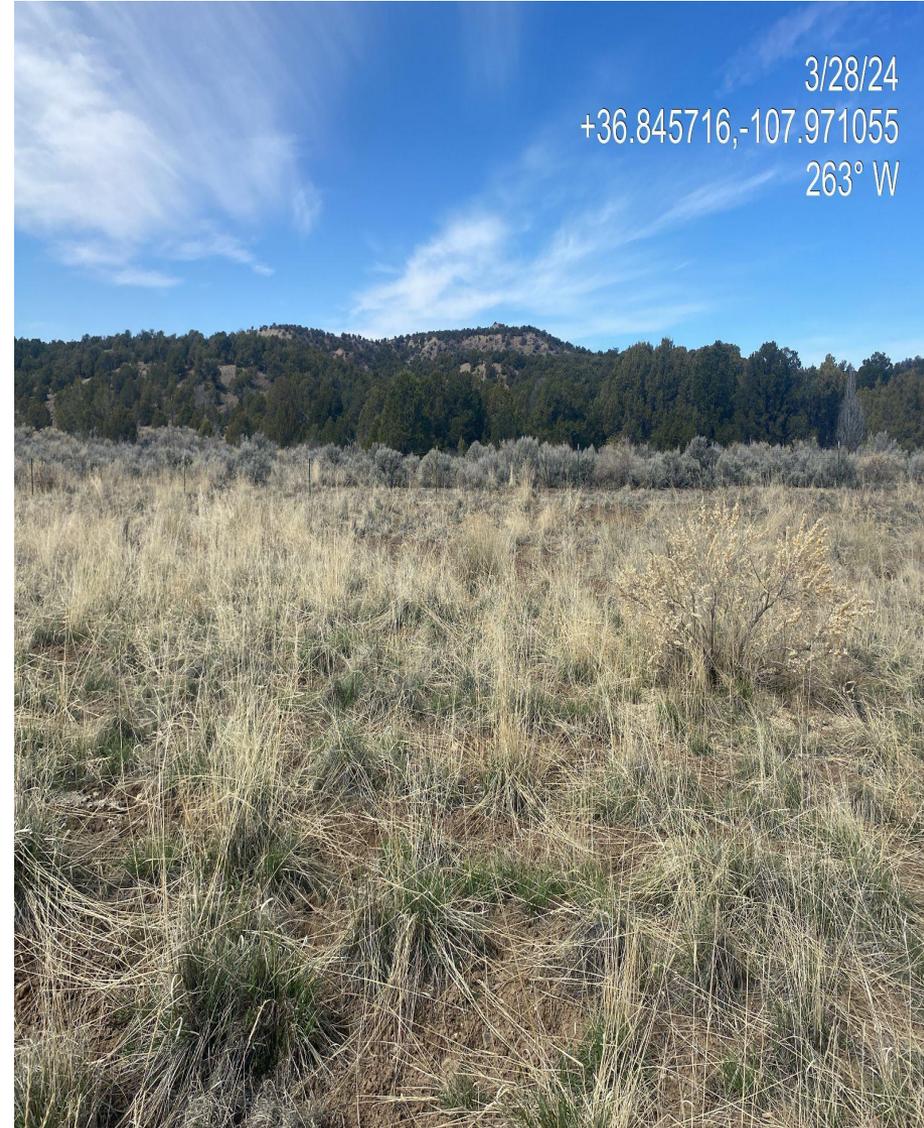
**Photo 4.** Cardinal photos taken from the center of the disturbance. Left photo facing south and right photo facing west. Note: project area vegetation and density appears consistent with adjacent reference area

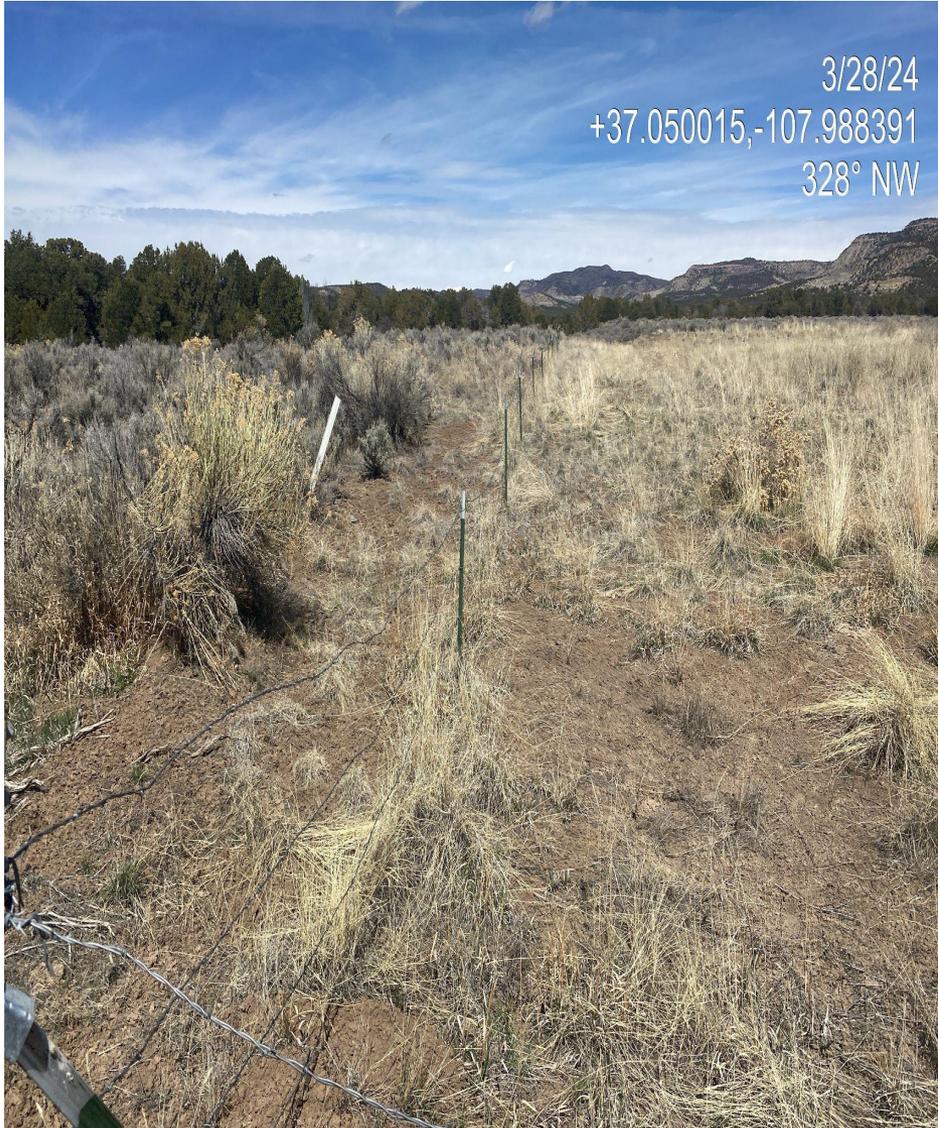
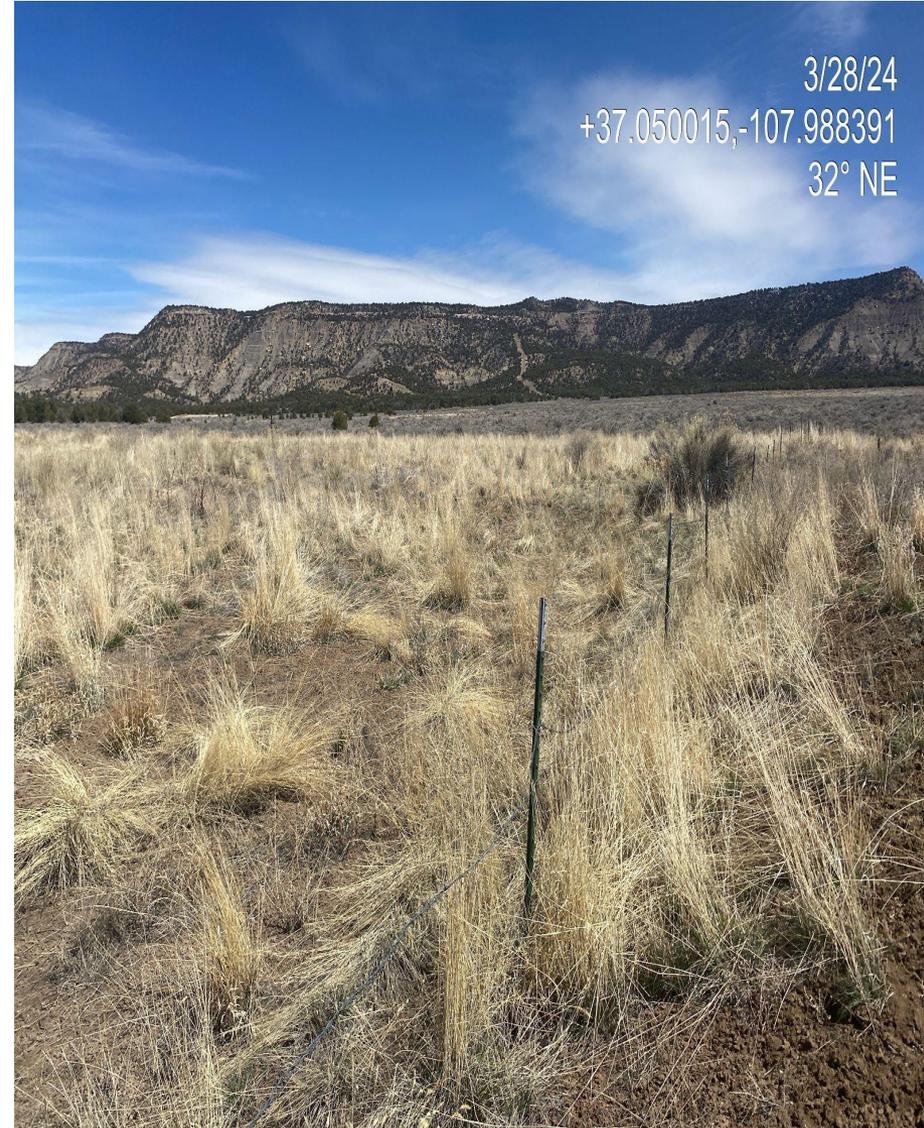
**Photo 5.** Perimeter fence remains on location. Fence will need to be removed before location can pass final reclamation.

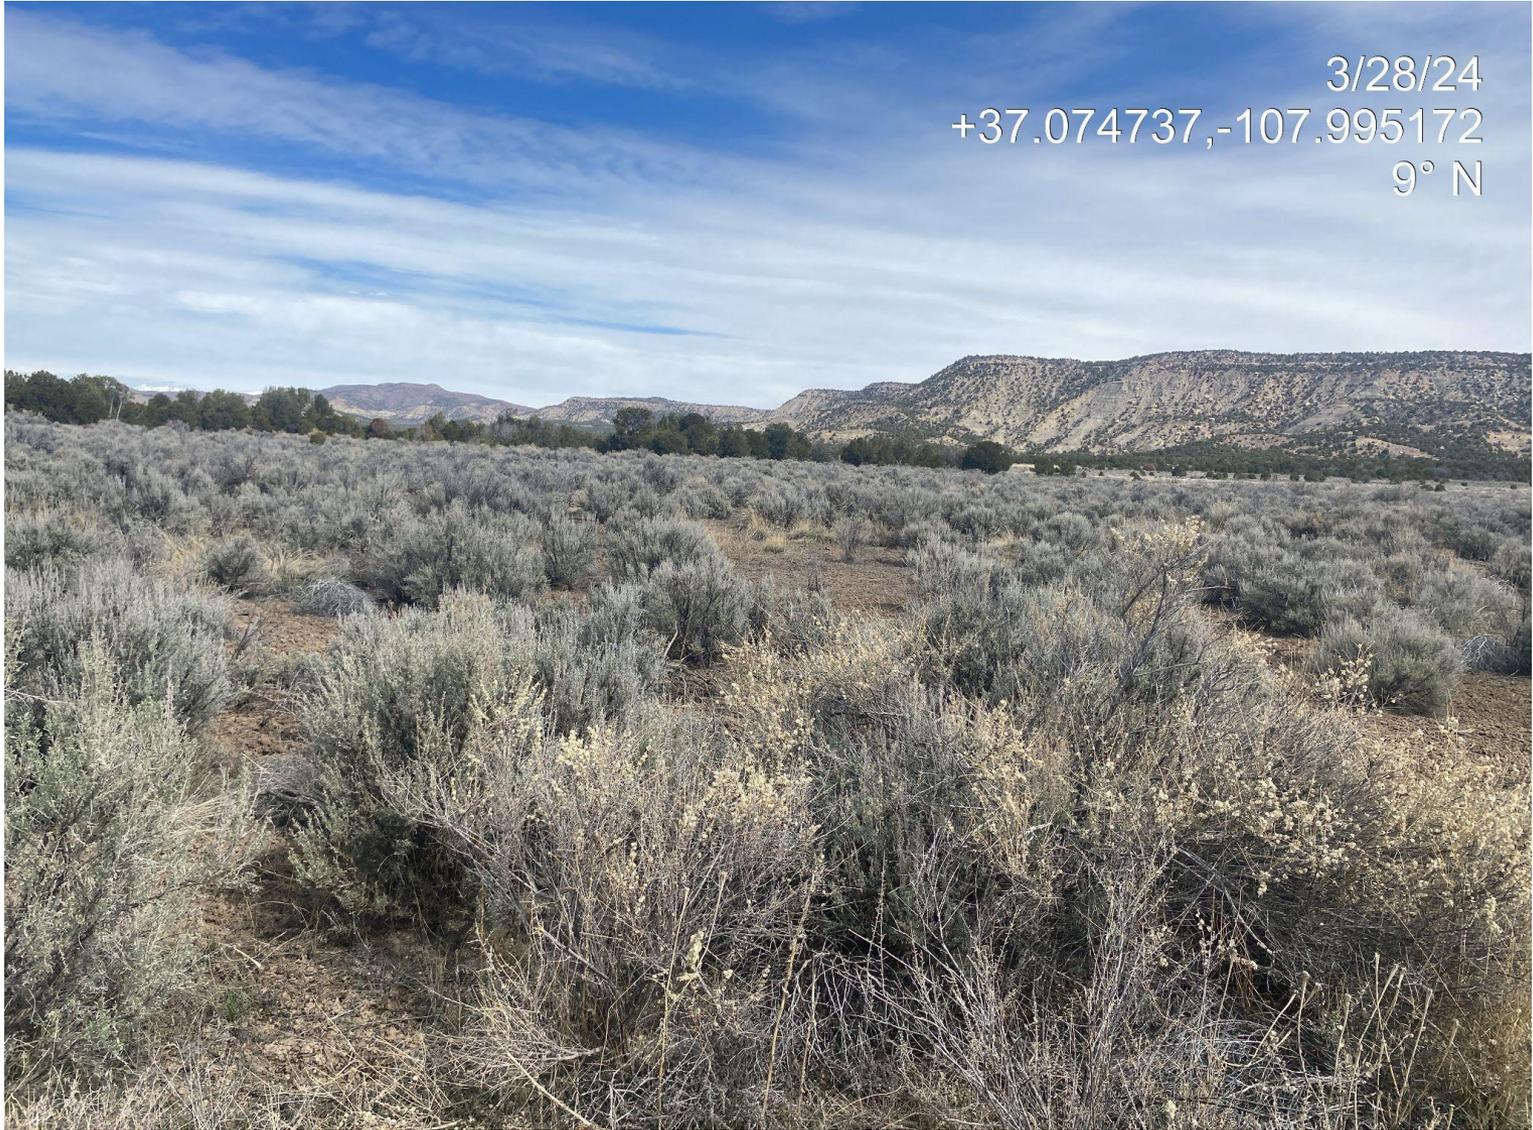
**Photo 6.** Reference comprised of sagebrush, rabbit brush, grease wood, smooth brome and crested wheatgrass.
