Final Reclamation Inspection

Operator: HIGHPOINT OPERATING CORPORATION - #10071

Location ID: 420523

Inspection Photos
Location Name: Critter Creek 24-30H
Location ID: 420523

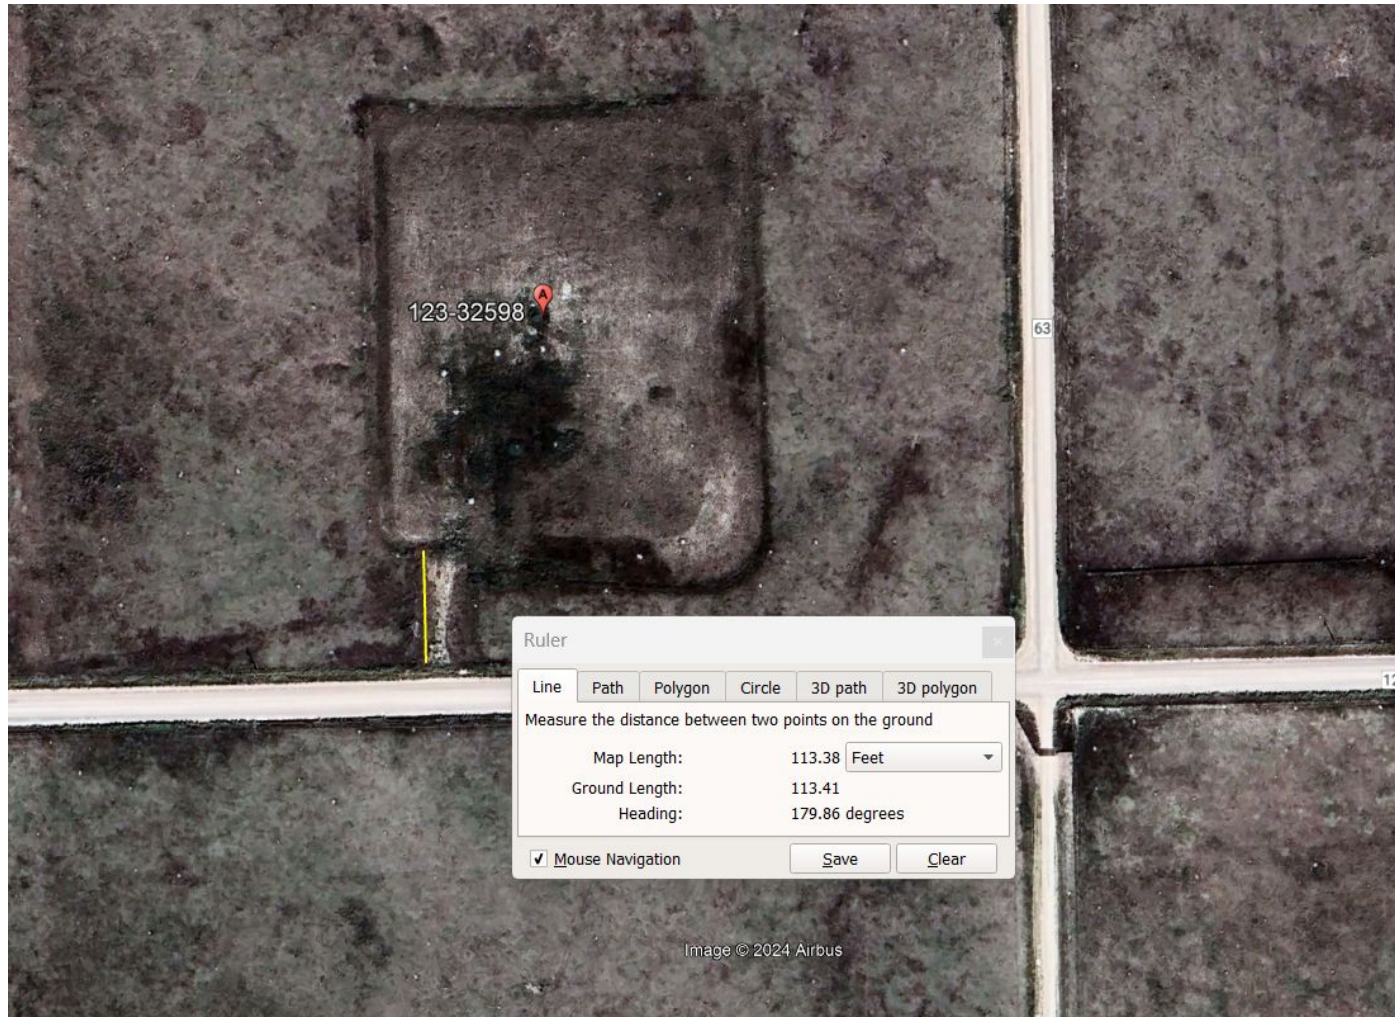
Photo 1. Google Earth aerial imagery from 9/3/2023 illustrating the location. Operator has performed final reclamation activities; however, Operator has left an approximate 100' section of access road in-place.

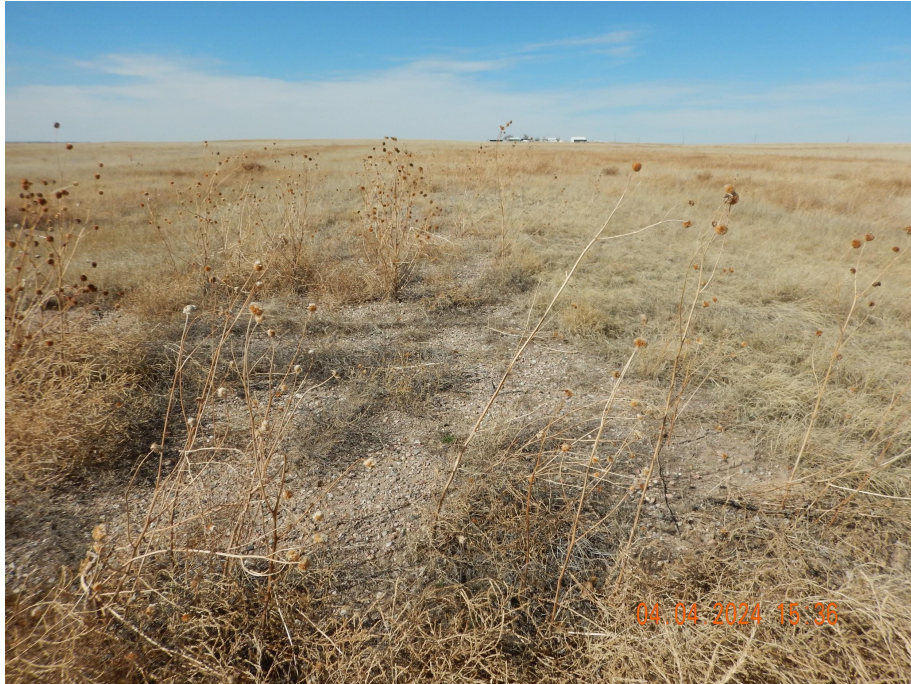
Photo 2. Photo taken from the entrance of location off CR124, facing North. Operator has failed to remove gravel, recontour and reclaim an approximate 100' section of access road.

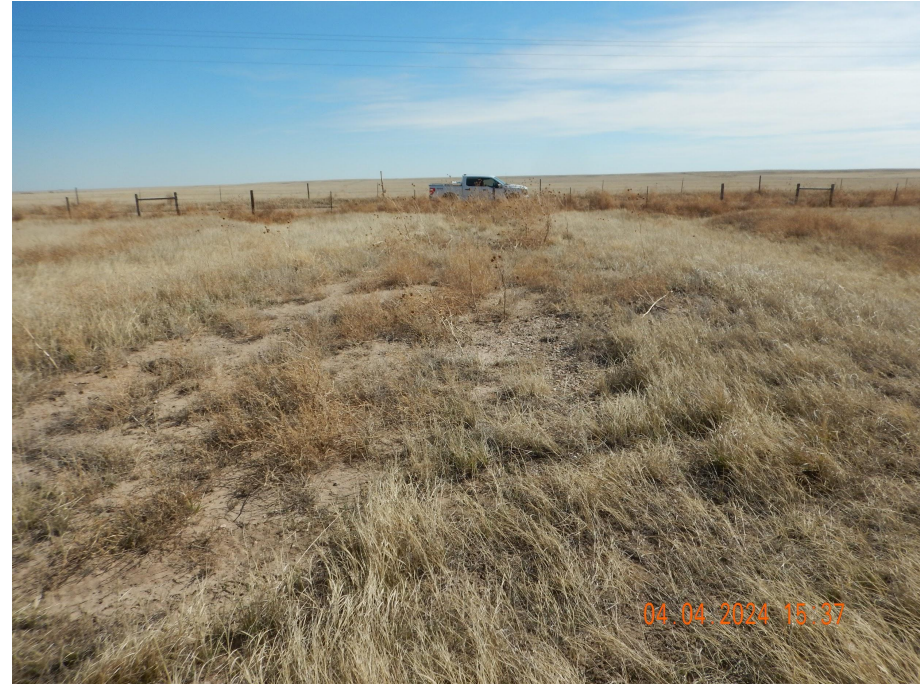
Photo 3. Photo taken from a section of the access road, facing South. See comments under Photo 2.

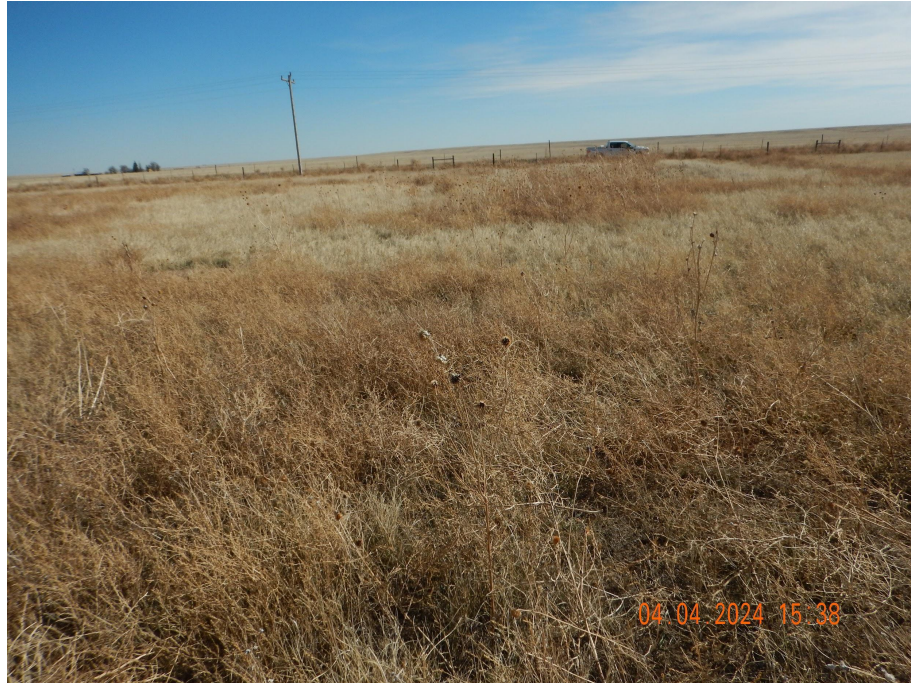
Photo 4. Photo taken from the southern location, facing South. Photo illustrates unmanaged weeds.

Note- much of the location does have desirable plant establishment but there are patches of unmanaged weeds.

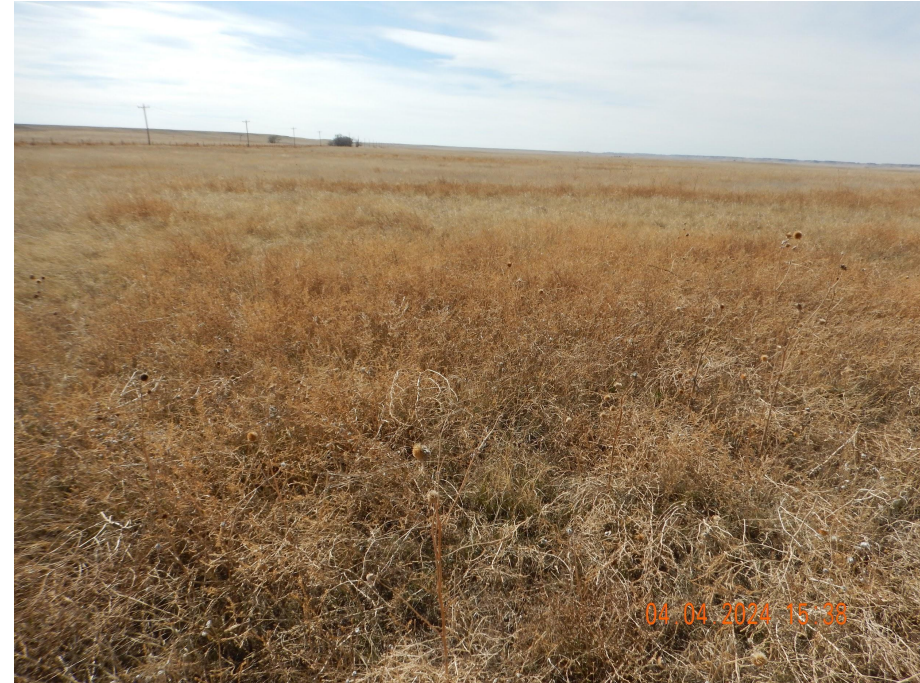
Photo 5. Photo taken from the southern location, facing West. See comments under Photo 4.

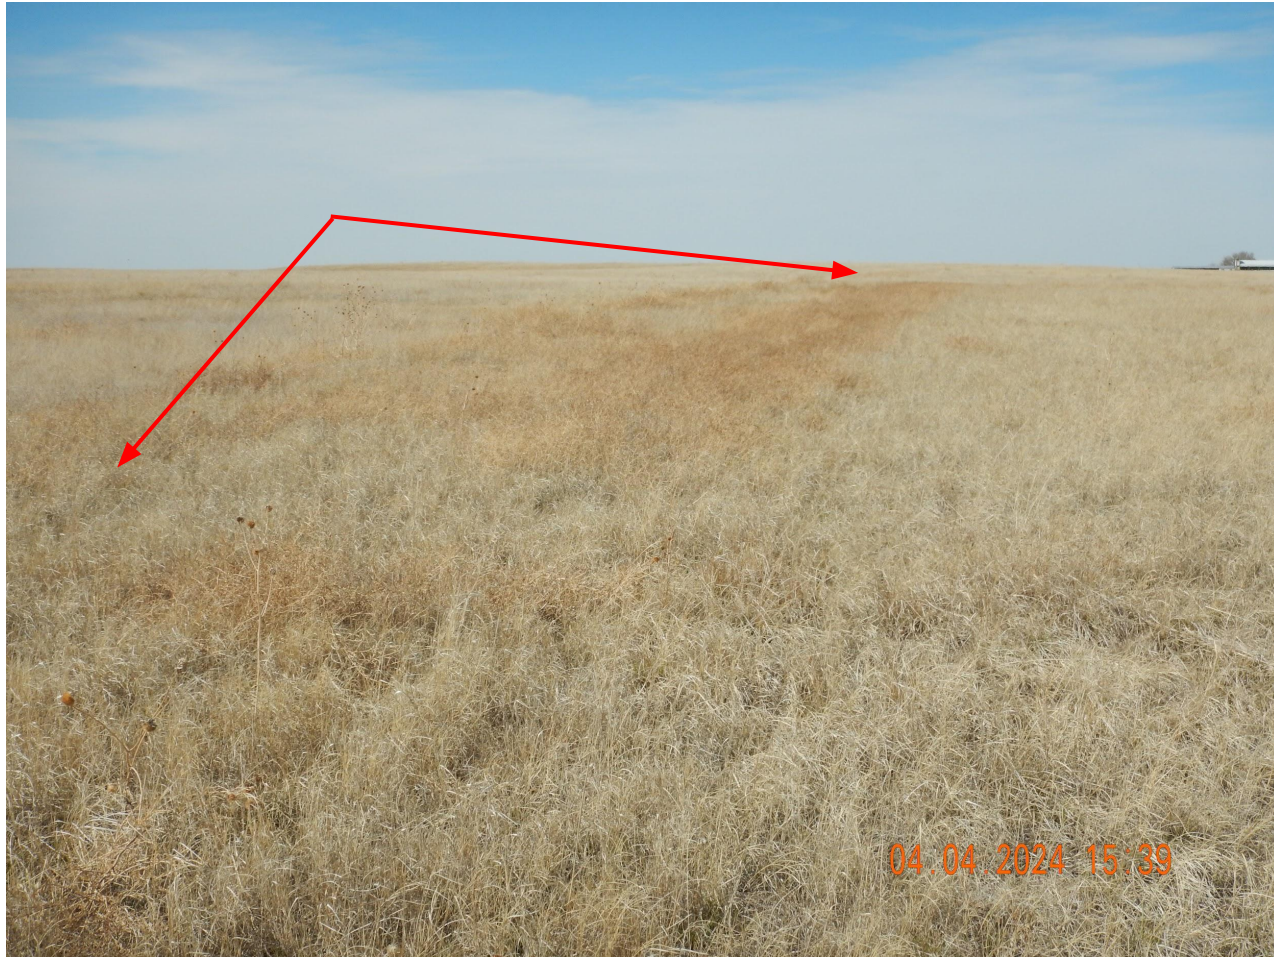
Photo 6. Photo taken from the southwestern location, facing North. Photo illustrates unmanaged weeds.
