Final Reclamation Inspection

Operator: Arkoma Operations LLC - 10766

Location ID: 311904

Inspection Photos
Location Name: VD Helton
Location ID: 311904

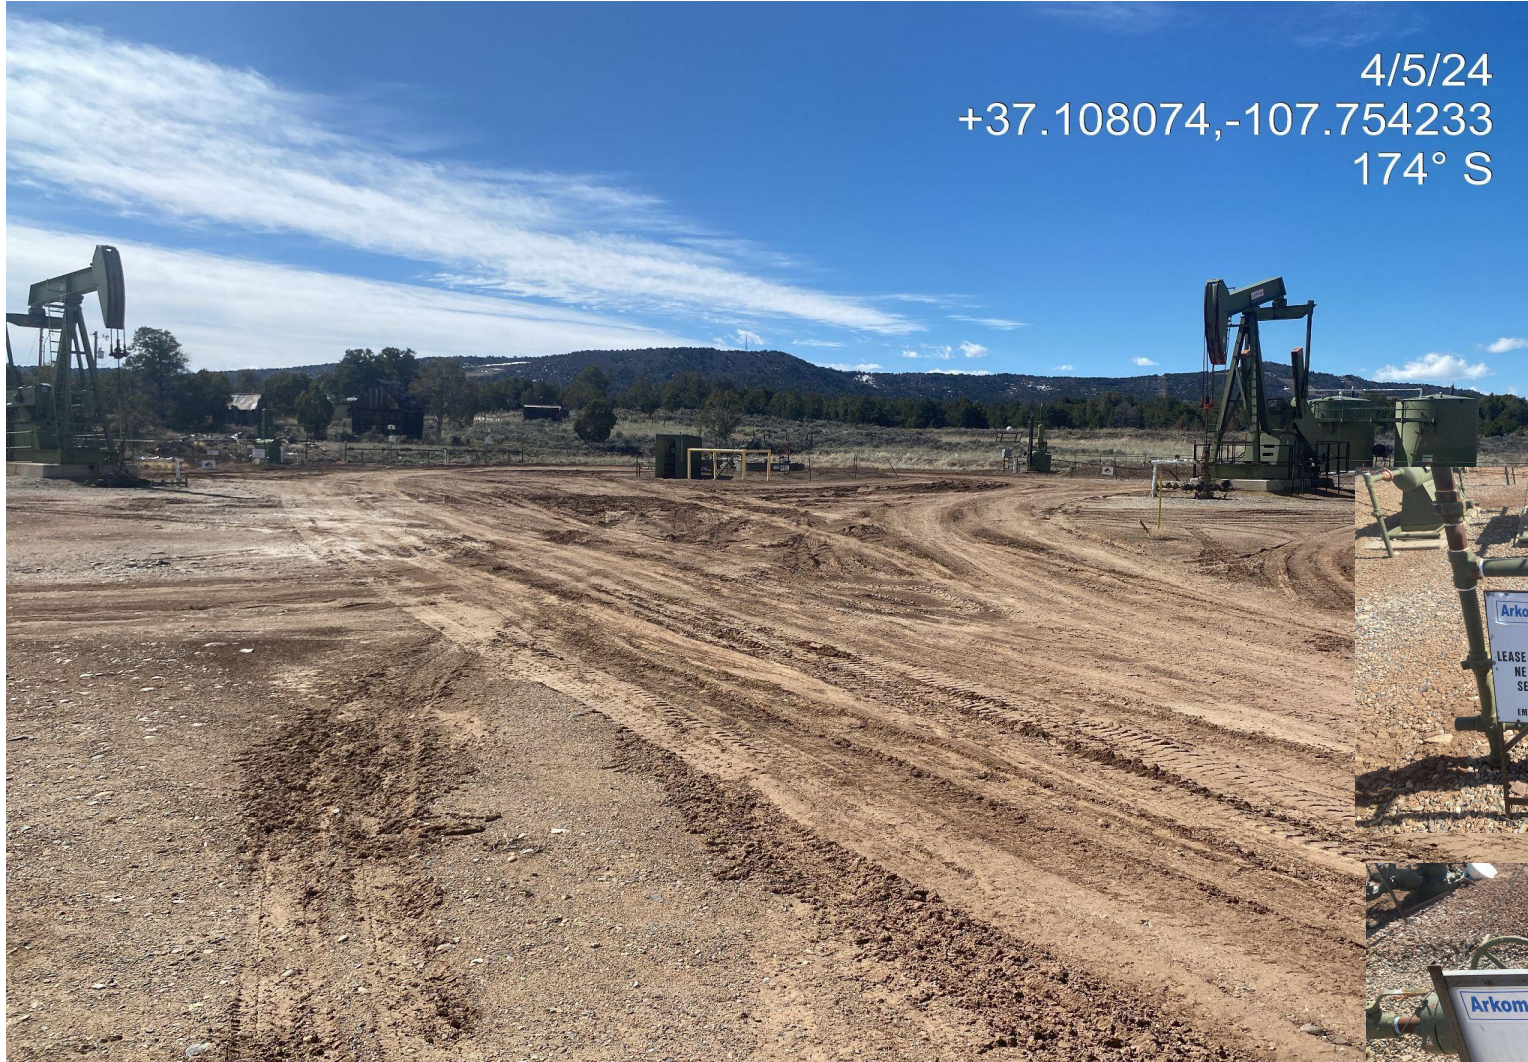
Photo 1. Overview of the well pad disturbance from the access point facing center. Note: Wells share a disturbance with the Advanced Wireless Communications Slugger 1, 11 wells.

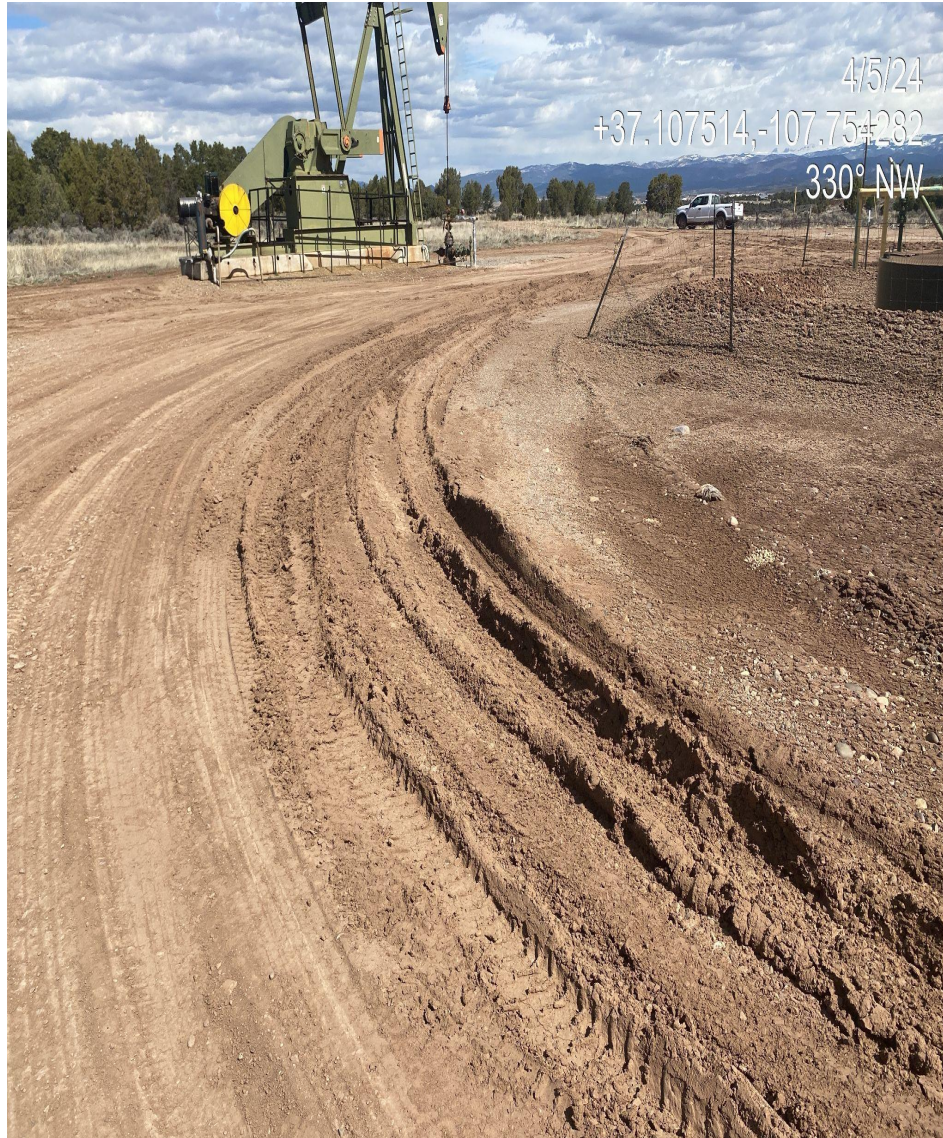
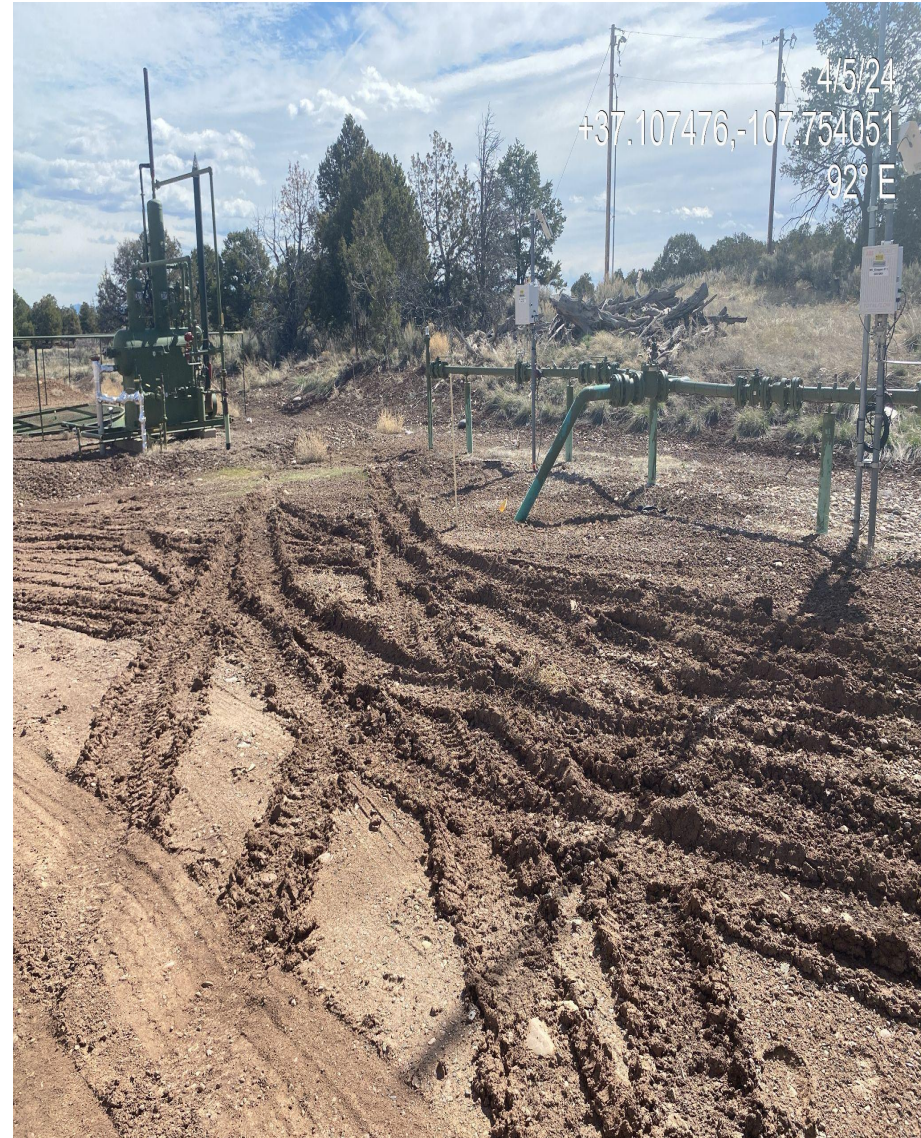
Photo 2. View of rutting/storm water issues observed on location.
Additional stabilization is needed to minimize site degradation.
