Inspection Photos

Operator: VISION ENERGY LLC - 10770

Location ID: 322451

Inspection Doc: 696205746

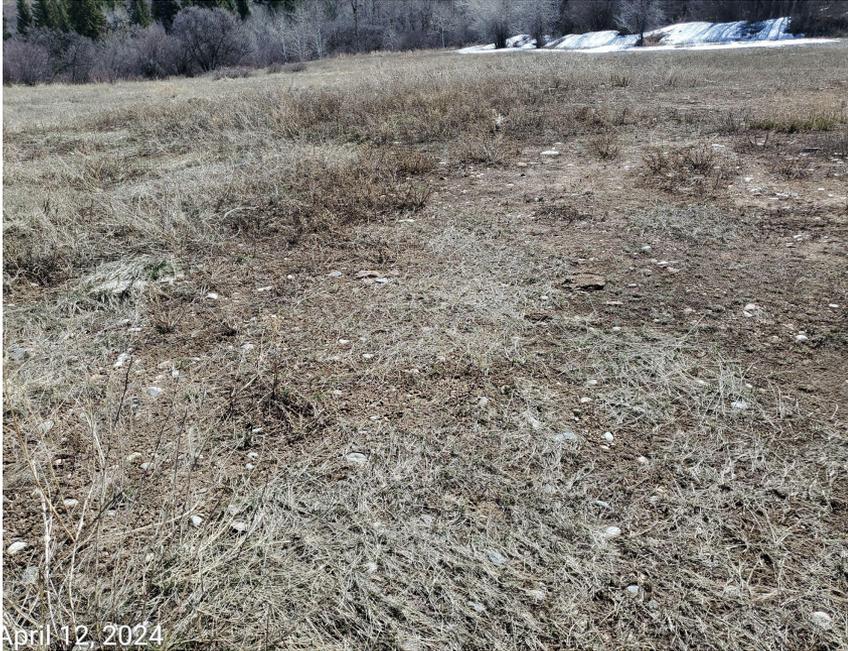
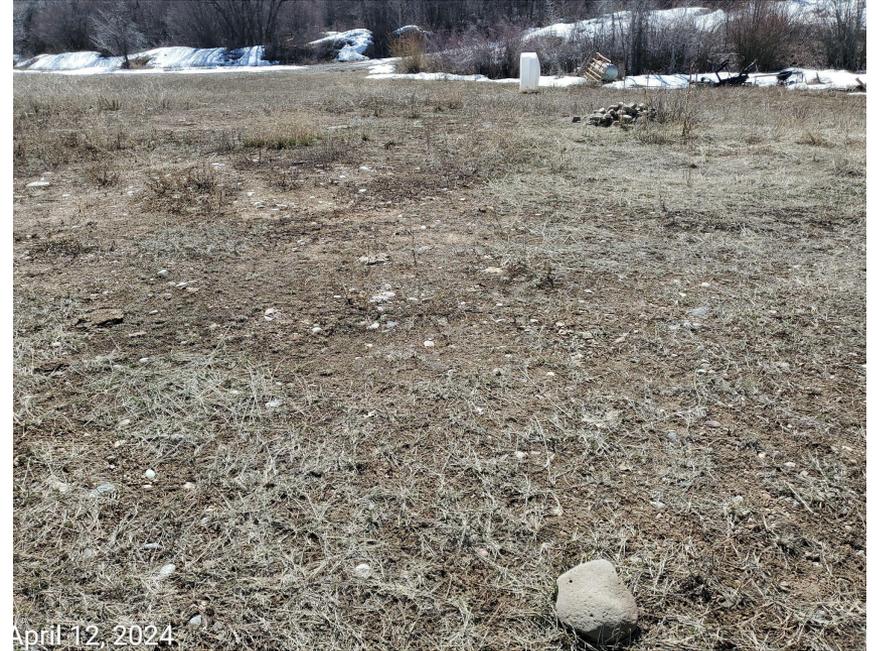
Photo 1: Photos 1-3 taken from the Location. Photos examples showing that the Location does not meet 1004 requirements; Location bare, or vegetated predominantly by Undesirable Plant species.

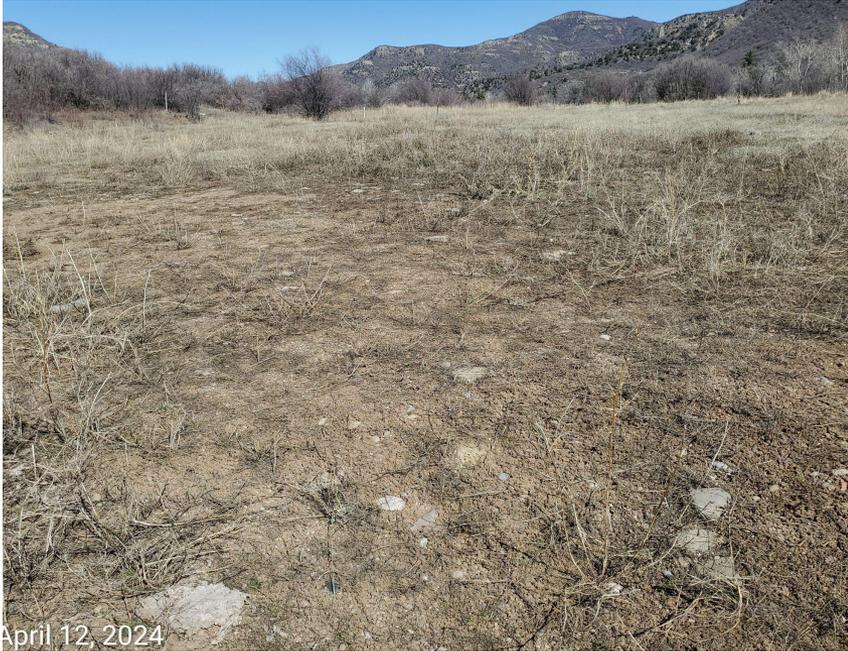
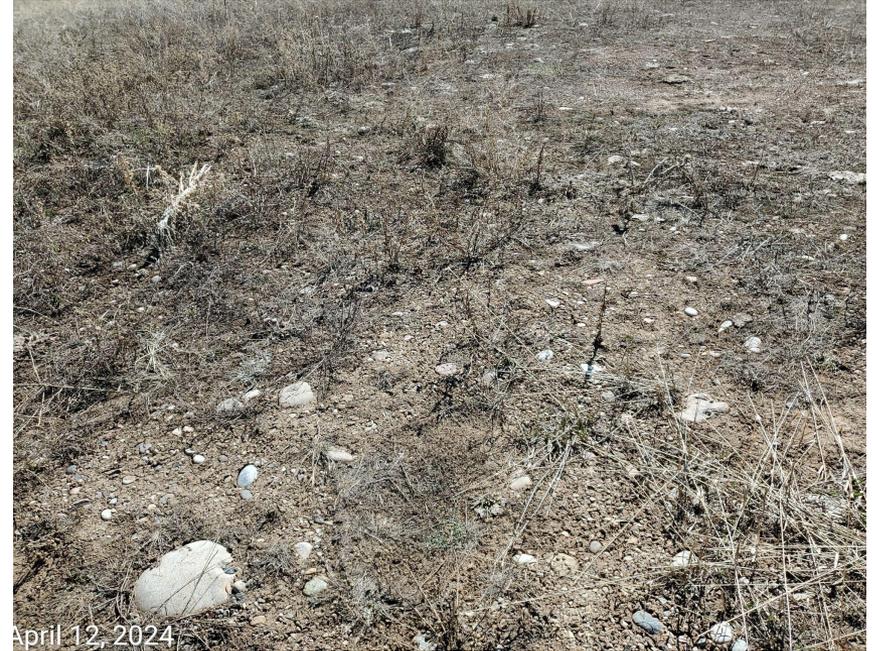
Photo 2: See comments under photo 1. Vegetation observed in photos predominantly Undesirable Plant Species such as *Melilotus officinalis*, and *Grindelia squarrosa*

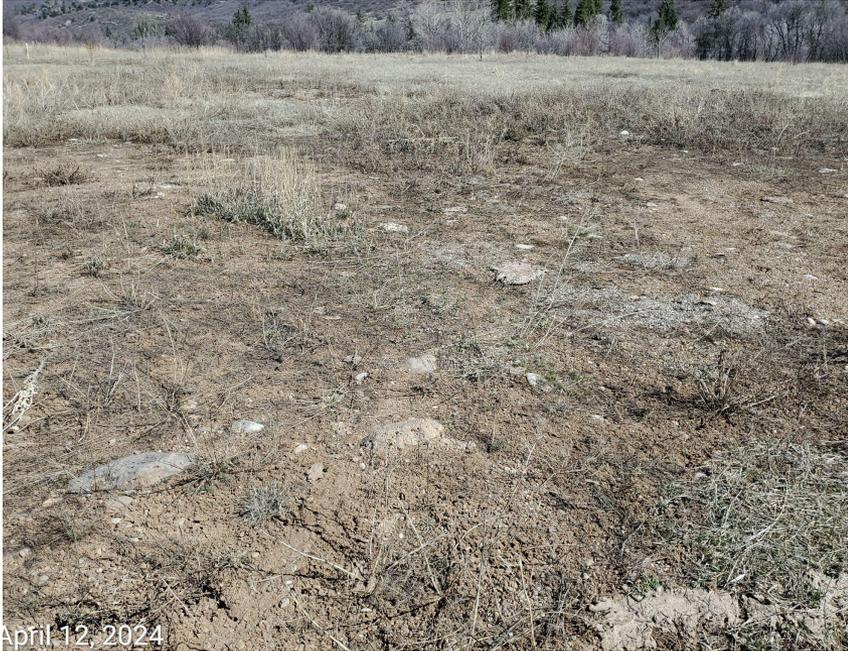
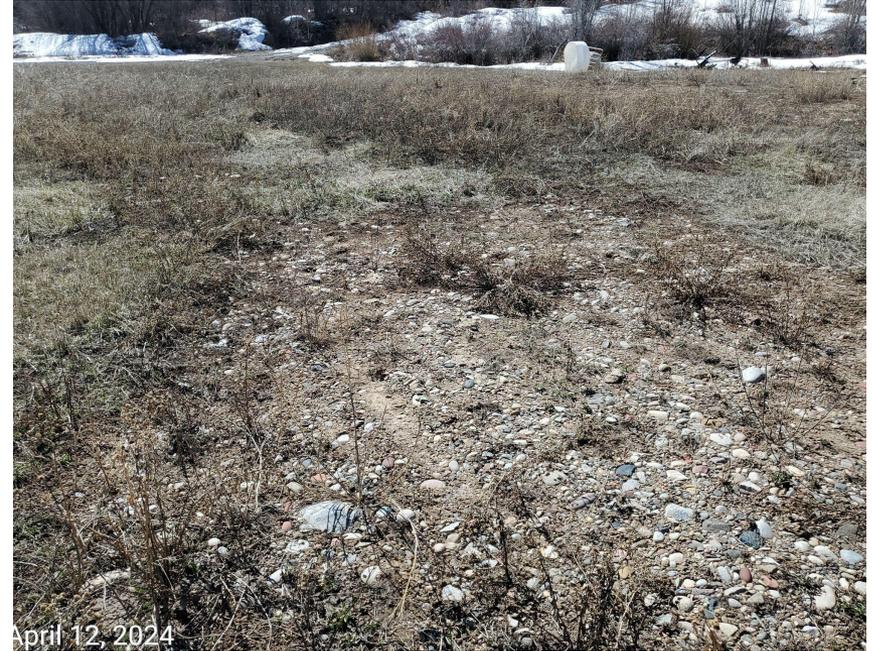
Photo 3: See comments under photo 1. Vegetation observed in photos predominantly Undesirable Plant Species such as *Melilotus officinalis*, and *Grindelia squarrosa*

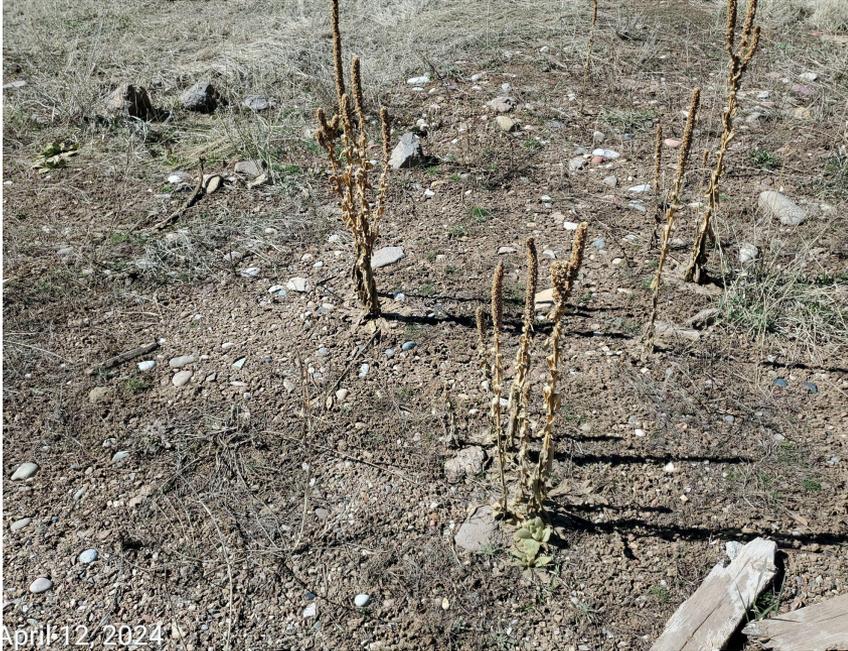
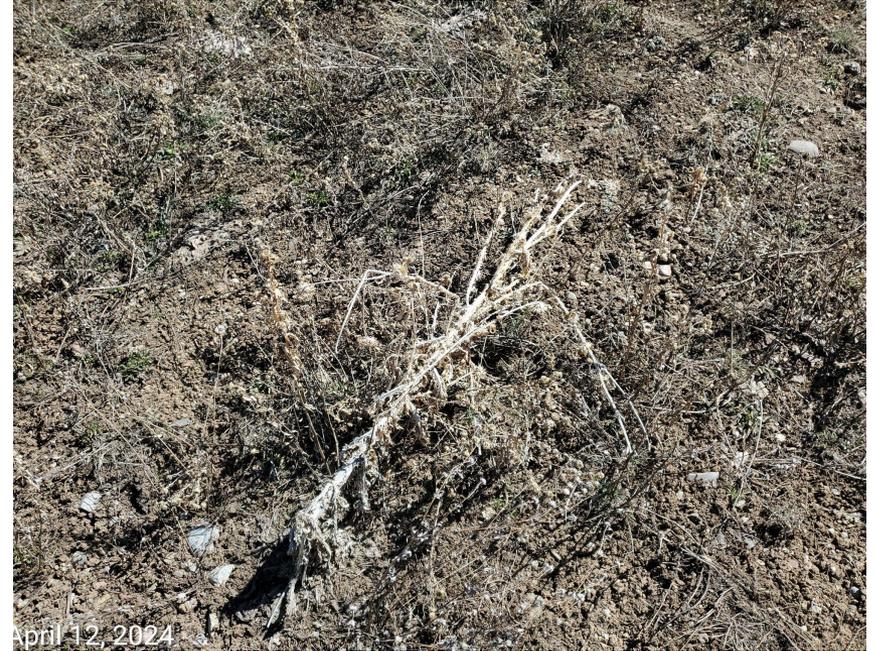
Photo 4: Photos examples of Noxious weeds (Common mullein, Musk thistle) observed on the Location.
