Inspection Photos

Operator: TEP ROCKY MOUNTAIN LLC - 96850

Location ID: 335053

Inspection Doc: 696205752

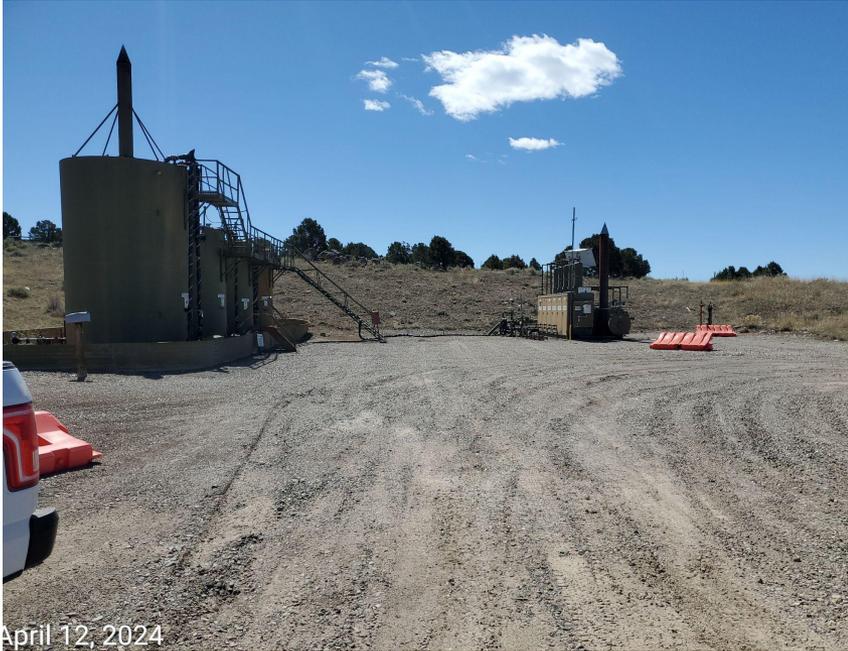
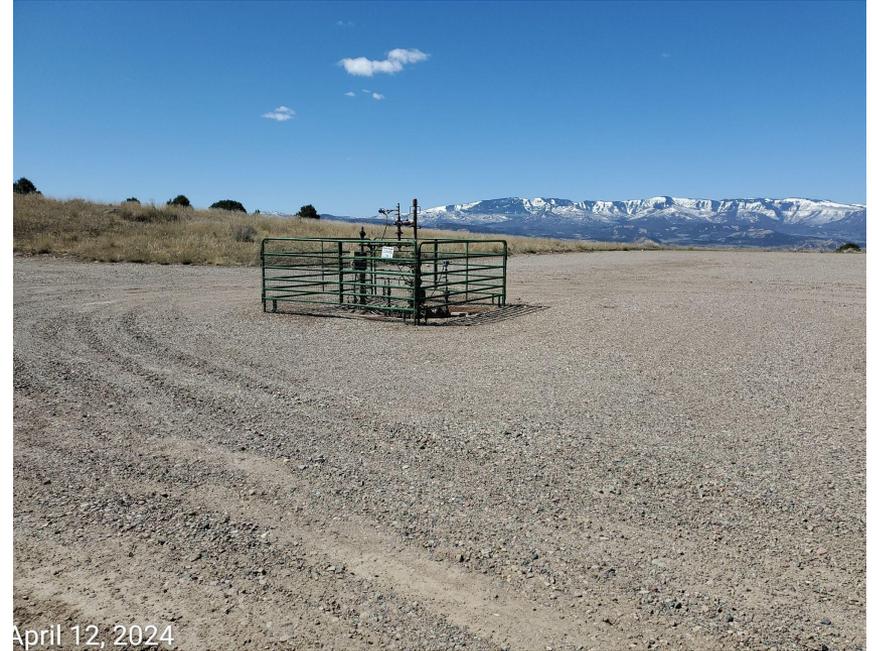
Photo 1: Photos 1-2 taken from the east end of the Location. Photos provide an overview of the Location from south, southwest, northwest to north. Photos also show all production equipment Located on the eastern half of the Location; western half of the working pad surface is no longer necessary for production, and requires reclamation pursuant to Rule 1003.b.

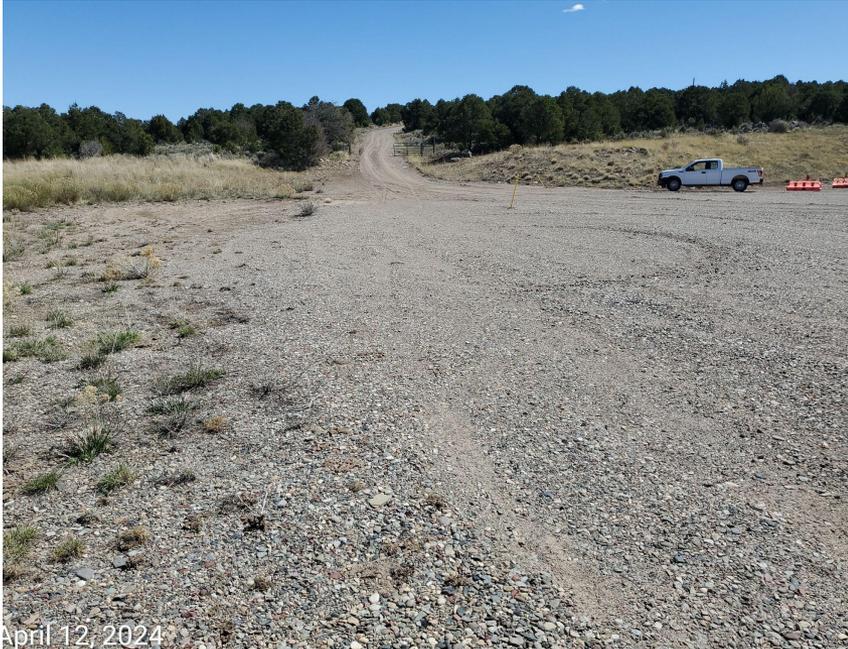
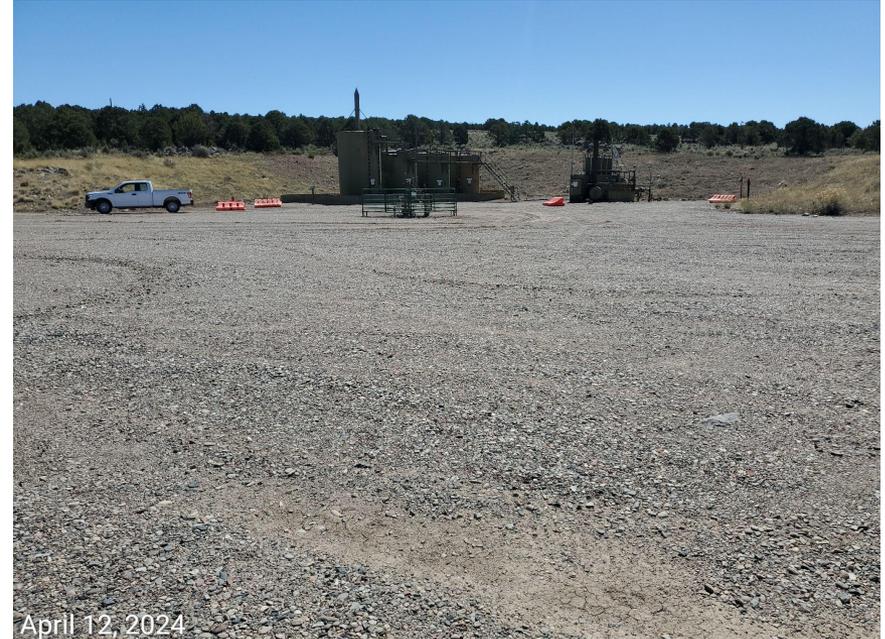
Photo 3: Photos 3-4 taken from the north end of the Location. Photos provide an overview of the Location from east, southeast, southwest to west. Photos also show all production equipment Located on the eastern half of the Location; western half of the working pad surface is no longer necessary for production, and requires reclamation pursuant to Rule 1003.b.

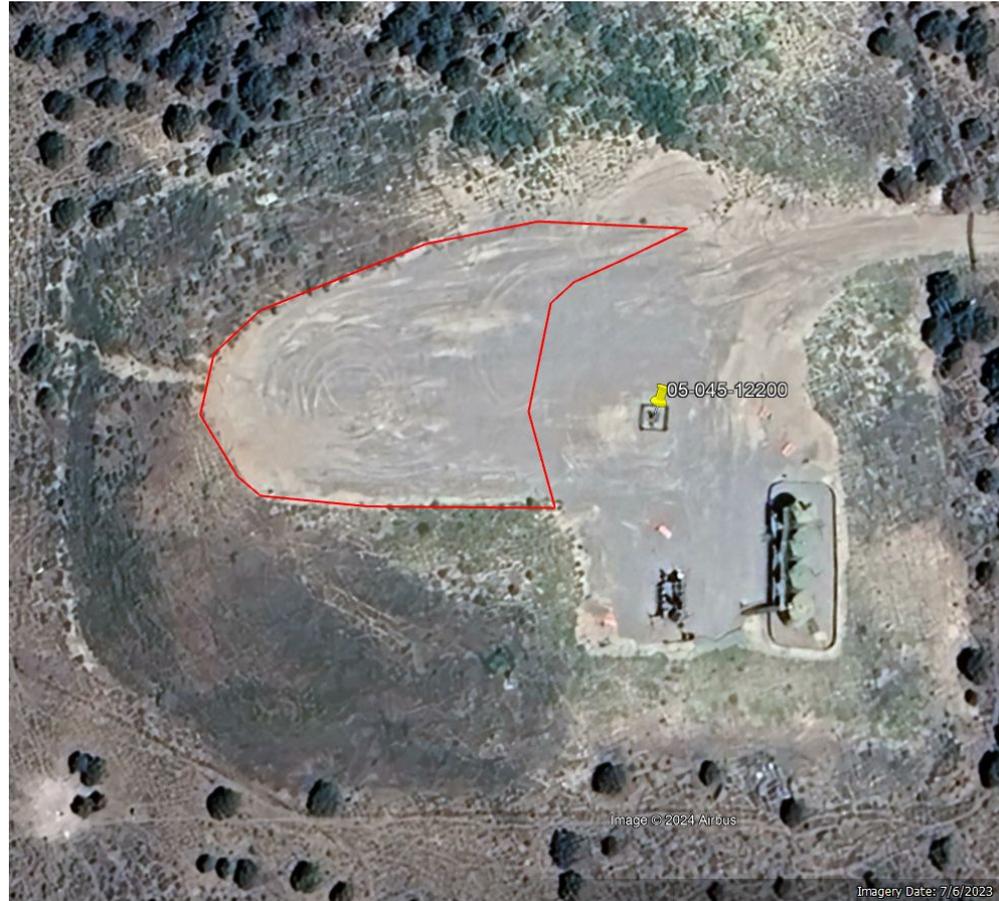
Photo 5: 2023 Google earth imagery. Red polygon represent approximate areas of the Location requiring reclamation pursuant to Rule 1003.b.

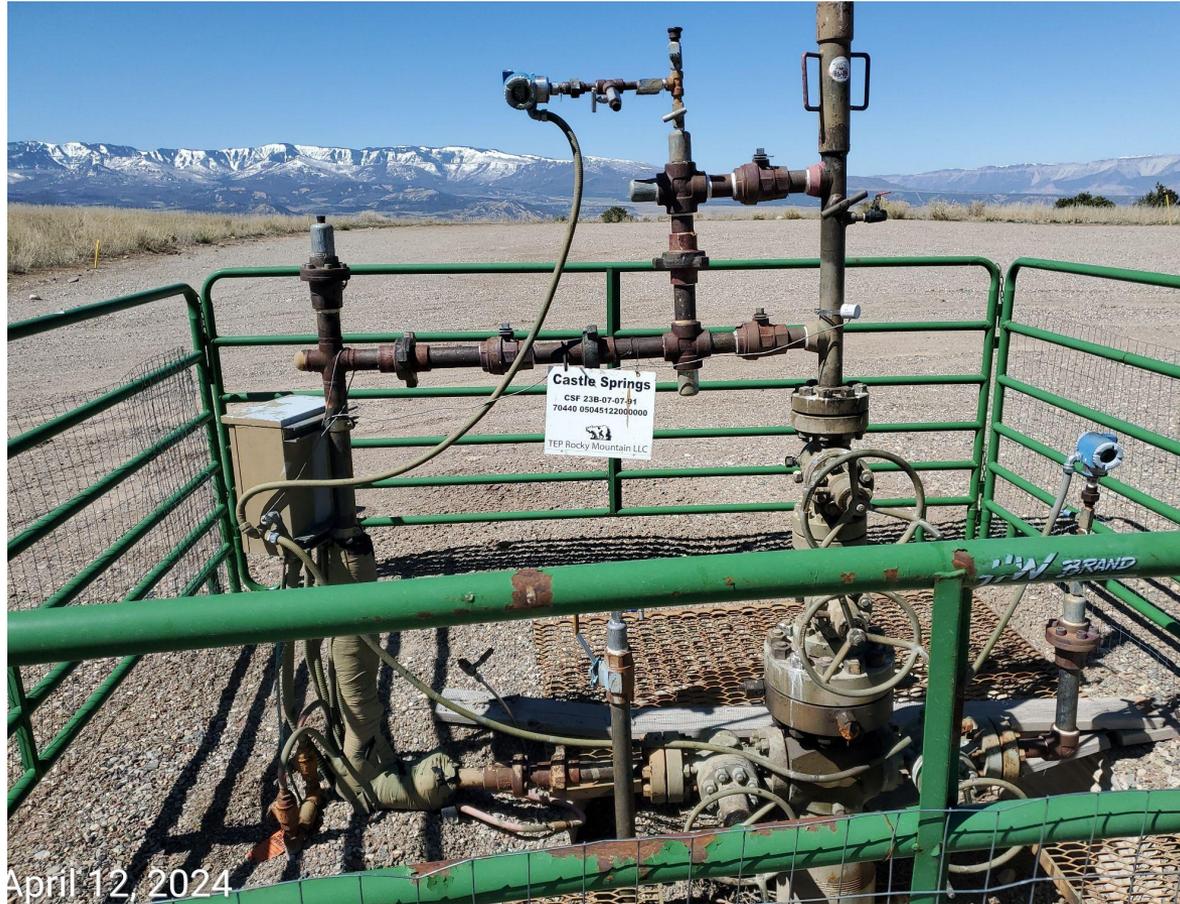
Photo 6: Photo shows the single PR well remaining on Location.

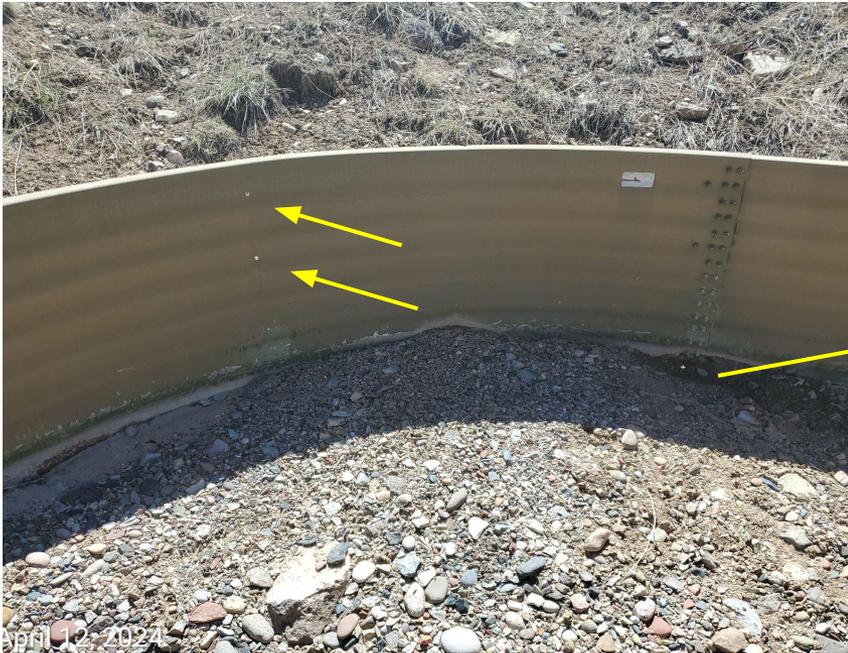
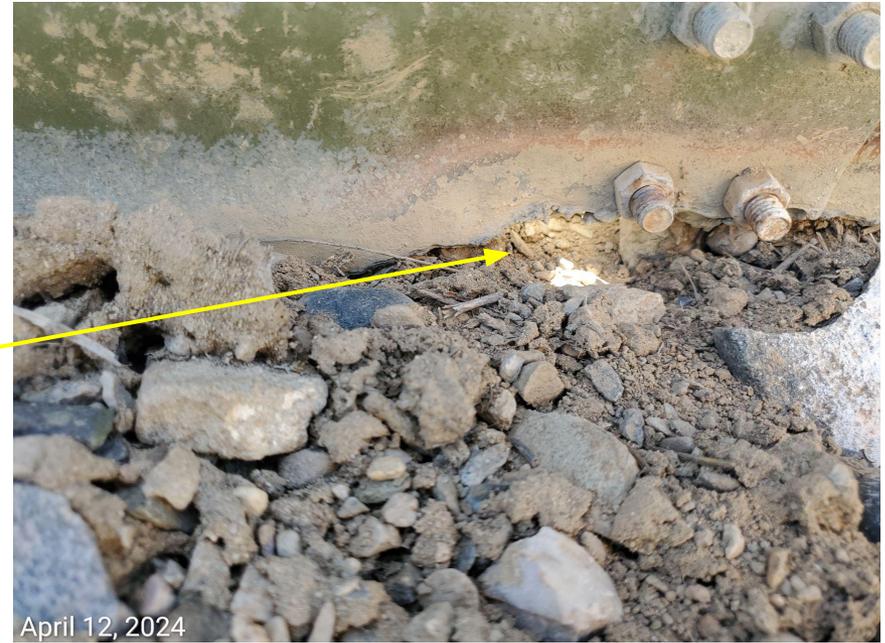
Photo 7: Photos 7-8 taken from the southern end of the tank battery facility. Photos examples showing holes within the secondary containment measure; BMP is no longer sufficiently impervious to contain a spill or release.
