Operator: *BONANZA CREEK ENERGY OPERATING*

Location Name: *State Pronghorn P-16 Pad*

Loc ID: *428090*

Inspection: *708201166*

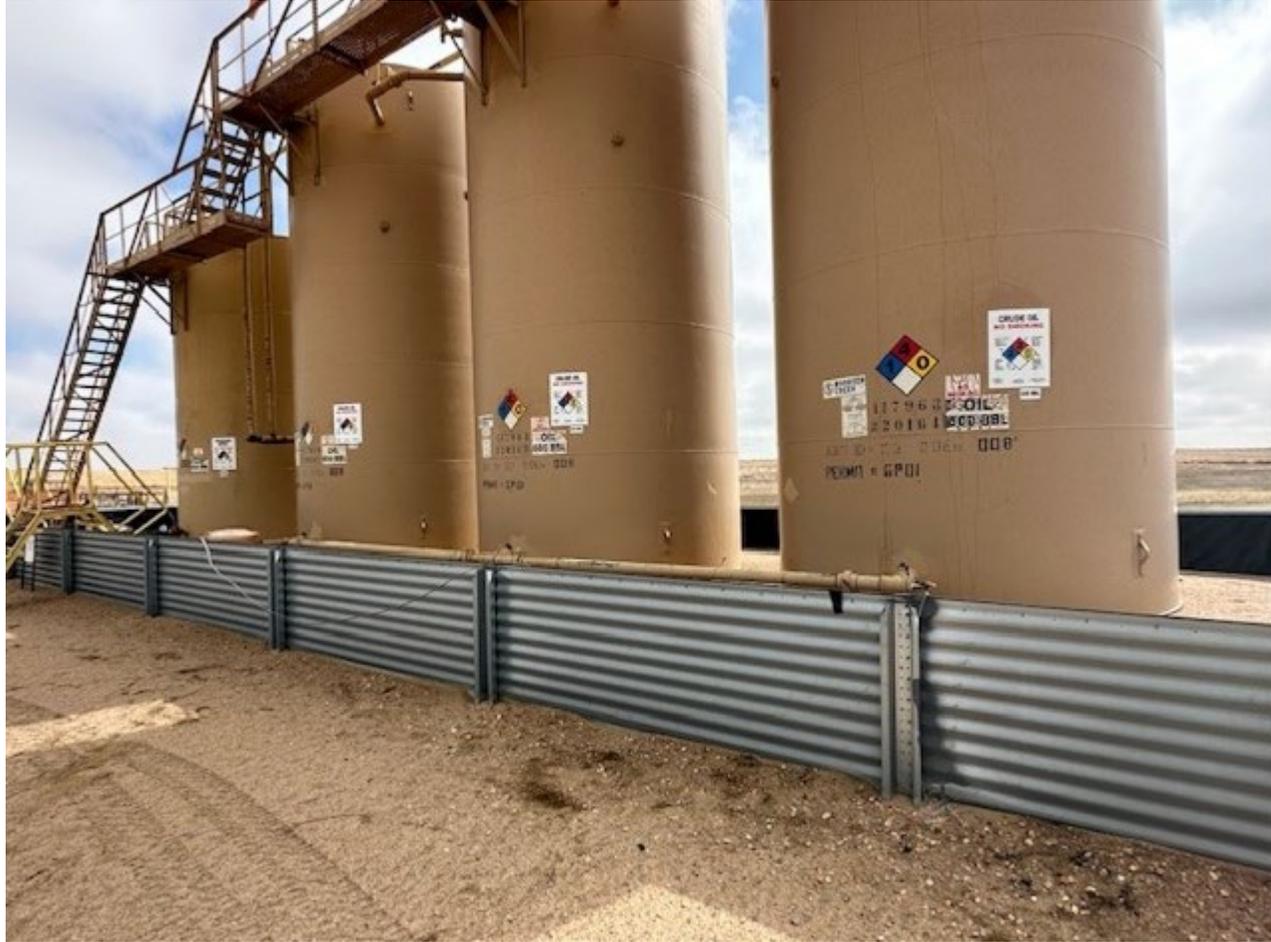
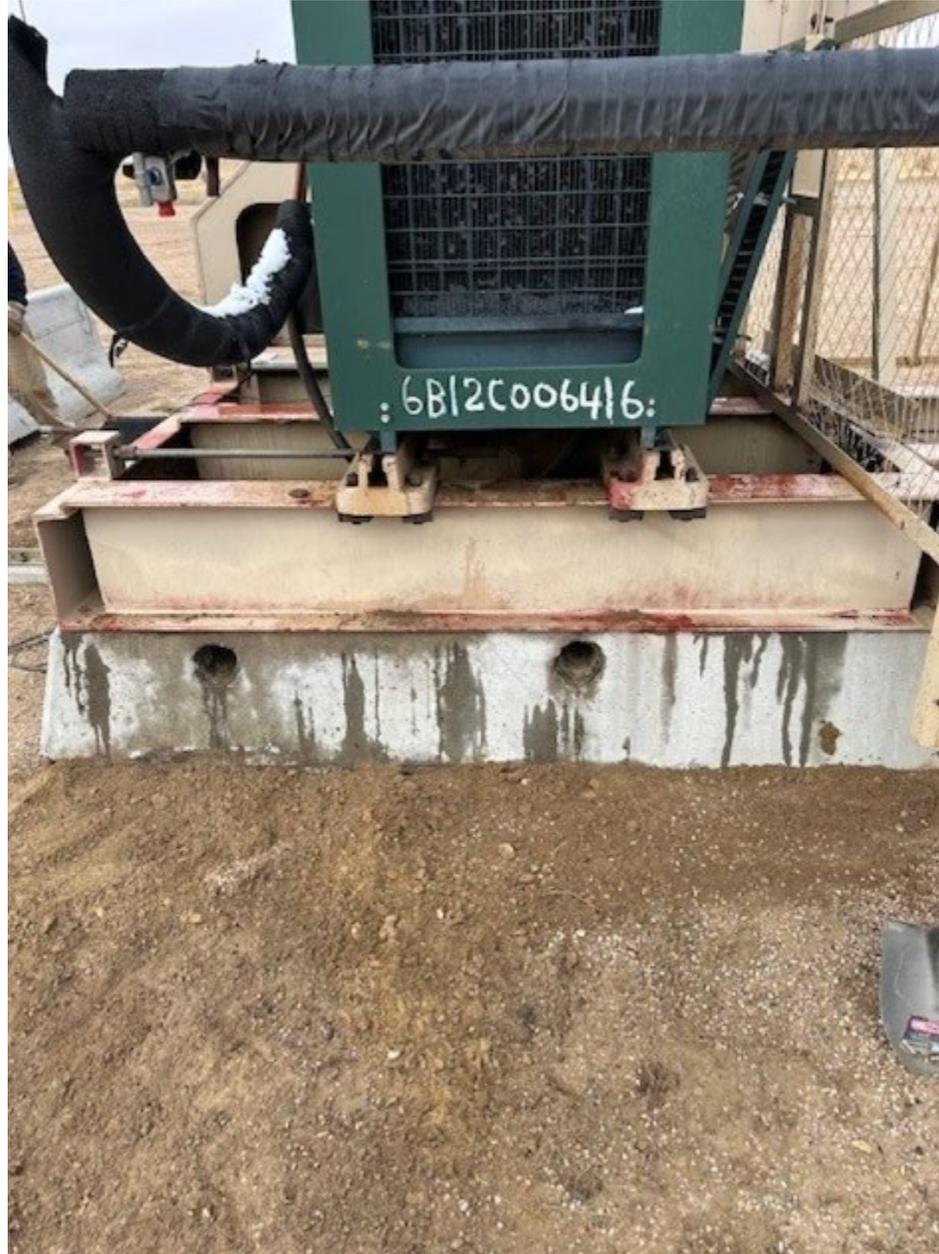
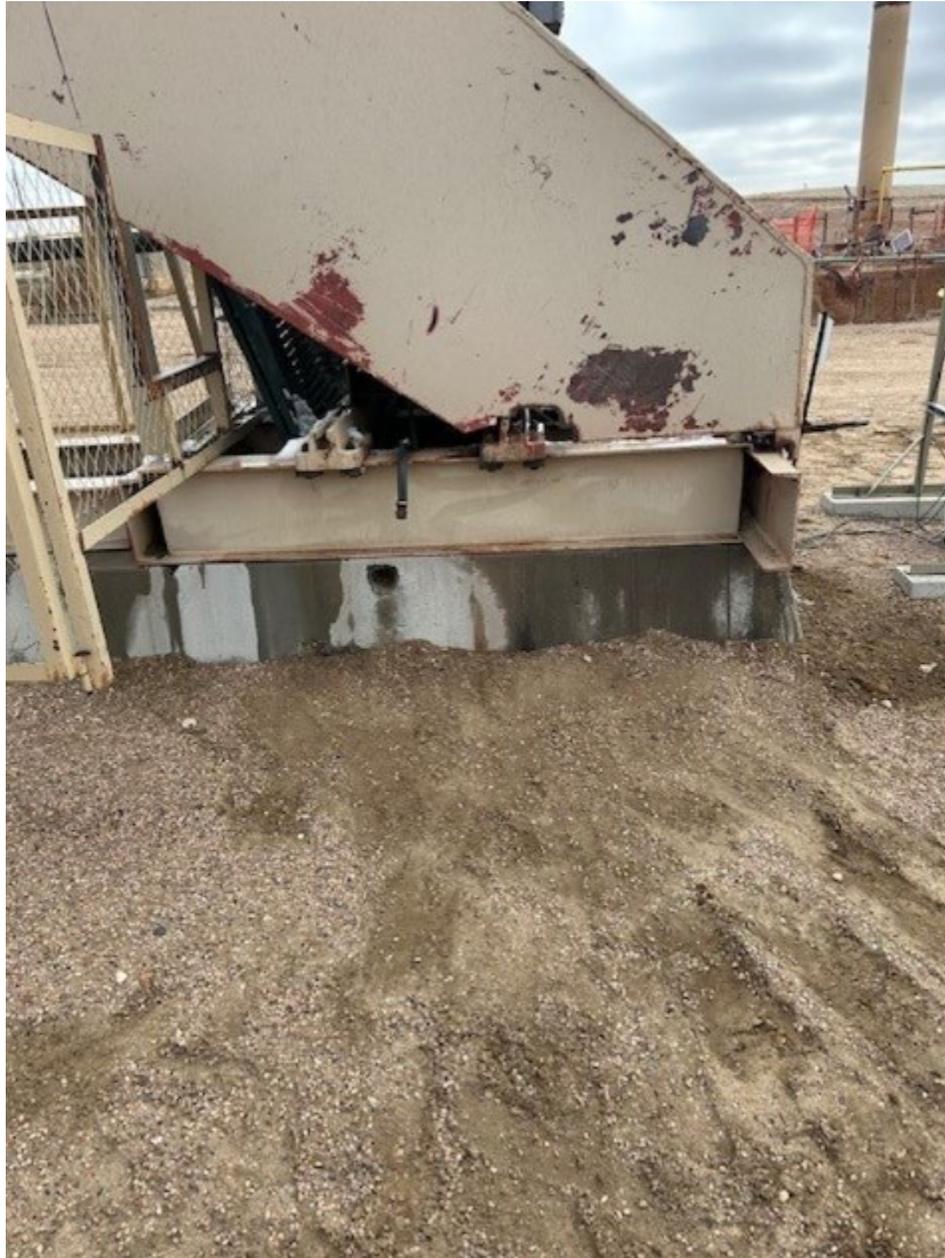
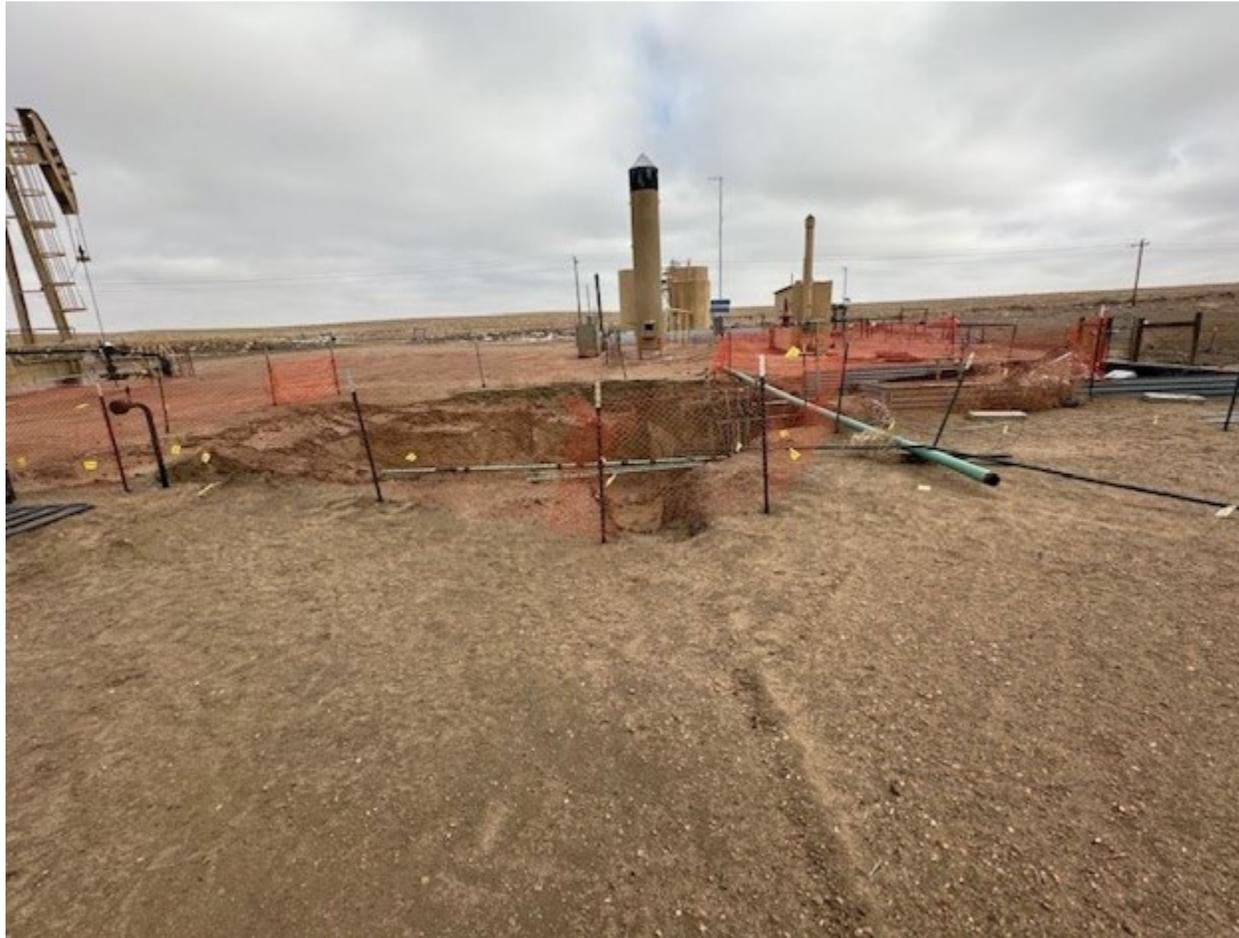
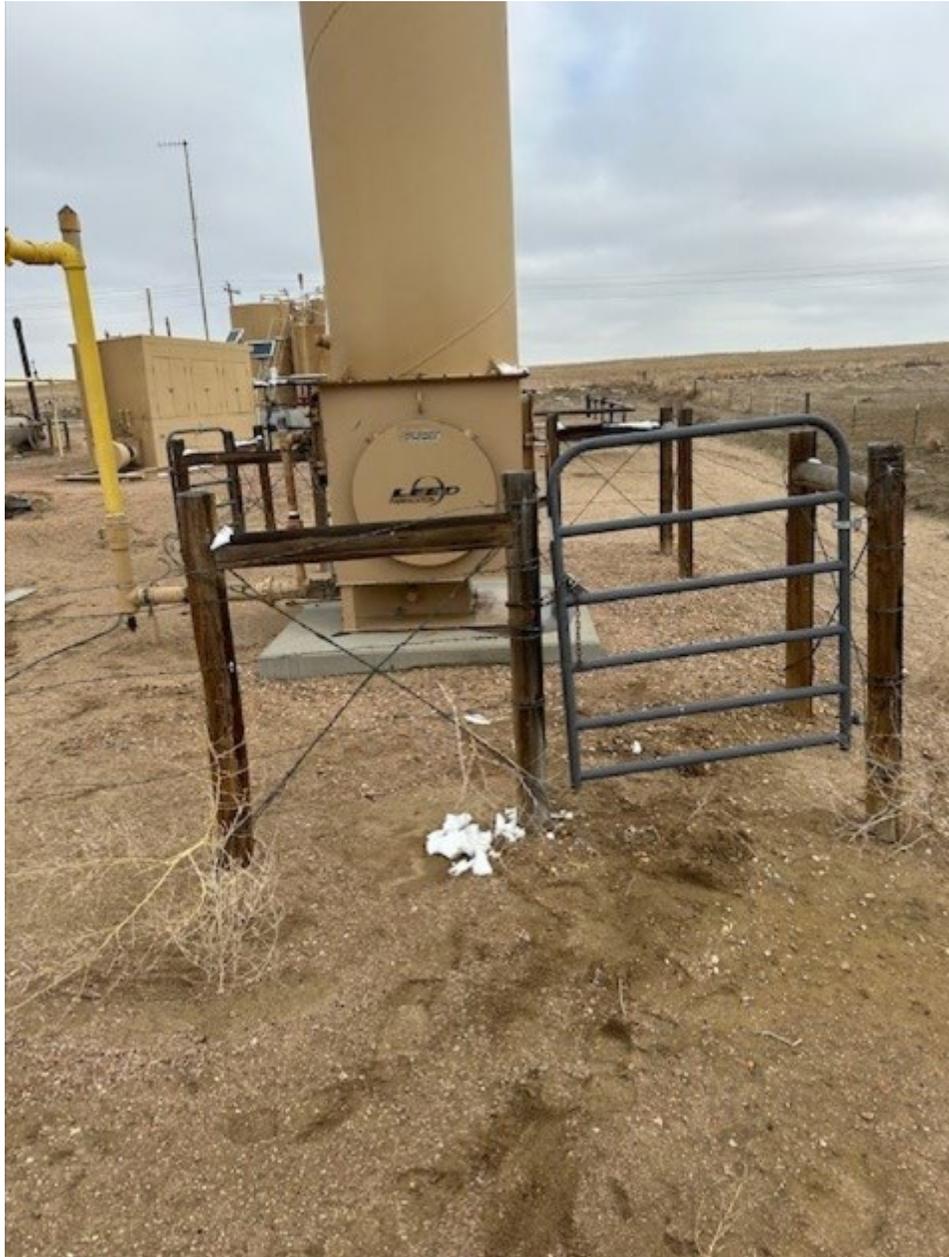
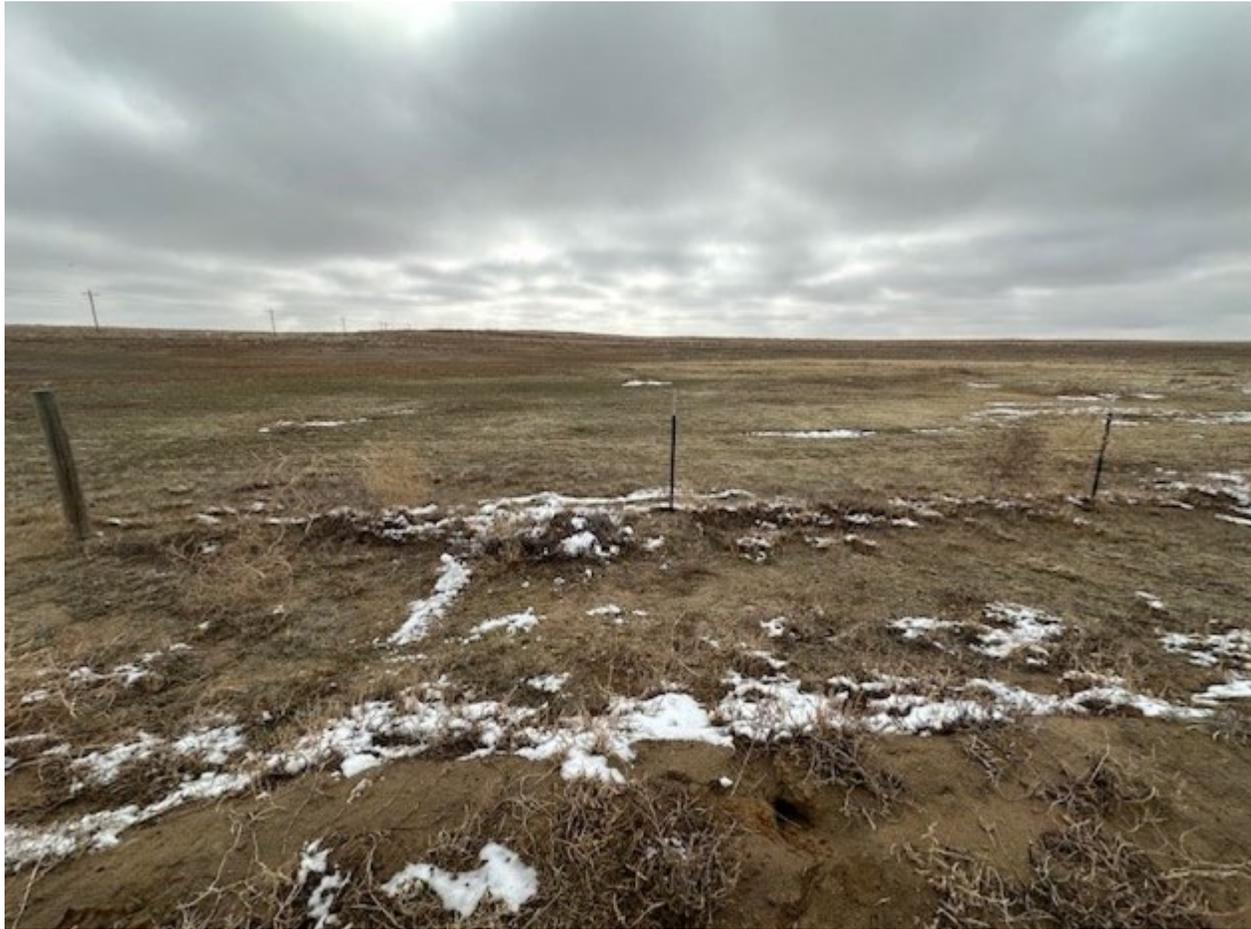
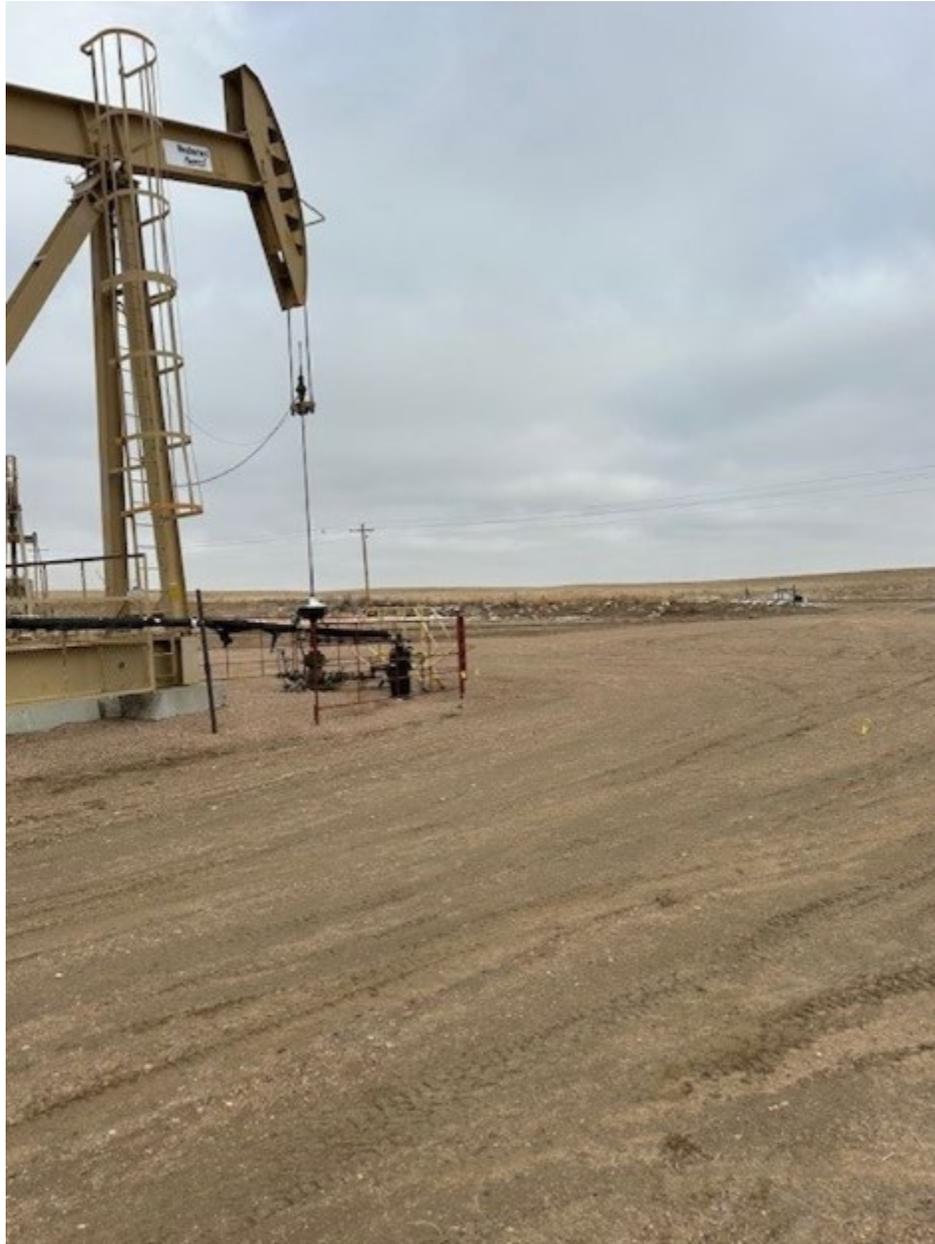
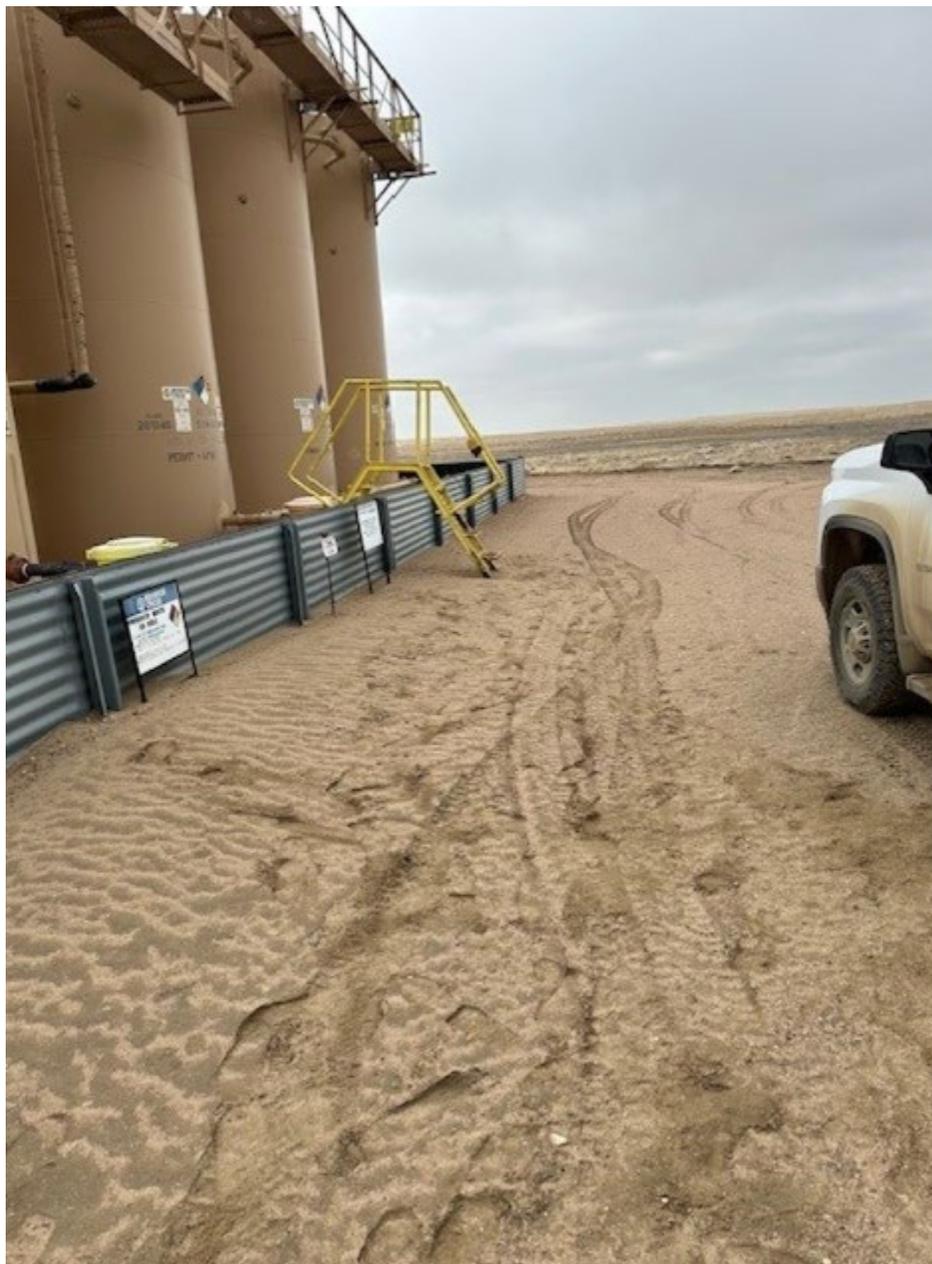
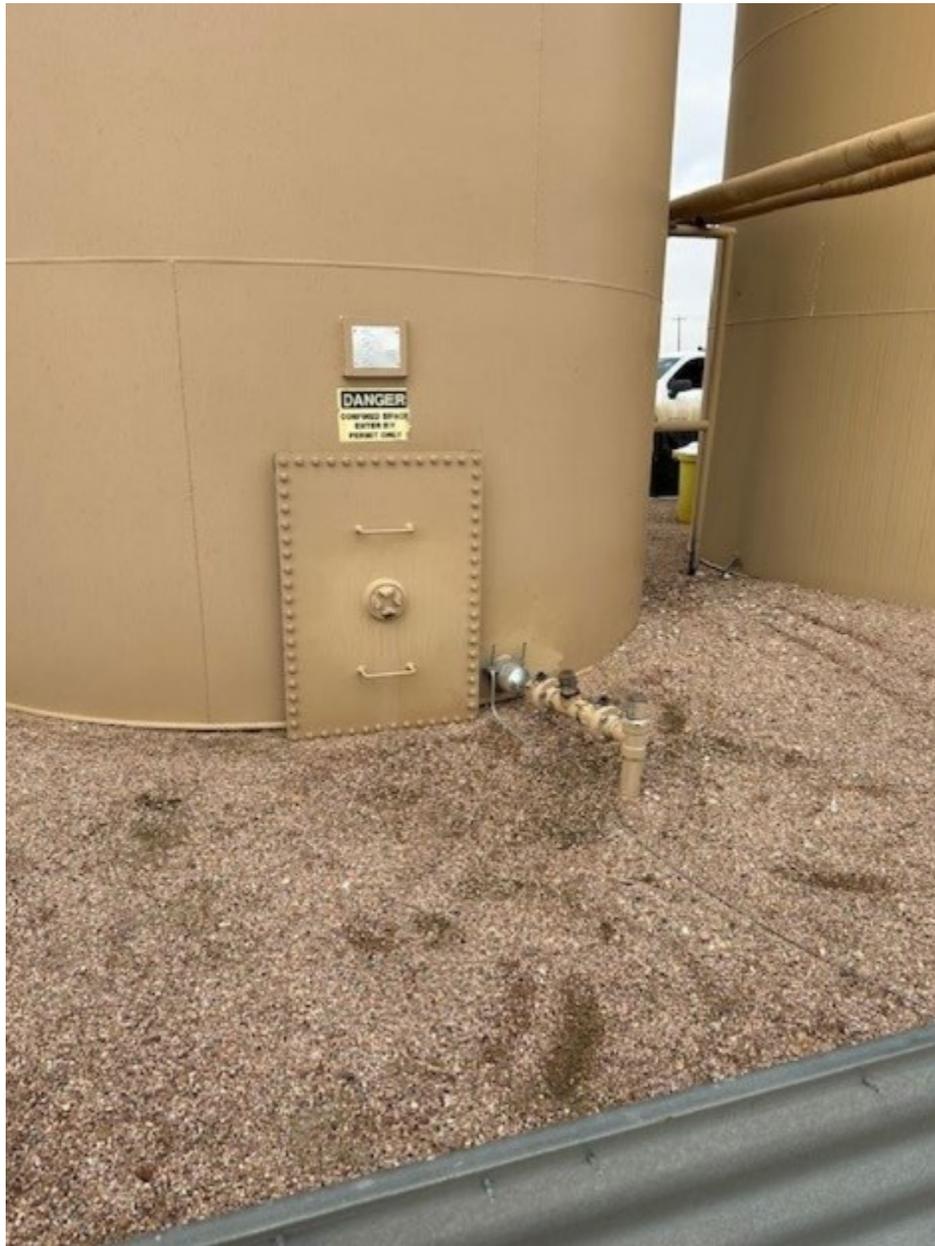
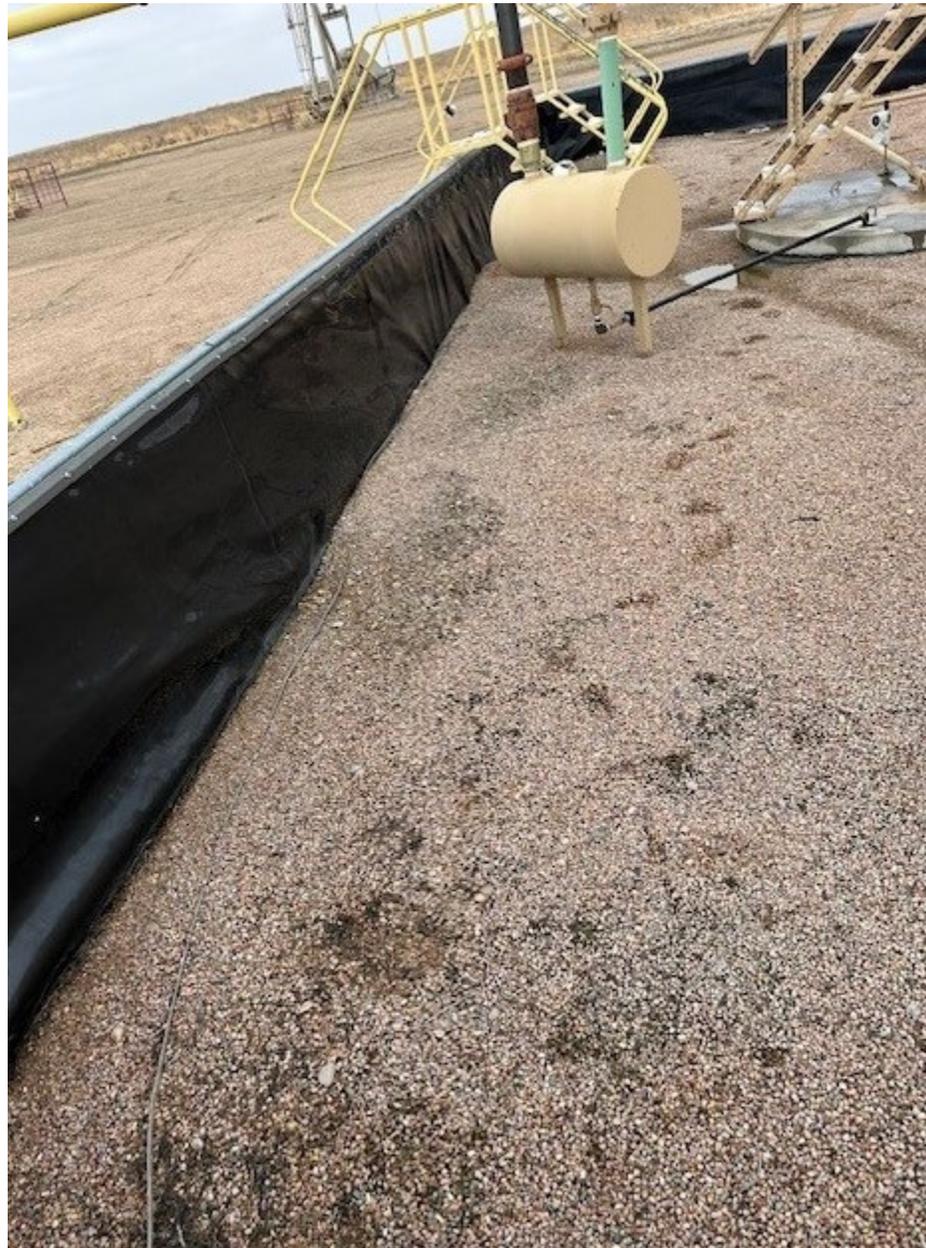
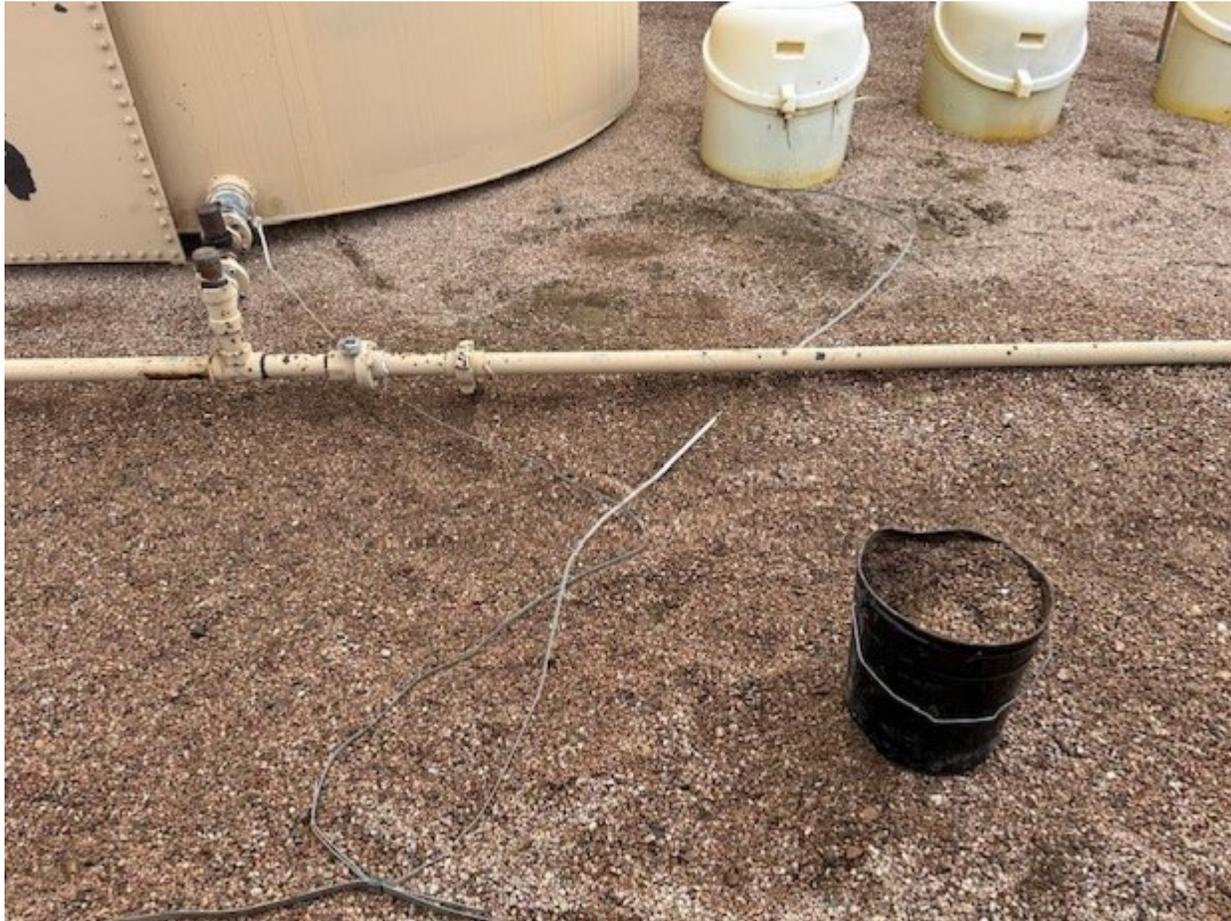
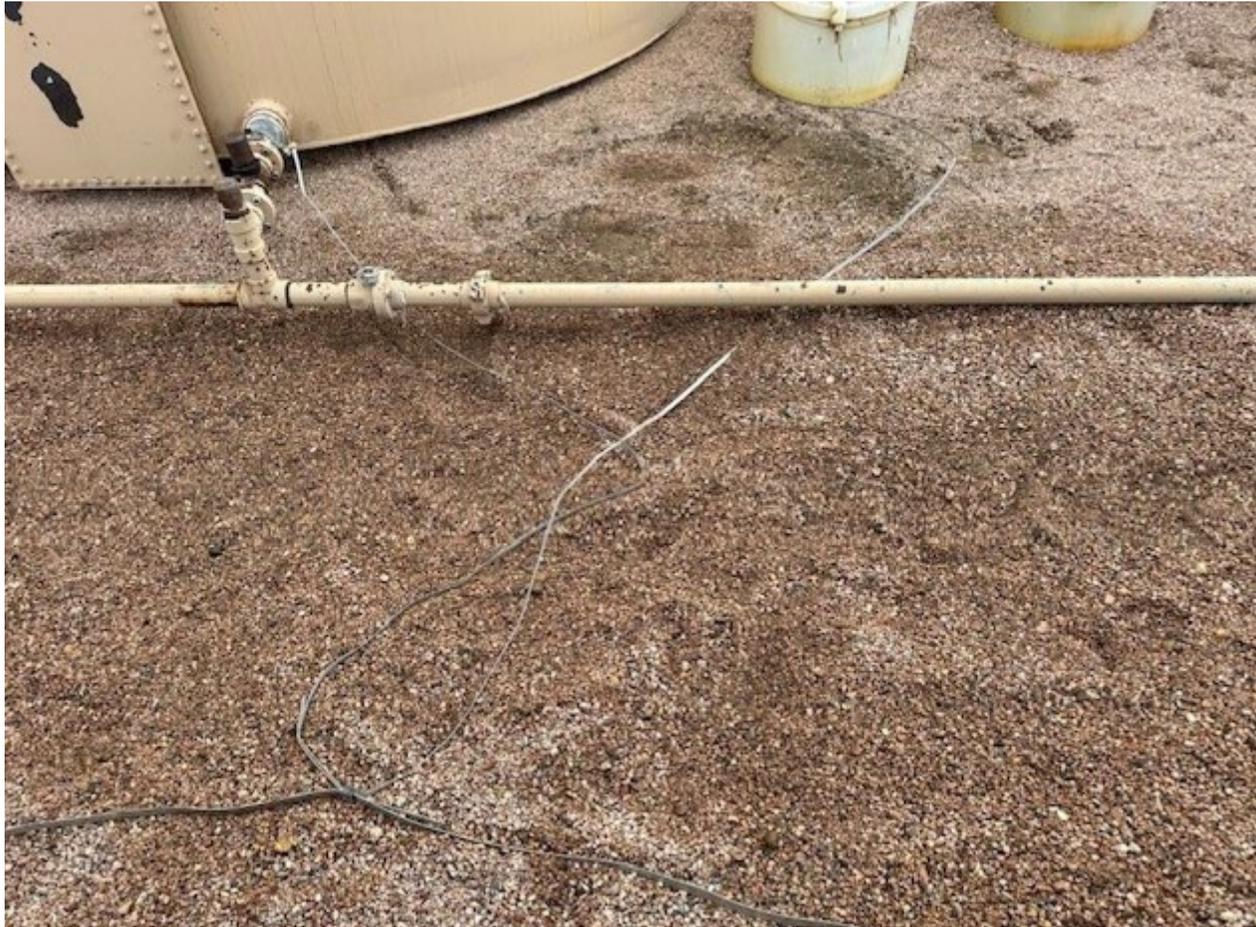
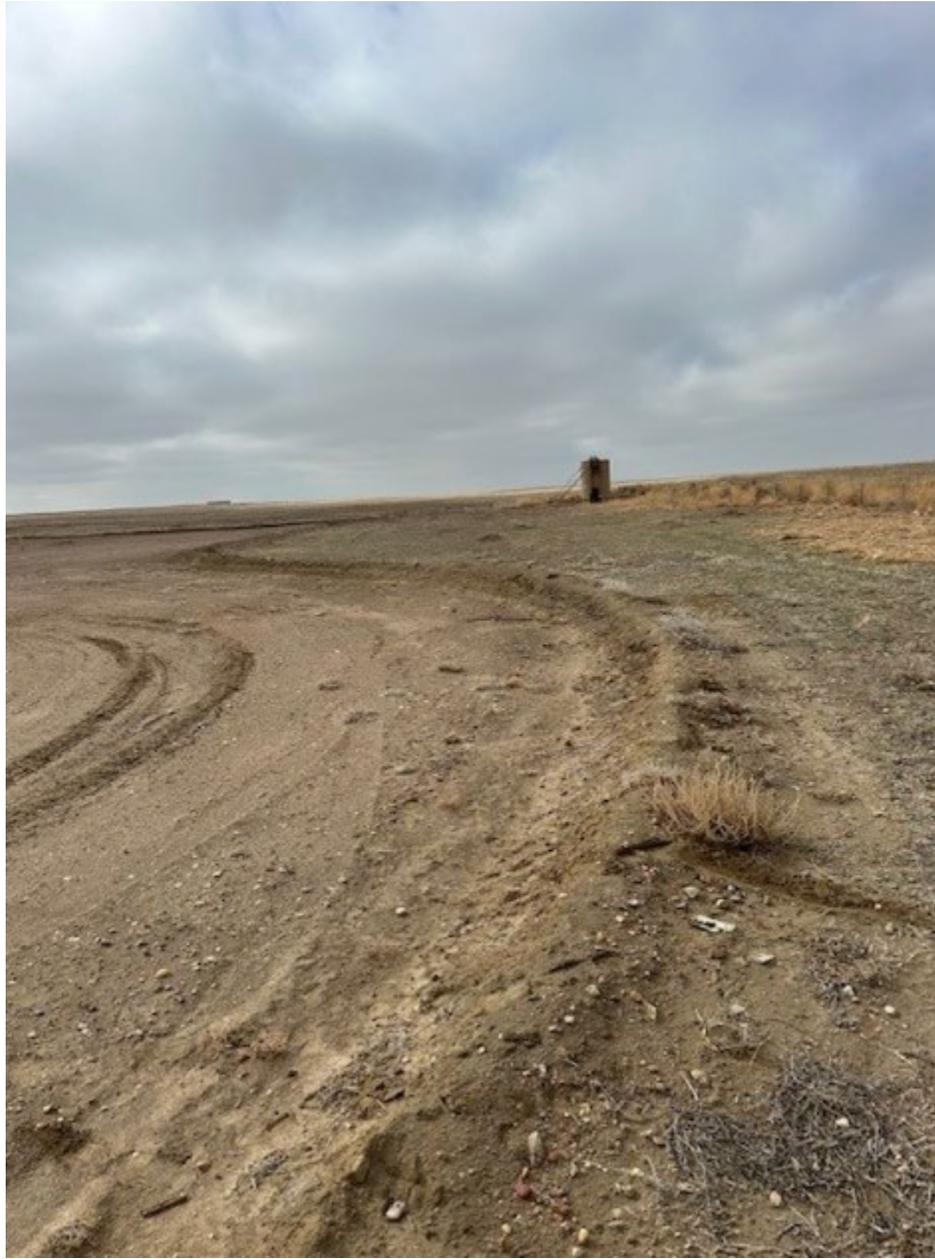
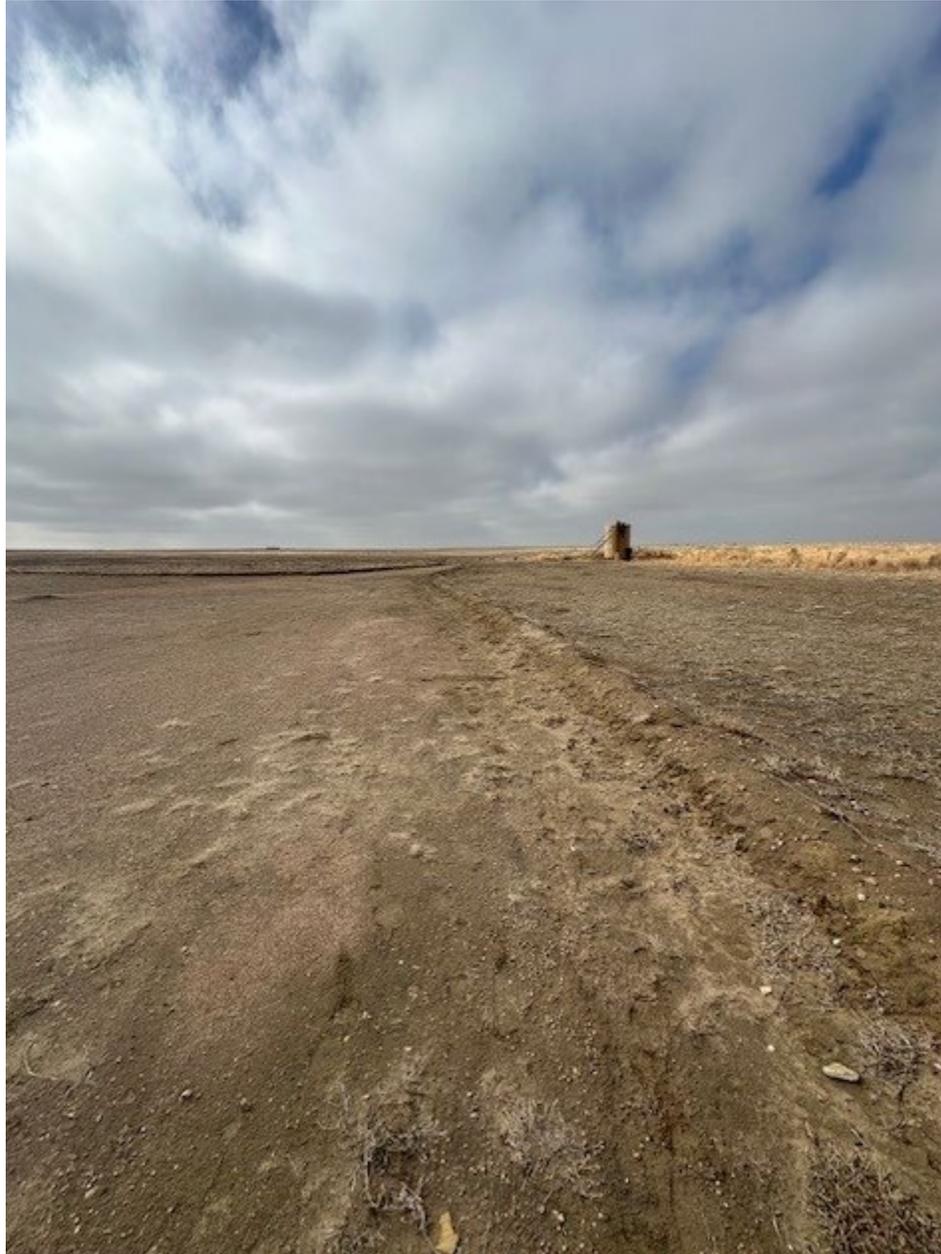
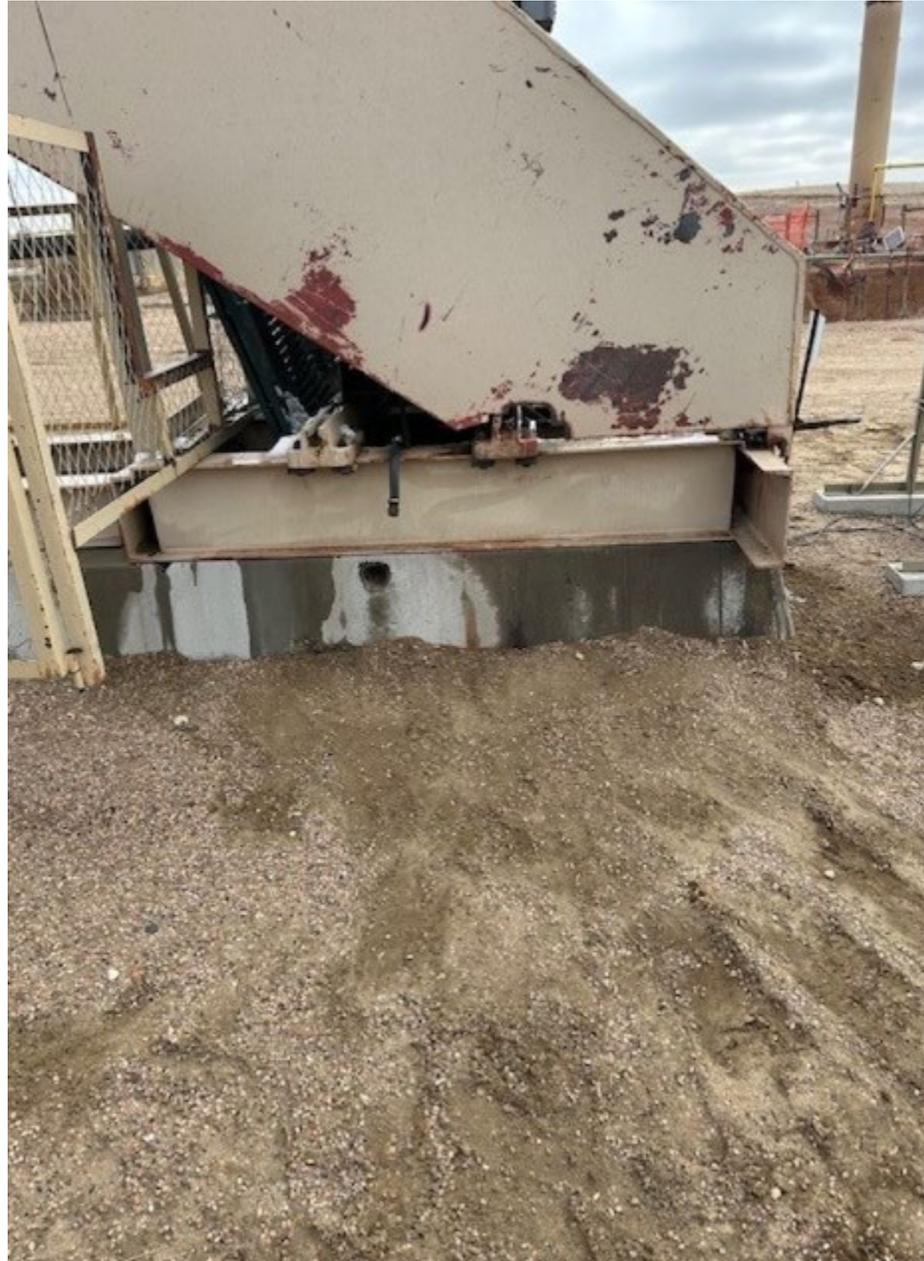
CA: Tank labels are peeling/faded/cracked and require replacement. Install sign to comply with Rule 605.g.

CA: Trash/debris observed throughout the location. Comply with Rule 606 and remove all trash/debris from the location.

CA: Stained soil observed within secondary containment and at pumpjacks. Properly dispose of oily waste in accordance with Rule 905.e.

CA: This location does not comply with Rule 1003. During this inspection, it was observed that the interim areas are not progressing towards interim reclamation standards with evidence of un-stabilized/bare soils and undesirable vegetation (e.g. Russian thistle) throughout. Additional reclamation activities are required. Perform reclamation in accordance with Rule 1003. Establish vegetation with total perennial, non-invasive uniform plant cover of at least eighty (80) percent of reference area levels. Use a seed mixture requested by the surface owner, or a mixture prescribed by the local county NRCS. Ensure erosion controls are implemented to stabilize the seeded soil and continue to monitor and manage this site until the location meets Rule 1003 standards.

CA Resolution: Tank labels have been installed to comply with Rule 605.g.

CA Resolution: Trash/debris has been removed to comply with Rule 606.

CA Resolution: Oily waste has been properly disposed of in accordance with Rule 905.e.

CA Resolution: Reclamation has been performed in accordance with Rule 1003.
