# Inspection Photos

**Operator:** TEP ROCKY MOUNTAIN LLC - 96850

**Location ID:** 324039

**Inspection Doc:** 696205763

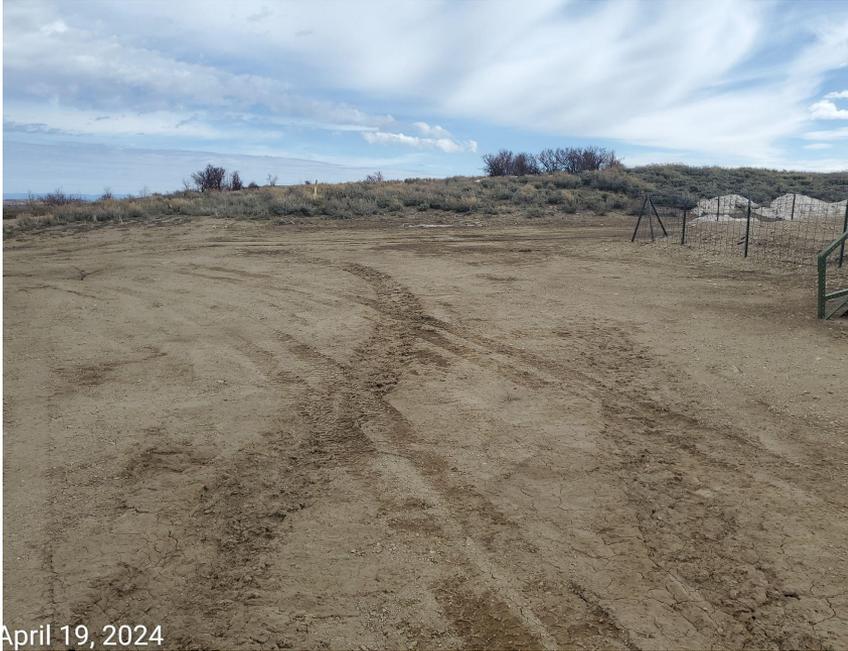
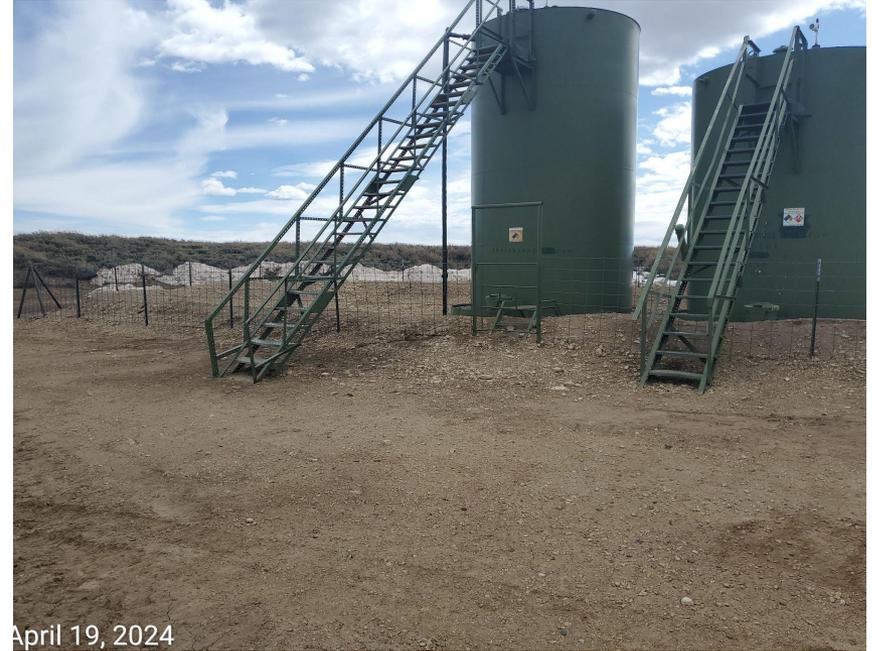
**Photo 1:** Photos 1-2 taken from the west end of the Location. Photo provides and overview from north, northeast, southeast to south. Photos also show signage missing from the battery facility.

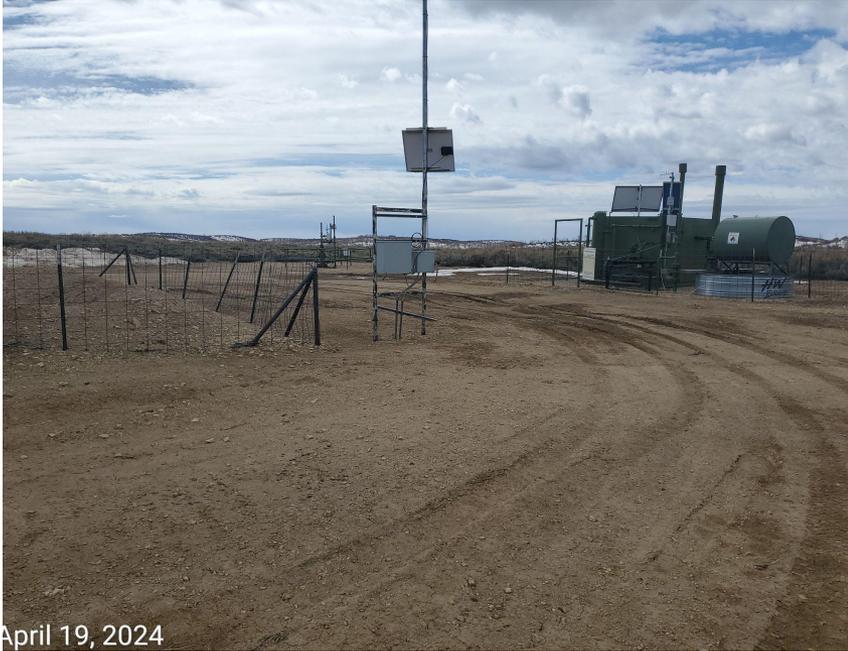
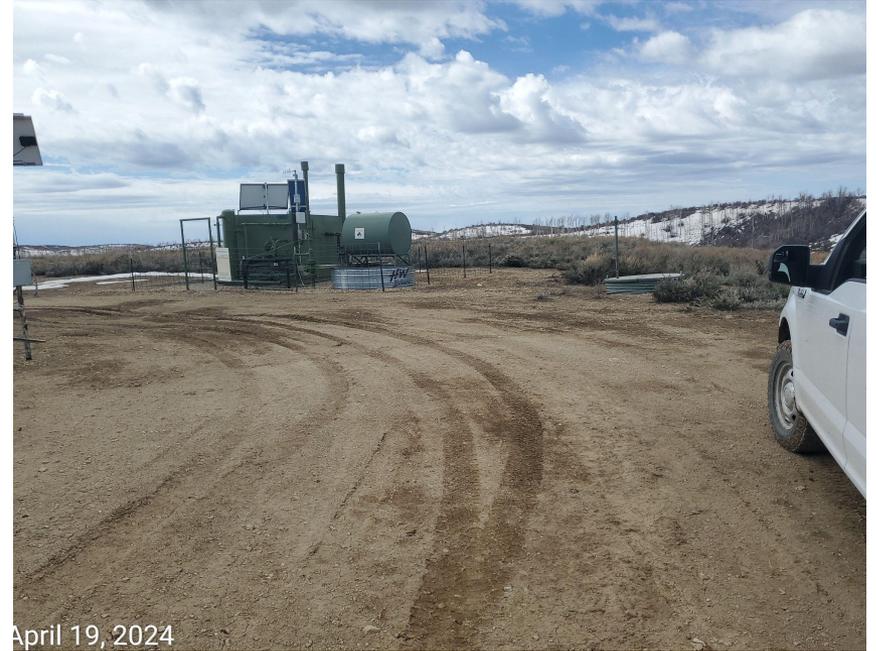
**Photo 2:** See comments under photo 1.

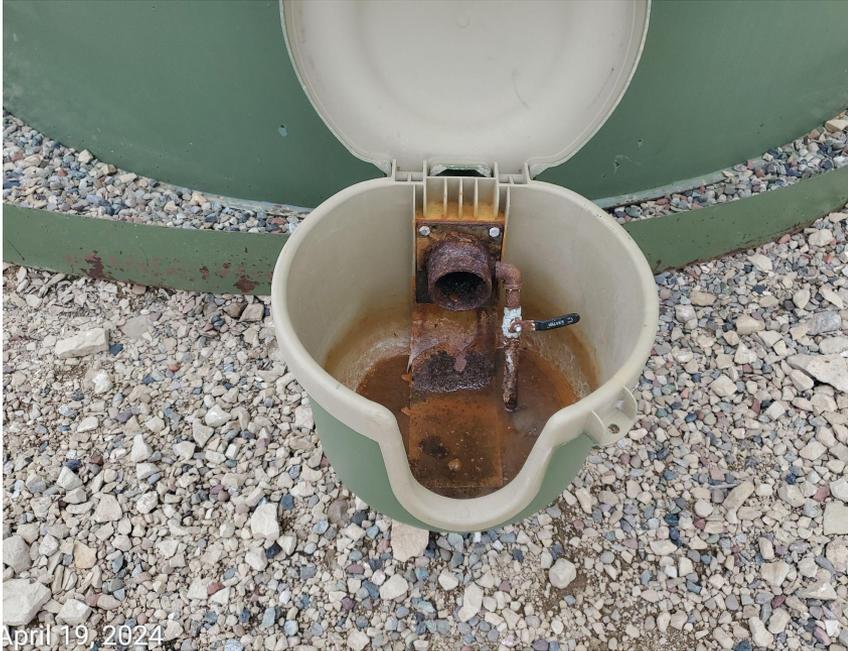
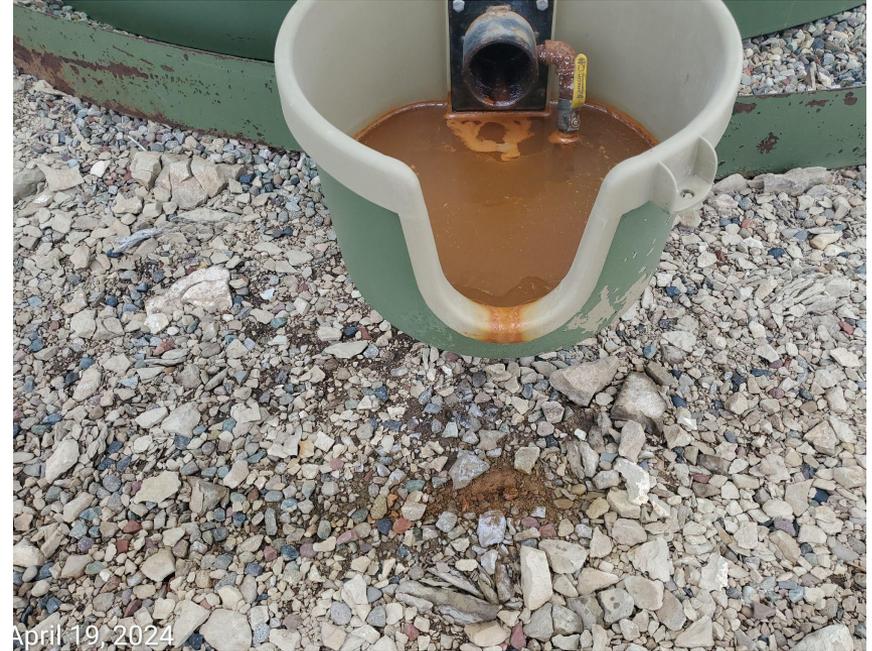
**Photo 3:** Lines at tanks missing cap/plug. Photo right shows line at condensate is leaking, with fluids spilling out of the honeypot. Inspector contacted/left message with Operator upon discovery. Leak requires stopping, and fluids/impacts require removal/cleaning.

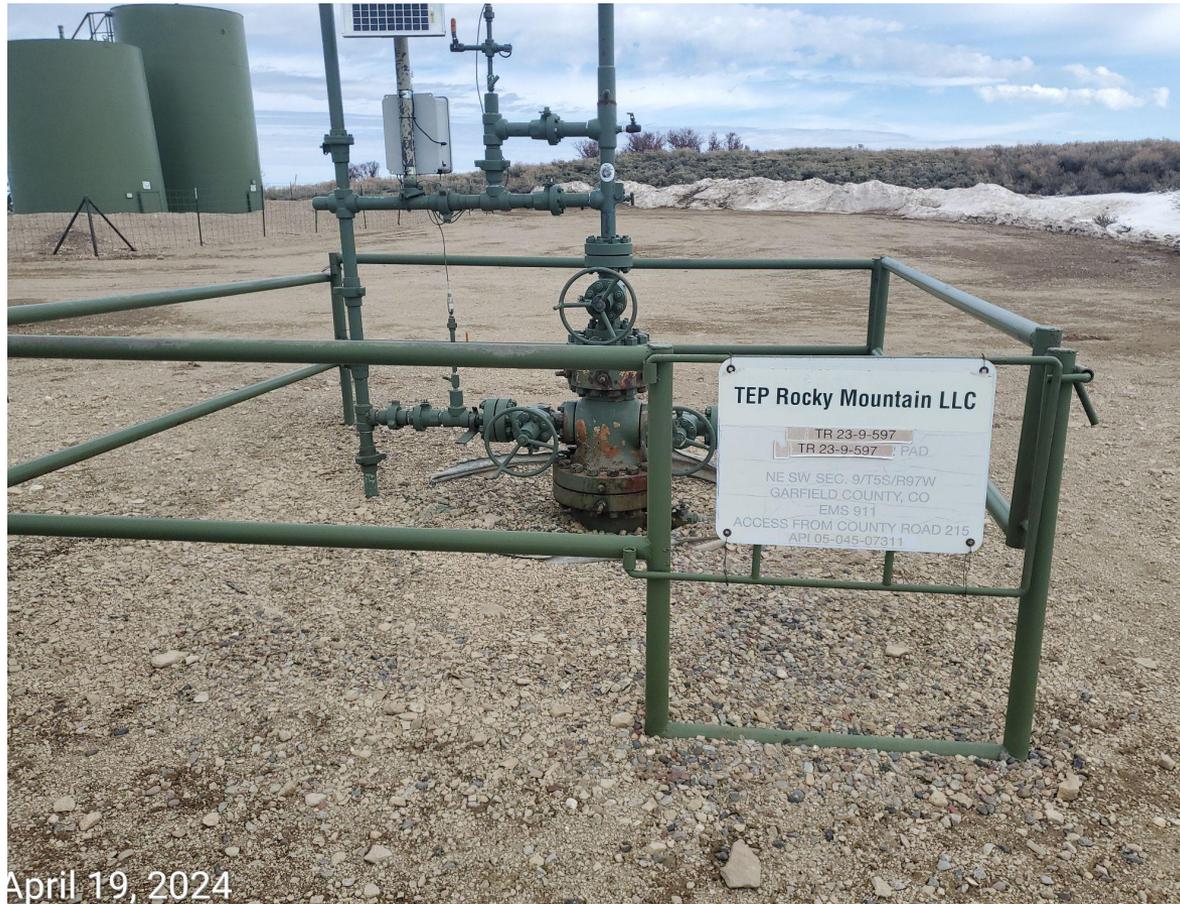
Photo 4: Wellhead. Sign is fading.

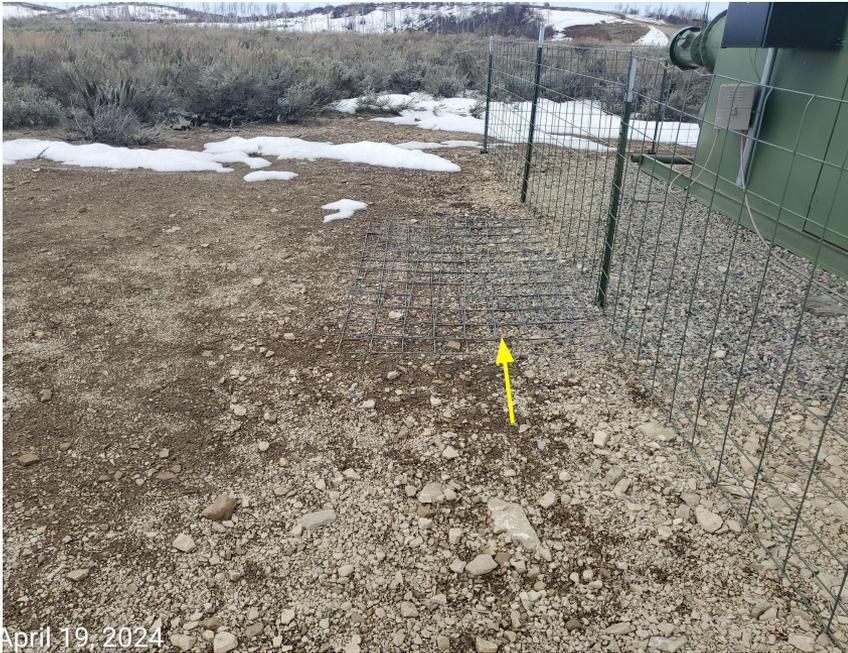
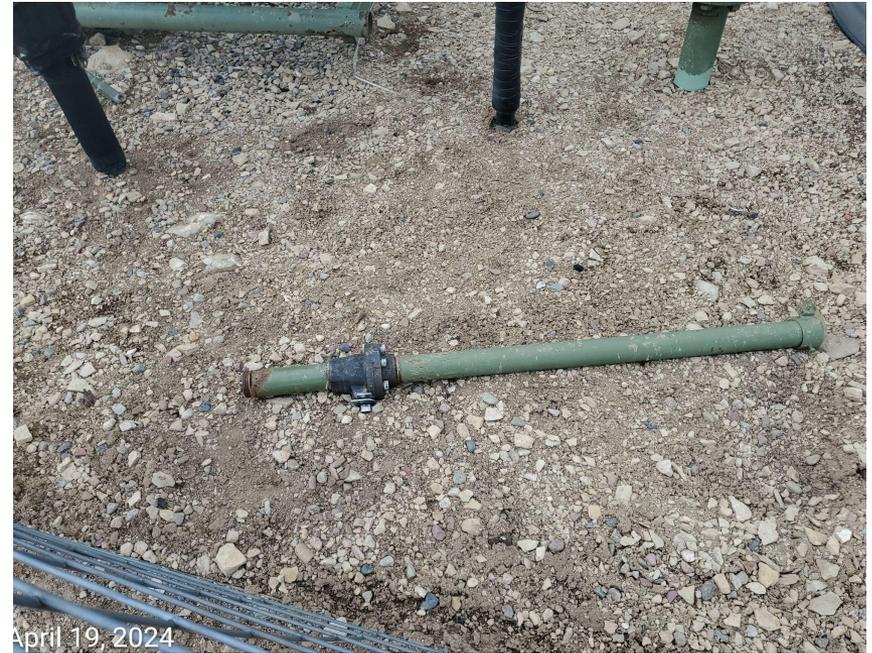
**Photo 5:** Unused equipment (Fence, pipe) observed at the separator equipment.

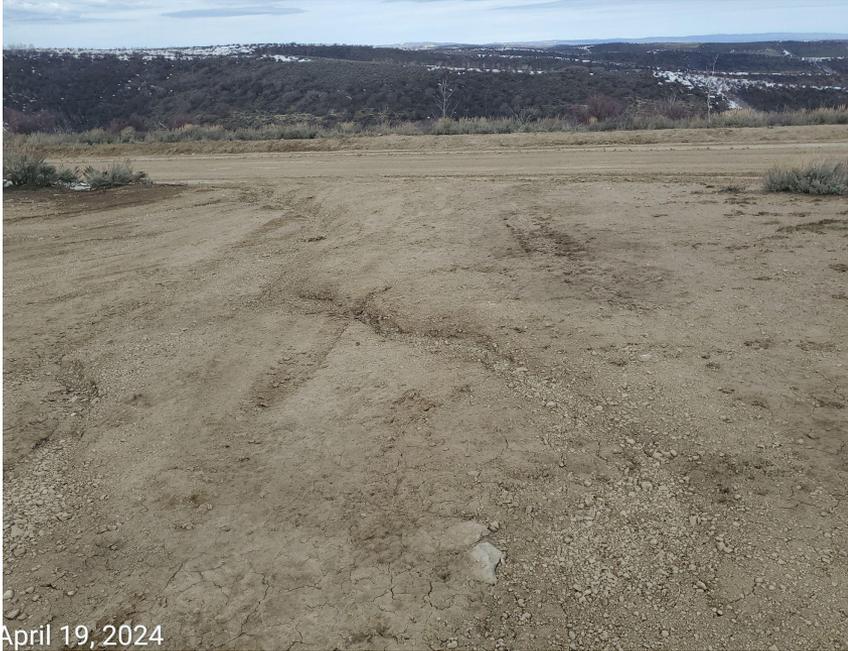
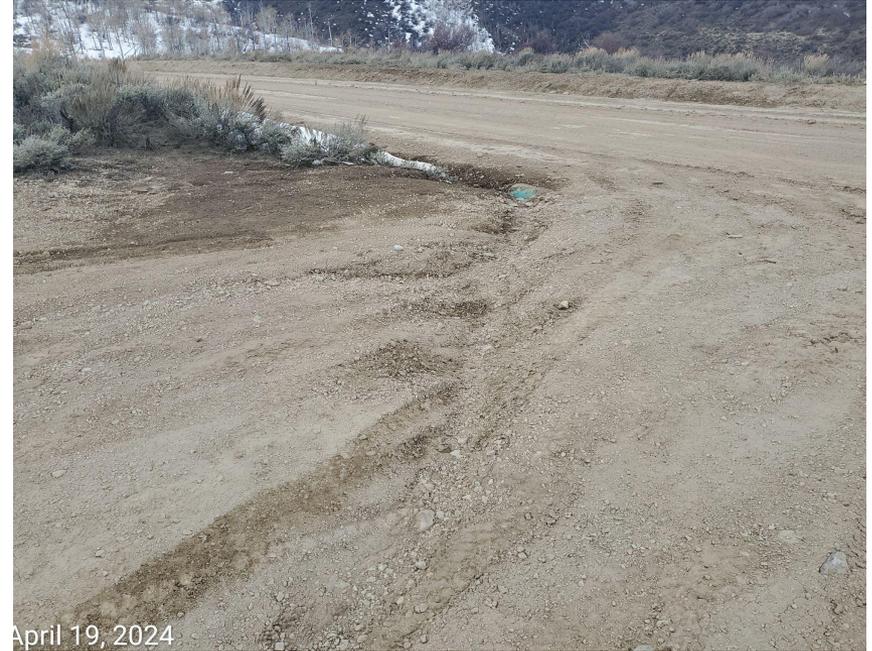
**Photo 6:** Photos taken from the Location entrance. Runoff from the pad is resulting in erosion, degradation and sediment transport. Stormwater and erosion control BMPs missing or insufficient.
