## Pre-Con Environmental Inspection Form

Inspection Date : 2/2/2024	Project Name: Denali State
County, State: Weld, CO	Survey Type: Pre-construction
Location (Township, Range, Section): T5N R67W S13	JSA Completed: 2/2/2024

# (3301-23) Denali State

SECTION 13, TOWNSHIP 5N, RANGE 67W, WELD COUNTY, CO

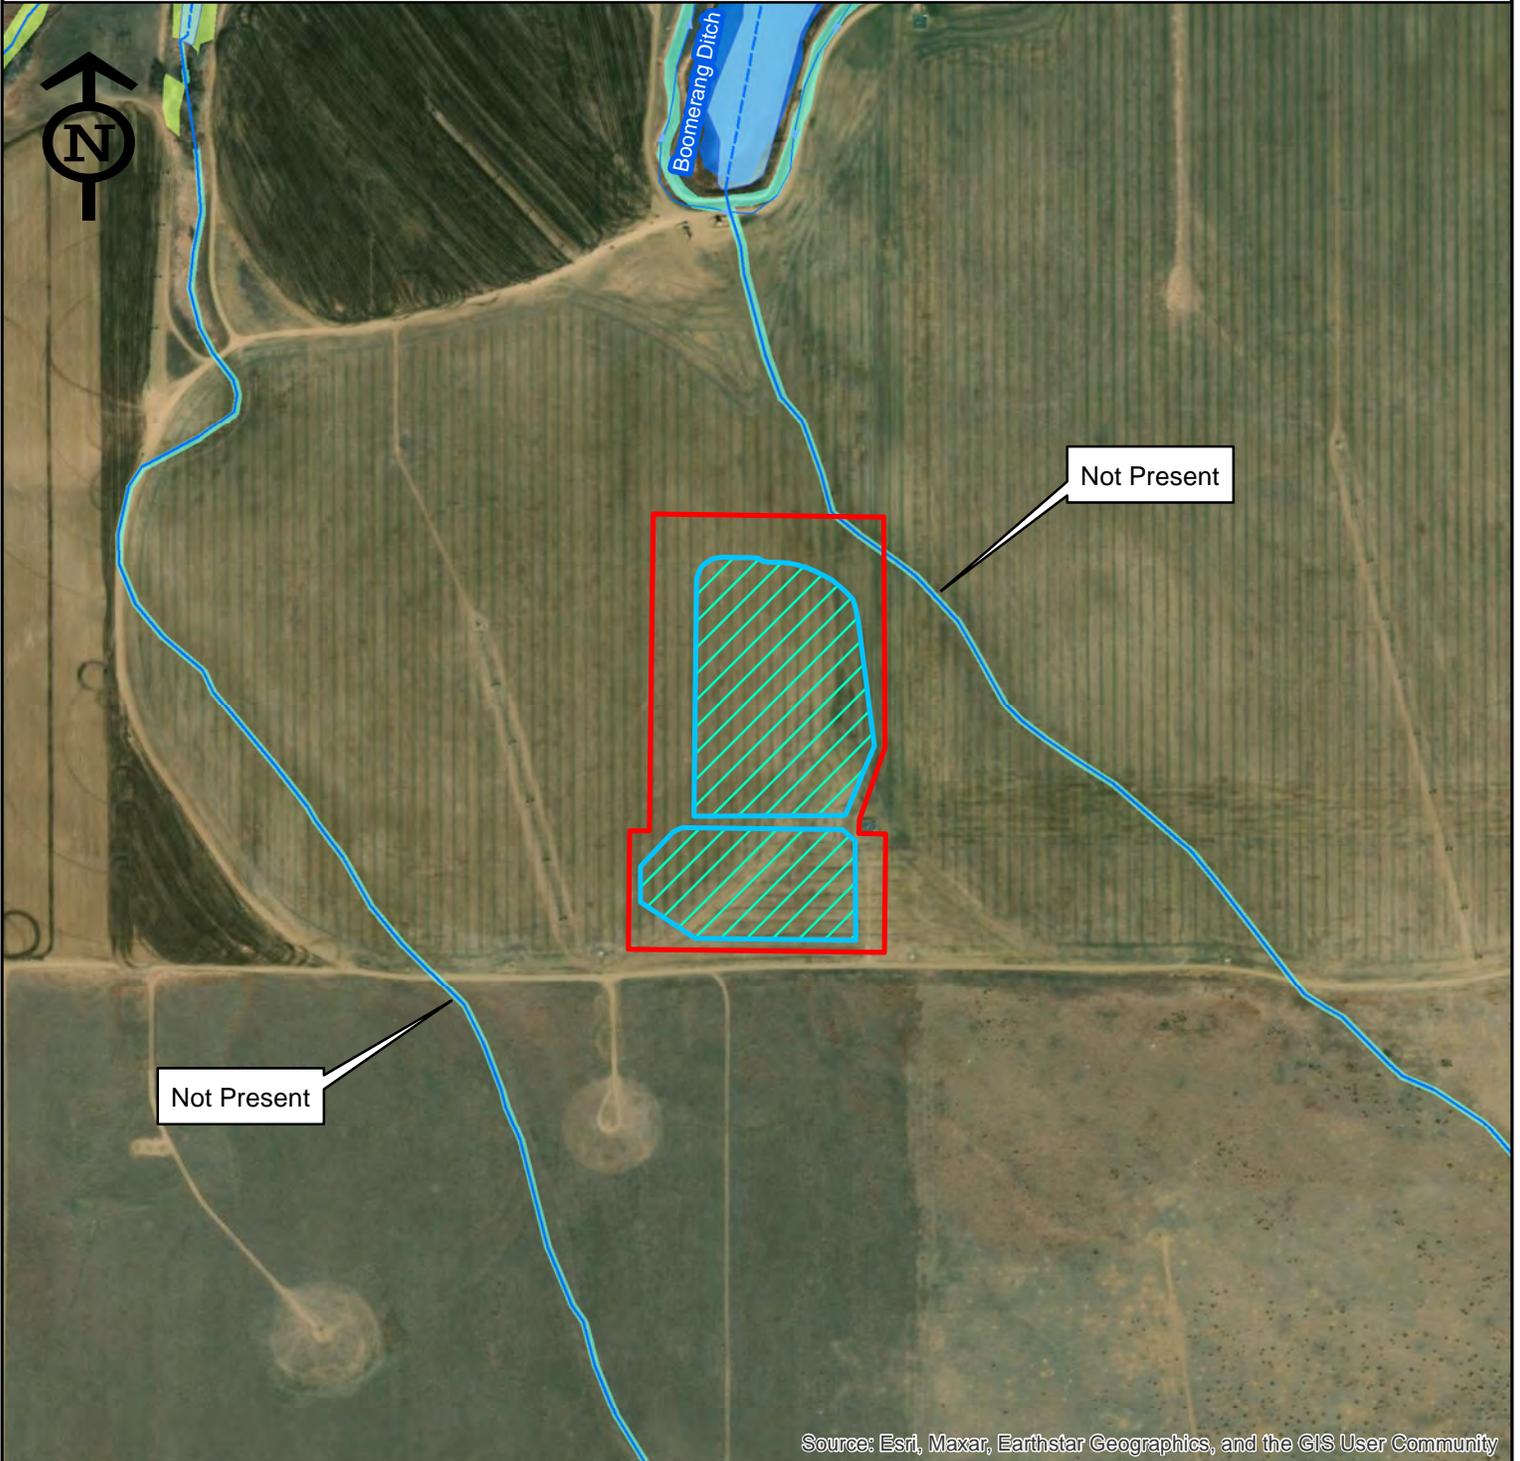
Hydrology  
Overview

Within 500ft?	No	Distance to Water of the U.S.:	NA
Distance to contaminant migration pathway:	NA		
Direction:	NA		
Baseline condition (if within 500ft):	A National Wetland Inventory (NWI) riverine wetland, in the northeast corner of the Disturbance Area, coincides with a National Hydrography Dataset (NHD) mapped stream and was confirmed not present during the field survey. A second NWI-mapped riverine wetland, located west of the Working Pad Surface, also coincides with an NHD-mapped stream and was confirmed not present during the field survey. No current constraint.

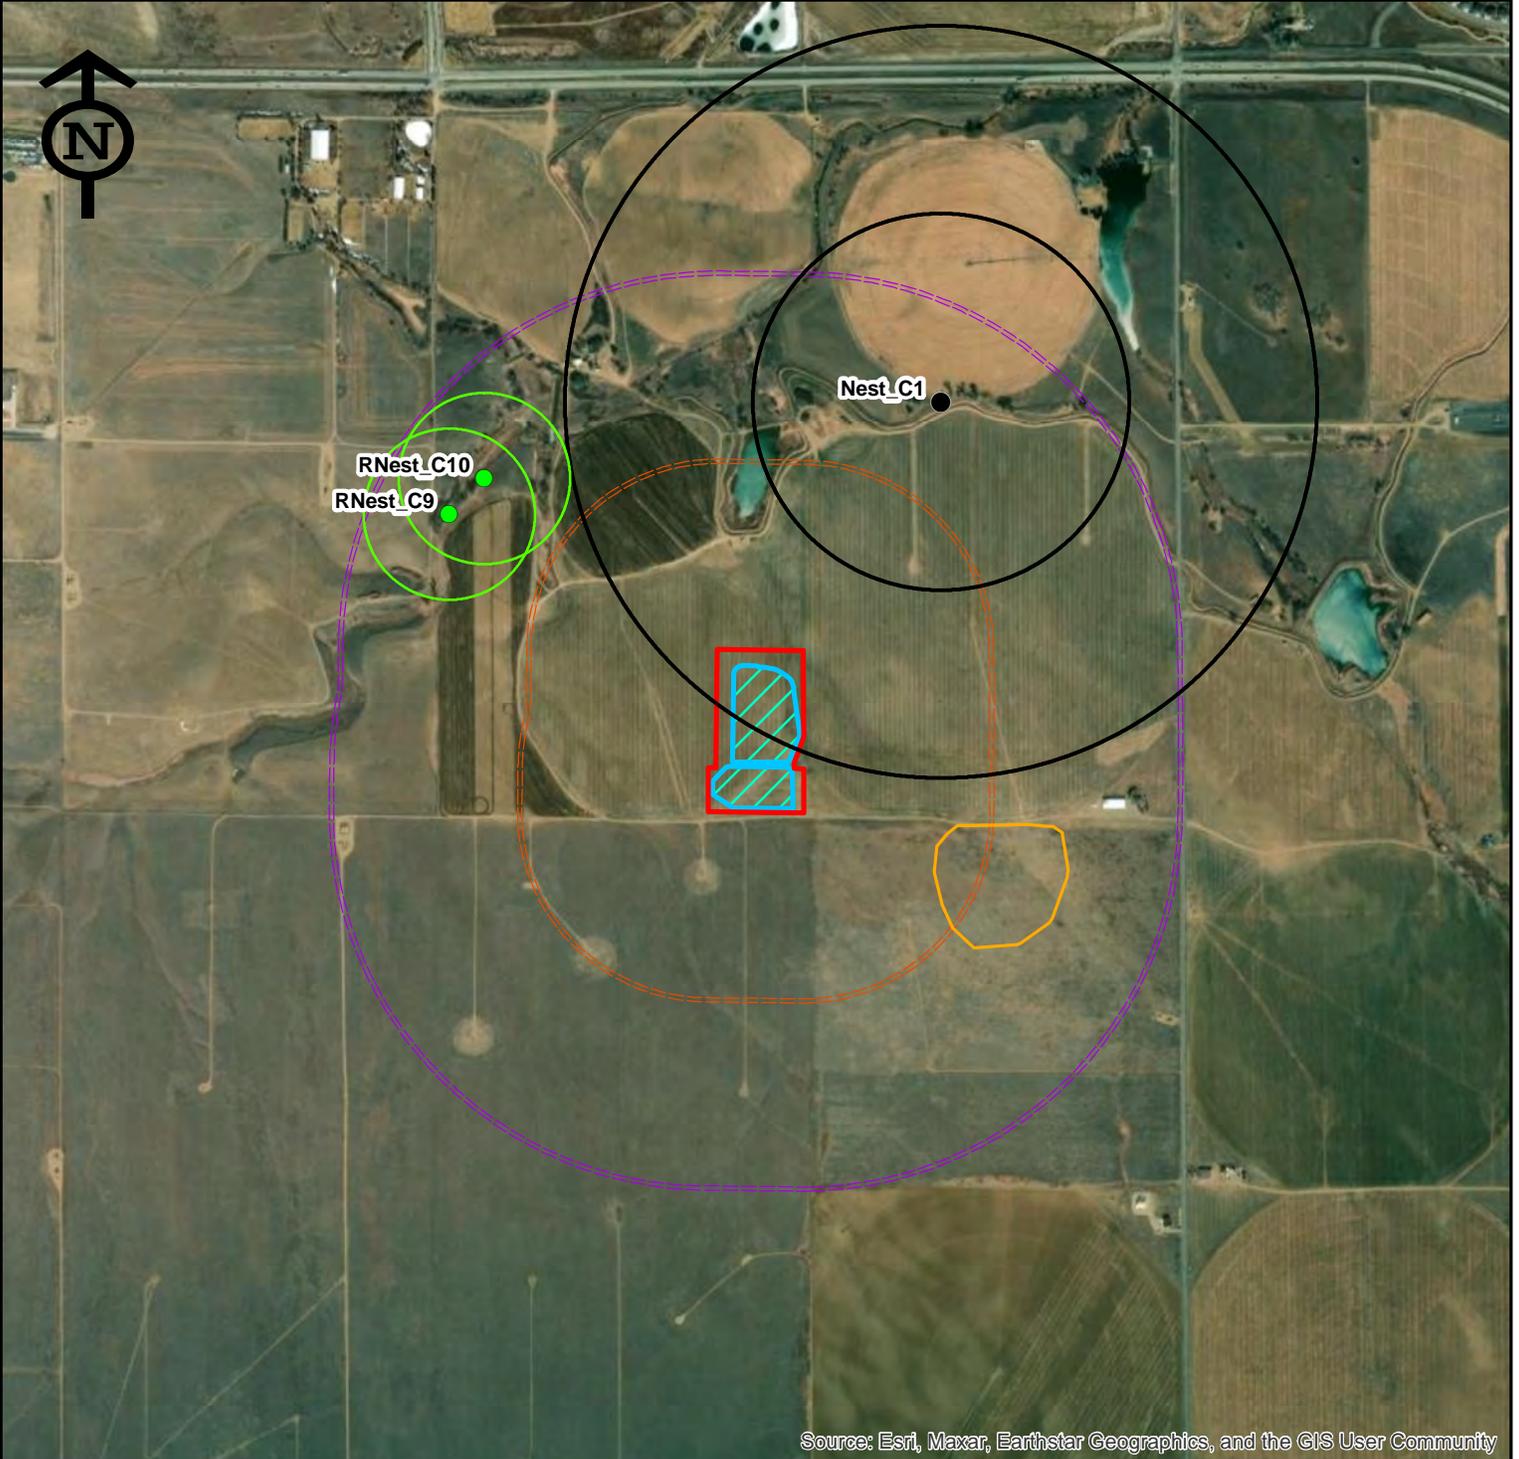
Wildlife  
Overview

An active prairie dog colony is present 965ft southeast of the Working Pad Surface. CPW recommends no permitted or authorized surface disturbing activities within 1/4 mile for large industrial disturbances (drill rig, building a residential development, etc.) of burrowing owl nest during March 15 - October 31. Construction start date is scheduled for 2/15/24 and surveys are recommended to determine if burrowing owls are present.

There is no bald eagle winter night roost mapped within 1/2 mile of the Working Pad Surface. A bald eagle nest, Nest\_C1, is present 1,993ft northeast of the Working Pad Surface. During the field survey, 1 adult bald eagle was observed on the nest. CPW recommends no permitted or authorized human activities within 1/2 mile of active nests from December 1 to July 31. 2DOT is currently monitoring the nest, no current constraint.

Two previously unmapped nests, RNest\_C9 and RNest\_C10, were observed within a 1/2 mile of the Disturbance Area during the field survey, both of which were unoccupied. If construction activities are anticipated within 1/2 mile of a nest between February 15 and July 31, raptor nest surveys are recommended.

Resolution: **SURVEYS RECOMMENDED**

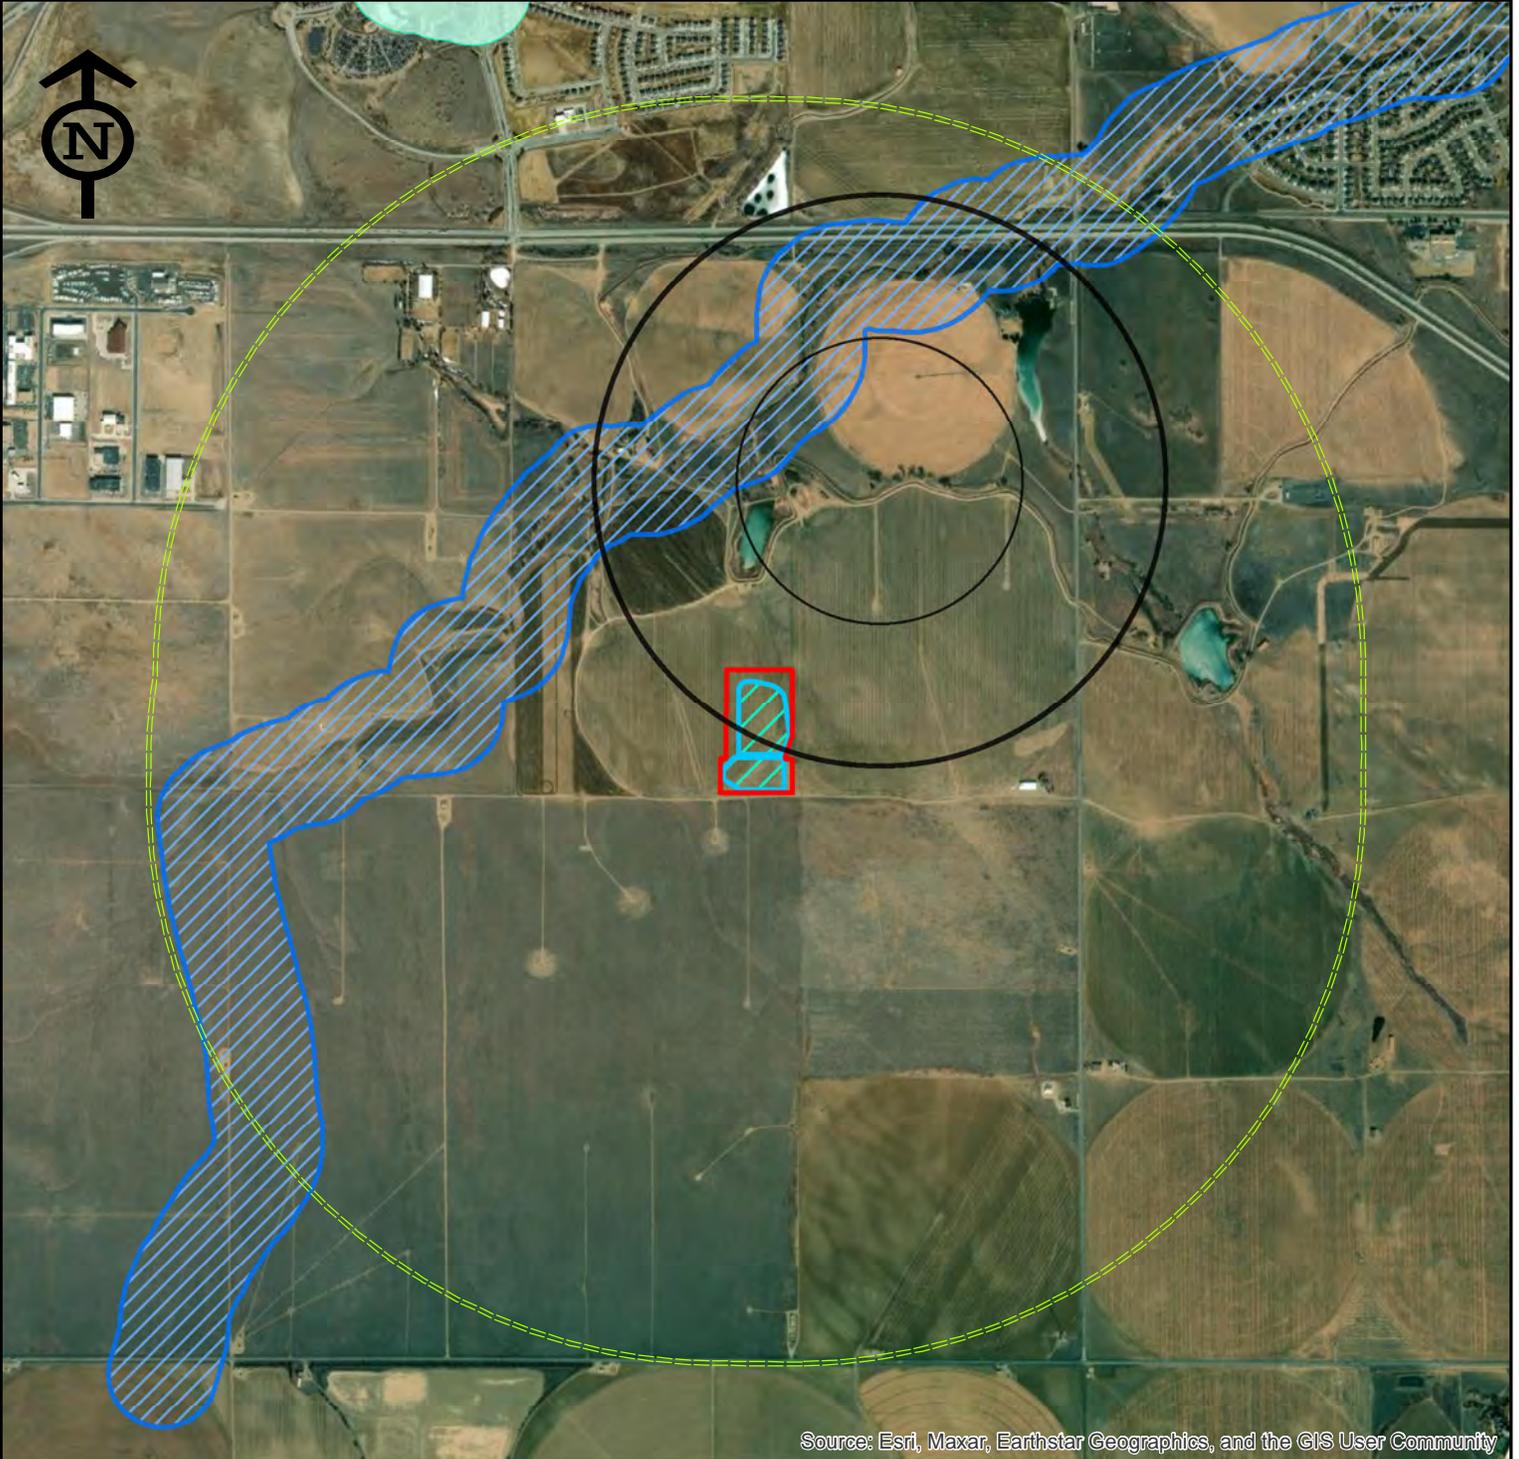
High Priority Habitat  
Overview

Total HPH Disturbed Acreage	8.89ac	Nearest HPH	0.0 mi (NE)		
<b>High Priority Habitat Name</b>	<b>Within 1 Mile (Y/N)</b>	<b>Distance (ft)</b>	<b>Estimated Acreage Disturbed (N/A if none)</b>	<b>Comments</b>	
<b>Raptors</b>					
Bald eagle active nest site	Y	Intersects	8.89ac	1/2 Mile HPH Buffer Intersects	
<b>Aquatics</b>					
Native Fish and other native aquatic species conservation waters	Y	1,370ft	N/A	ANSCW, No project impacts

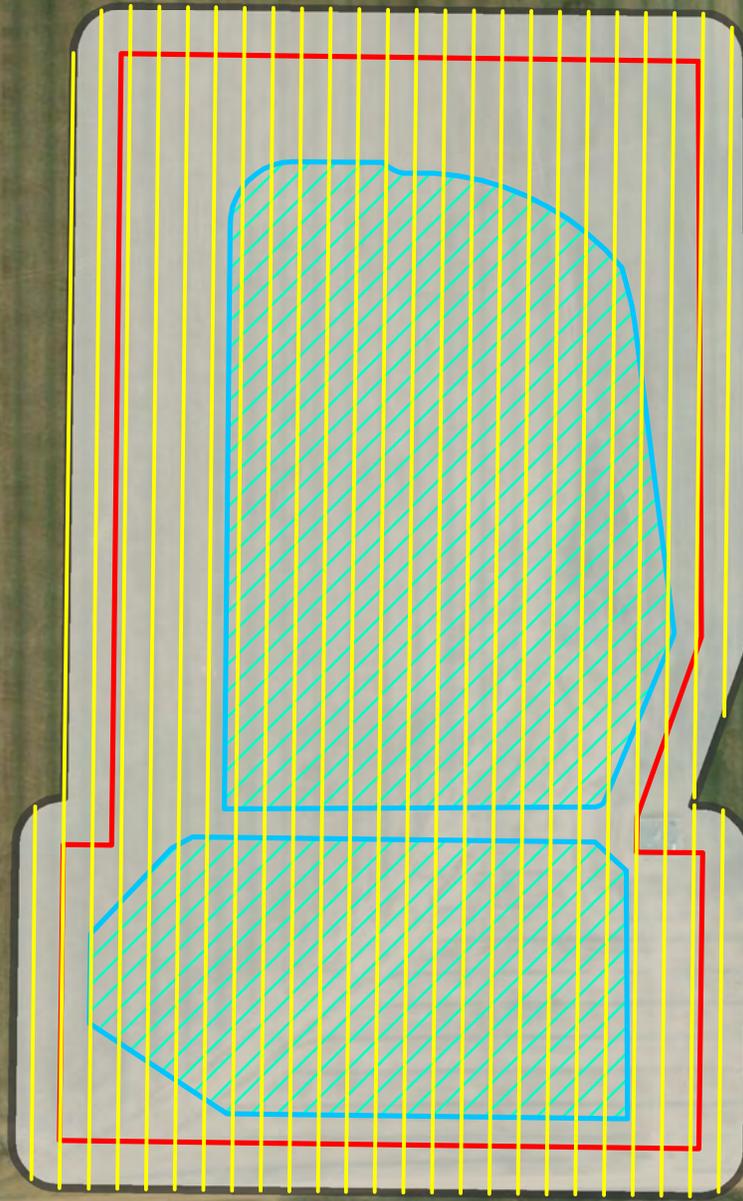
Ground Nest  
Transects

The Disturbance Area falls within an agricultural field that is annually harvested for sod. Due to on-going agricultural practices, it is unlikely for any ground nesting birds to establish nests within the Disturbance Area. No ground nests were observed during the field survey. No current constraints.

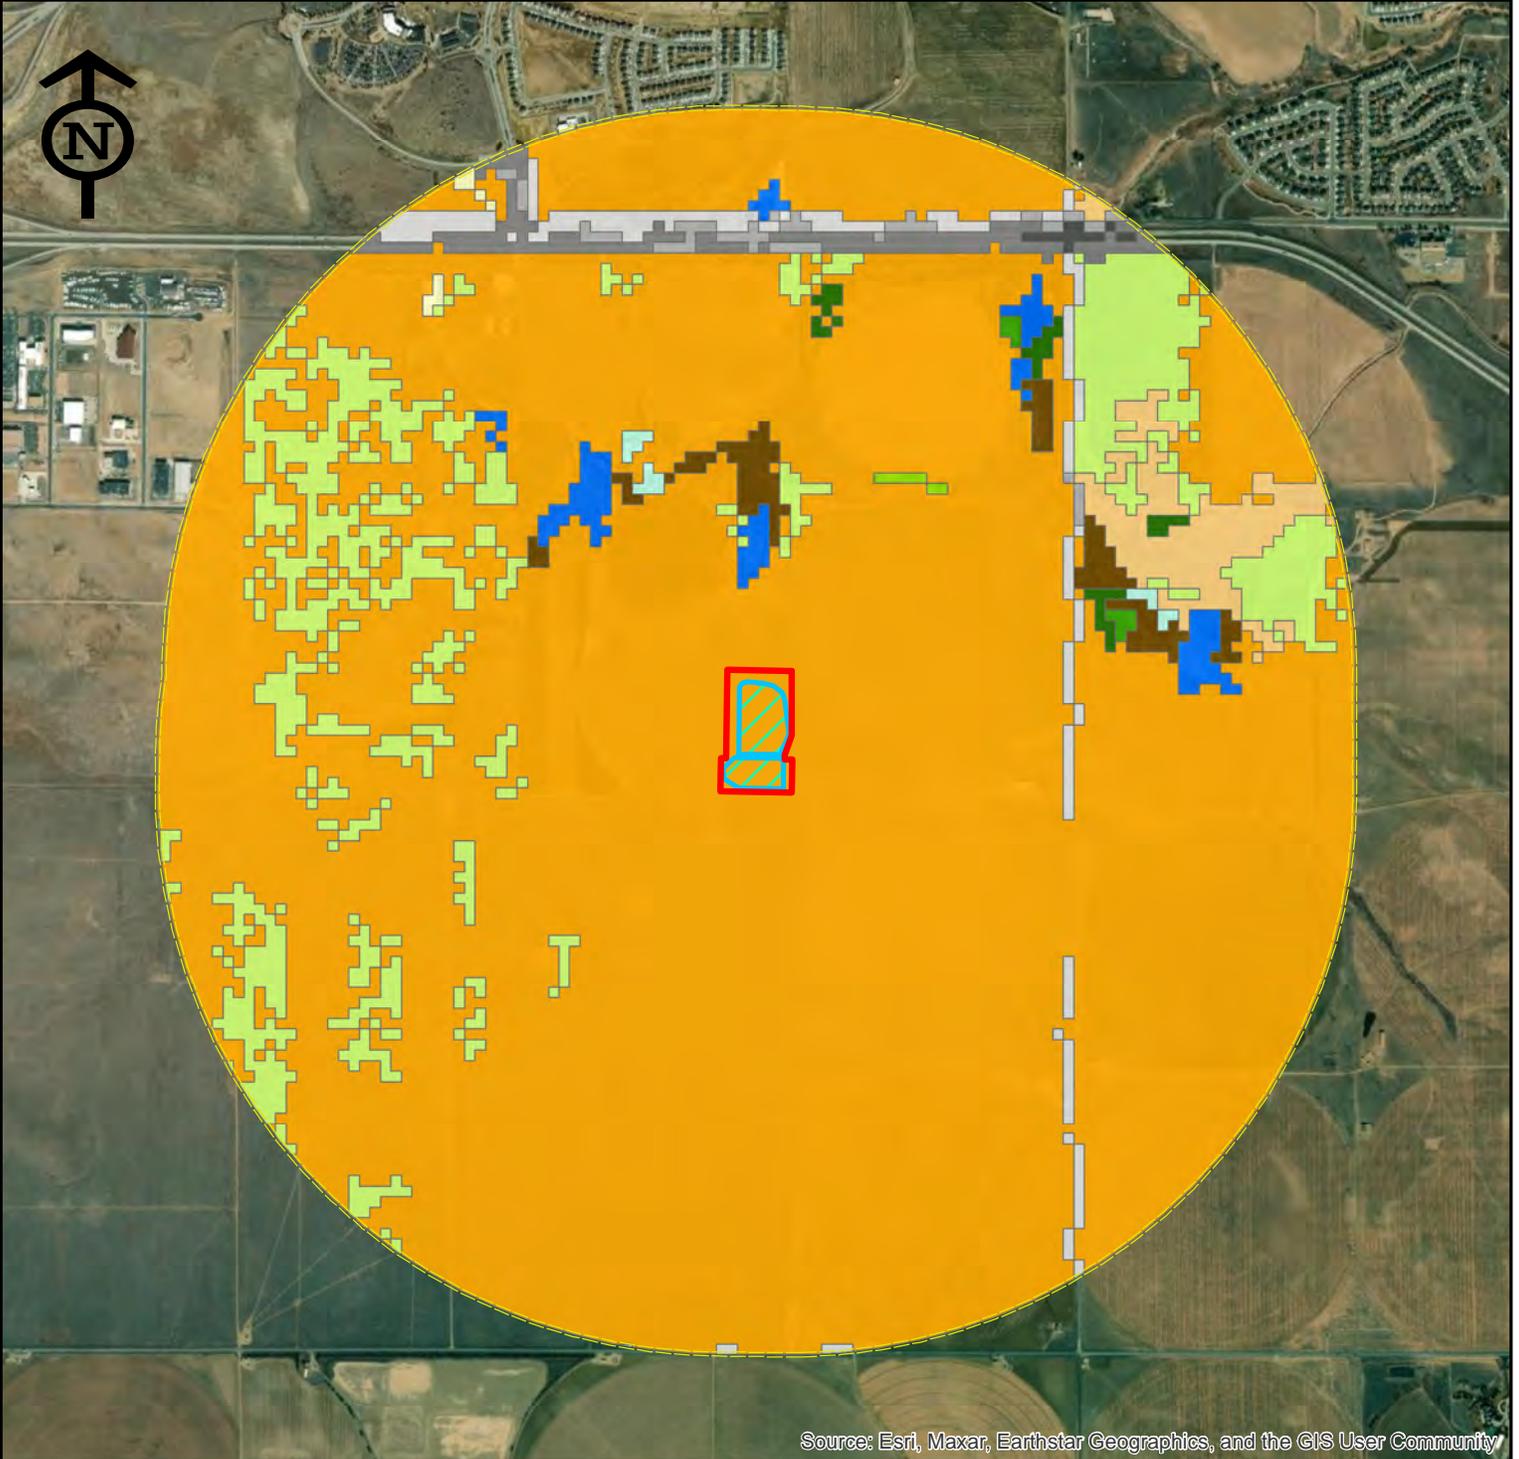
Land Cover  
Overview

Land Cover Type	Acreeage within 1 mile	
Cultivated Crops	2,042.74	
Herbaceous	211.63	
Hay/Pasture	45.56	
Developed, Open Space	40.76	
Developed, Medium Intensity	30.35	
Woody Wetlands	26.93	
Open Water	25.82	
Developed, Low Intensity	12.91	
Deciduous Forest	8.01	<b>Description:</b> Based on National Land Coverage Data (NLCD), the overall agricultural area shows predominantly Cultivated Crops within 1 mile of the Disturbance Area. The field survey confirmed that the dominant land use within 1 mile from the Disturbance Area is agricultural fields, with some rangeland and oil and gas operations.
Emergent Herbaceous Wetlands	4.23	
Developed, High Intensity	3.12	
Evergreen Forest	2.45	
Barren Land	2.33	
Mixed Forest	1.56	
Land Cover Type	Disturbed Acreeage	
Cultivated Crops	16.93	<b>Description:</b> Based on NLCD, the Disturbance Area consists of cultivated crop fields, with a majority falling within a center-pivot irrigated area. The field survey confirmed that the Disturbance Area falls within an irrigated agricultural field, used to grow sod.

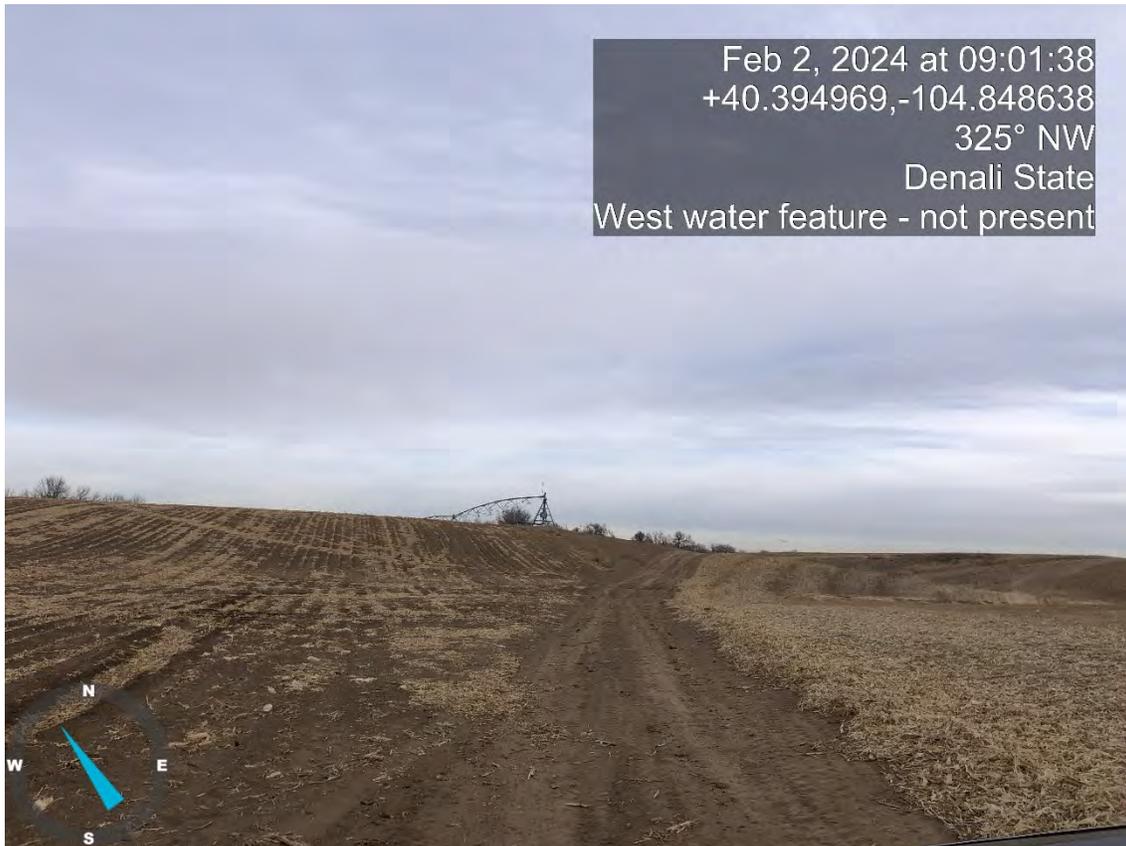
Photograph 5. West water feature, facing northwest. Photo was taken from on top of the feature. The mapped stream is not present.

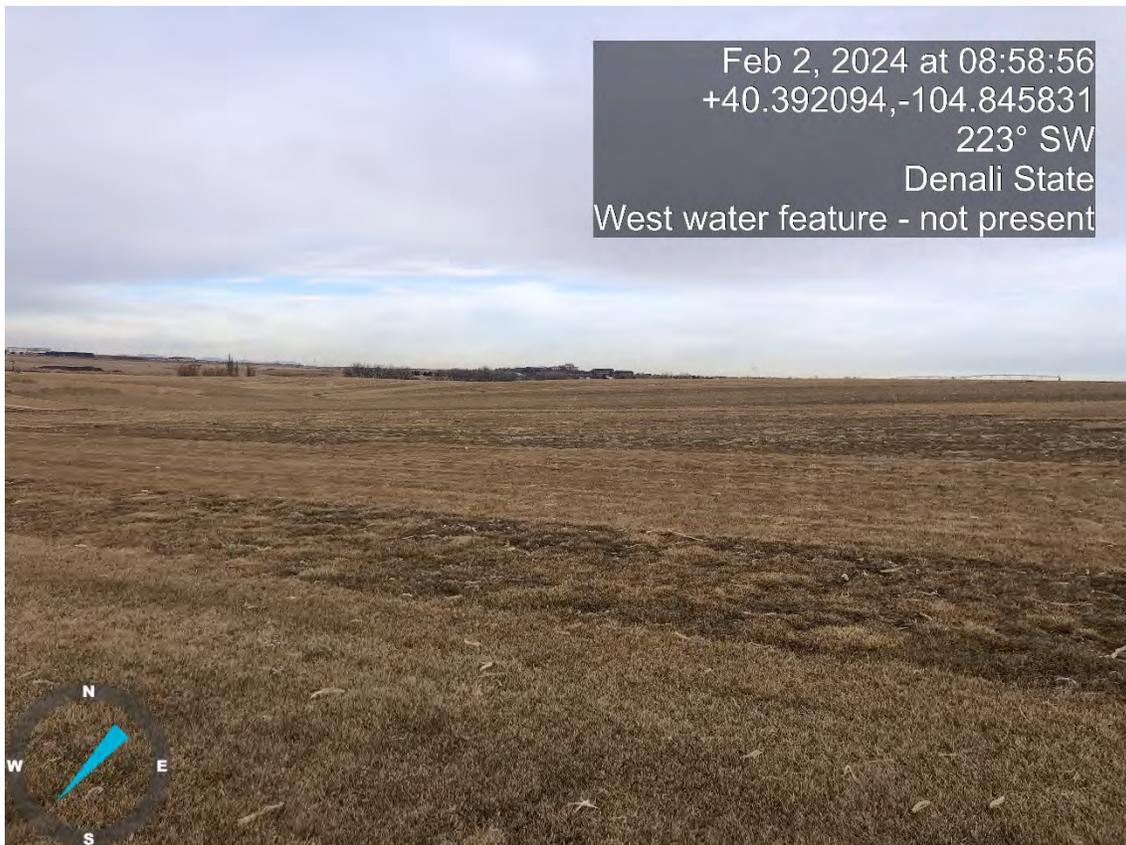
Photograph 6. West water feature, facing southwest. Photo was taken from on top of the feature. The mapped stream is not present.

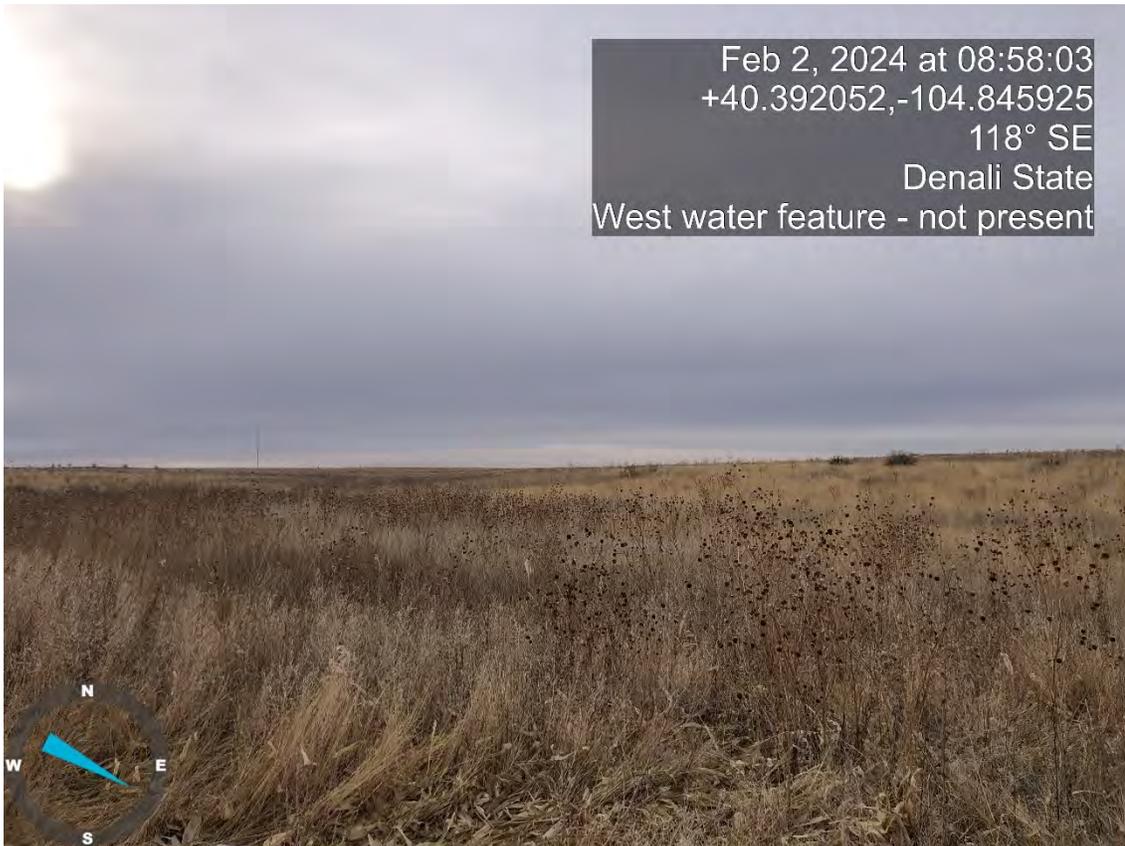
Photograph 7. West water feature, facing southeast. Photo was taken from on top of the feature. The mapped stream is not present.

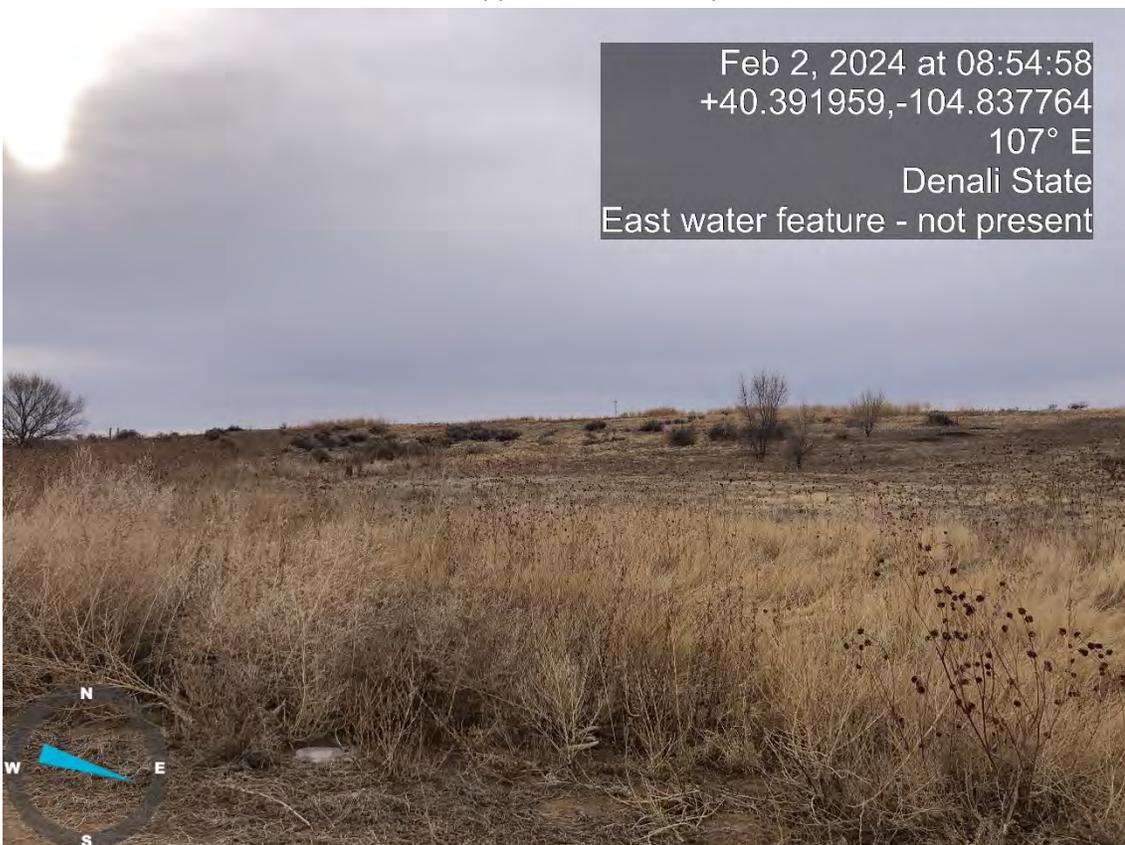
Photograph 8. East water feature, facing southeast. Photo was taken from on top of the feature. The mapped stream is not present.

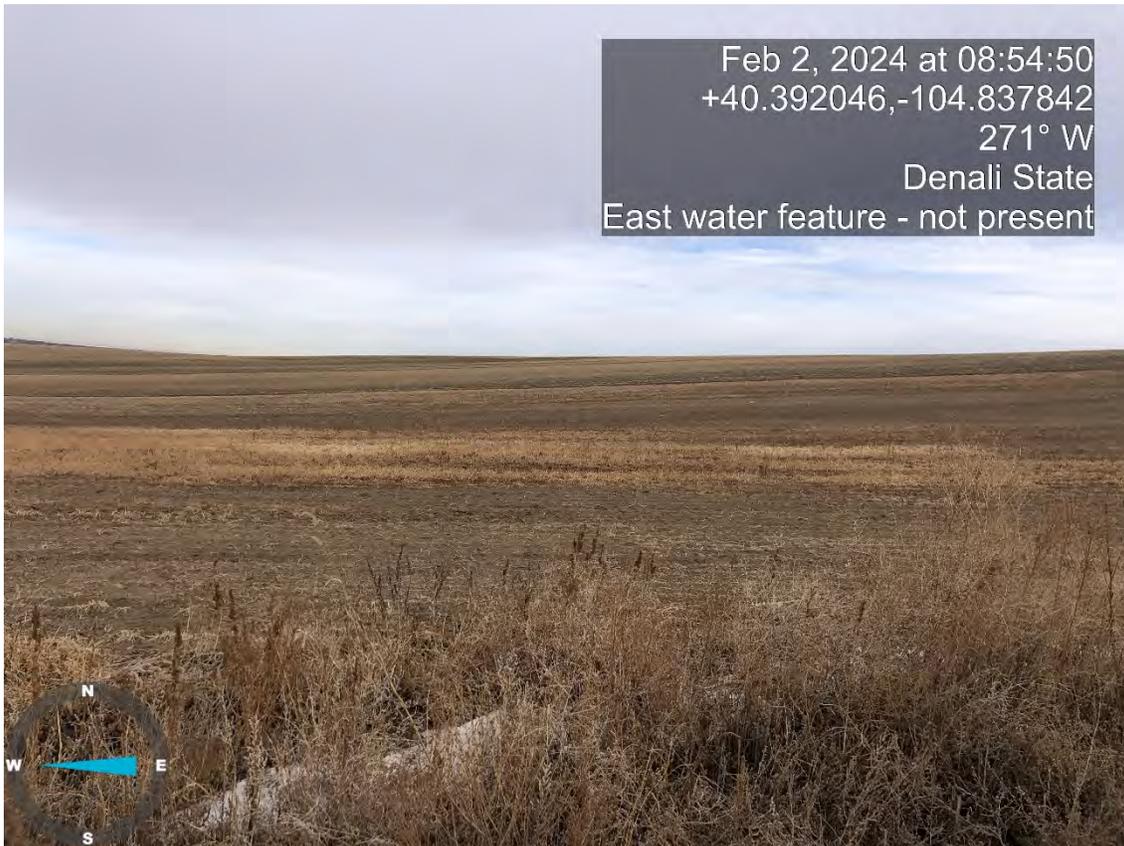
Photograph 9. East water feature, facing west. Photo was taken from on top of the feature. The mapped stream is not present.

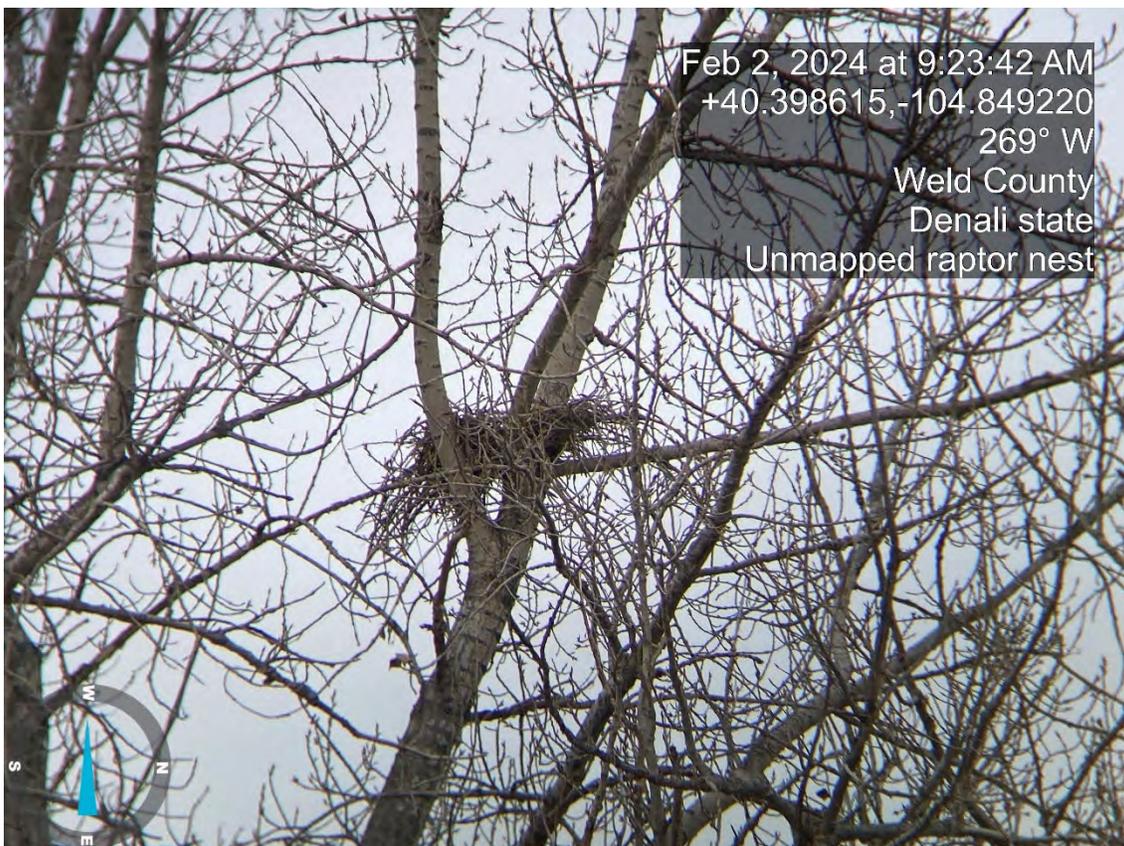
Photograph 10. Previously unmapped raptor nest, RNest\_C10.

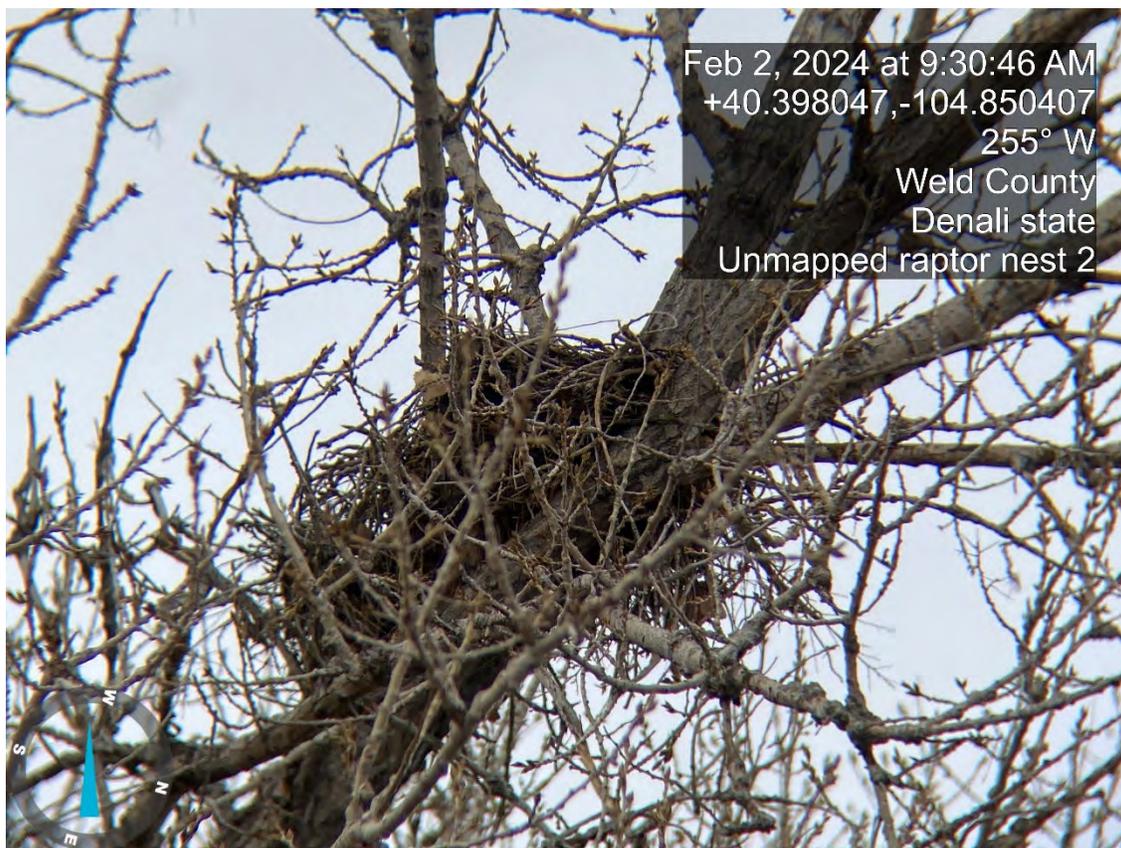
Photograph 11. Previously unmapped raptor nest, RNest\_C9.

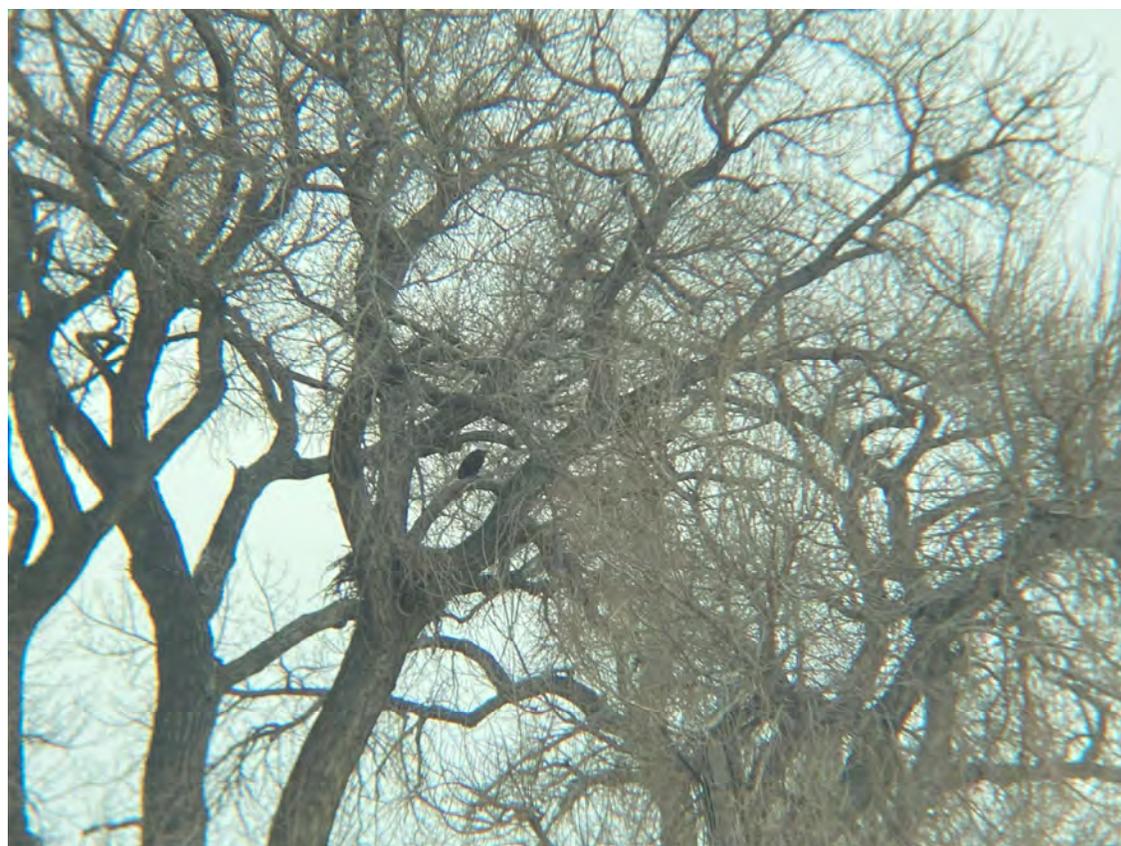
Photograph 12. Adult Bald Eagle roosting above Nest\_C1.
