Inspection Photos

Operator: CAERUS PICEANCE LLC - 10456

Location ID: 334558

Inspection Doc: 696205784

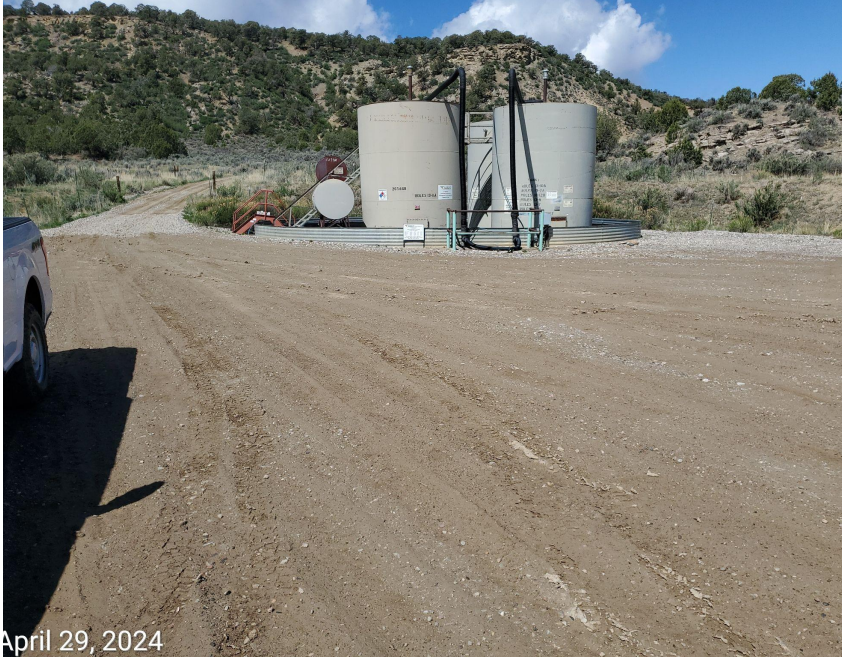
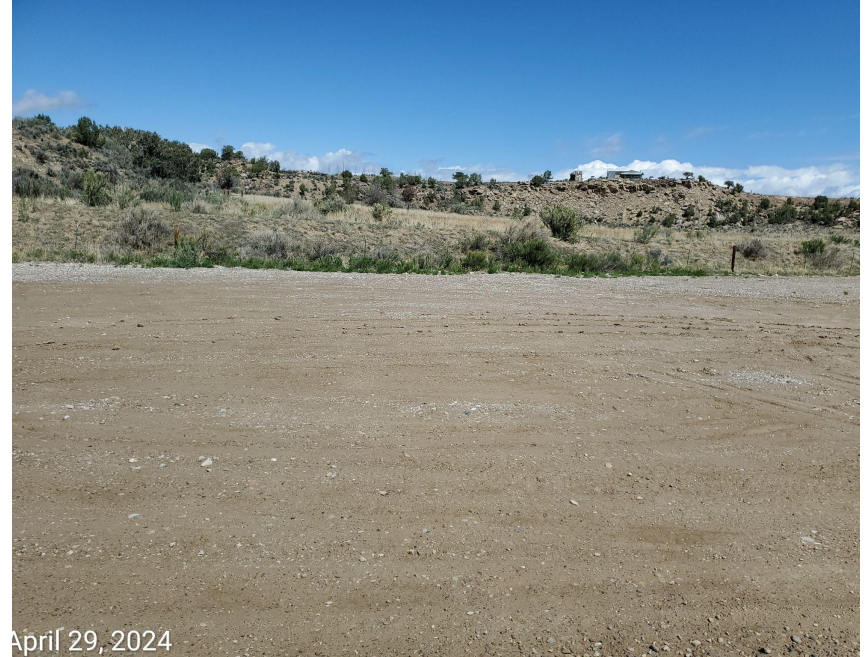
Photo 1: Photo 1-2 taken from the south end of the Location, facing northeast and southeast. Photos provides an overview of the Location from west, northwest, northeast to east.

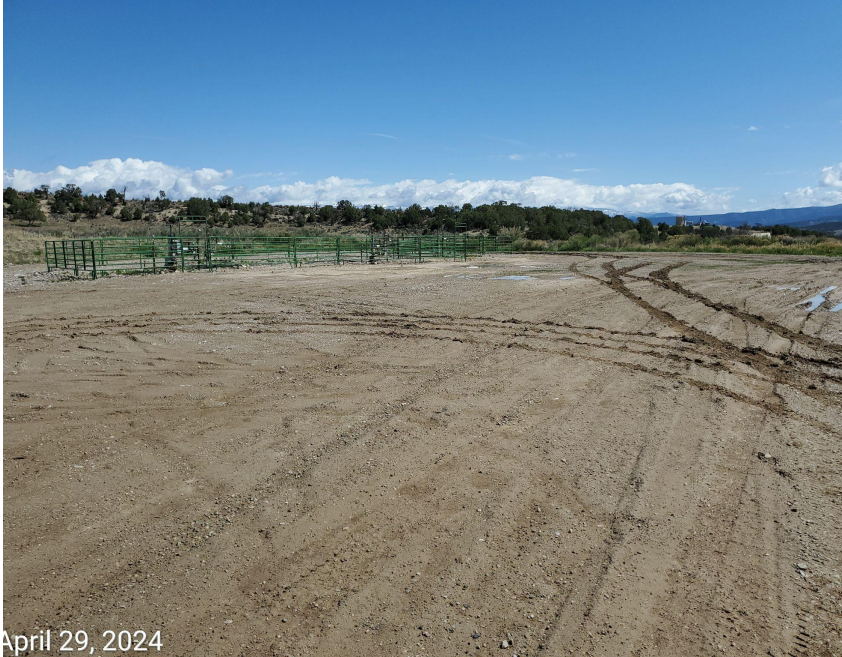
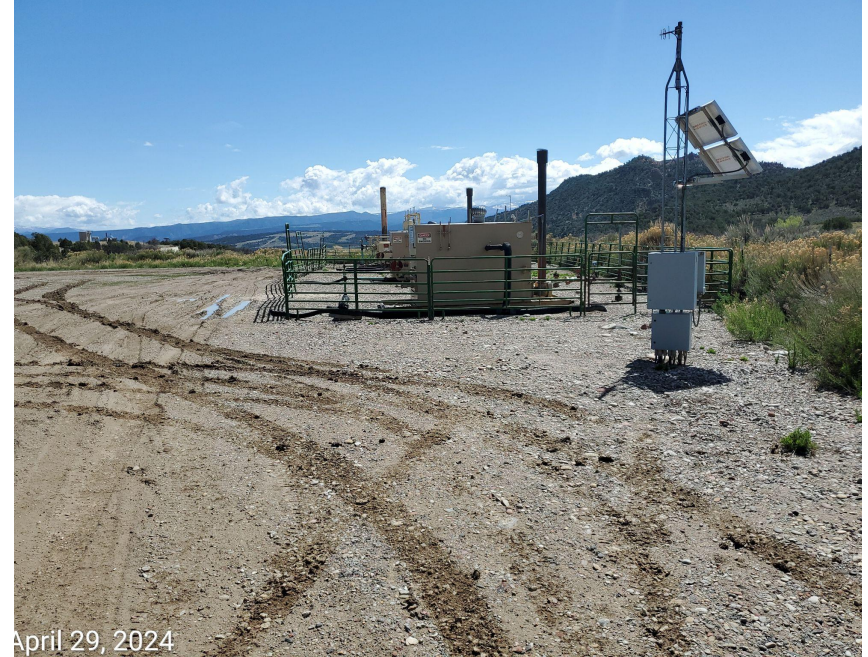
Photo 2: See comments under photo 1. Photos also examples showing BMPs to stabilize the working pad surface, as well as to minimize erosion, degradation and sediment transport are no longer in proper functioning condition.

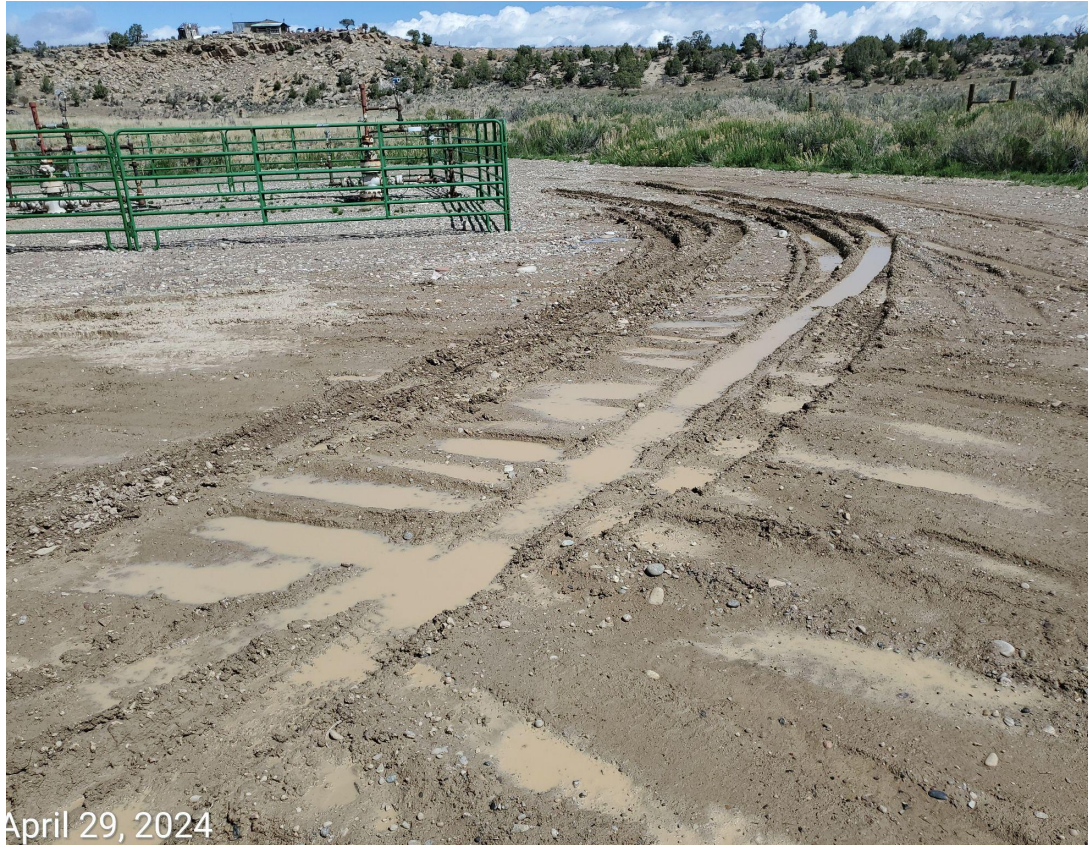
Photo 3: Photos example showing BMPs to stabilize the working pad surface, as well as to minimize erosion, degradation and sediment transport are no longer in proper functioning condition.

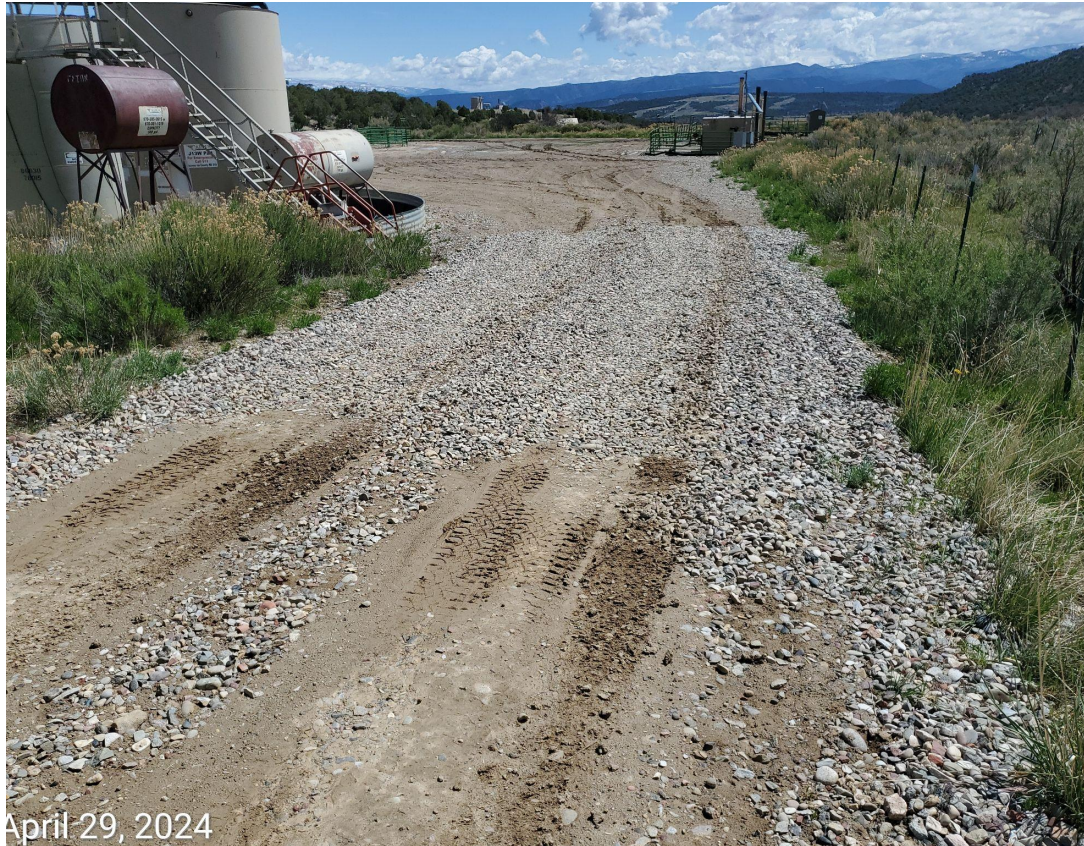
Photo 4: Photo taken from the location entrance. A thick layer of gravel has been placed at the Location entrance as a "VTC"; aggregate appears to be single sized material- BMP has not been constructed with course multiangular rock of appropriate size; BMP does not appear to be per good engineering practices and is unlikely to be effective during wet or muddy conditions; sediment tracking/transport evident.

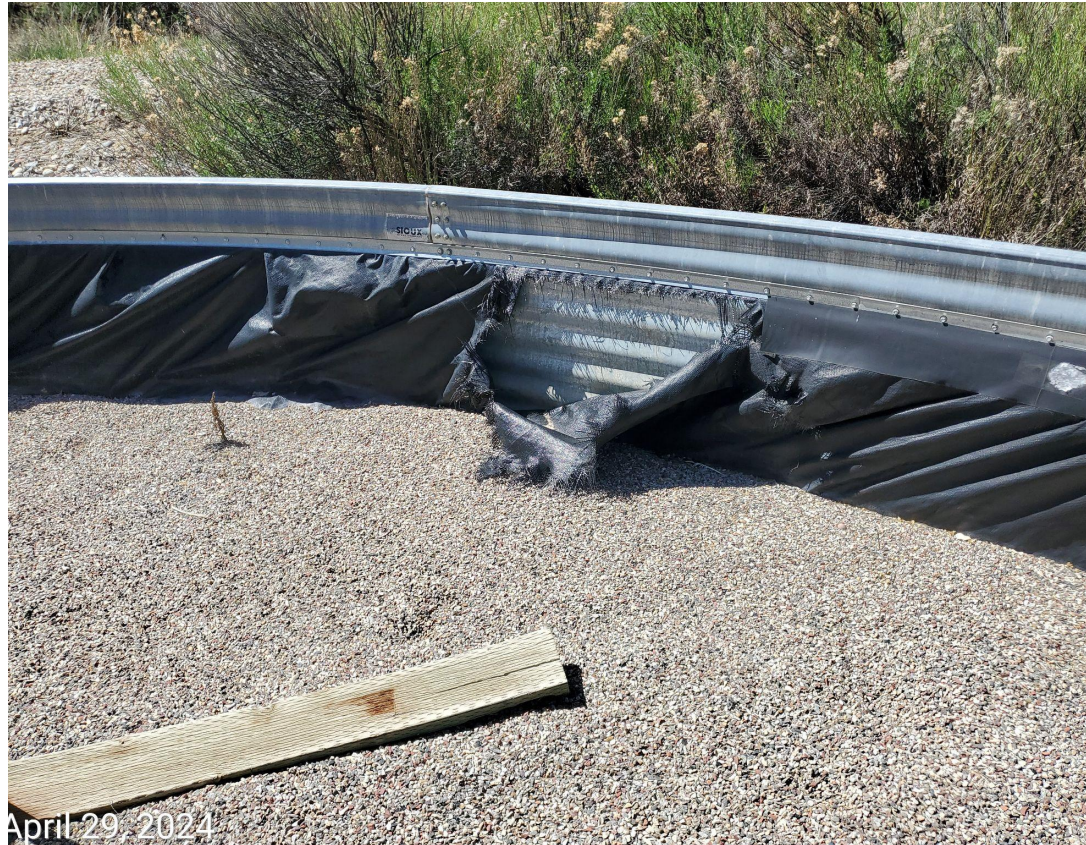
Photo 5: Liner in disrepair at tank battery facility.

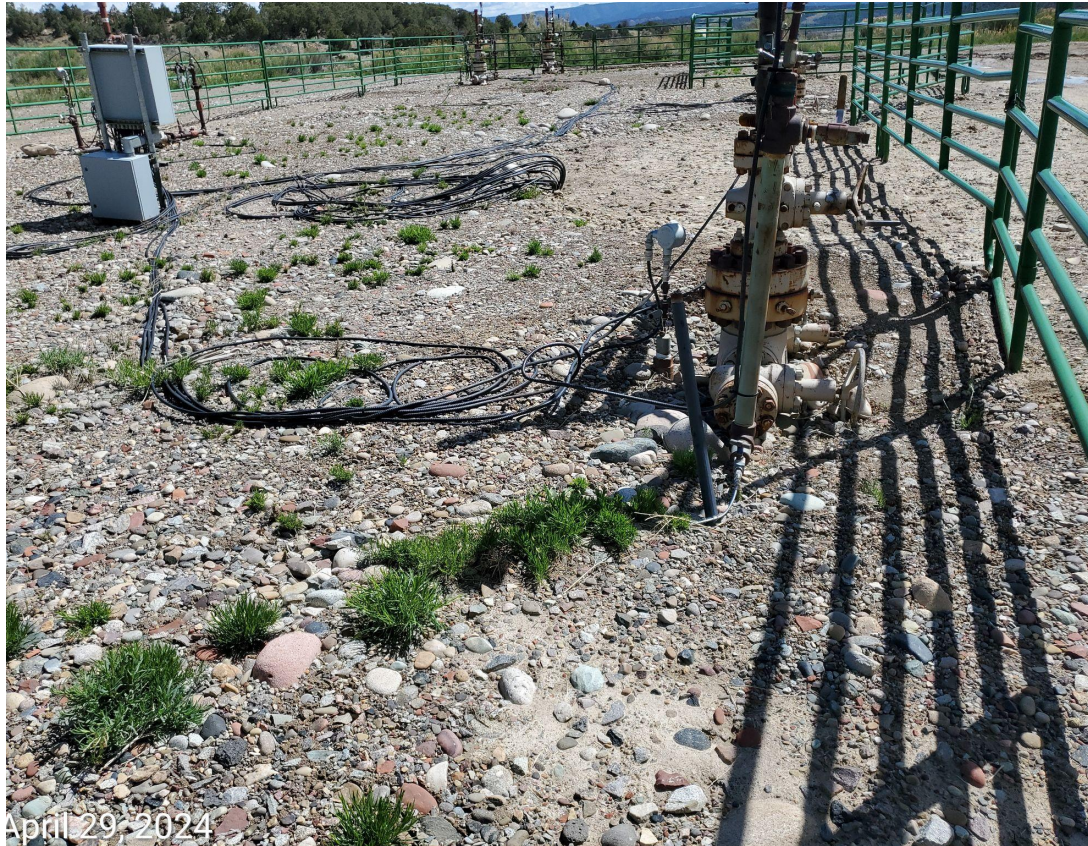
Photo 6: Photos examples showing vegetation establishing around production equipment. This is a potential fire hazard.

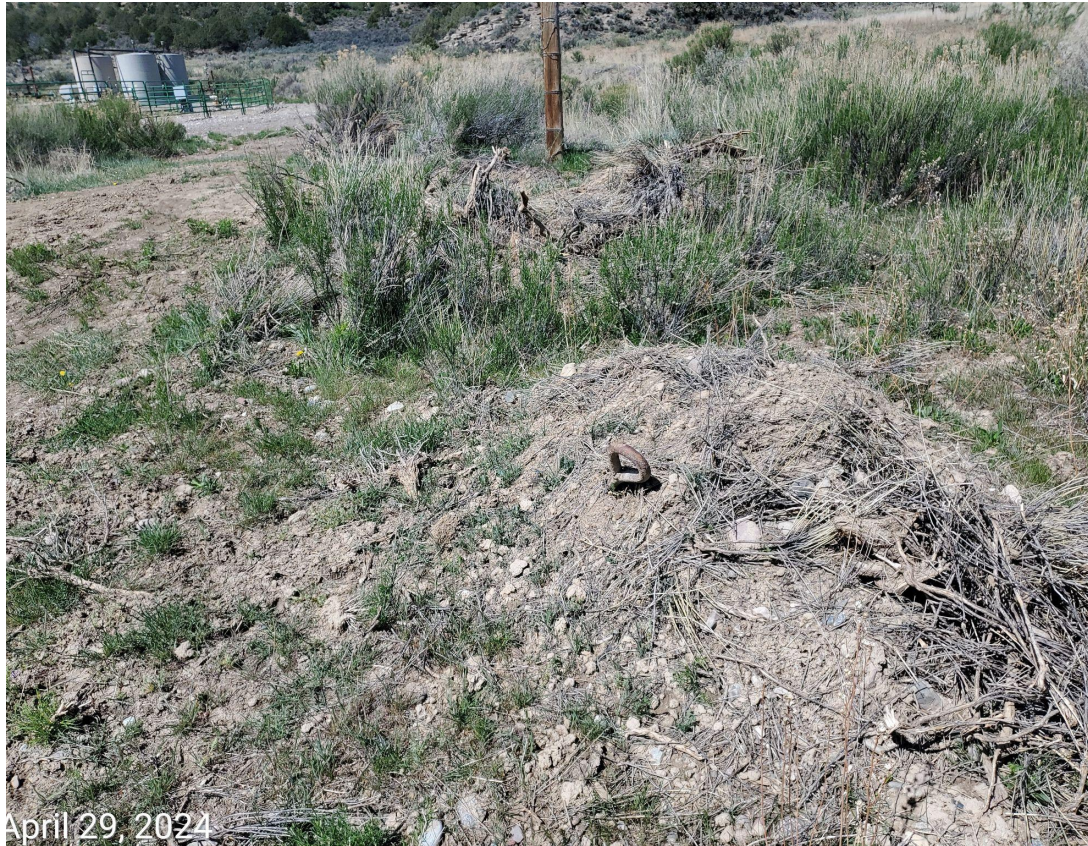
Photo 7: Photo taken from the northeast end of the Location. Photo shows unmarked anchor.

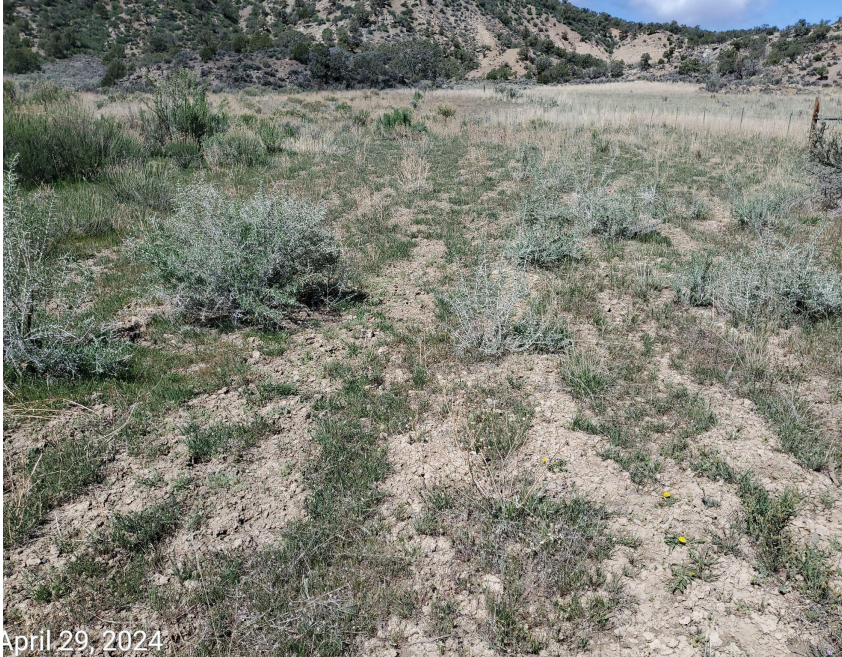
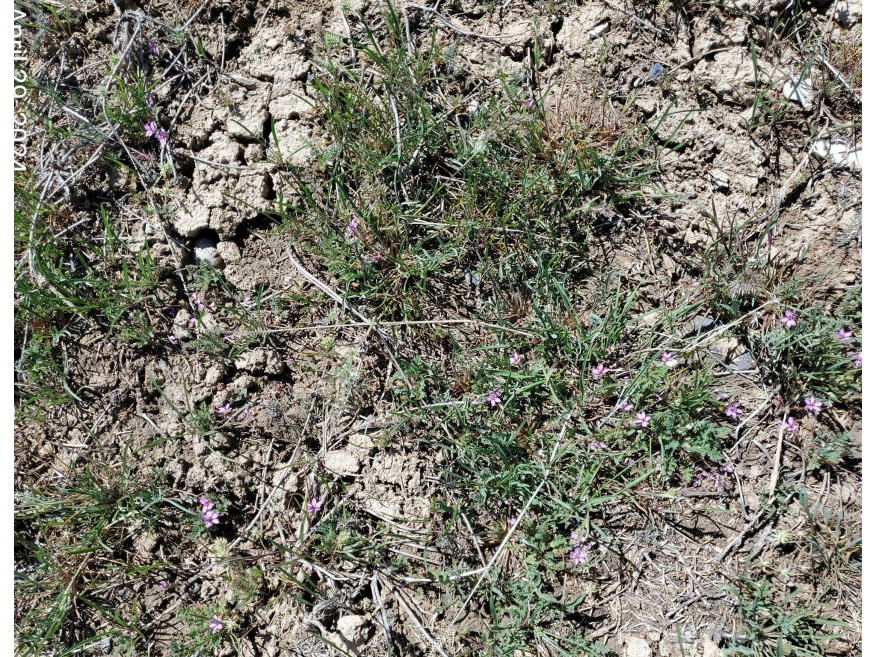
Photo 8: Photos taken from the interim areas on the North end of the Location. Excluding shrubs species, vegetation is predominantly undesirable plant species, including Bulbous bluegrass, purple mustard, etc...
