Inspection Photos

API: 017-07127

Operator: CITATION OIL & GAS CORP

Inspection Date: 5/1/2024

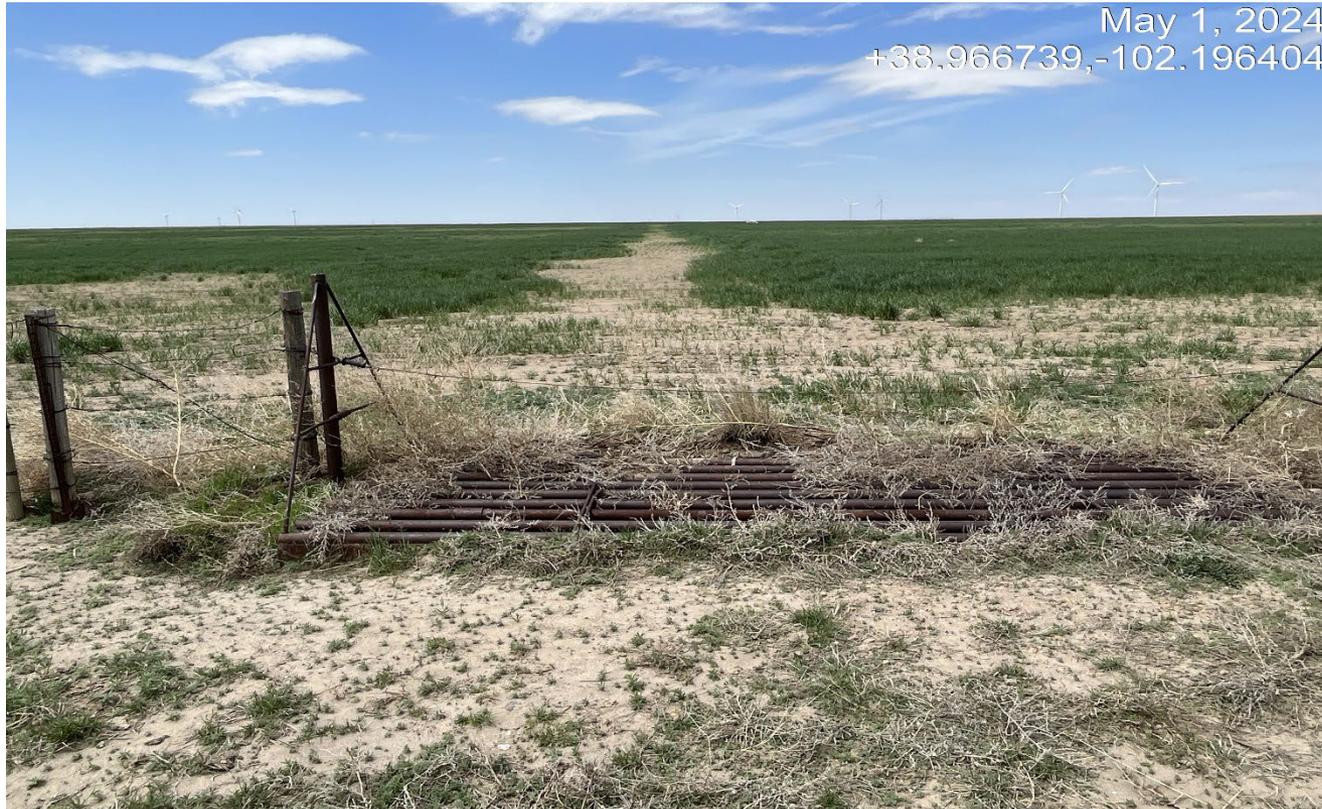
Photo 1. Facing west at the beginning of the access road. The cattleguard has not been removed..

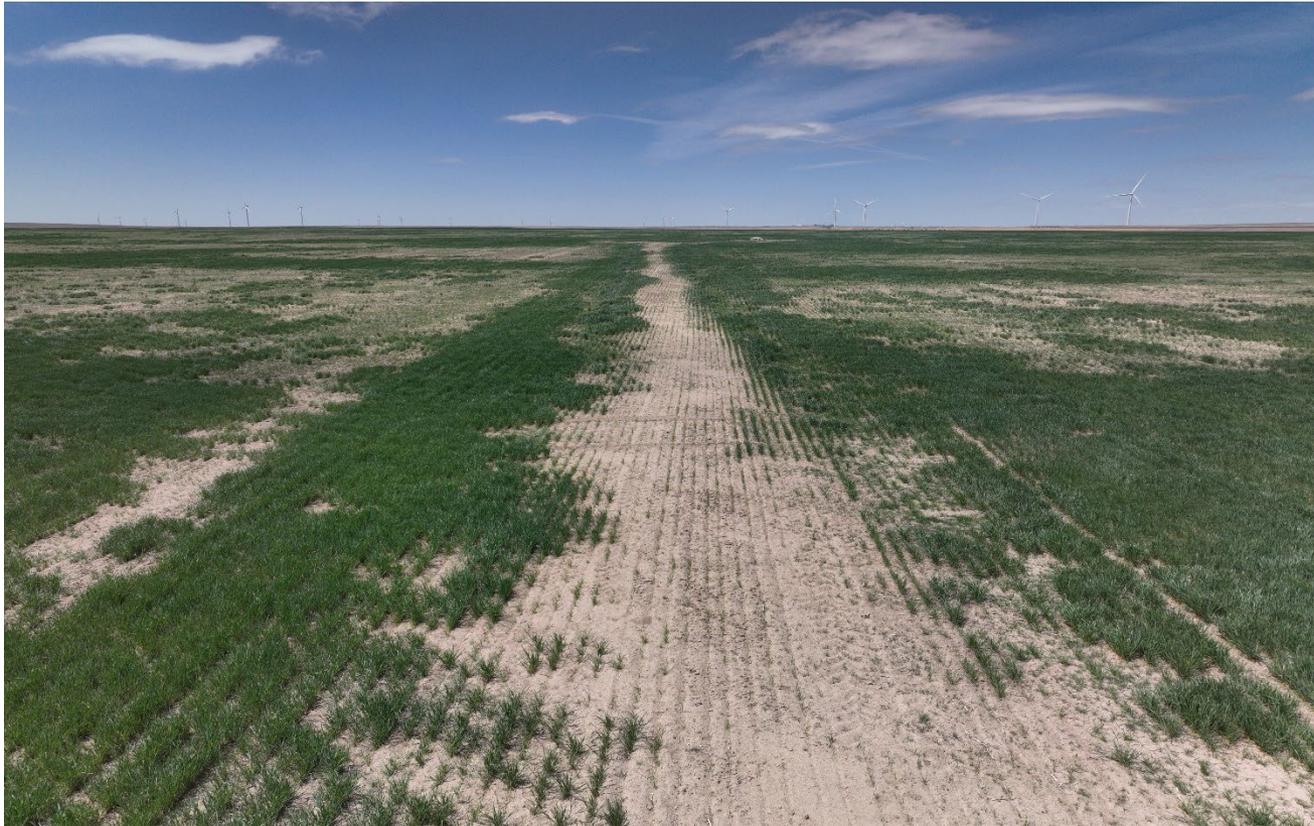
Photo 2. Facing east along the former access road. There is a definitive area along the former road that is not establishing crop growth. Consider checking for compaction issues.

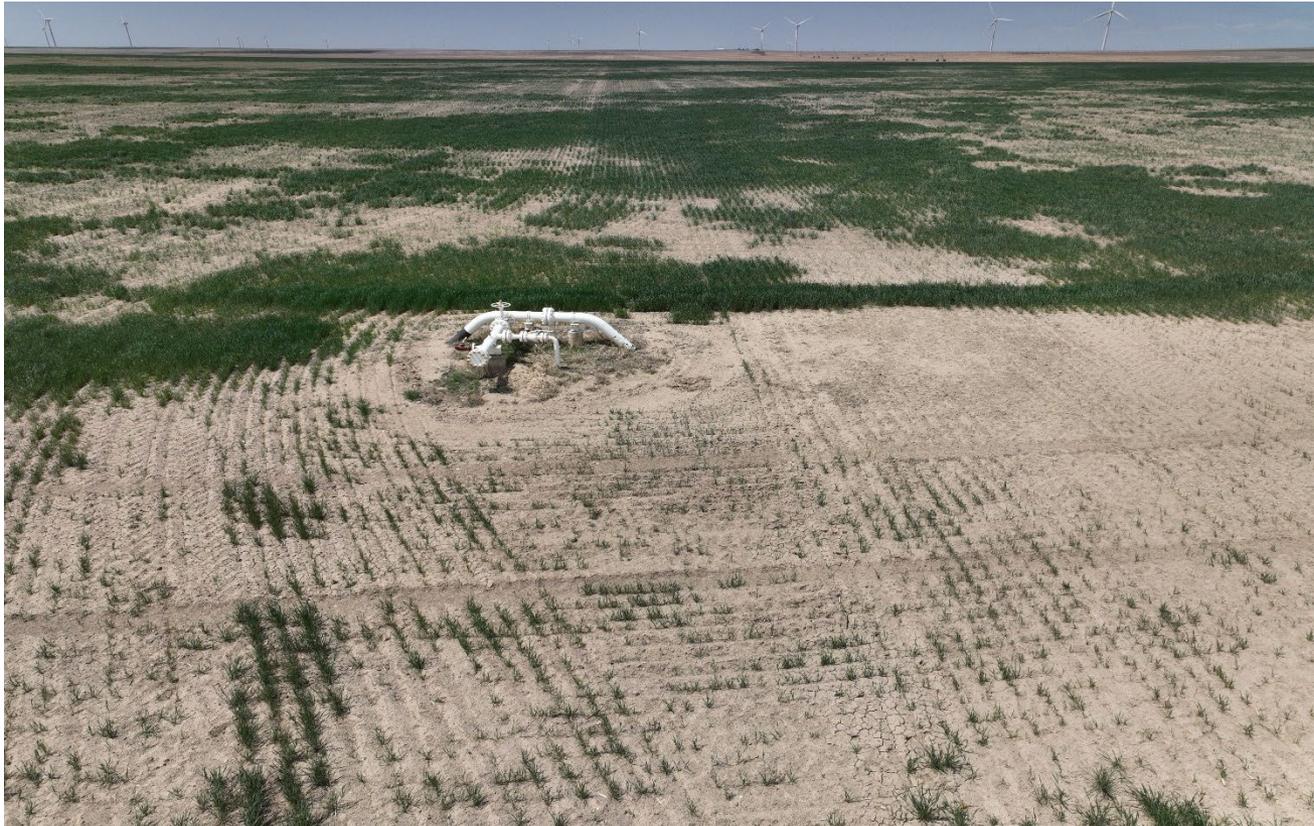
Photo 3. Facing west toward the abandoned wellsite location. There are pipe risers and lines that have not been abandoned and removed.

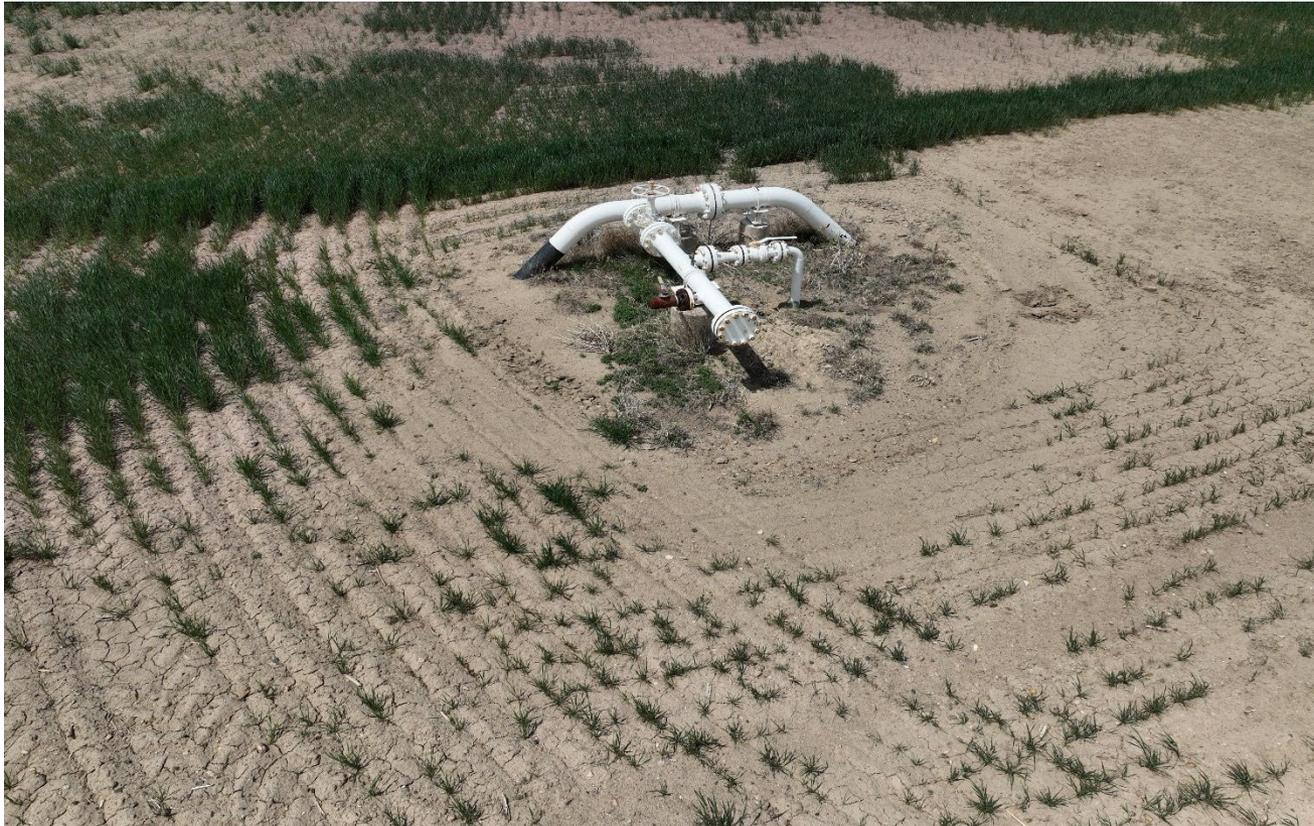
Photo 4. Facing down toward the abandoned wellsite. There are pipe risers and lines that have not been abandoned and removed and are interfering with crop production.

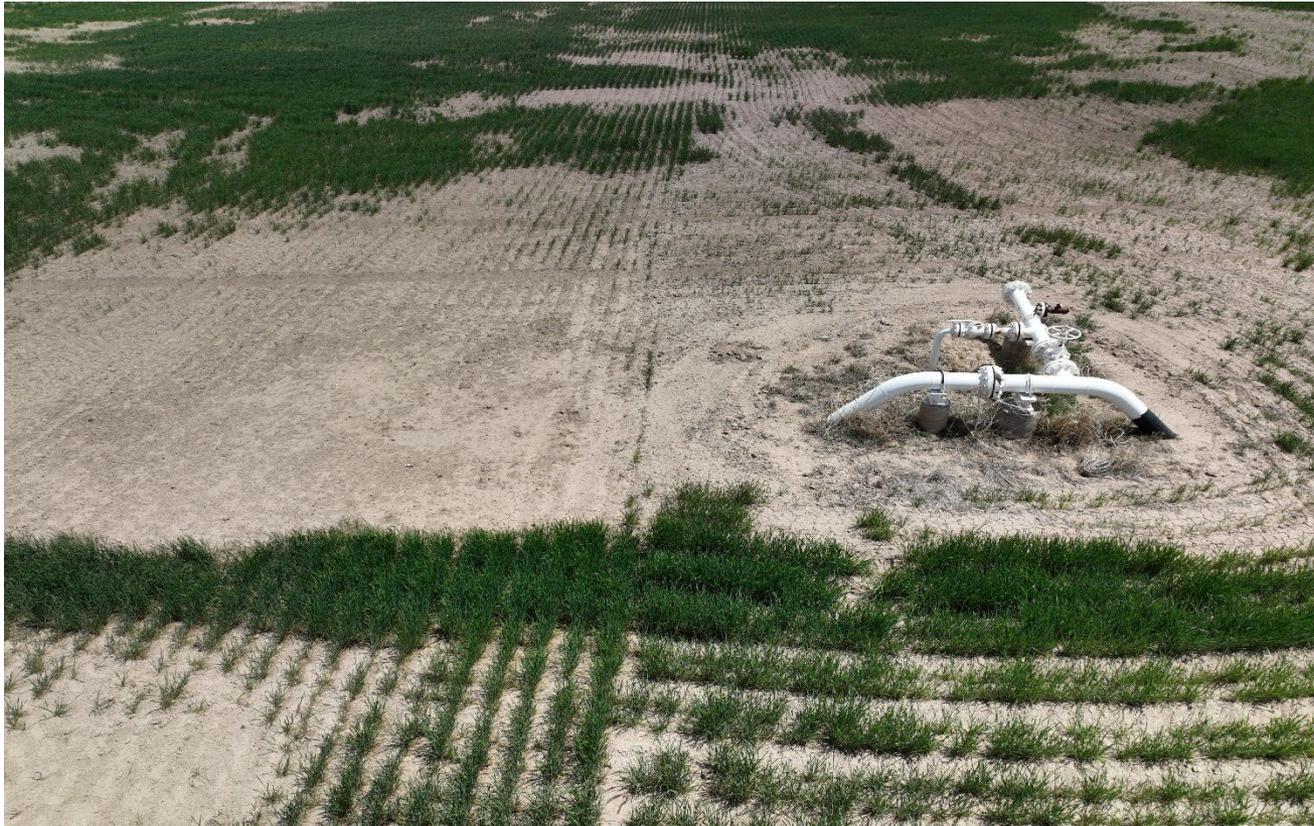
Photo 5. Facing east down toward the abandoned wellsite. It appears there is no crop growth coming up to the left of the pipe risers.
