Operator: BONANZA CREEK ENERGY OPERATING COMPANY LLC

Location Name: Latham 14-12 Facility

Loc ID: 429893

Inspection: 713900513

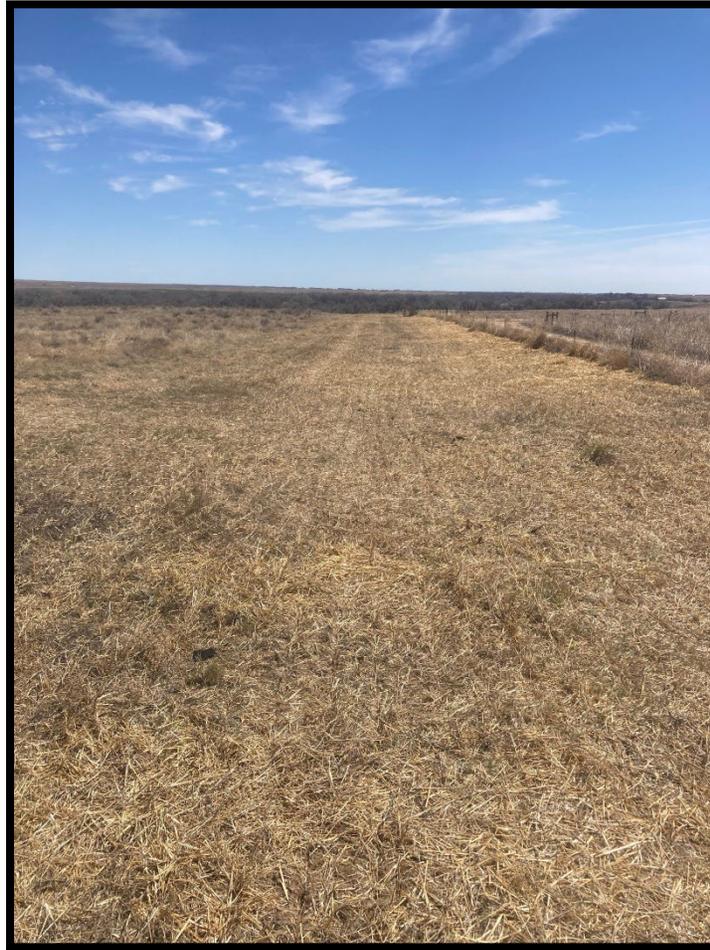
Exhibit I

CA: Barbed wire fencing remains around the tank battery facility and flowline corridor. It does not appear there is currently any cattle grazing in the area and so fencing should be removed. Remove fencing to comply with Rule 1004.

CA Resolution: Operator has reported that the fence was been removed from the east and north side of the facility location and the north side of the flowline corridor. The fence along the west side of the facility pad was left in place since it ties into the landowner's fence that continues to the north beyond location disturbance area. The fence along the location access road was left in place to prevent wildlife or future grazing of animals from accessing lease roads and pads. Operator also notes that they added a section with a drop gate along the south edge of where the facility was for access. Location currently complies with Rule 1004.
