# Interim Reclamation and Stormwater Inspection

Operator: FULCRUM ENERGY OPERATING LLC- #10805

Location ID: 445005

Inspection Photos  
Location Name: Surprise Unit 0680 S9  
Location ID: 445005

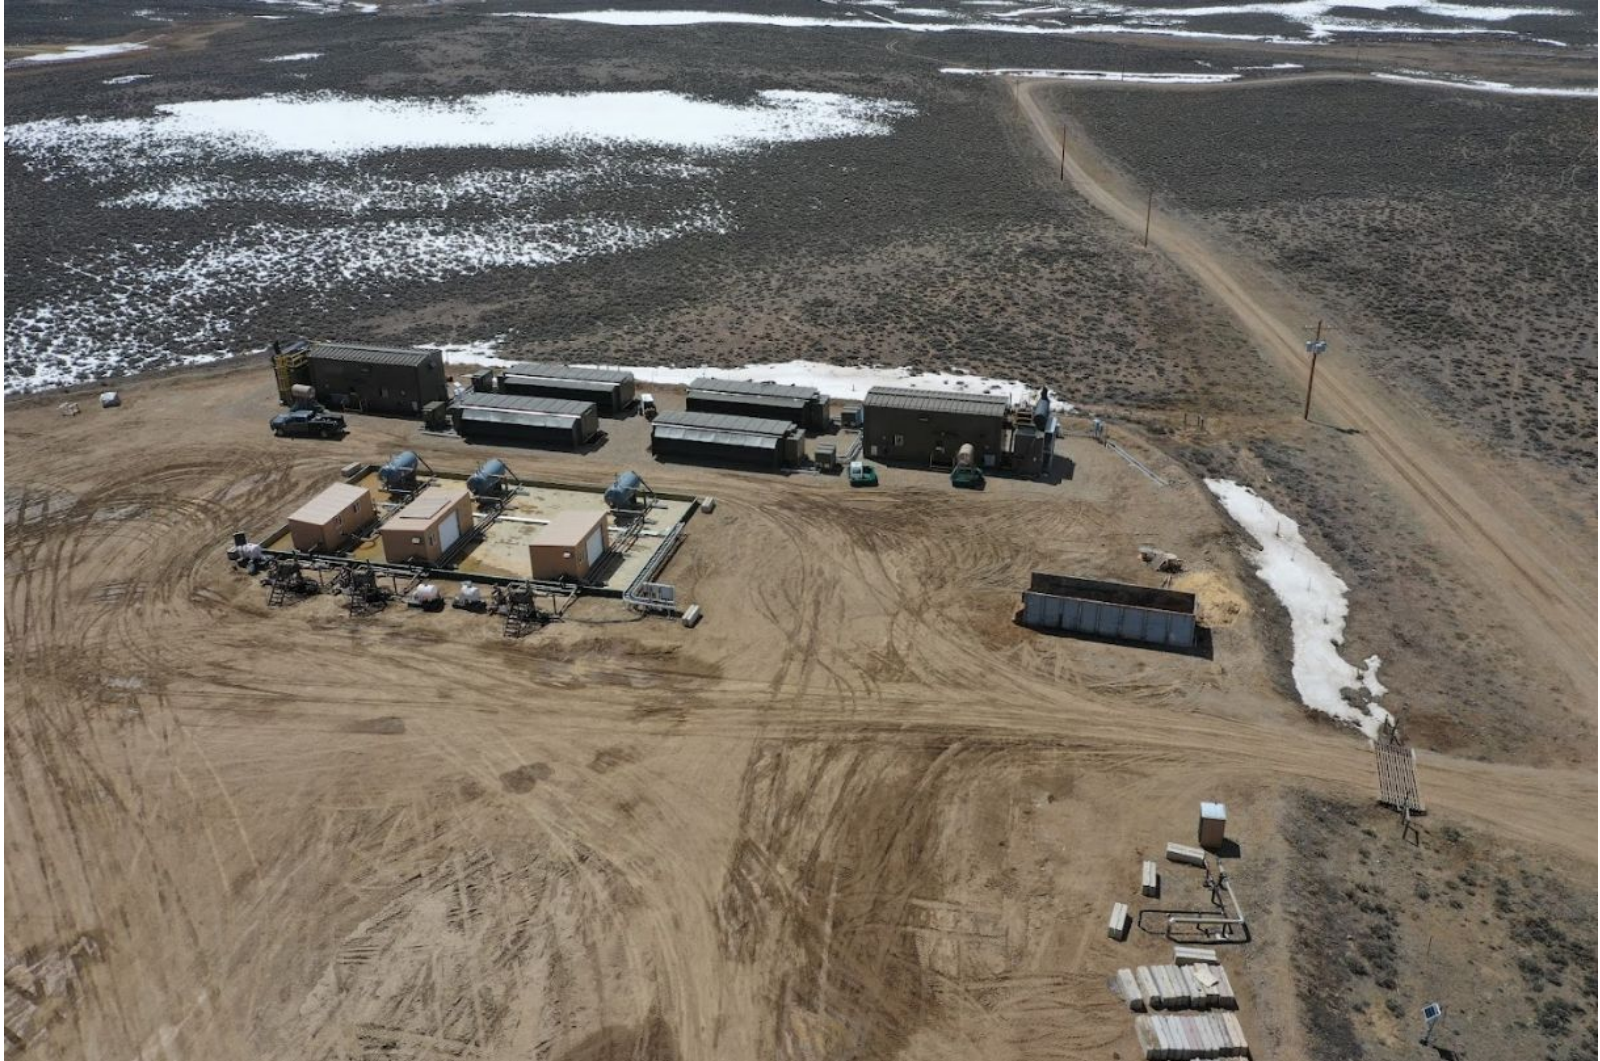
**Photo 1.** Drone imagery illustrates Fulcrum's 3rd party cloud computing/data processing company along the western perimeter of the working pad surface.

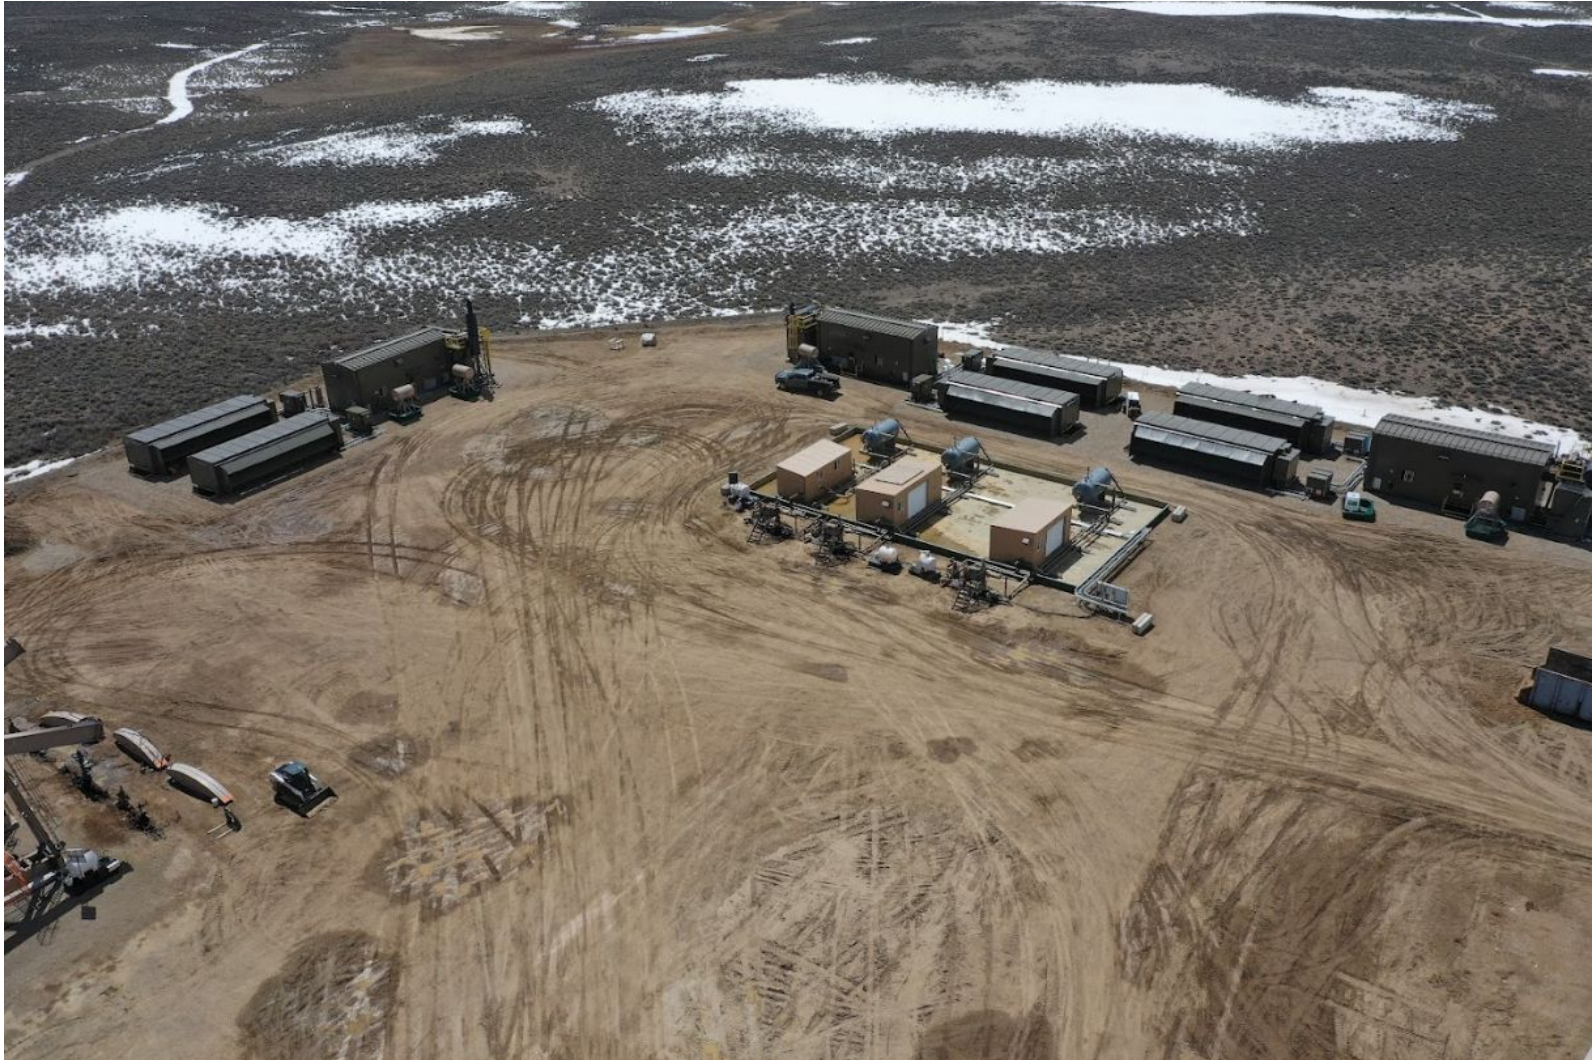
**Photo 2.** Drone imagery illustrates Fulcrum's 3rd party cloud computing/data processing company along the western and southern perimeter of the working pad surface.

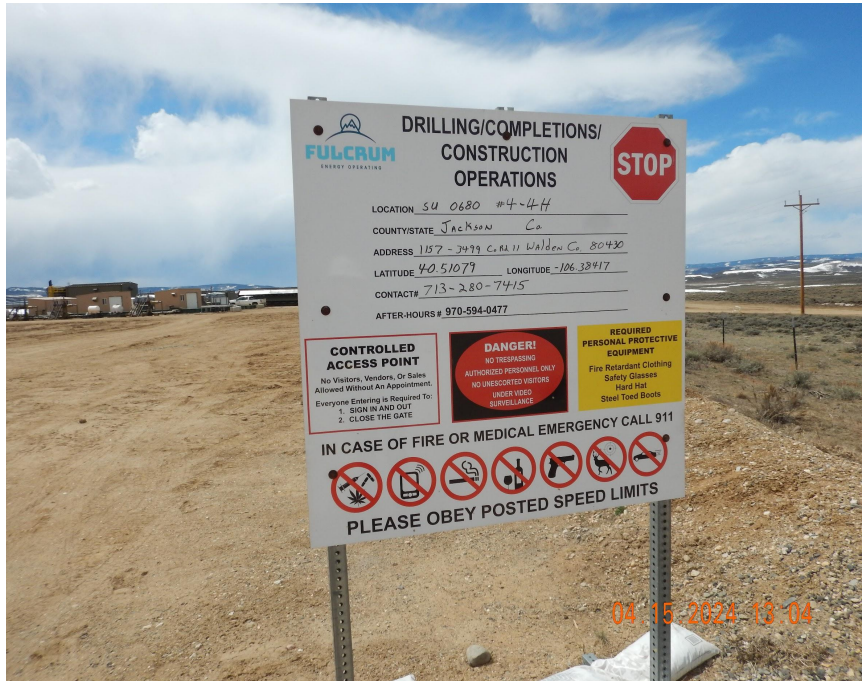
**Photo 3.** Photo taken from the entrance of location. Photo illustrates the Location Operator sign.

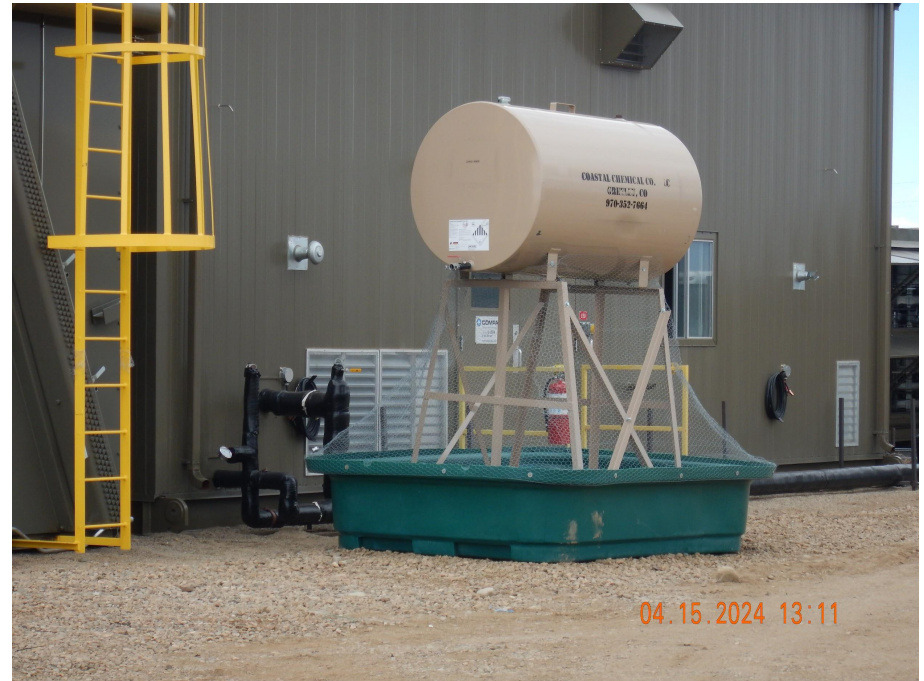
**Photo 4.** Photo taken from the western working pad surface, facing West. Photo illustrates the equipment and secondary containment has proper wildlife protection.

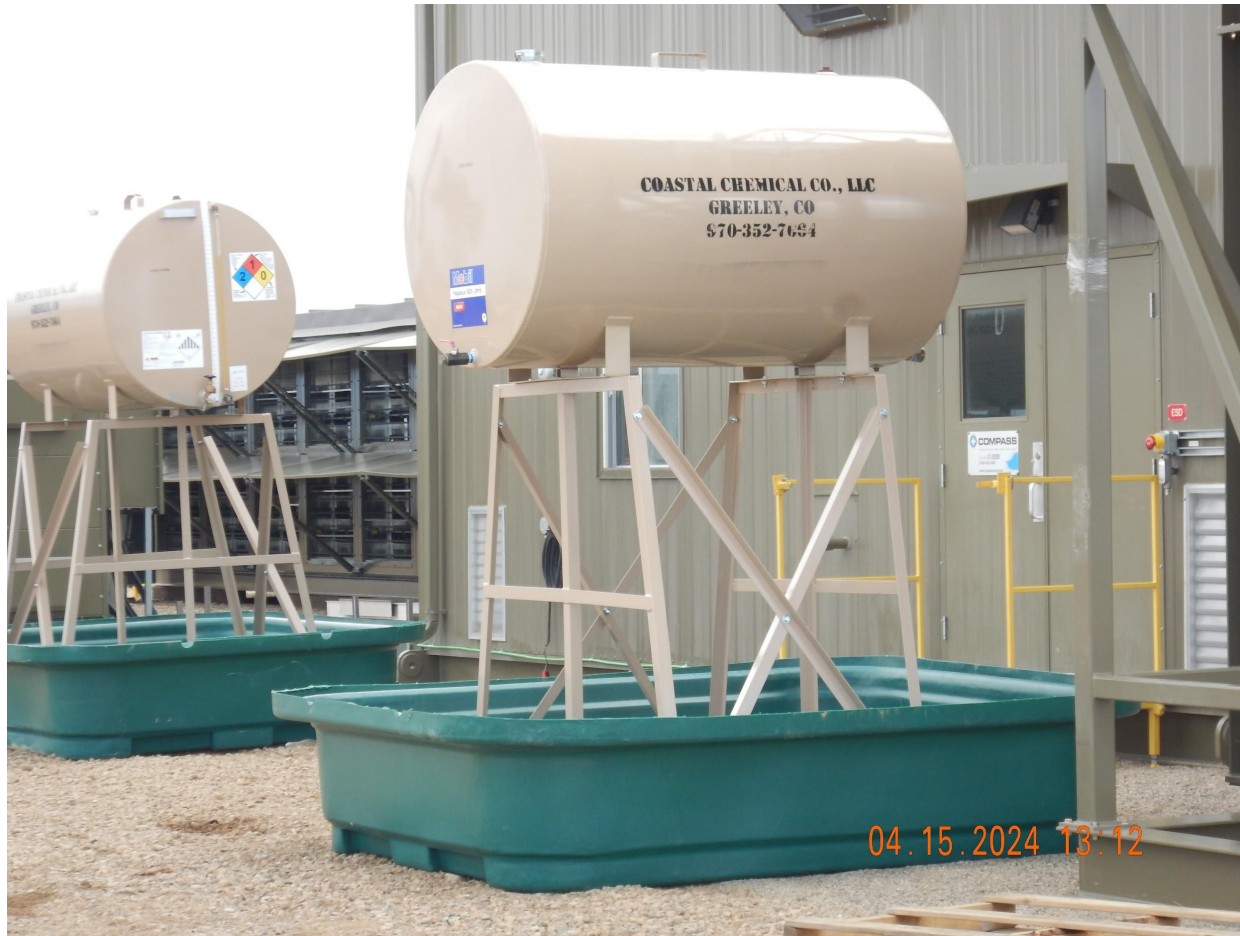
**Photo 5.** Photo taken from the southern working pad surface, facing Southeast. Photo illustrates the equipment and secondary containment lacks wildlife protection.

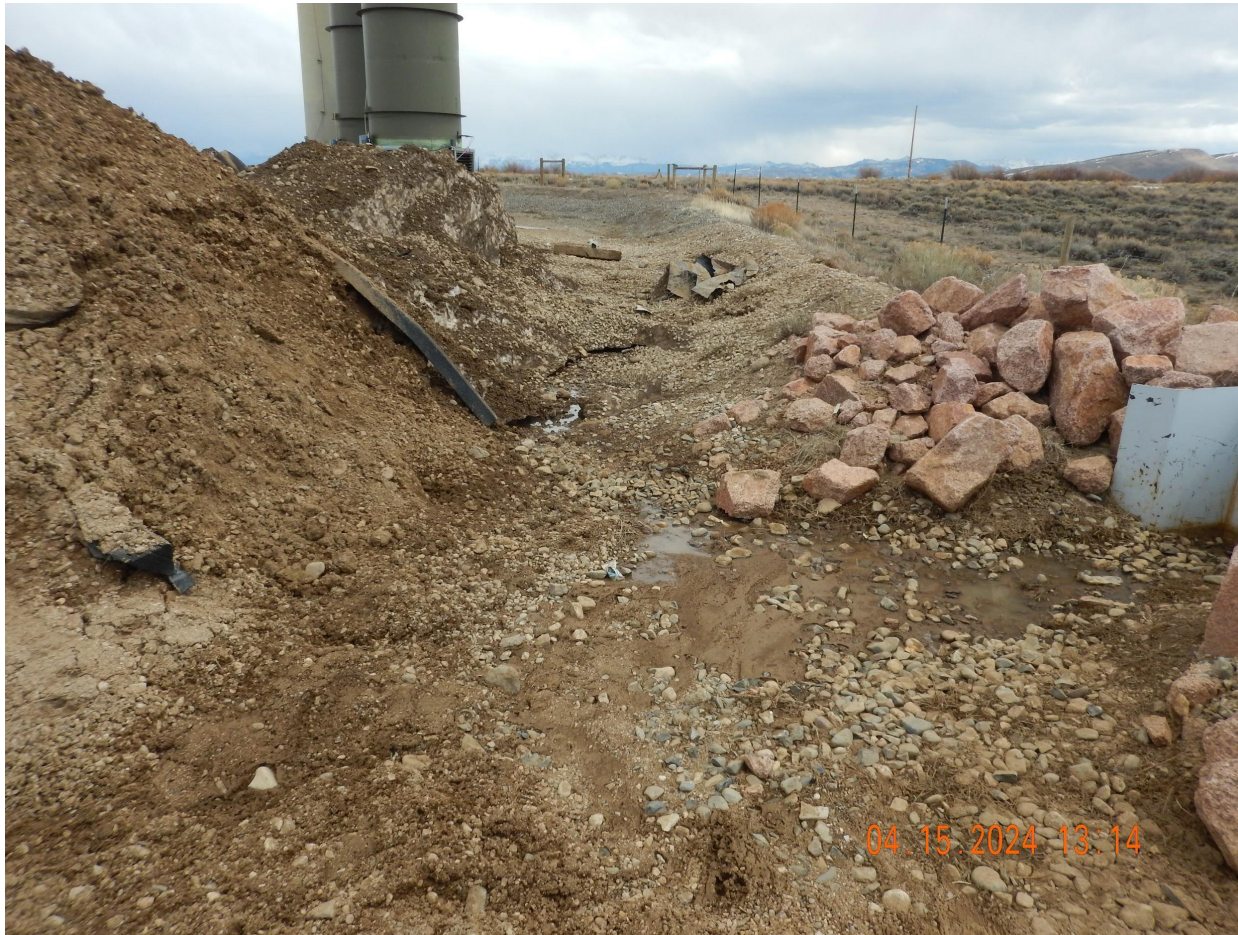
**Photo 6.** Photo taken from the southeastern working pad surface, facing East. Photo illustrates a snow plow pile with random debris. Operator reported that as the pile melts debris is being removed and being properly disposed of.

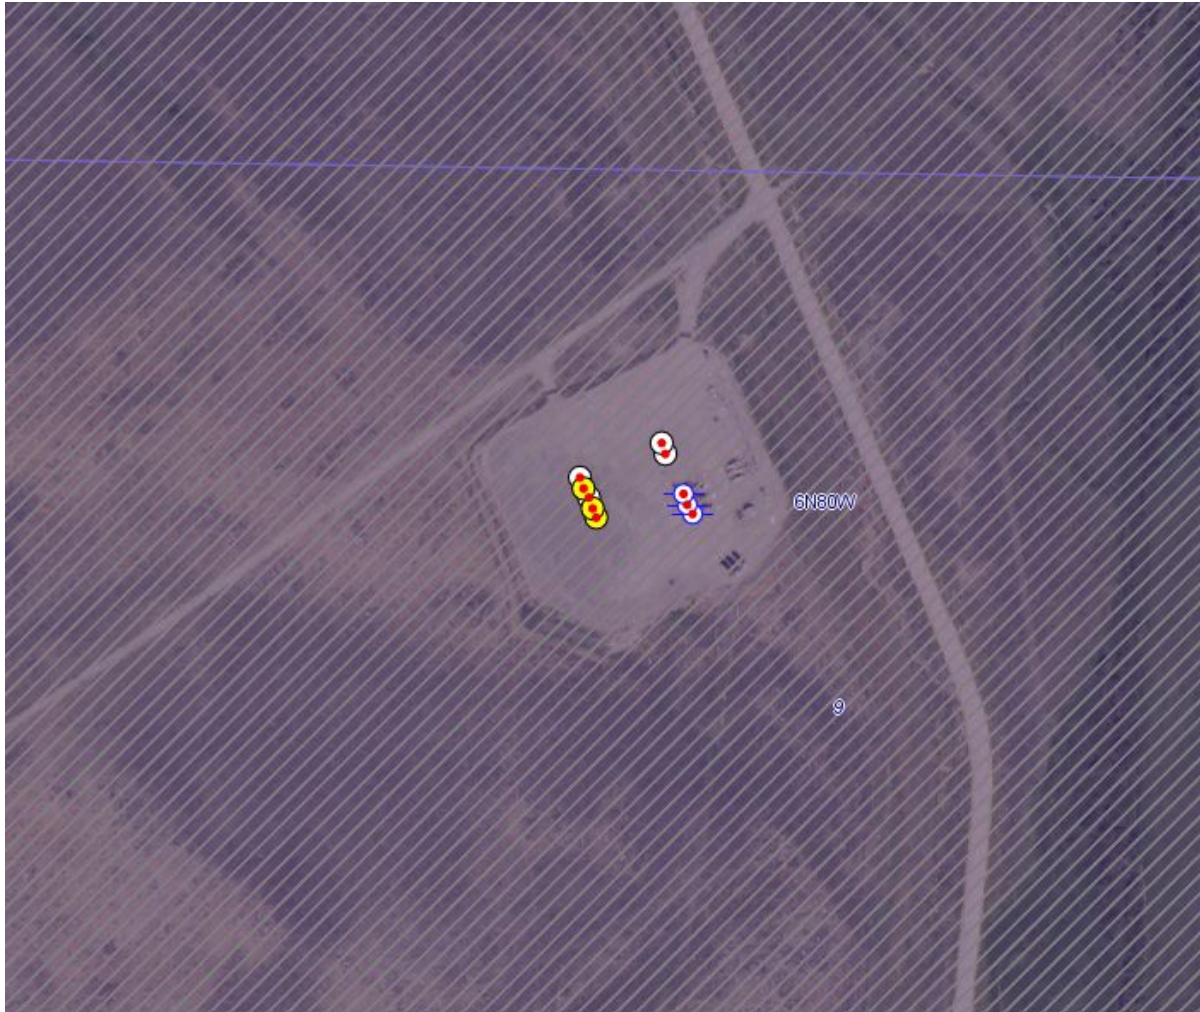
**Photo 7.** ECMC GIS aerial imagery illustrates the location falls within Greater Sage Grouse Priority Habitat Management Area.
