Interim Reclamation and Stormwater Inspection

Operator: FULCRUM ENERGY OPERATING LLC- #10805

Location ID: 467526

Inspection Photos
Location Name: Spicer S32 Annex Pad
Location ID: 467526

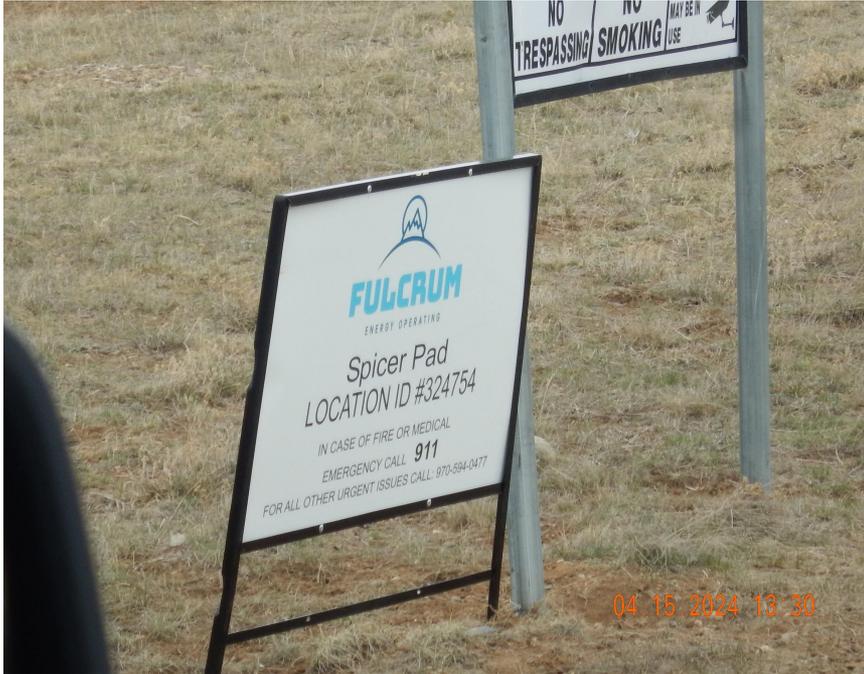
Photo 1. Photo taken from the entrance of location. Photo illustrates the Location Operator sign for the western location. Staff did not observe a Location sign for the Spicer Annex Pad.

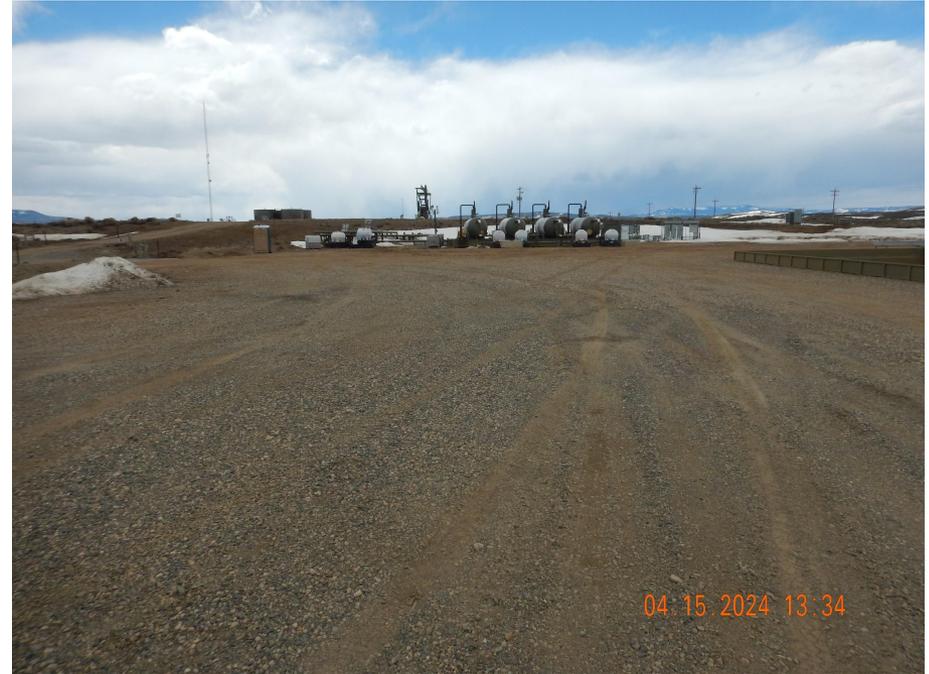
Photo 2. Photo taken from the southern location, facing West. Photo illustrates equipment along the western location.

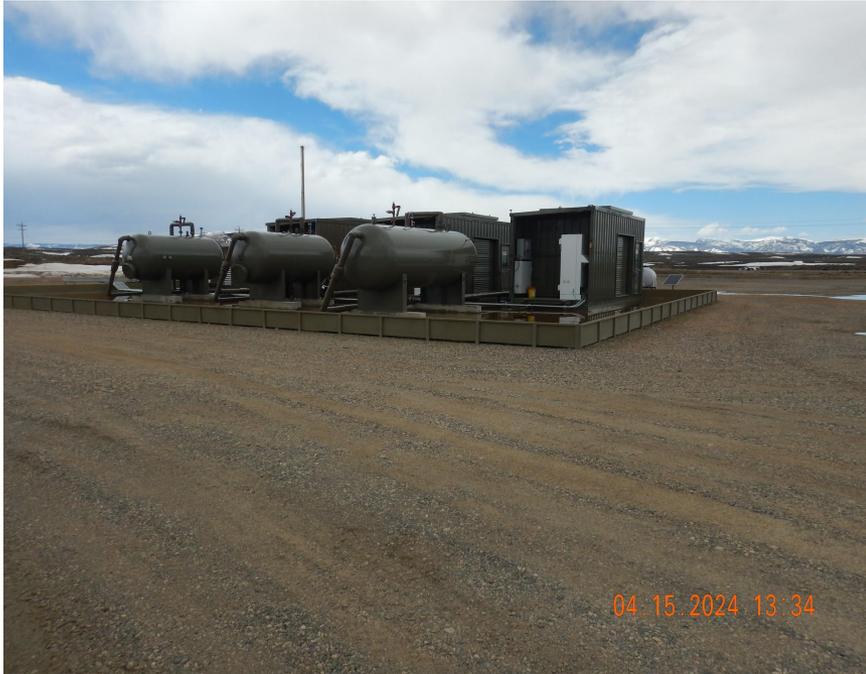
Photo 3. Photo taken from the southern location, facing North. Photo illustrates equipment along the central location.

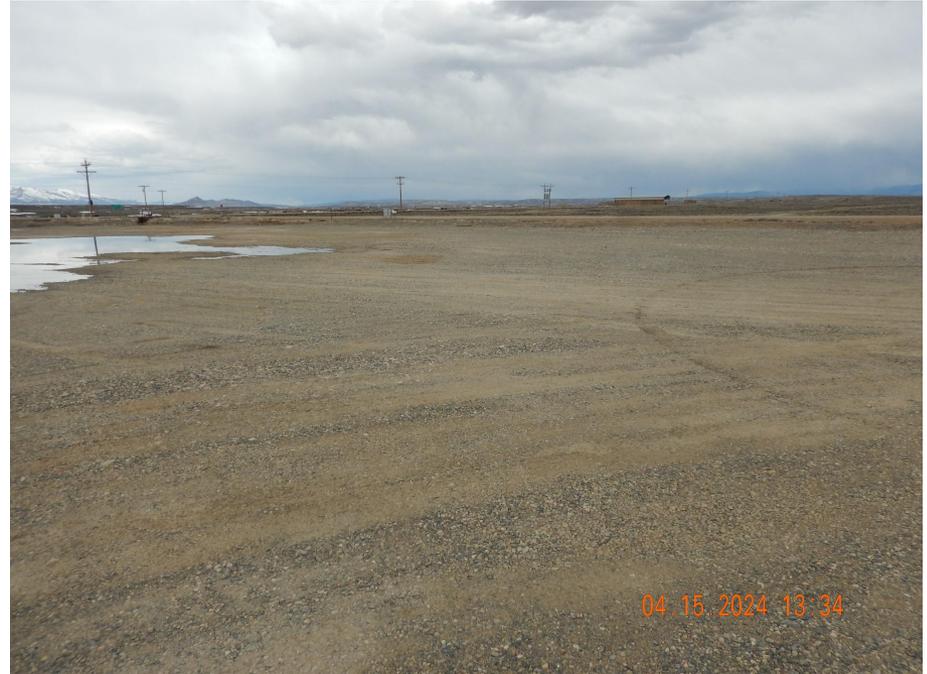
Photo 4. Photo taken from the southern location, facing Northeast. Photo illustrates the Operator has failed to perform interim reclamation and reduce the size of the location.

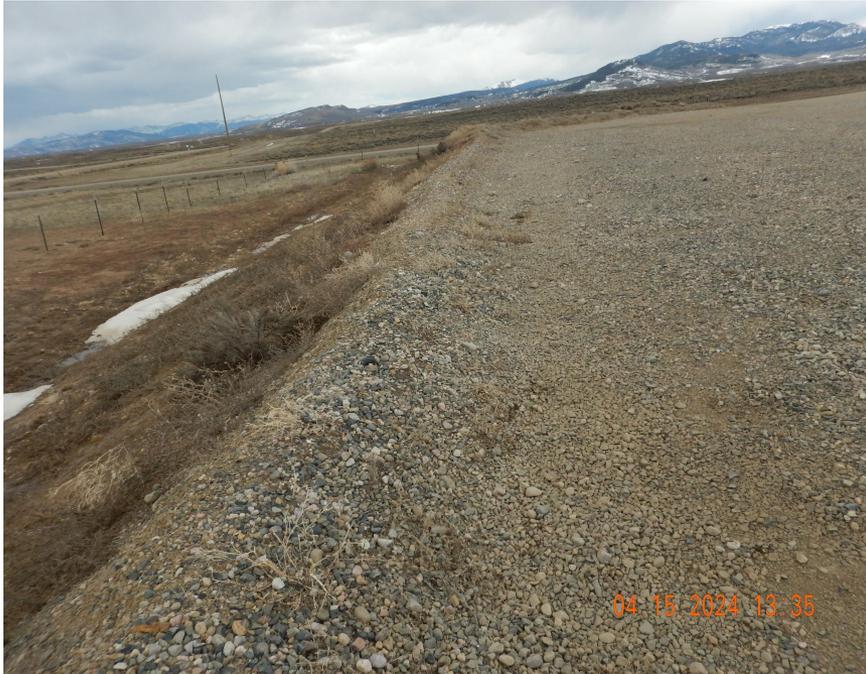
Photo 5. Photo taken from the eastern location, facing South. See comments under Photo 4. Note- there appears to be weed growth along the fill slope that will need to be managed in the future.

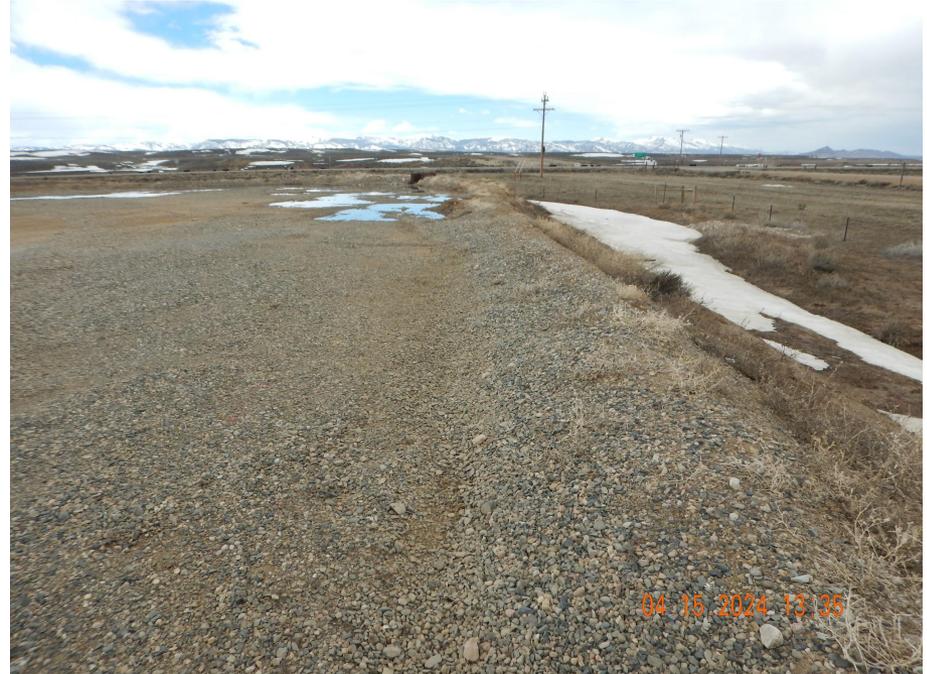
Photo 6. Photo taken from the eastern location, facing North. See comments under Photos 4 and 5.

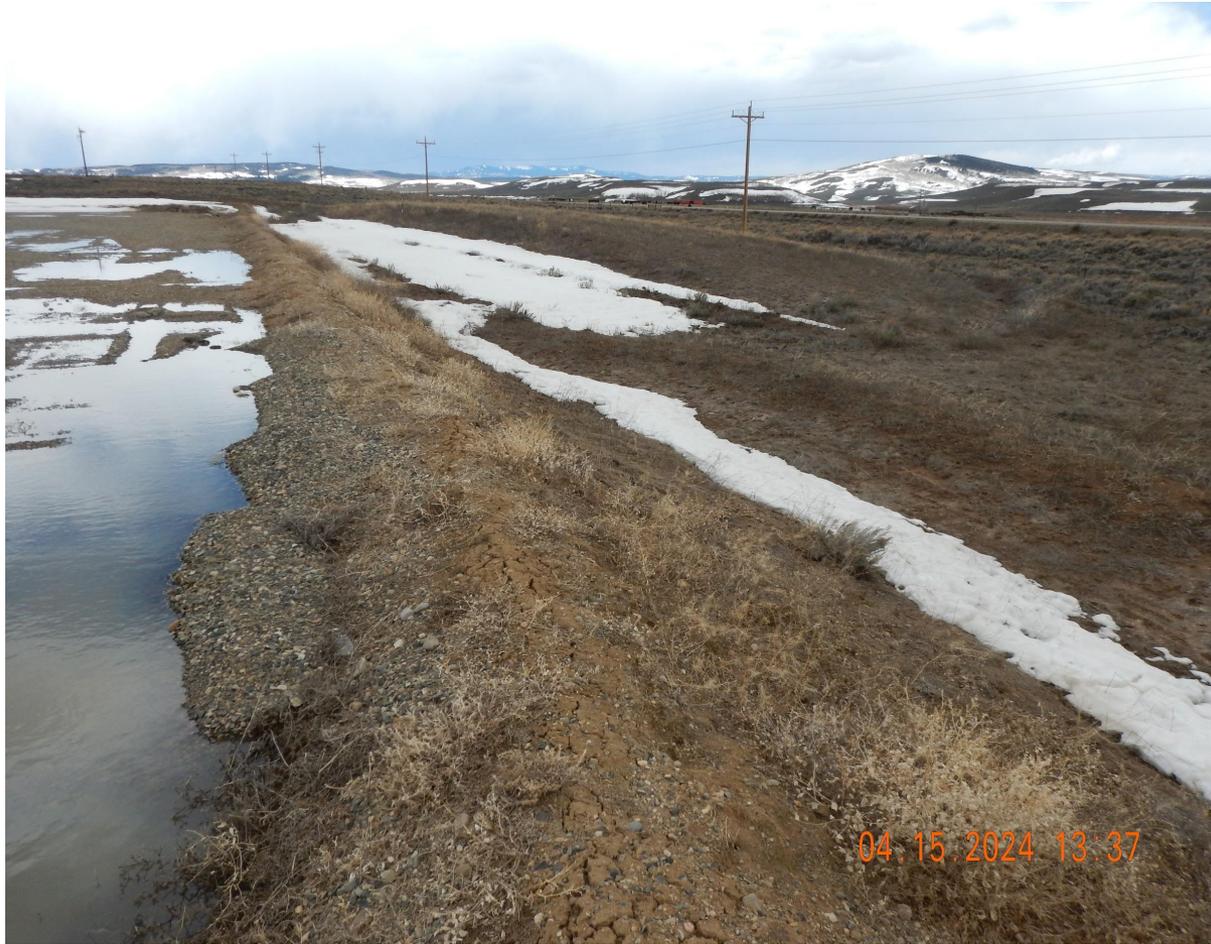
Photo 7. Photo taken from the northeastern location, facing West. Photo illustrates the topsoil stockpile which will need to be managed after interim reclamation is performed.

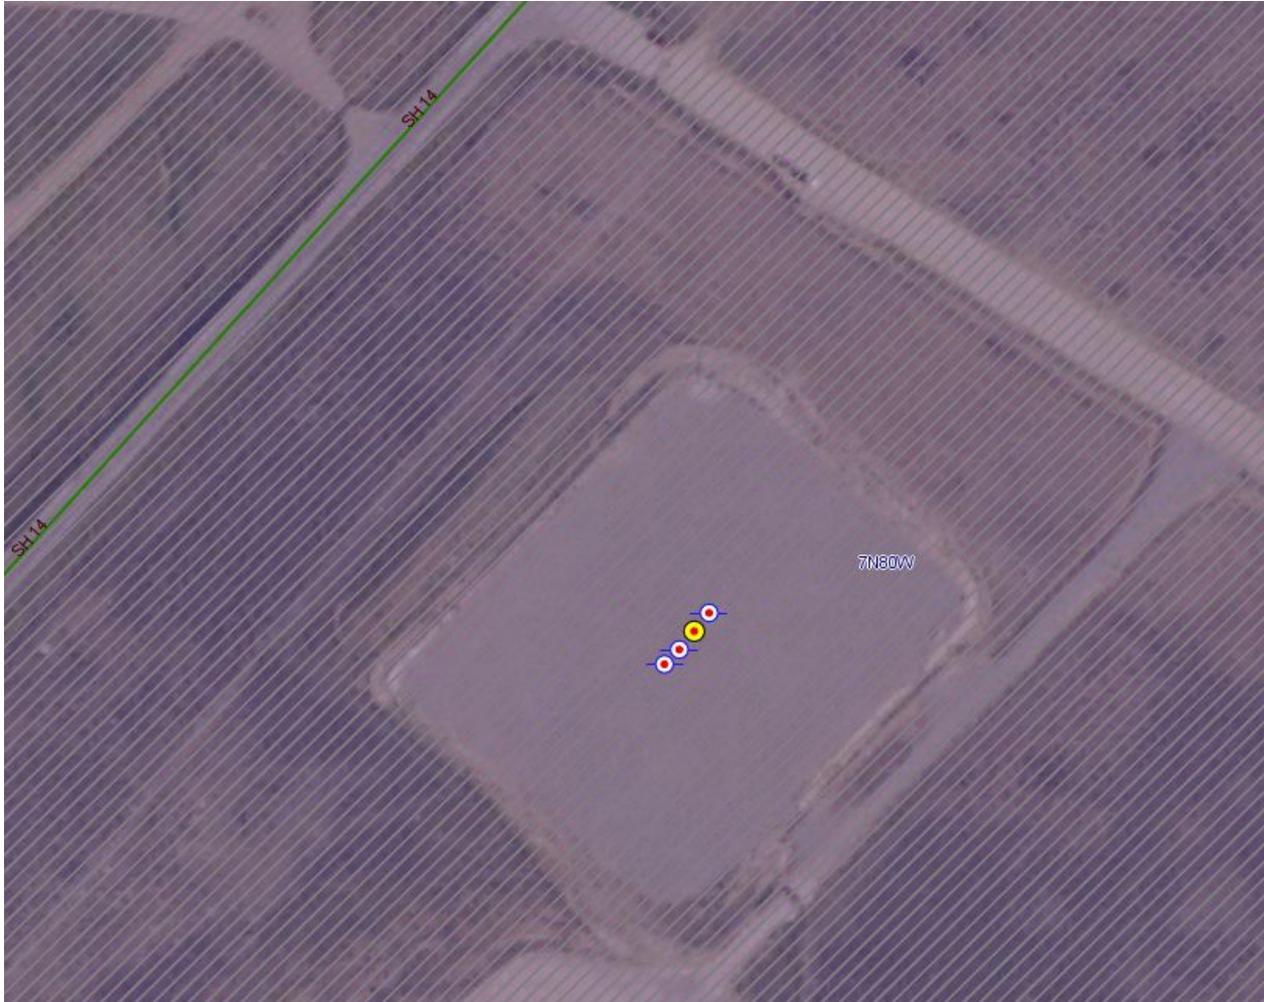
Photo 8. ECMC GIS aerial imagery illustrates the location falls within Greater Sage Grouse Priority Habitat Management Area.
