Interim Reclamation and Stormwater Inspection

Operator: FULCRUM ENERGY OPERATING LLC- #10805

Location ID: 416625

Inspection Photos
Location Name: Surprise-Damfino S6 Pad
Location ID: 416625

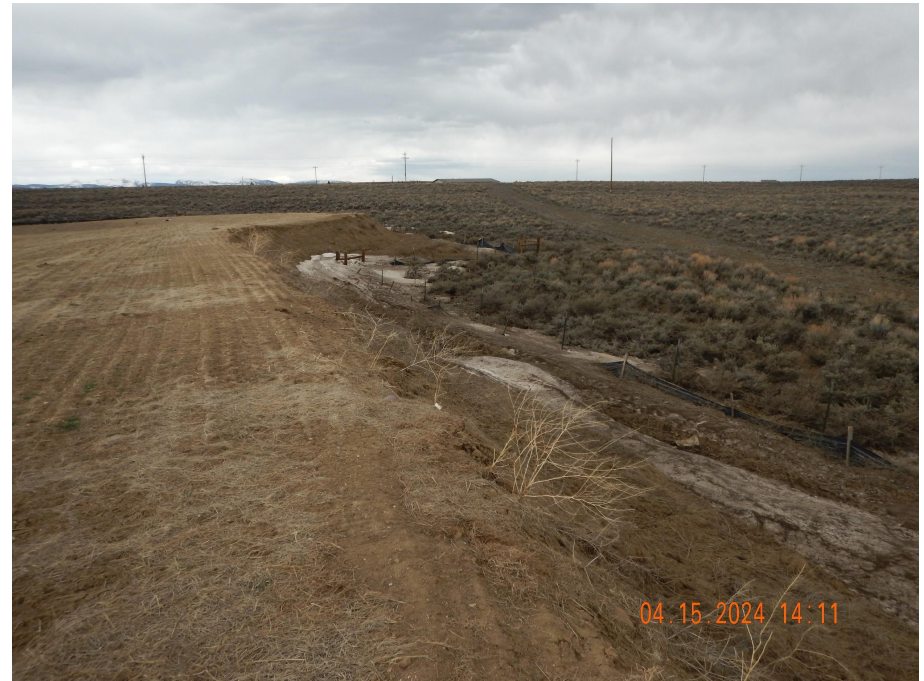
Photo 2. Photo taken from the eastern location, facing North. Photo illustrates the topsoil stockpile which has not been properly stabilized and the perimeter BMP has not been maintained.

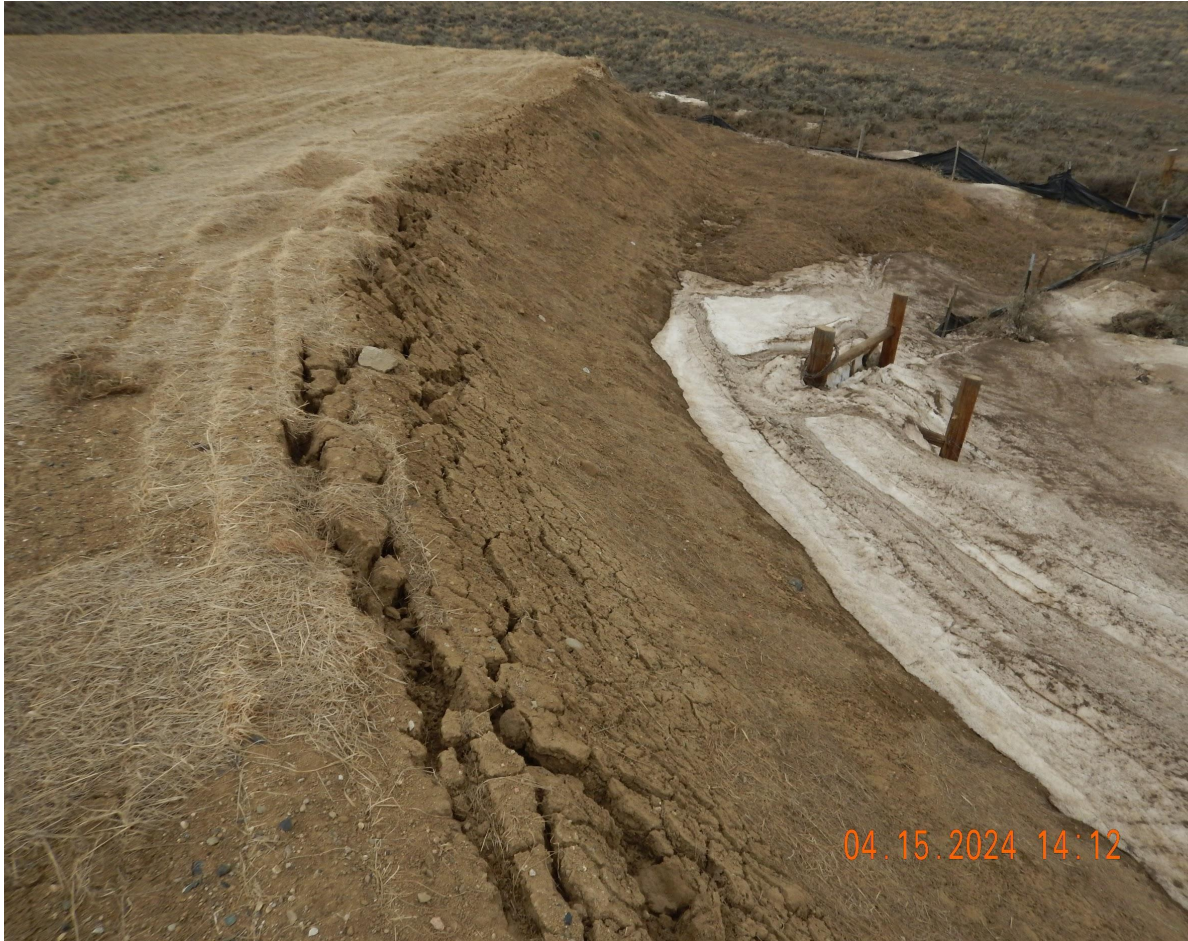
Photo 3. Photo taken from the eastern location, facing North. Photo illustrates the topsoil stockpile has not been properly stabilized and is eroding due to vertical slopes. The perimeter BMP does not appear to be an appropriate BMP given the snow accumulation in the winter months, which will continue to cause failures.

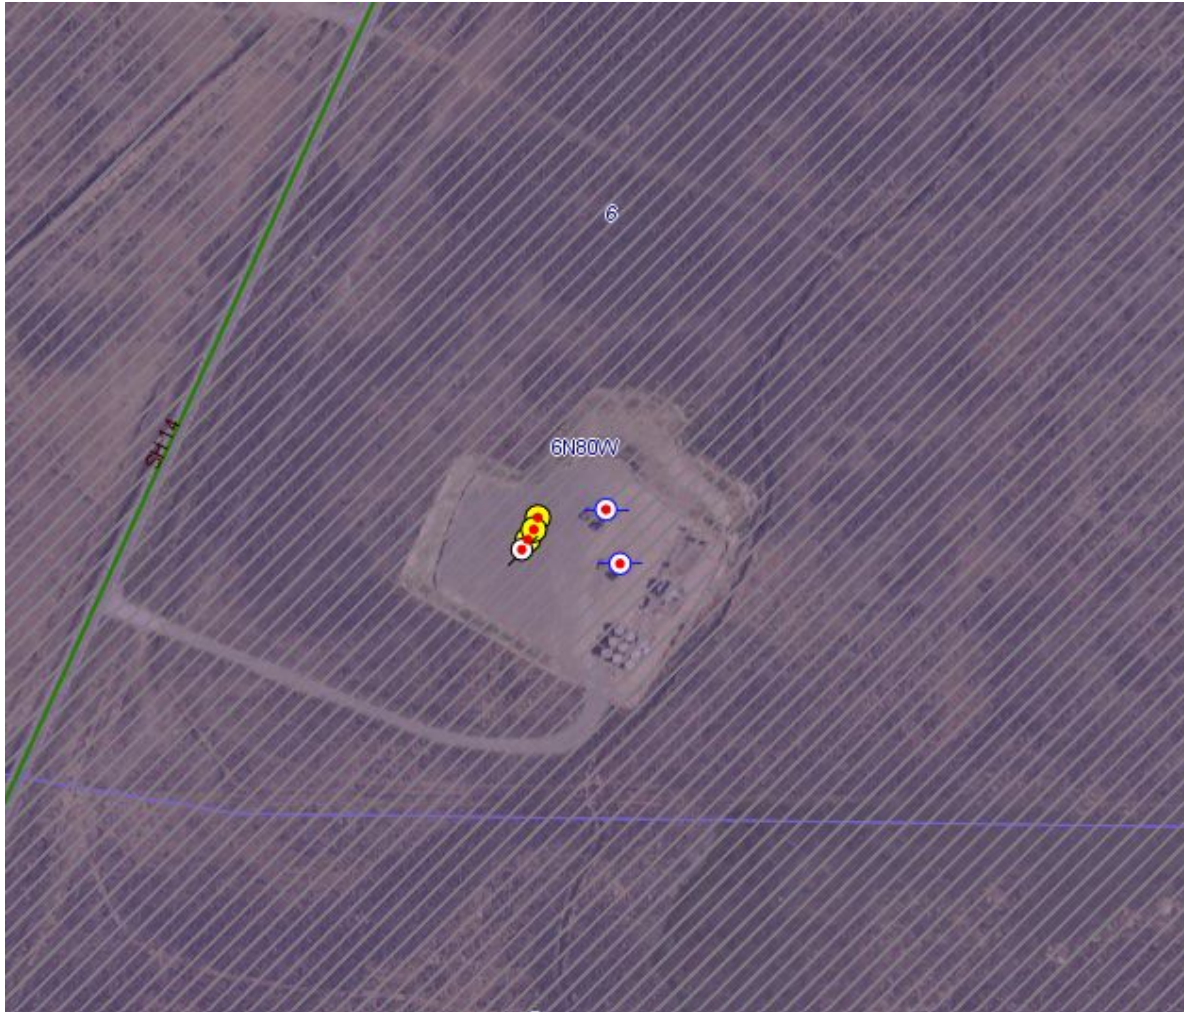
Photo 4. ECMC GIS aerial imagery illustrates the location falls within Greater Sage Grouse Priority Habitat Management Area.
