Operator: CRESTONE PEAK RESOURCES OPERATING LLC

Location Name: ARISTOCRAT ANGUS-63N65W 4SWSW

Loc ID: 333169

Inspection: 714200948

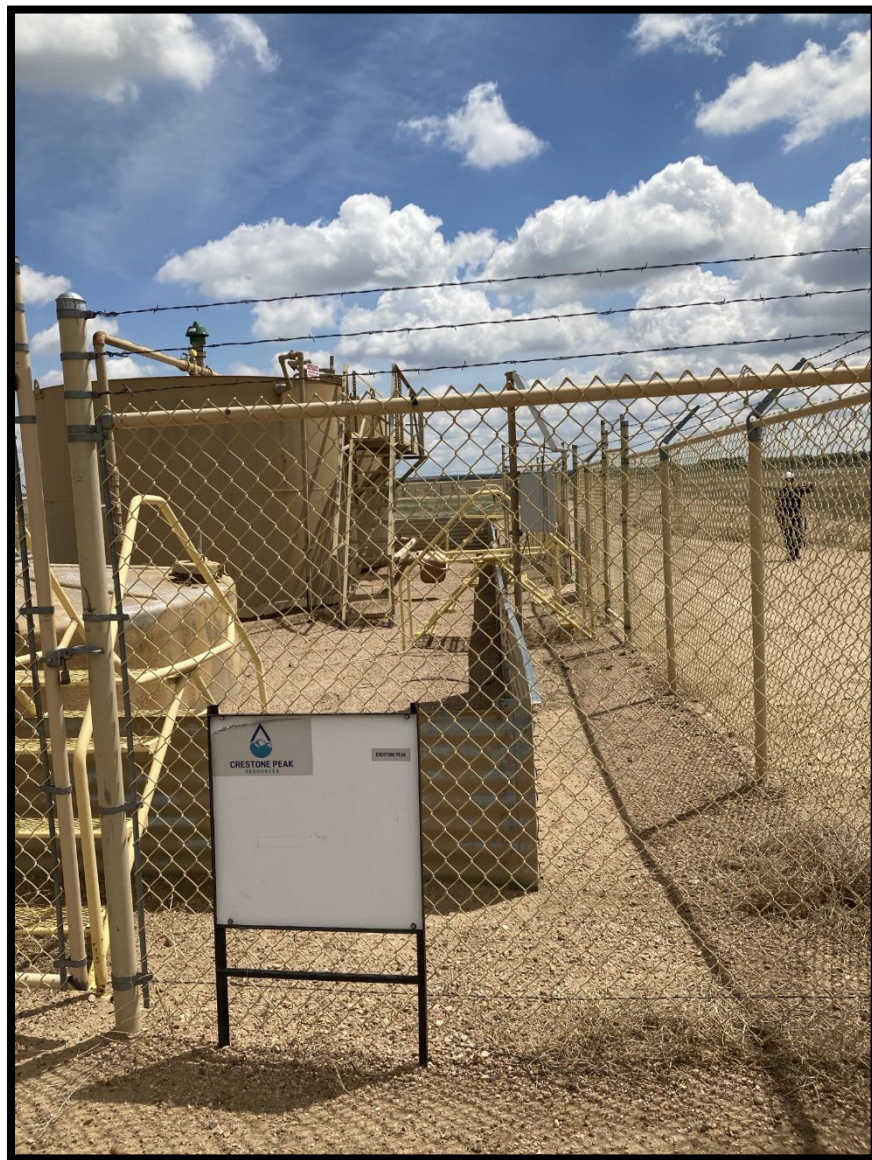
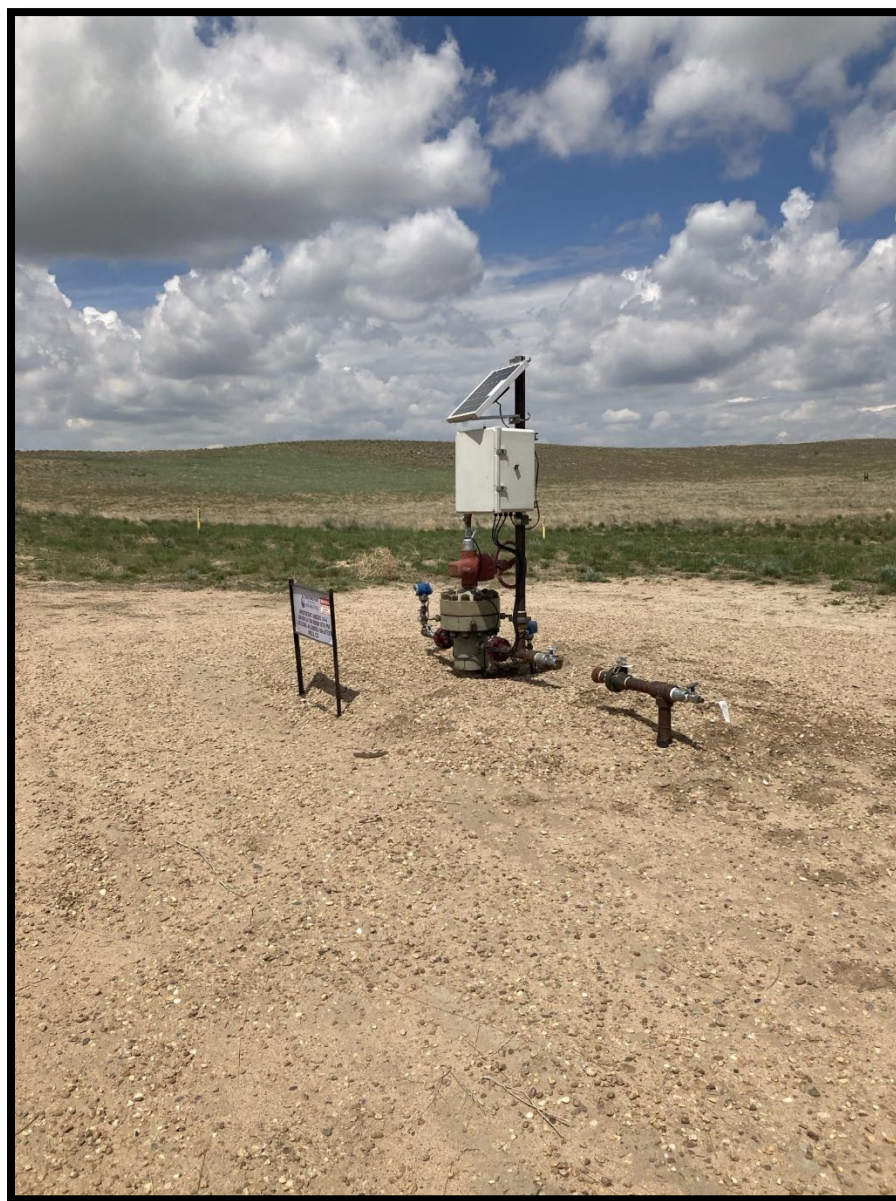
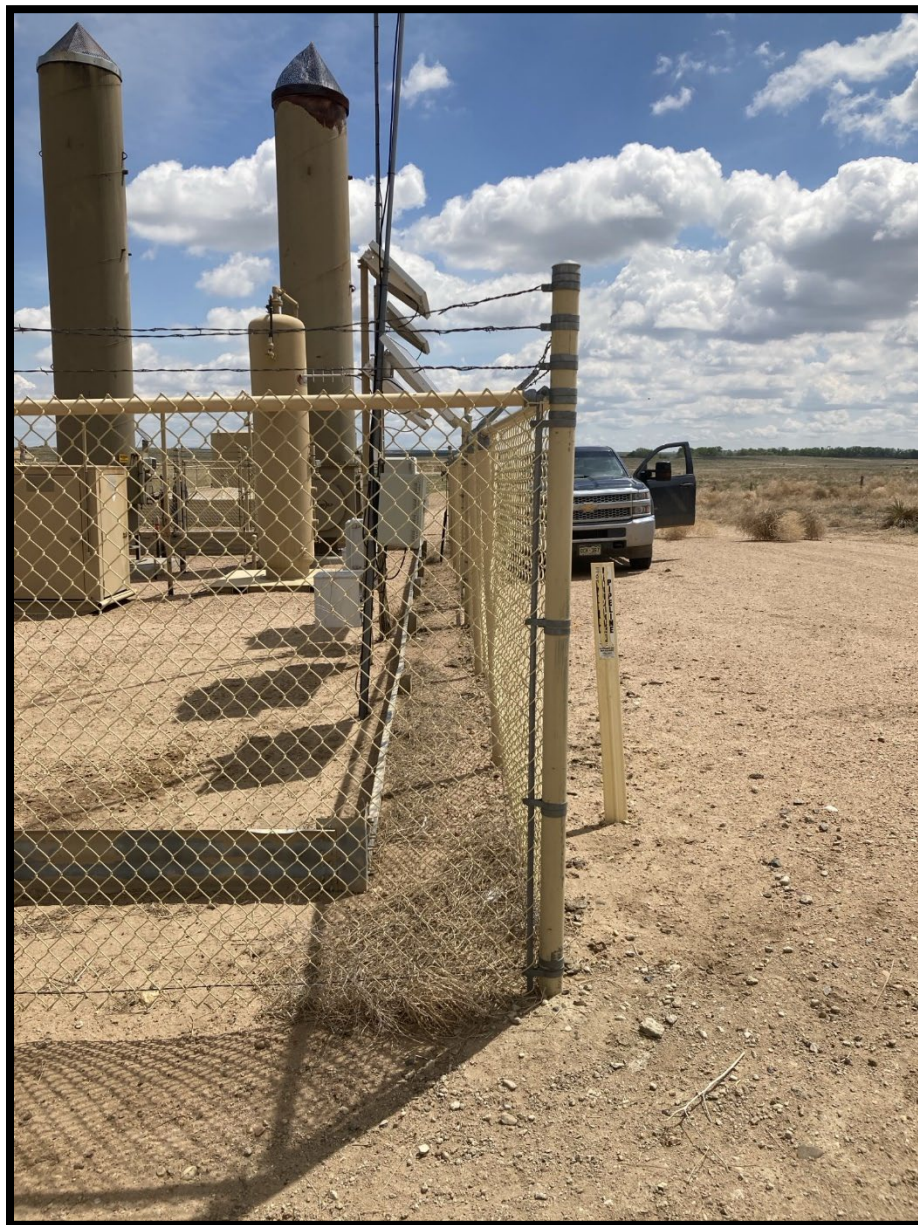
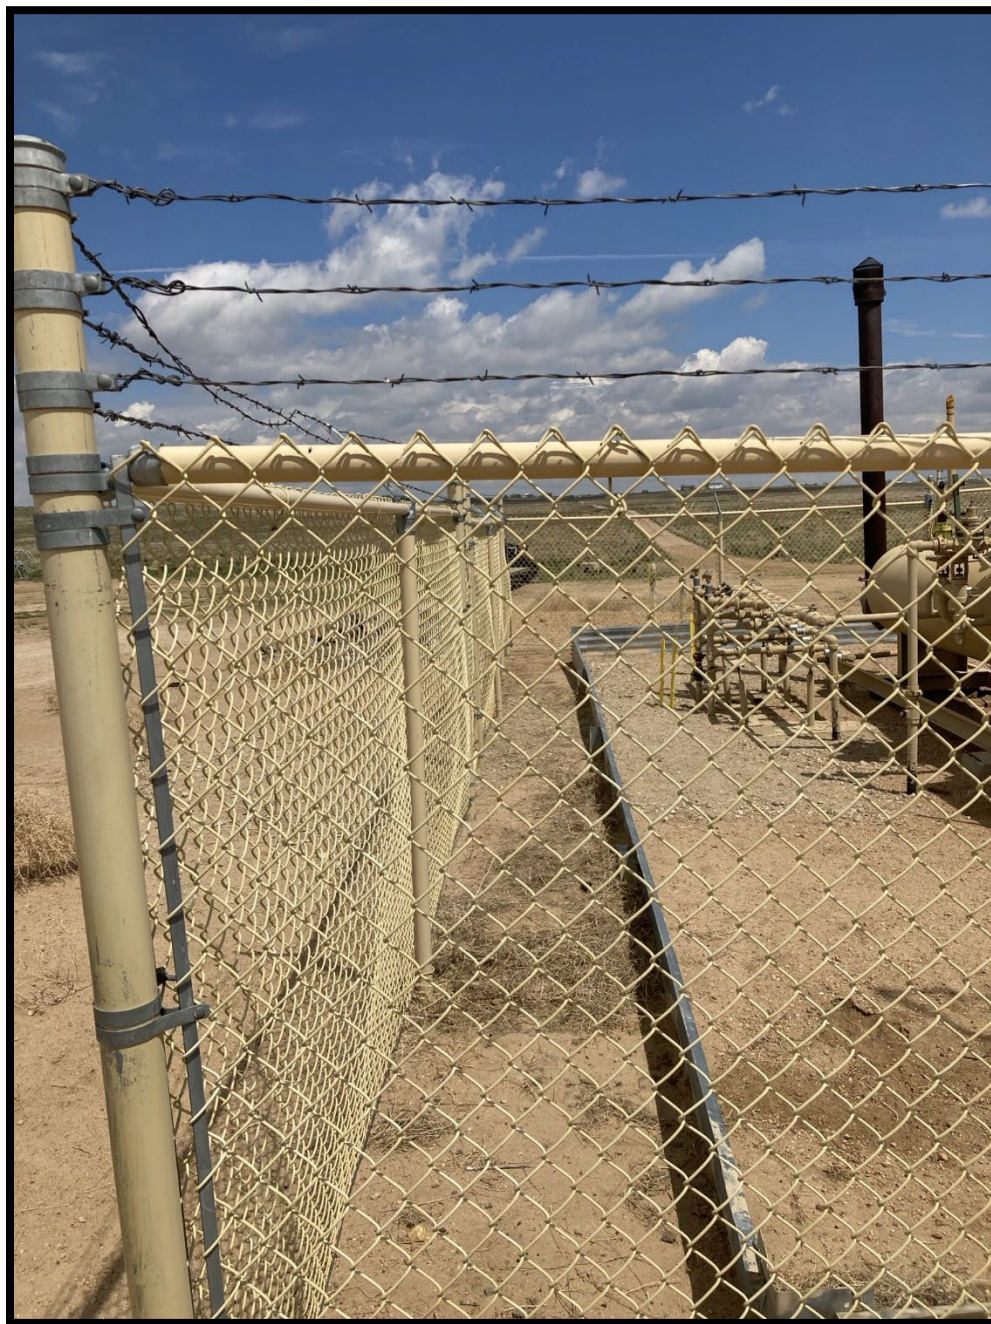
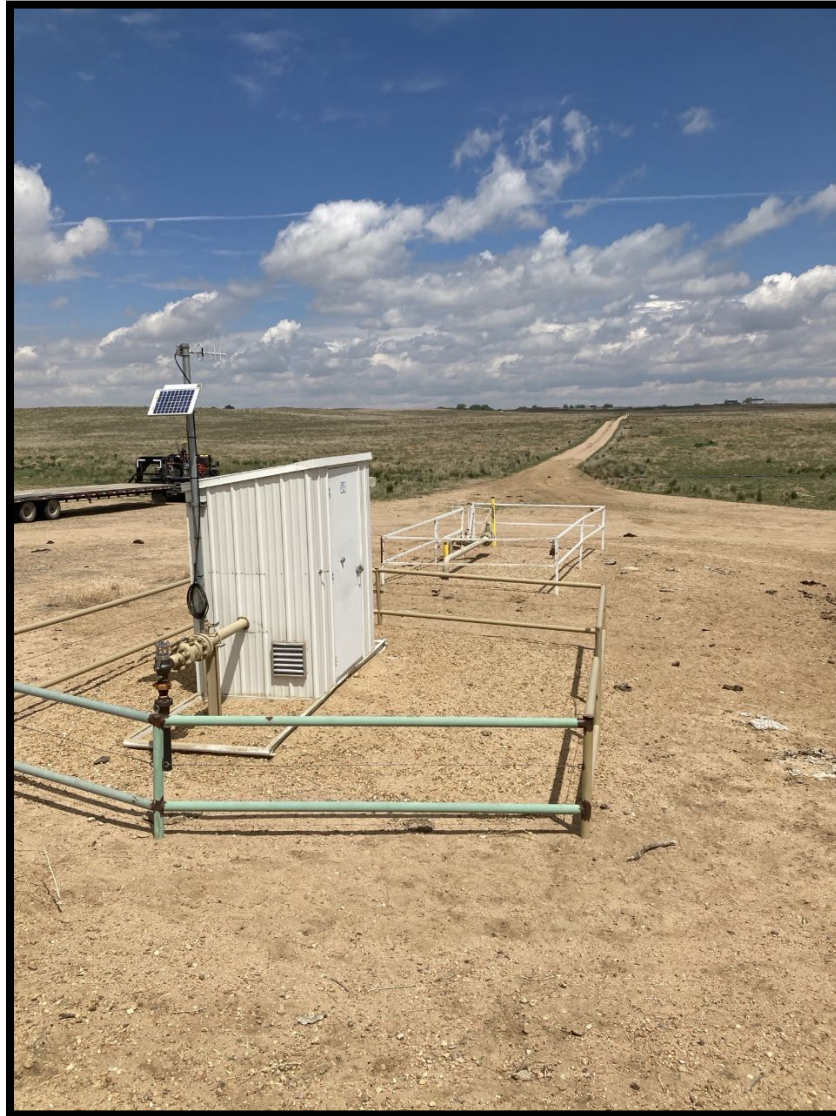
CA: Debris on various areas of location. See attached photos. Comply with Rule 606.

CA Resolution: Operator has reported that the location has been appropriately cleared of identified debris, trash and tumbleweeds to comply with Rule 606.

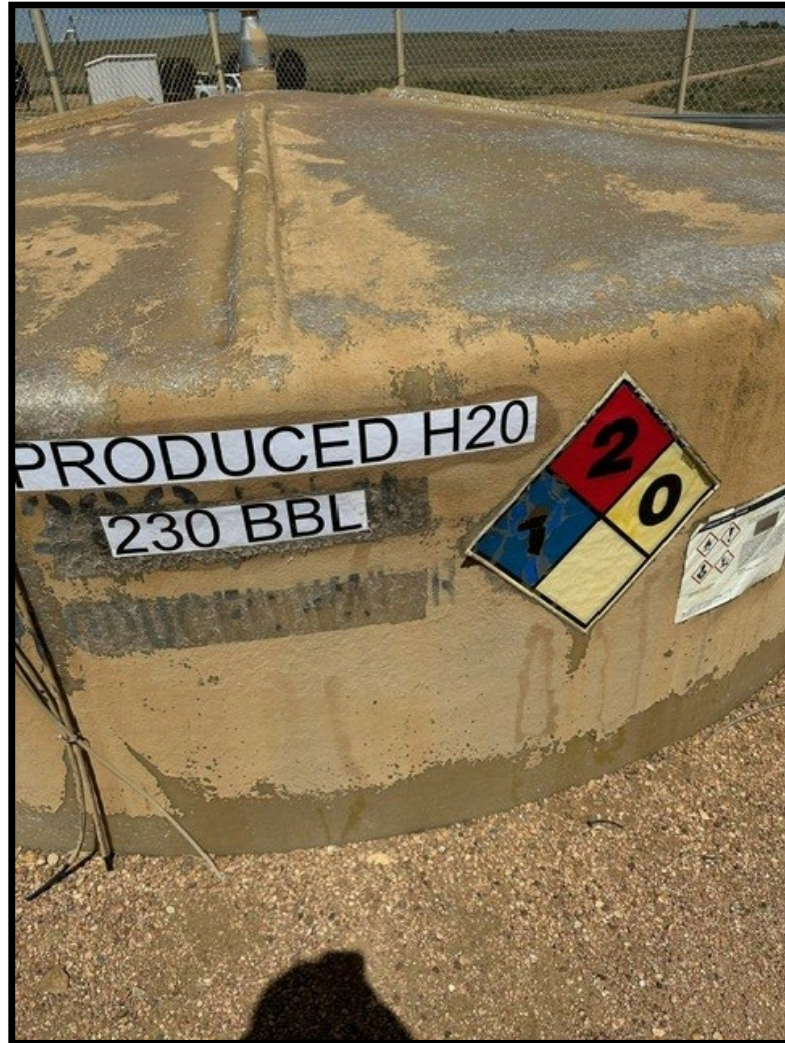
Exhibit A

CA: Capacity/contents are no longer legible on one tank. See attached photos. Comply with Rule 605.

CA Resolution: Operator has reported that capacity and content signage on identified tank has been updated to comply with Rule 605.
