Inspection Photos

Operator: GUNNISON ENERGY LLC #10515

Location ID: 324485

Inspection Doc: 696205822

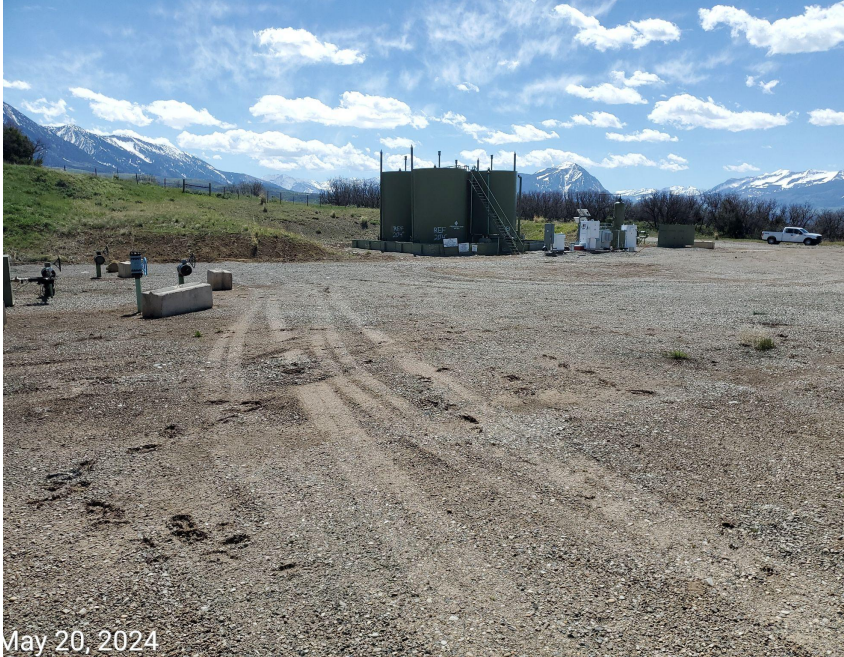
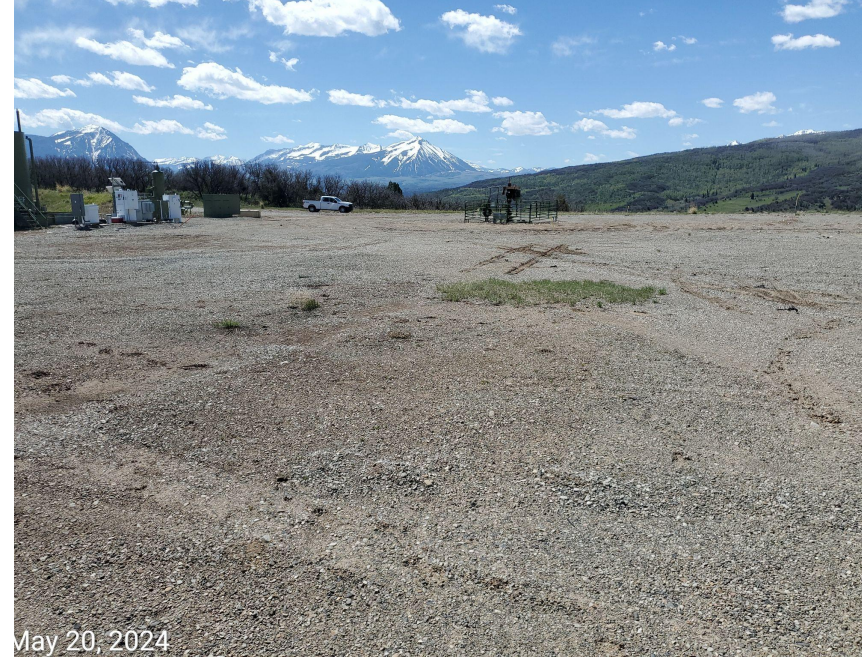
Photo 1: Photos 1-2 taken from the north end of the working pad surface. Photos provide an overview of the Location from east, southeast, southwest and west. Photos also show interim reclamation to reduce the Location to areas only needed for production has not been performed in accordance with 1003 Rules.

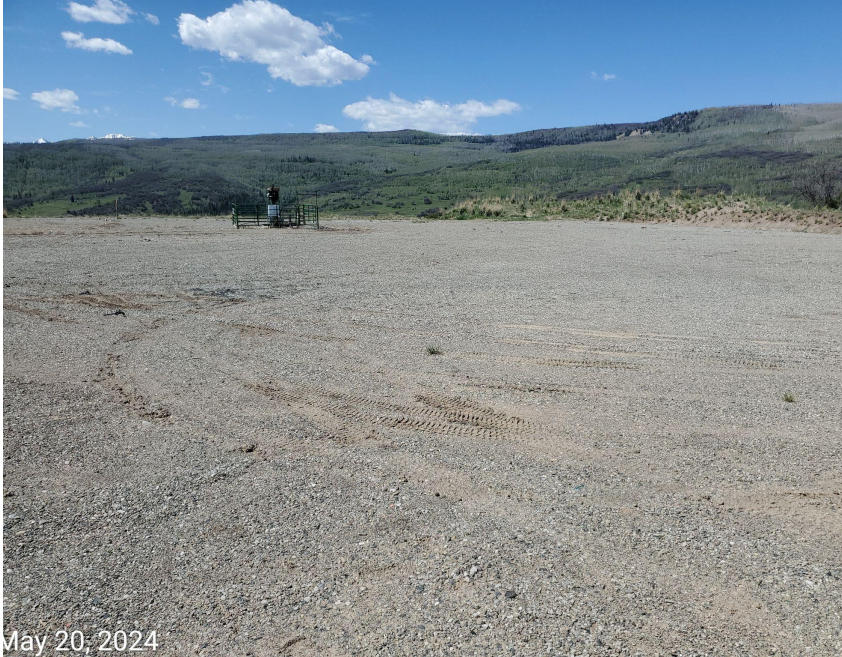
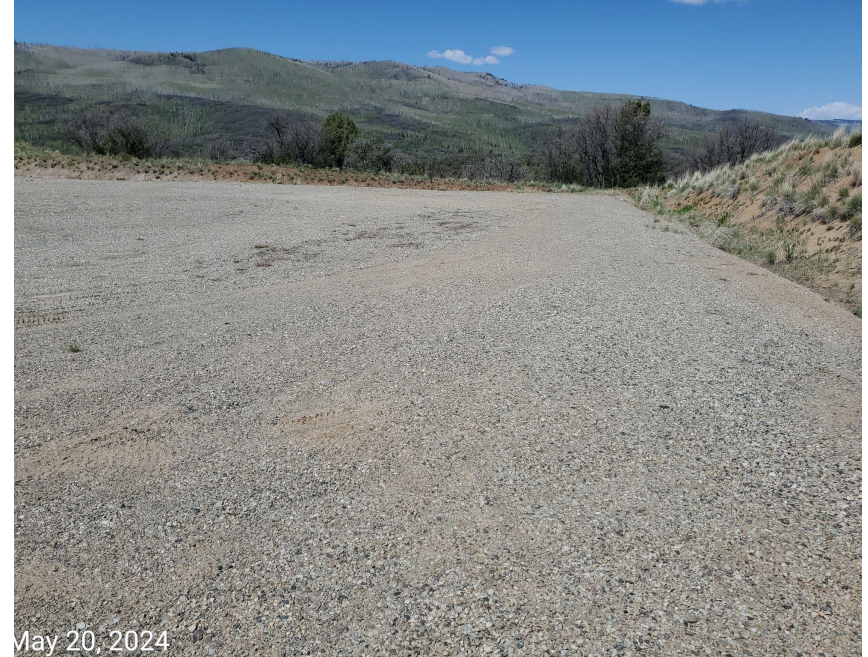
Photo 2: See comments under photo 1.

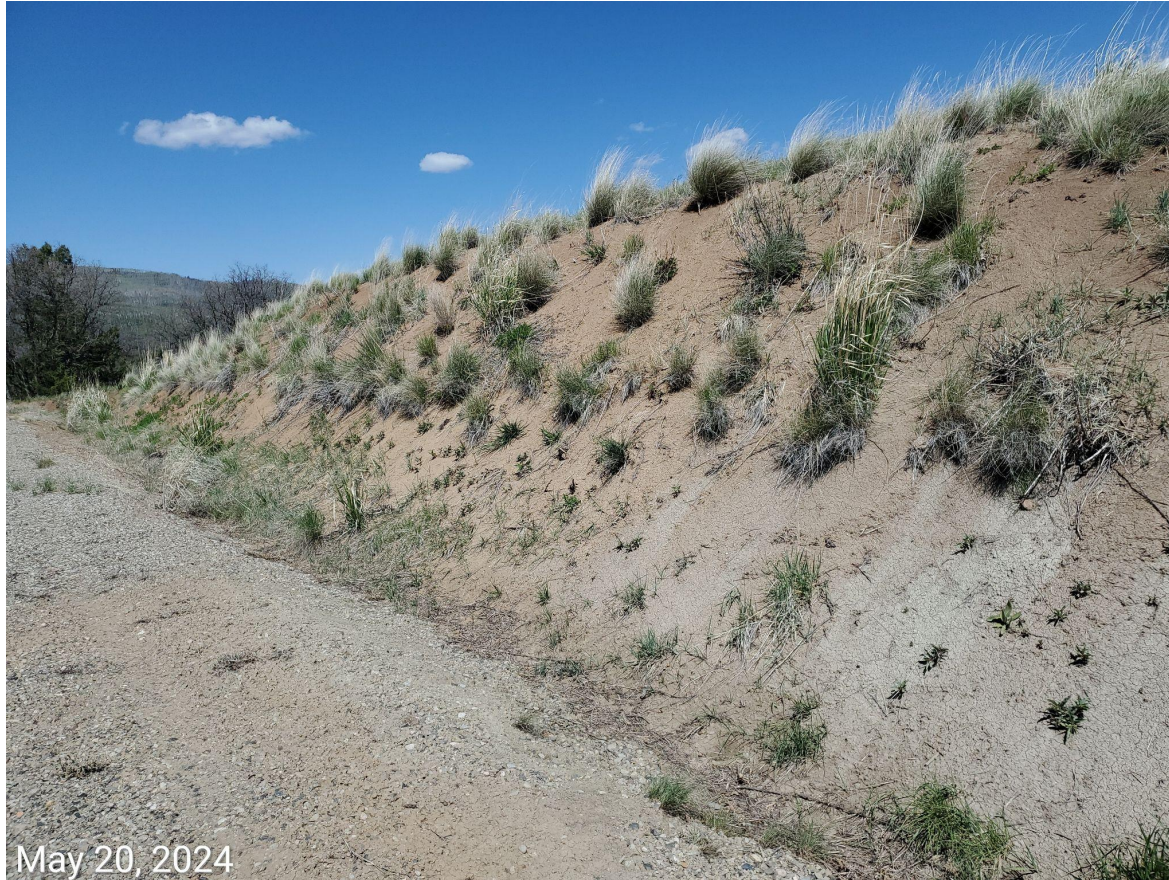
Photo 3: Photo taken from the Topsoil stockpile on the northwest end of the Location. BMPs to stabilize soils are missing or insufficient; soils are bare and at risk to wind and water erosion.

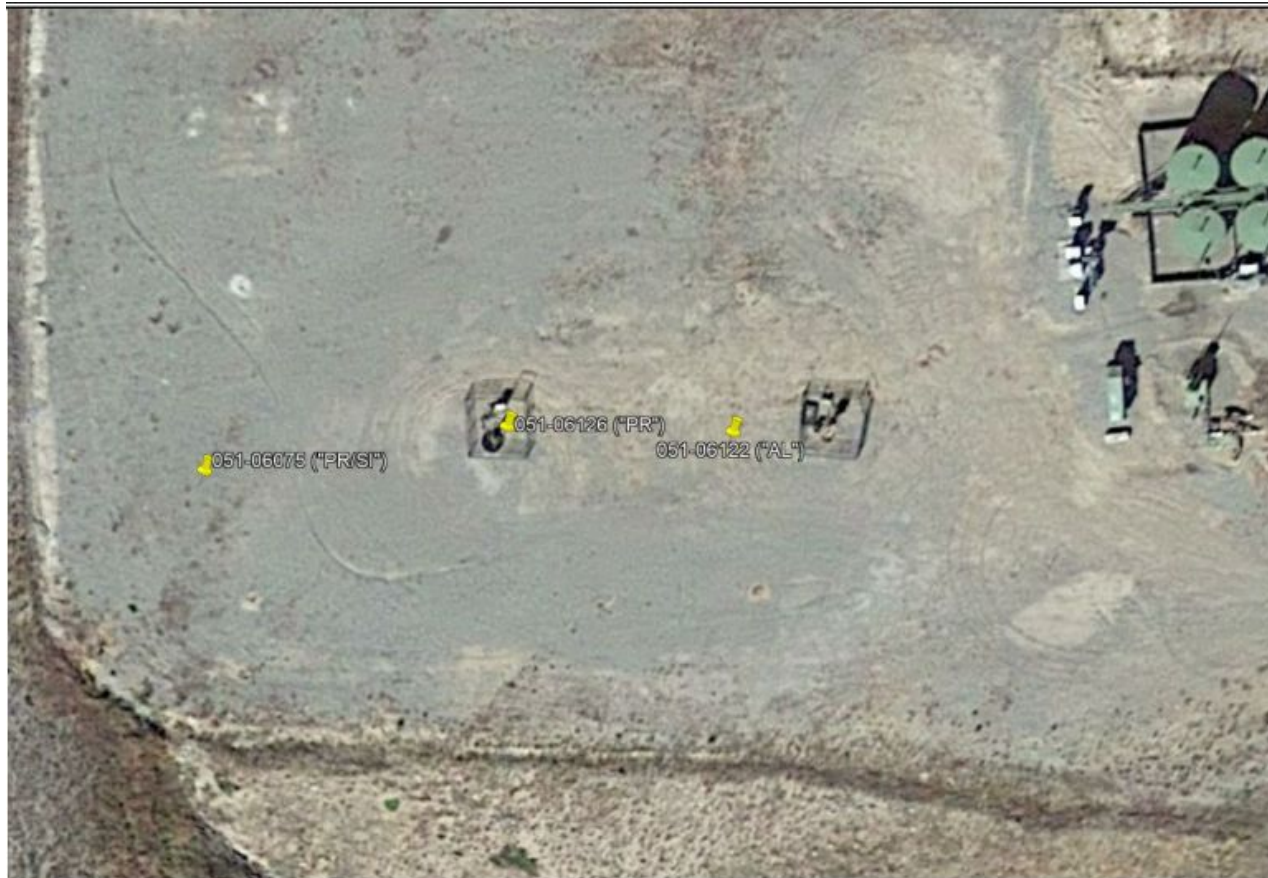
Photo 4: Image from doc. 696205083. Photo a Google Earth aerial image of the Location. Photo shows well coordinates from the Scout Cards; as drilled coordinates for Well API 051-06075 incorrect; coordinates for the abandoned Well API 051-06122 also incorrect.
