Operator: CRESTONE PEAK RESOURCES OPERATING LLC

Location Name: ARISTOCRAT ANGUS 63N65W 4SESW MULTI WELL PAD

Loc ID: 332754

Inspection: 714200947

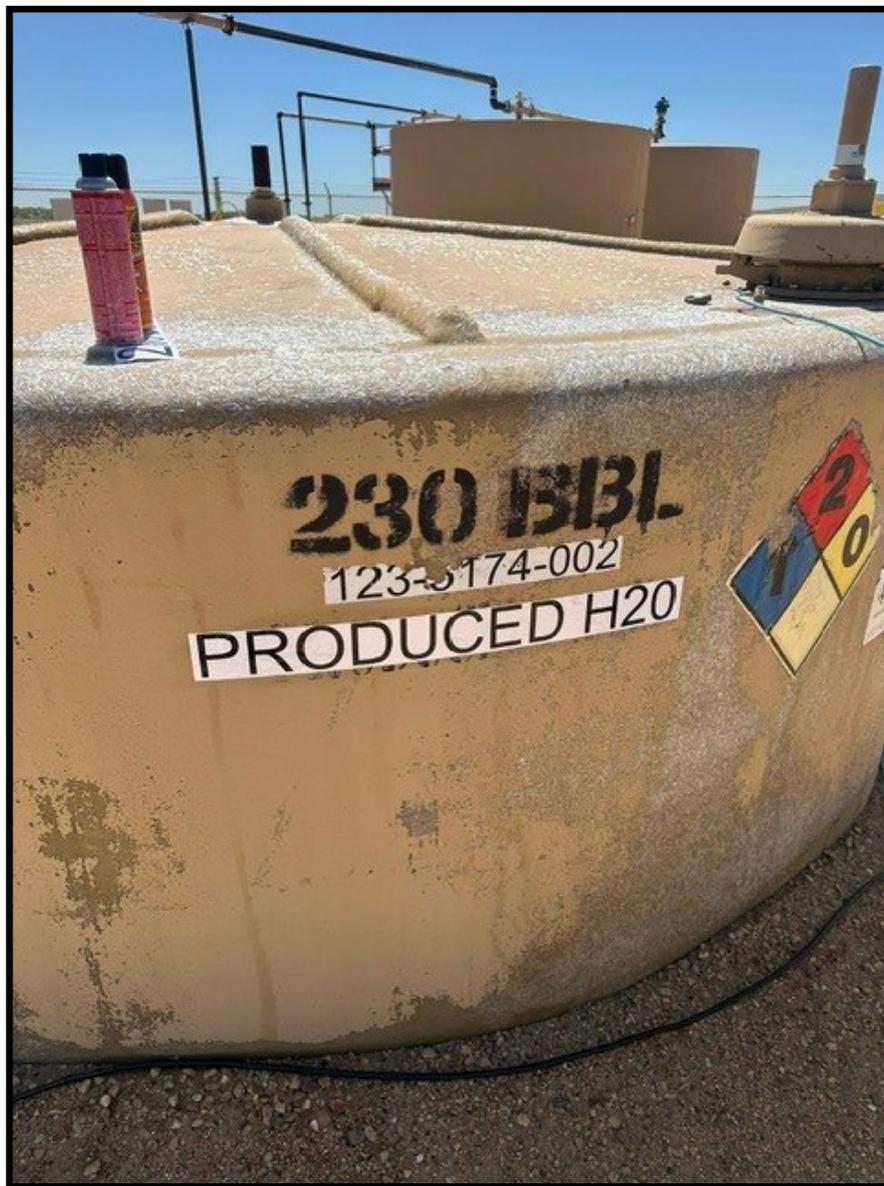
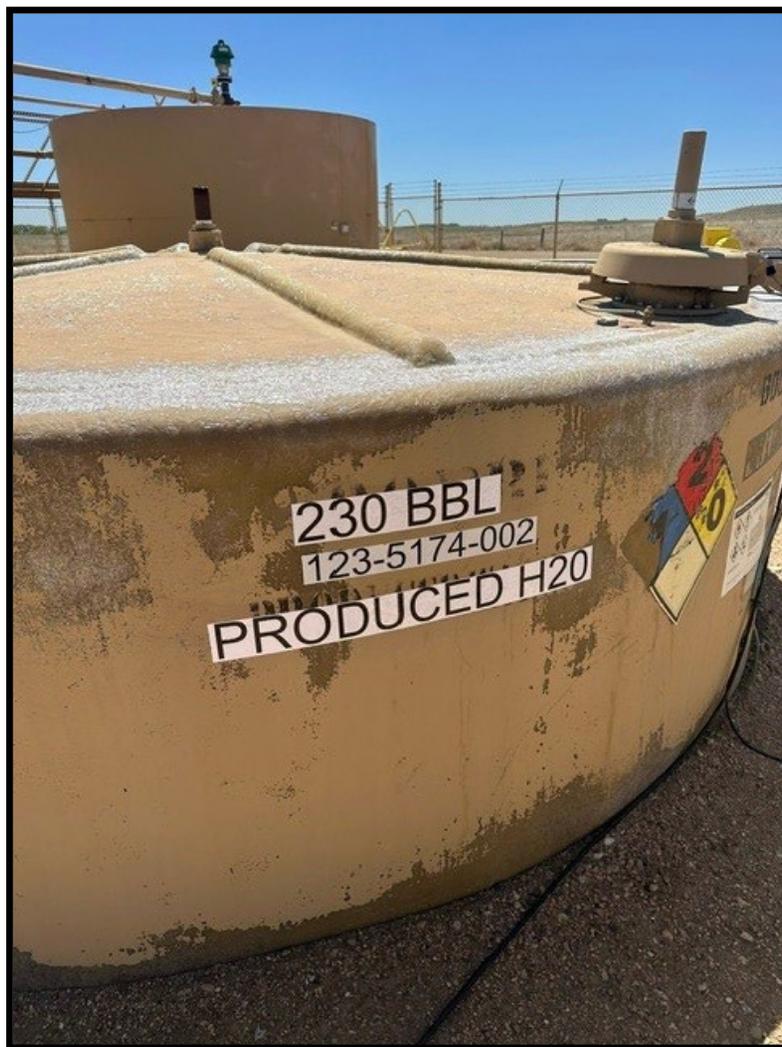
Exhibit A

CA: It appears contents/capacity is no longer legible on two tanks. See attached photos. Comply with Rule 605.h.

CA Resolution: Operator has reported that capacity and content signage has been updated on the identified tanks to comply with Rule 605.h.

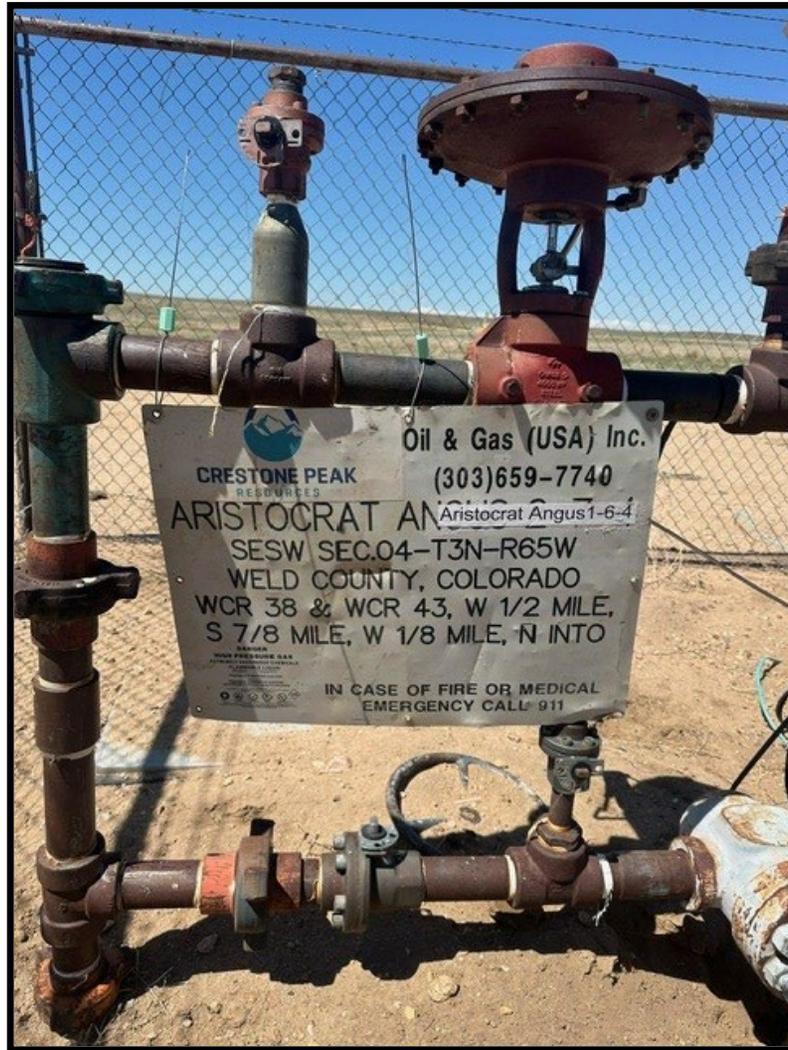
Exhibit A

CA: One wellhead has incorrect signage. See attached photo. Comply with Rule 605.d.

CA Resolution: Operator has updated sign with WH label, while waiting for permanent sign to comply with Rule 605.d.

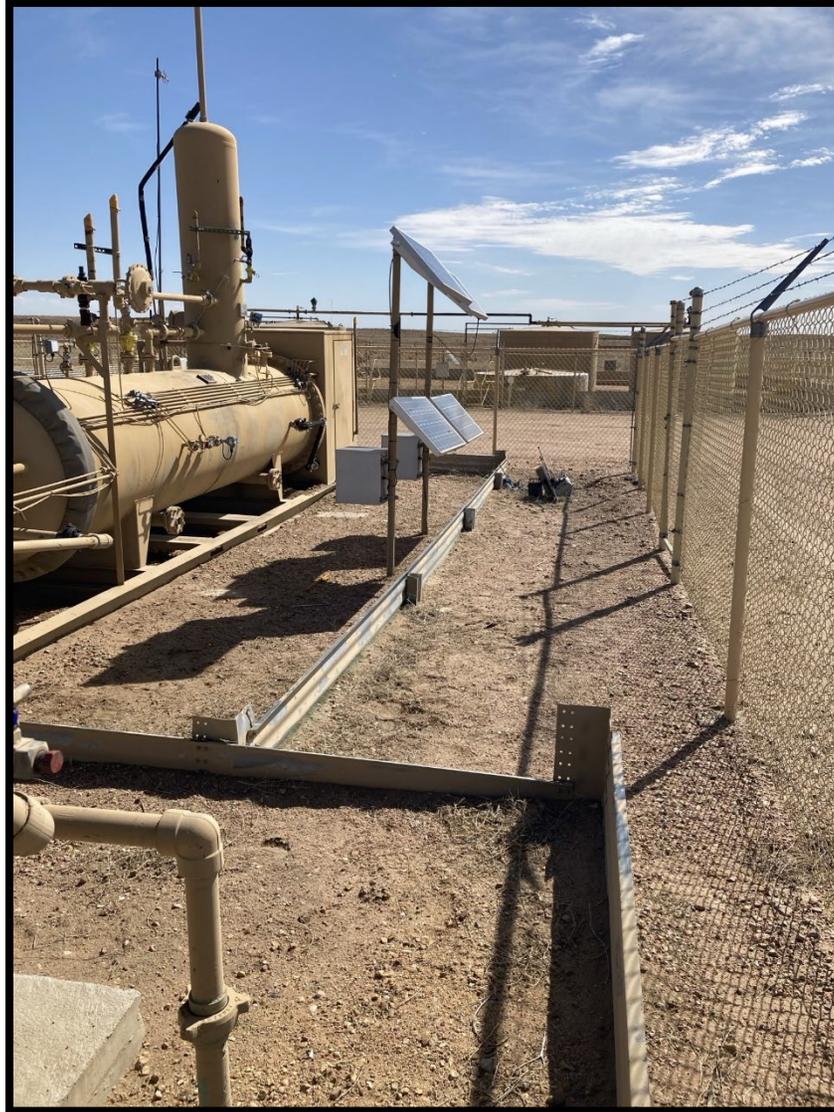
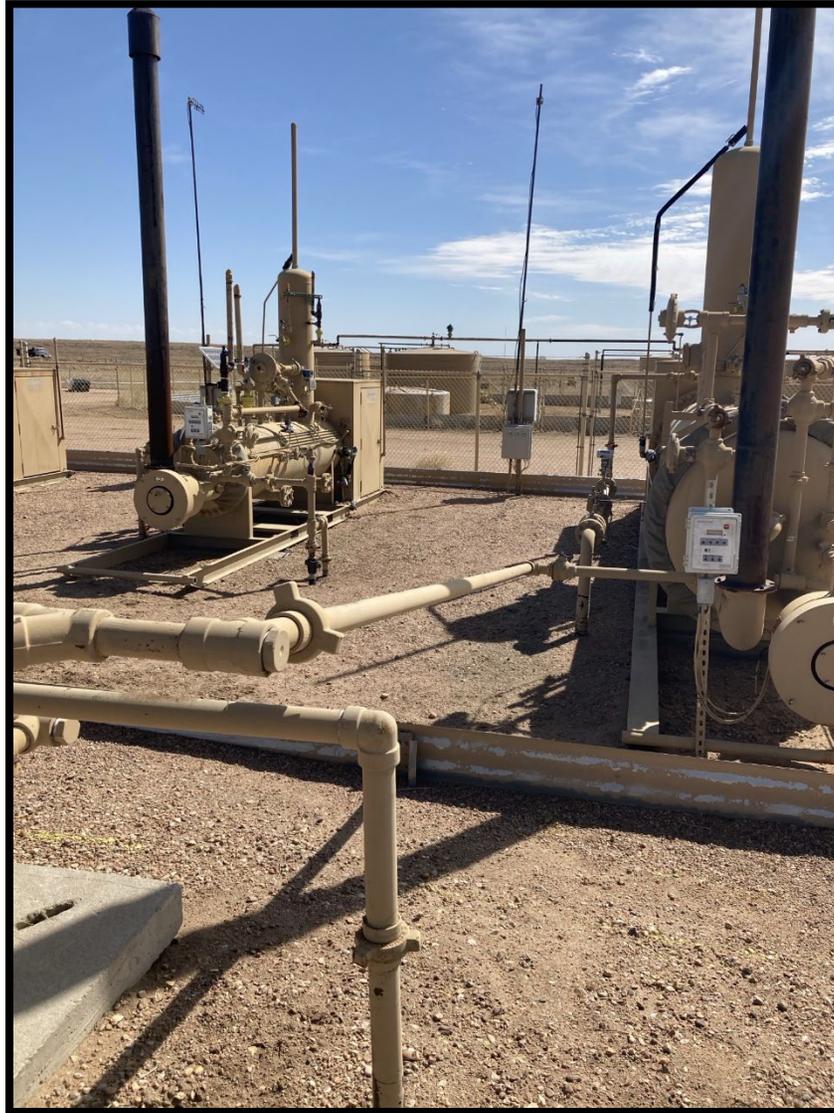
Exhibit A

CA: Debris on various areas on location. See attached photos. Comply with Rule 606.

CA Resolution: Operator has reported that the location has been appropriately cleared of identified debris, trash and tumbleweeds to comply with Rule 606.
