Inspection Photos

API: 017-06632

Operator: **WILLIFORD ENERGY COMPANY**

Inspection Date: 5/30/2024

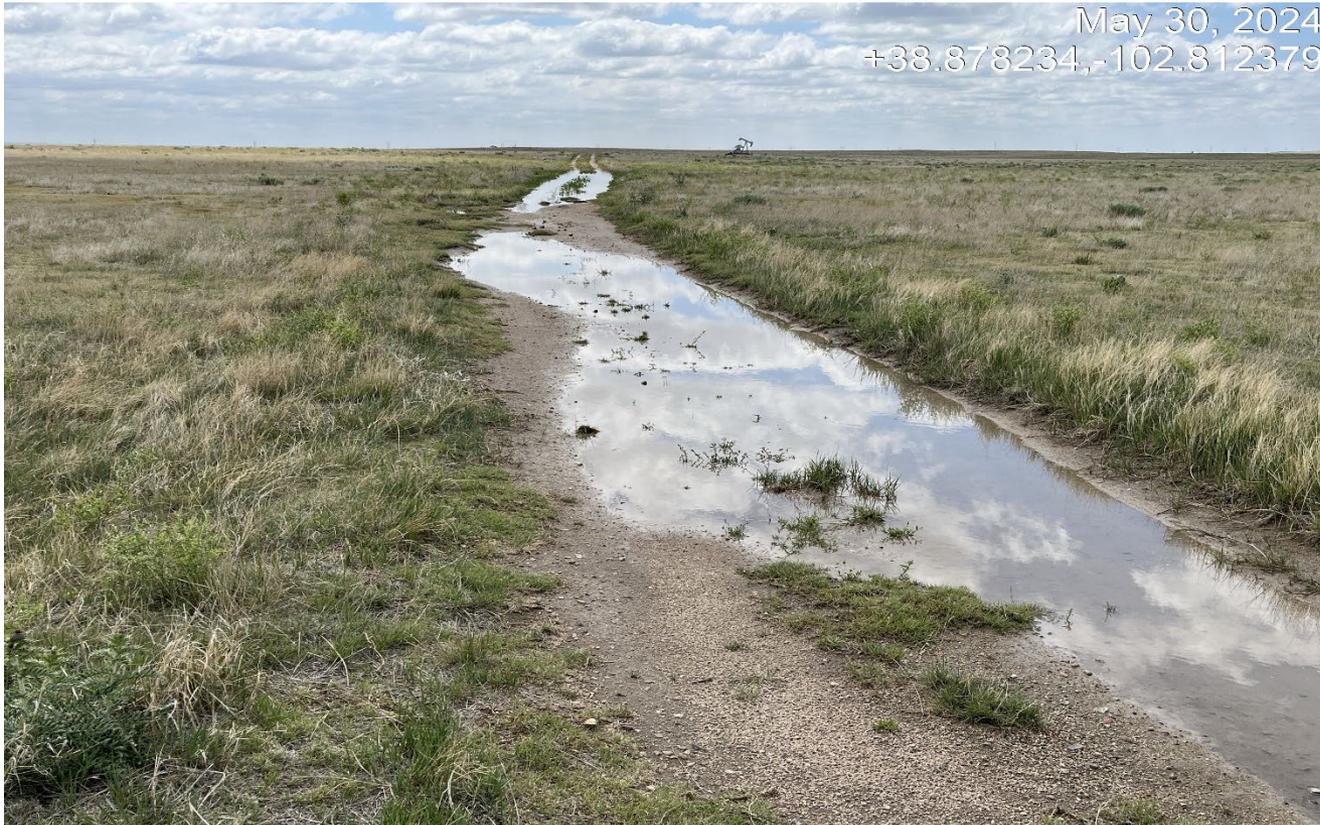
Photo 1. Facing southeast toward the access road. The access road was inaccessible due to water pooling on the road. The road needs to be built up with road base to allow proper stormwater drainage.
