# Inspection Photos

Operator: Dugan Production Corporation - 25250

Location ID: 385591

Inspection Document #: 714000813

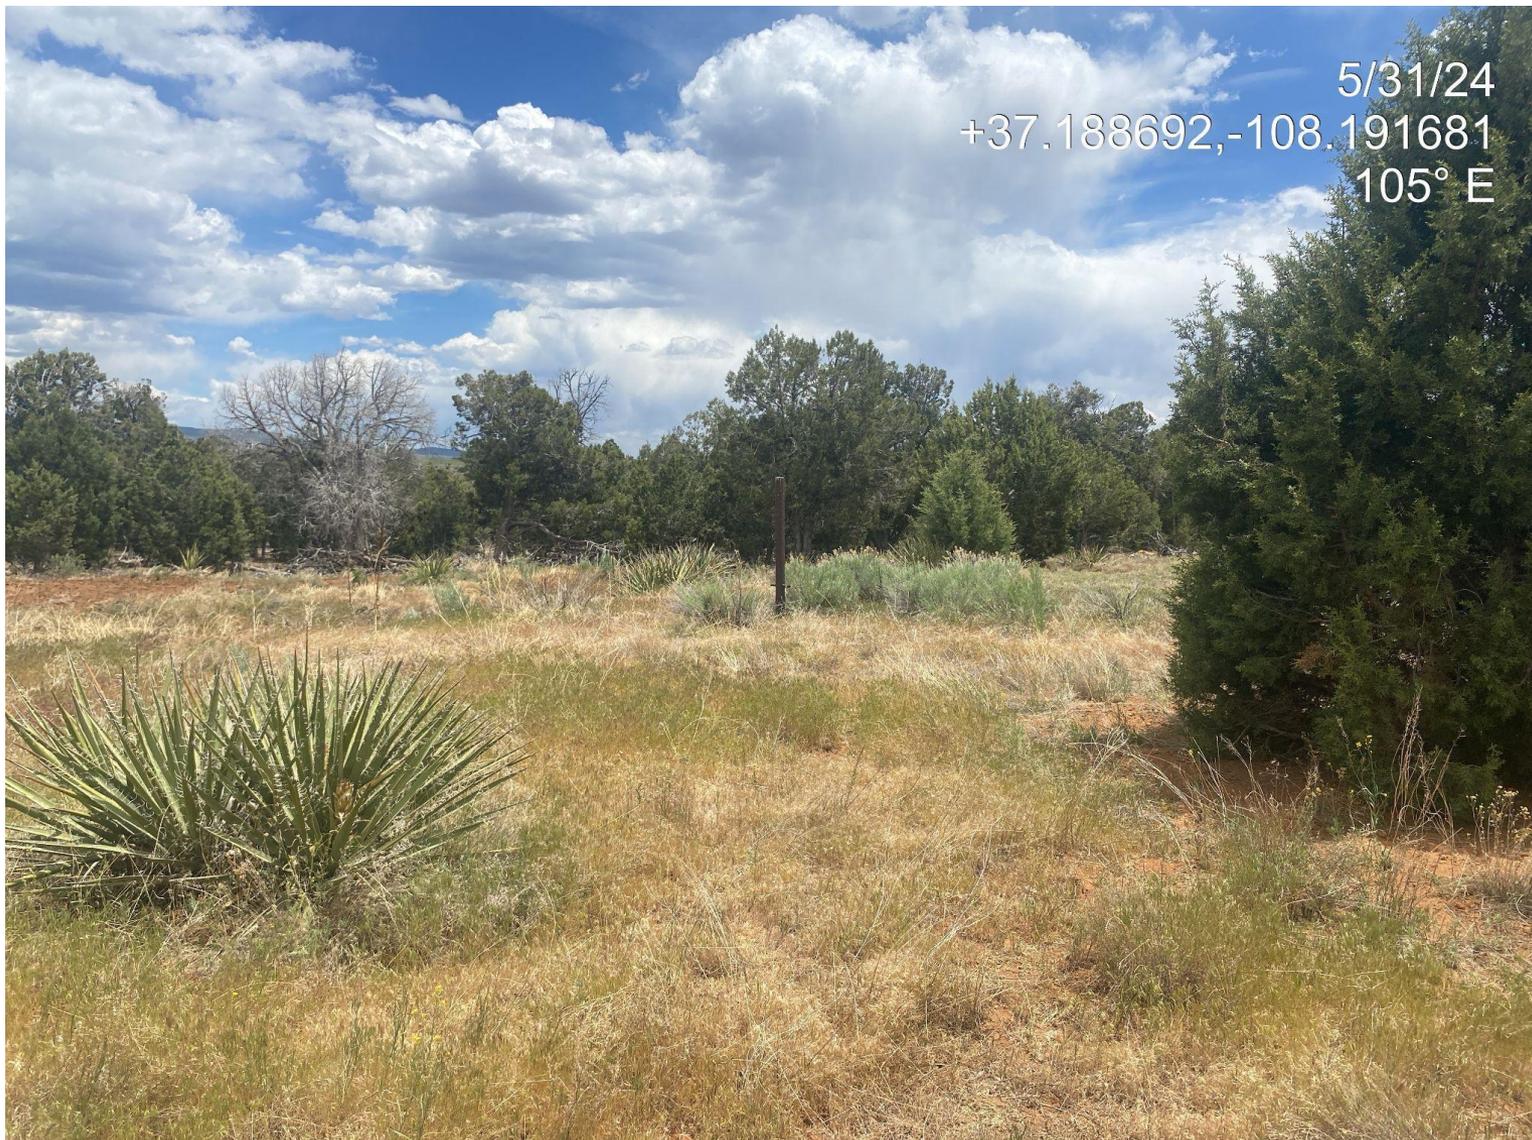
**Photo 1.** View of the project area taken from the western edge facing center.

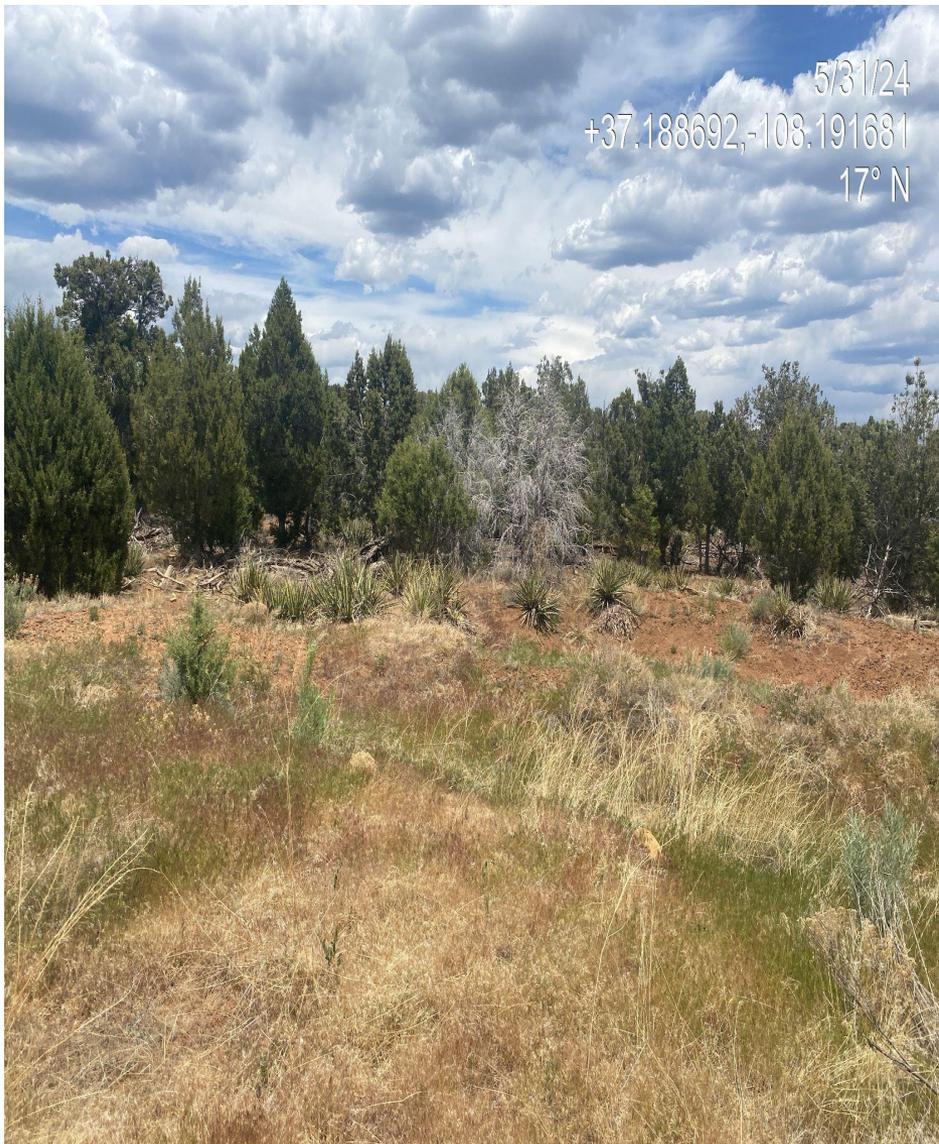
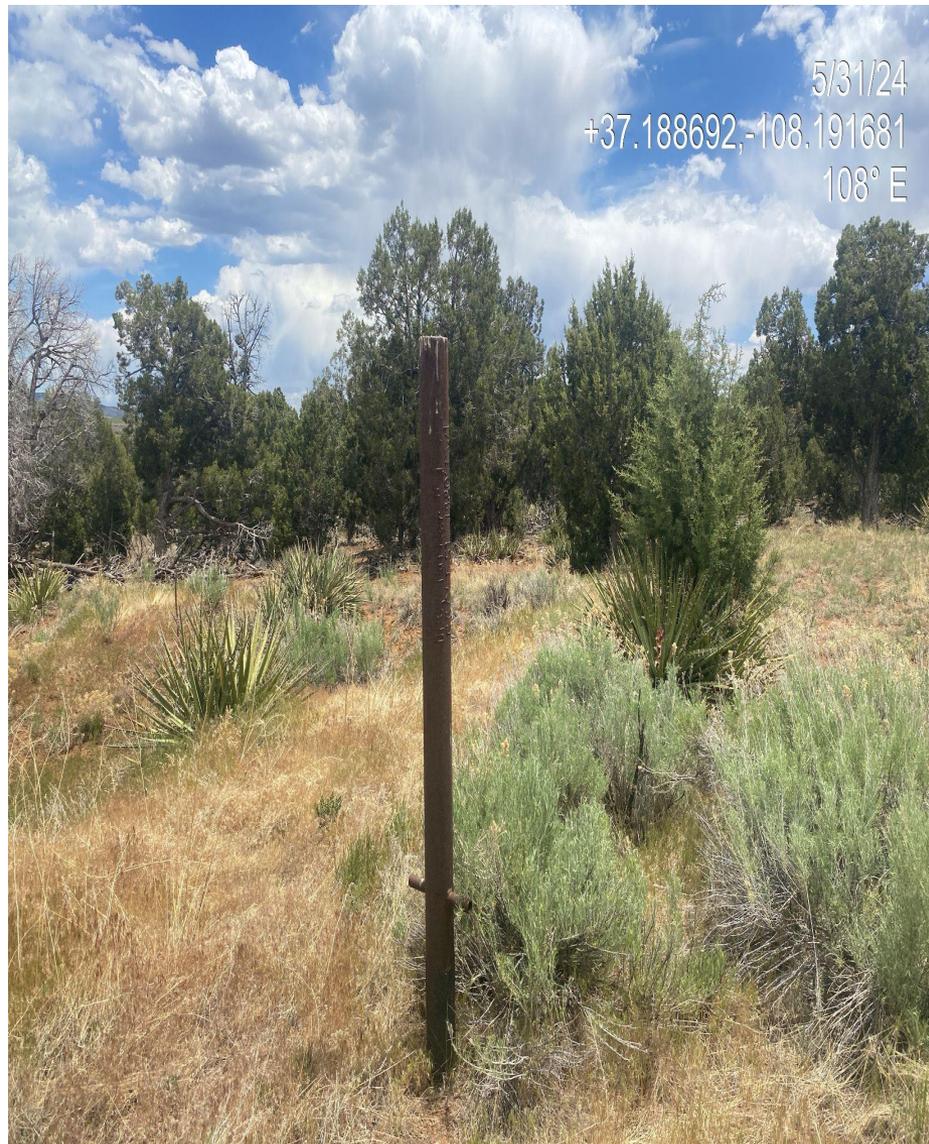
**Photo 2.** Cardinal photos taken from the center of the disturbance. Left photo facing north, right photo facing east.

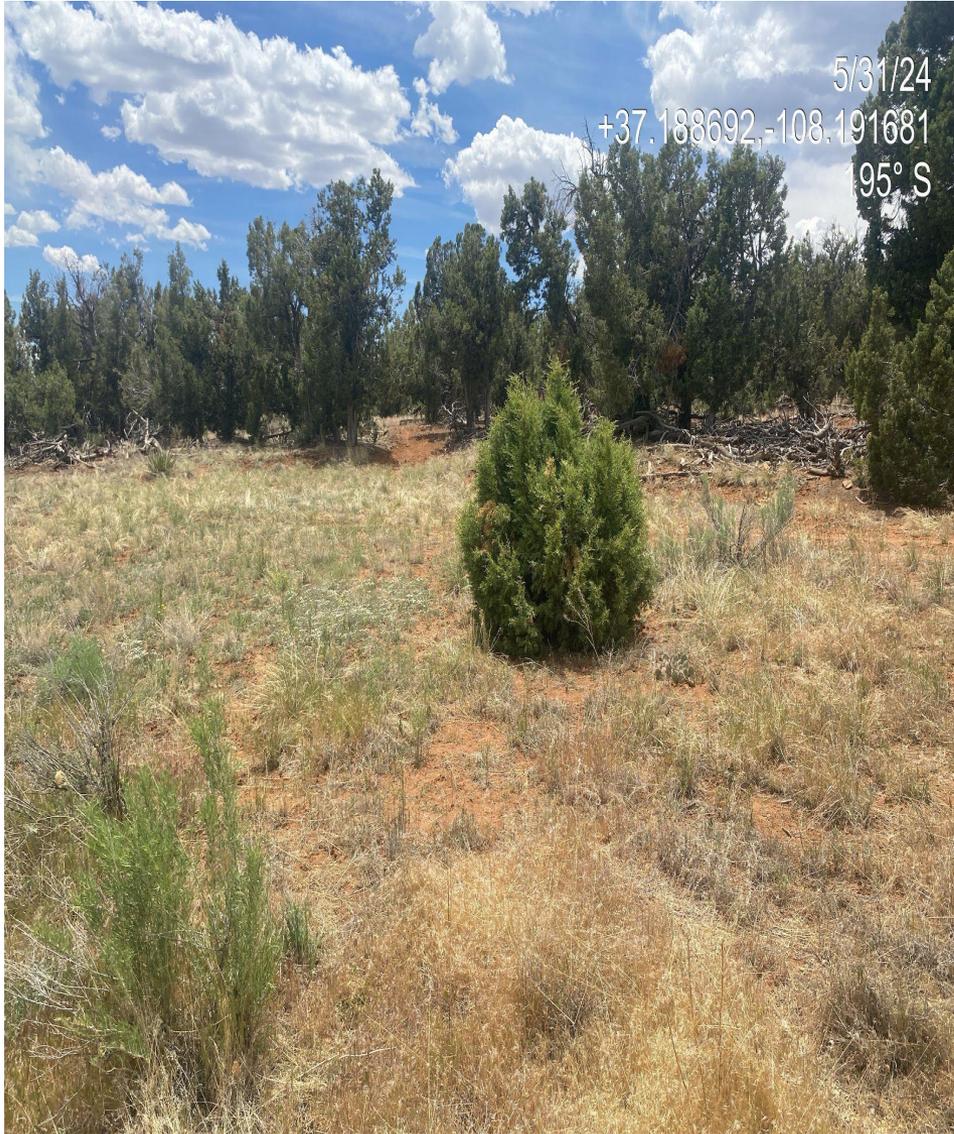
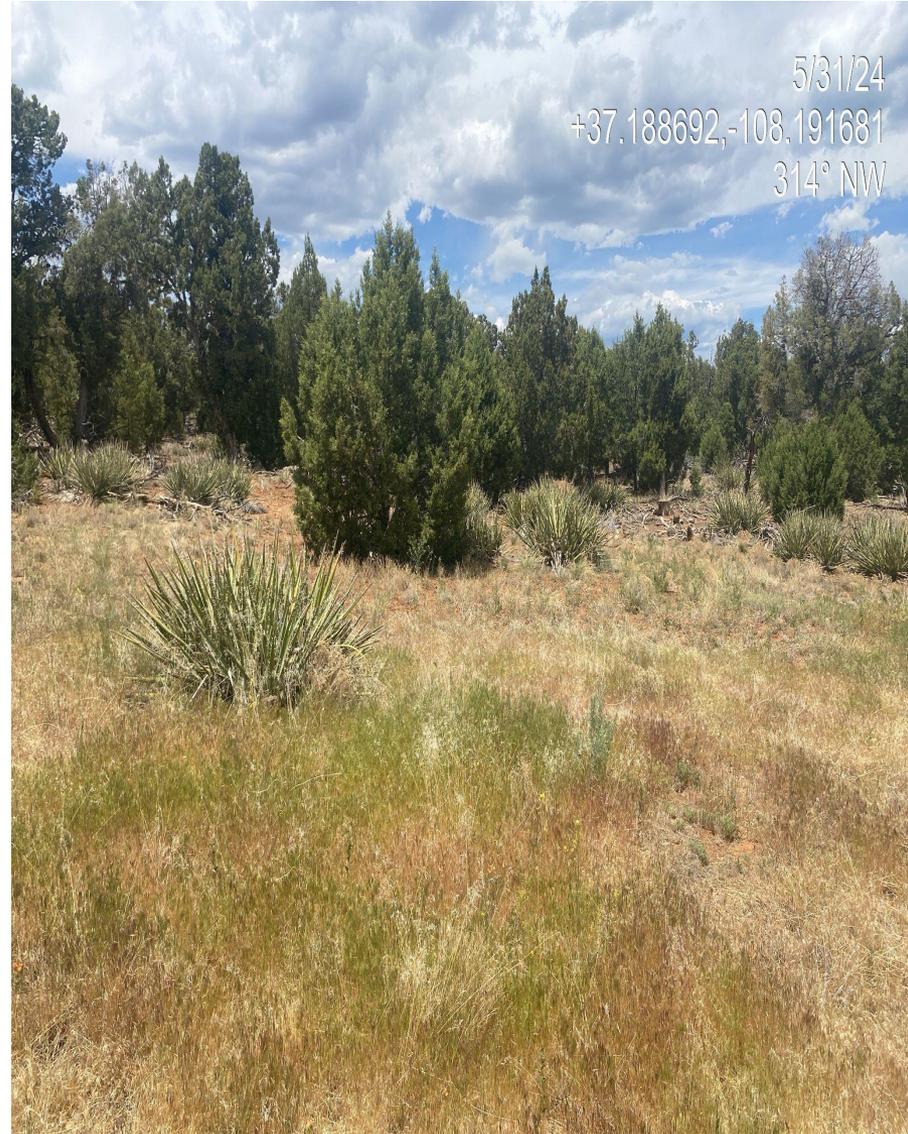
**Photo 3.** Cardinal photos taken from the center of the disturbance, left photo facing south, right photo facing west. Note: disturbance does not appear consistent with adjacent reference area and is dominated by an annual weed, cheatgrass.

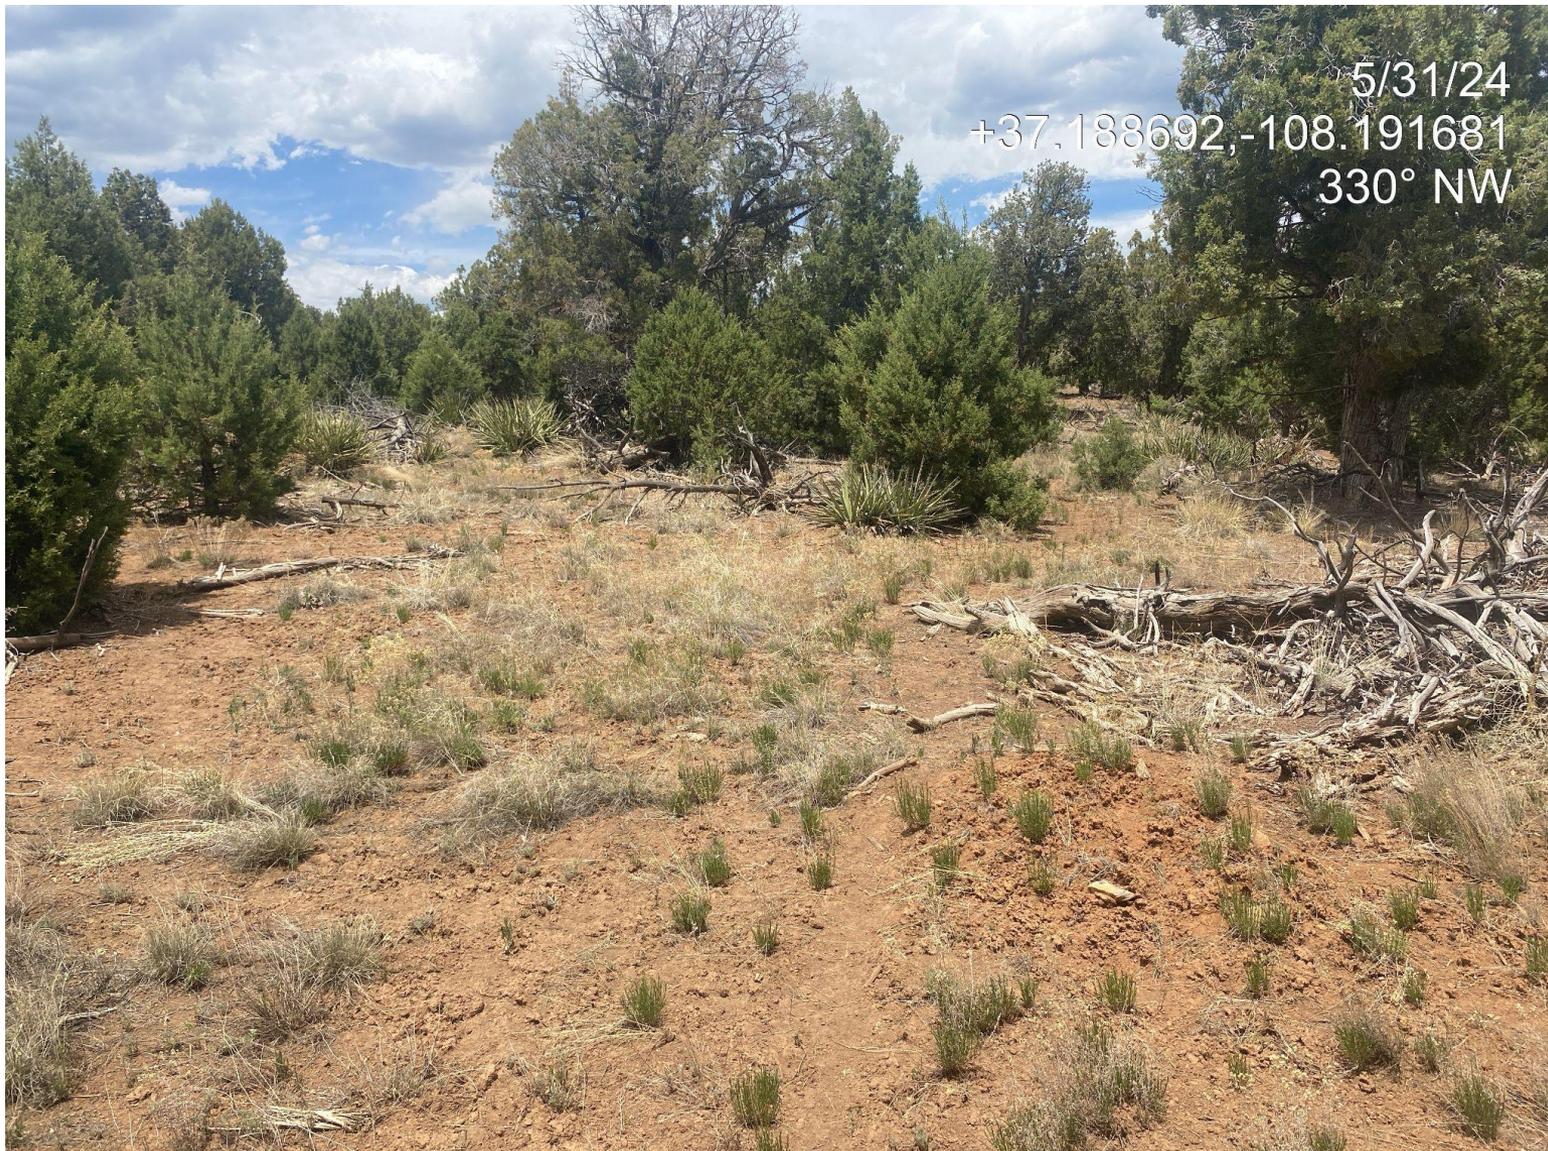
**Photo 4.** Reference area comprised of smooth brome, broom snake weed and juniper.
