Inspection Photos

API: 071-06815

Operator: WAPITI OPERATING LLC

Inspection Date: 6/10/2024

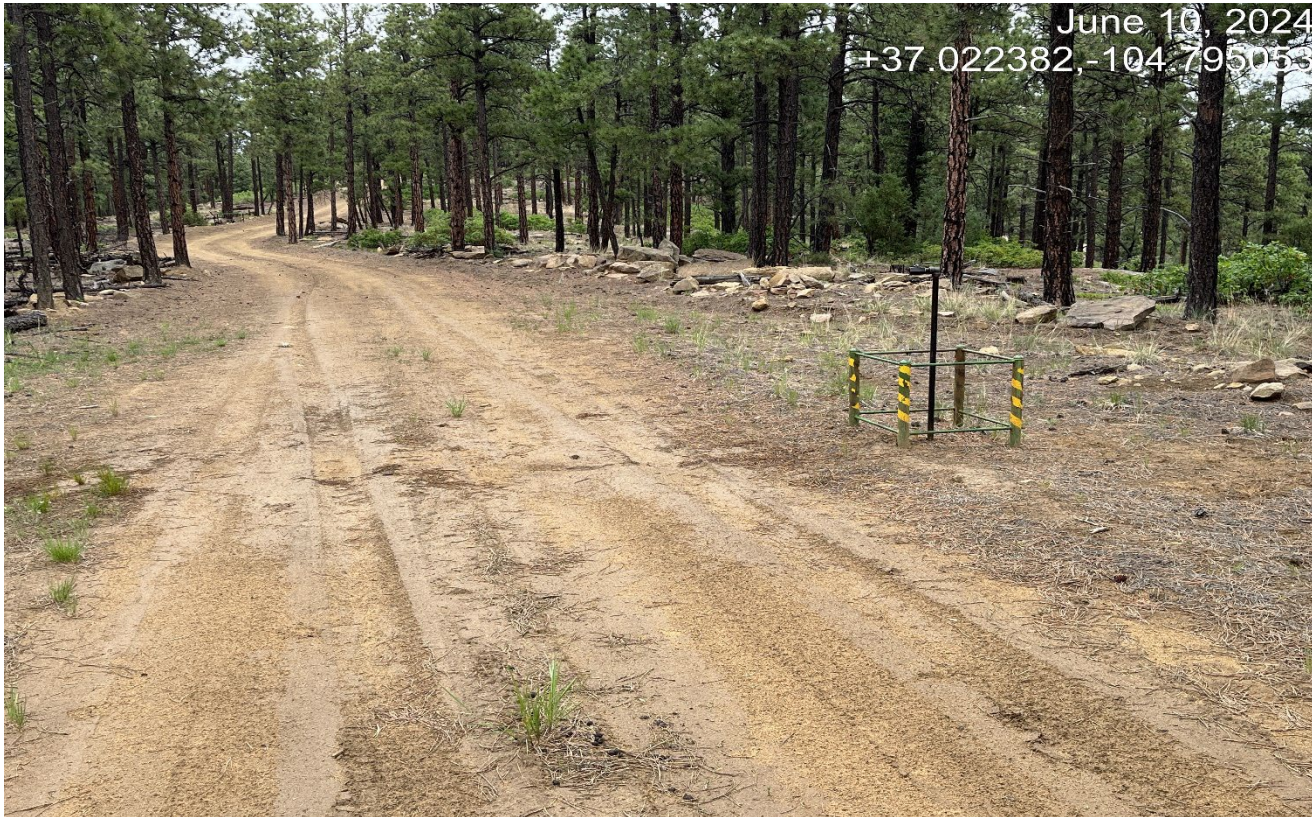
Photo 1. This gas line was vent along the access road blowing gas in the direction of the road which is a safety concern.
