# Final Reclamation and Stormwater Inspection

Operator: Noble Energy Inc - 100322

Location ID: 330481

Inspection Photos  
Location Name: Western 13-35  
Location ID: 330481

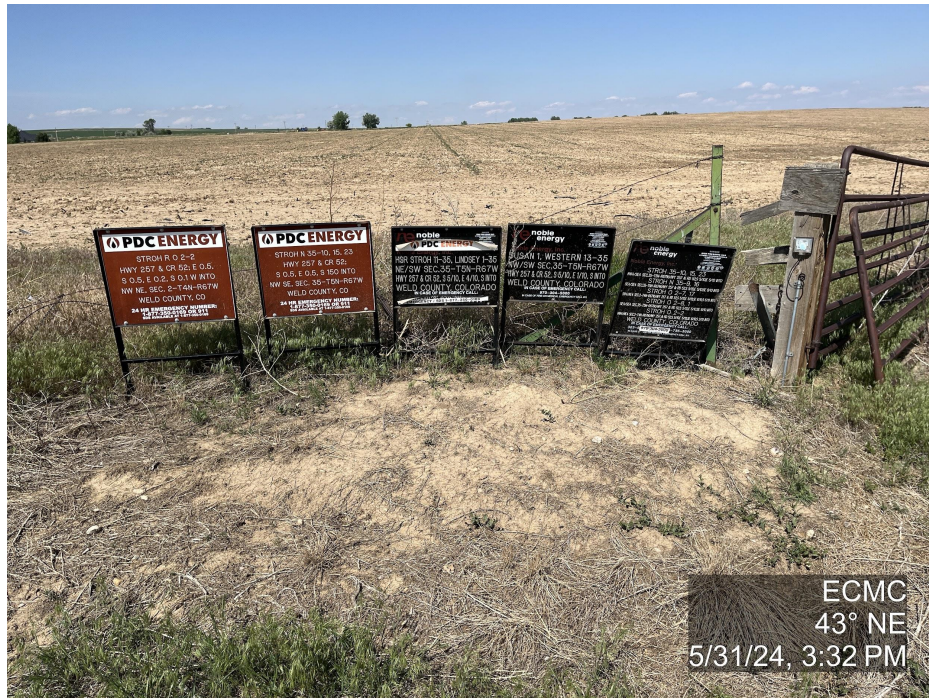
**Photo 1.** The photo was taken at the entrance to the well location facing Northeast. The photo illustrates Operator signs at the entrance.

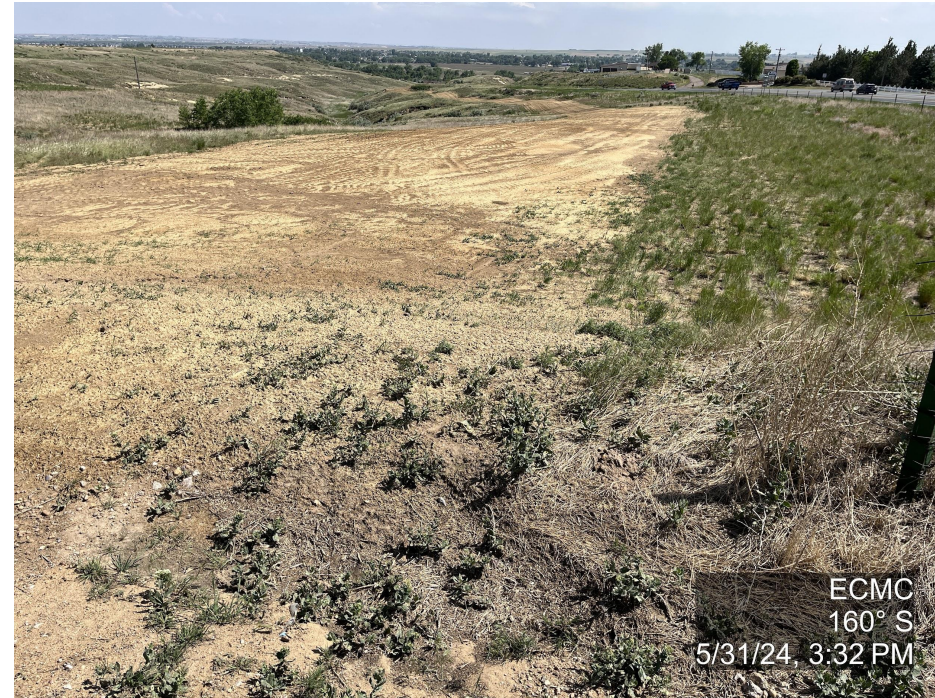
**Photo 2.** The photo was taken at the entrance to the well location facing South. The photo illustrates the operator has conducted final reclamation activities.

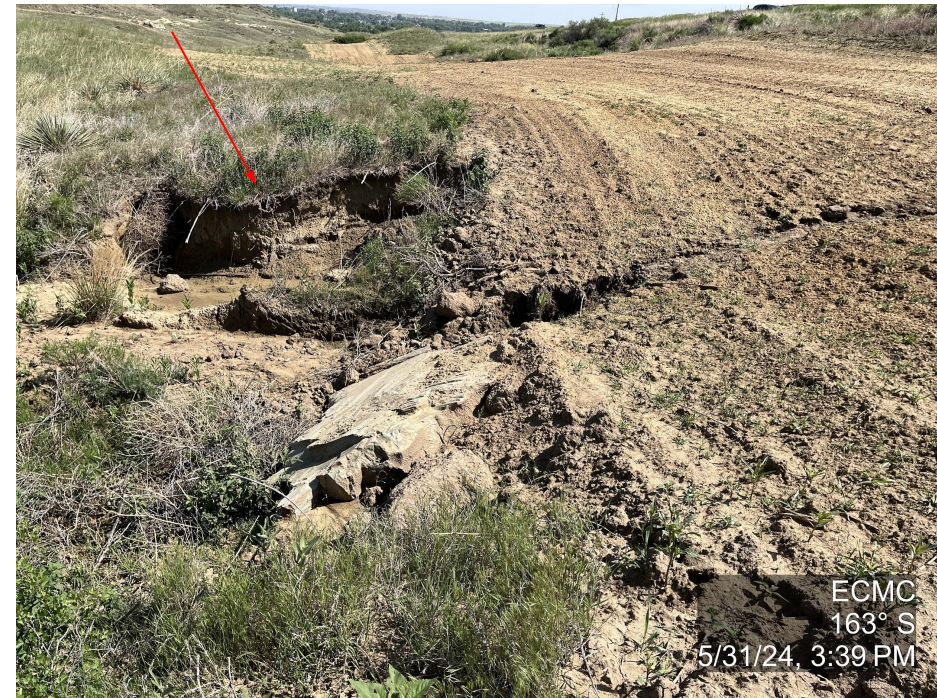
**Photo 4.** The photo was taken along the access road to the well location facing South. The photo illustrates erosion along the access road as well as erosion from issues in the previous inspection.

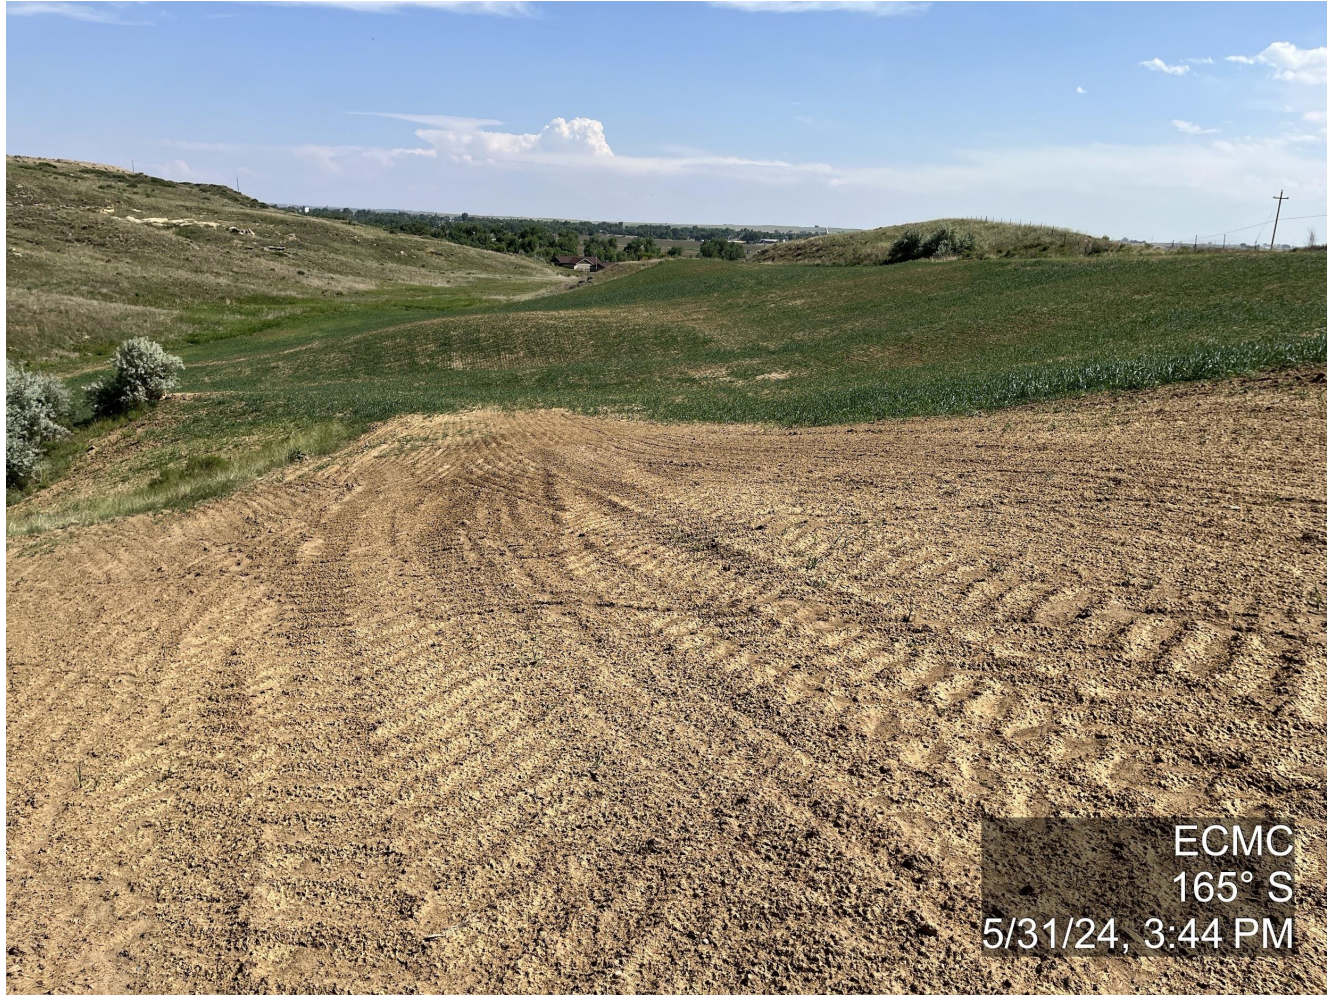
**Photo 5.** The photo was taken at the well location facing South. The photo illustrates the Operator has conducted final reclamation activities at the well location with germination and evidence of contouring.
