# Complaint Inspection

Operator: KP Kauffman Company Inc - 46290

Location ID: 317748

Inspection Photos  
Location Name: McCrumb-62N66W 17NWSE  
Location ID: 317748

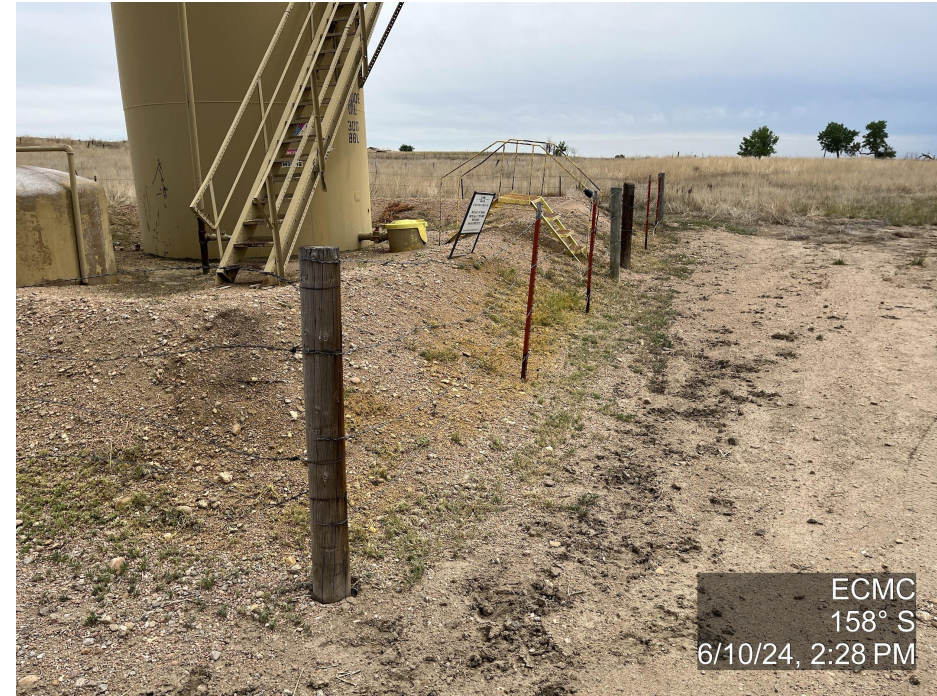
**Photo 1.** The photo was taken at the tank battery location facing East. The photo illustrates weeds noted in the previous FIR and complaint were mowed and sprayed around equipment as well as the Operator tank battery sign.

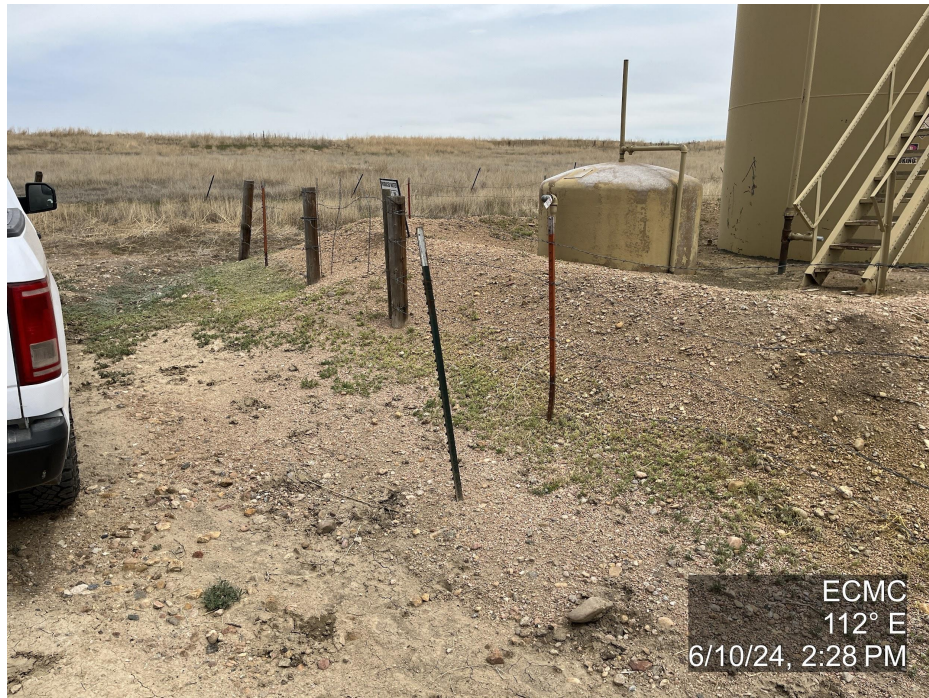
**Photo 2.** The photo was taken at the tank battery location facing South. Refer to the comment for photo 1.

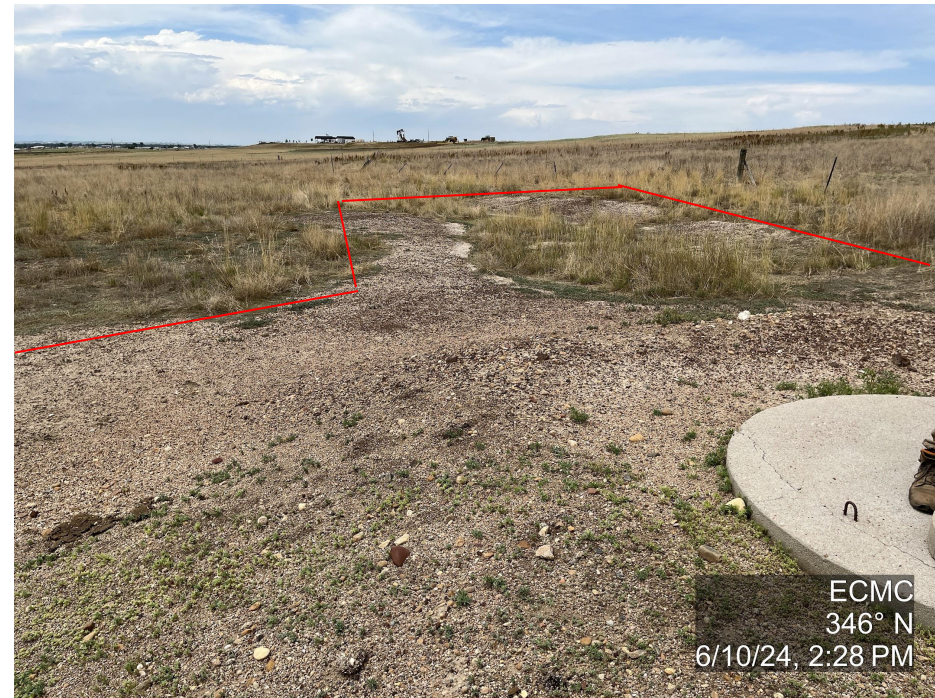
**Photo 3.** The photo was taken at the tank battery location facing East. Refer to the comment for photo 1.

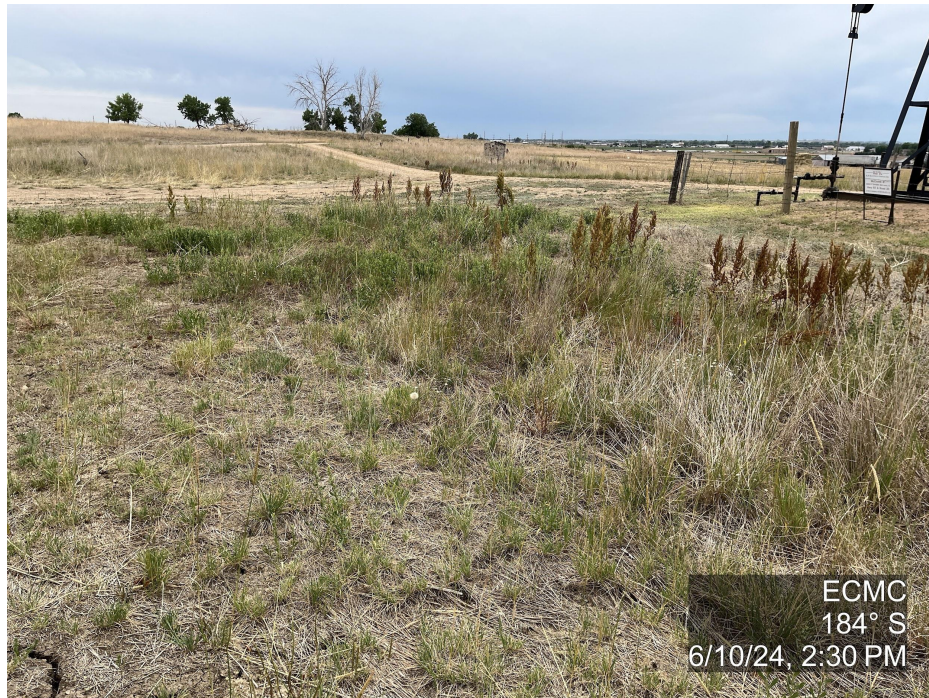
**Photo 4.** The photo was taken at the active pit facing North. The photo illustrates areas not in use that have not been reclaimed with evidence of gravel remaining and no vegetation growth.

Note - The pit appears to be inactive.

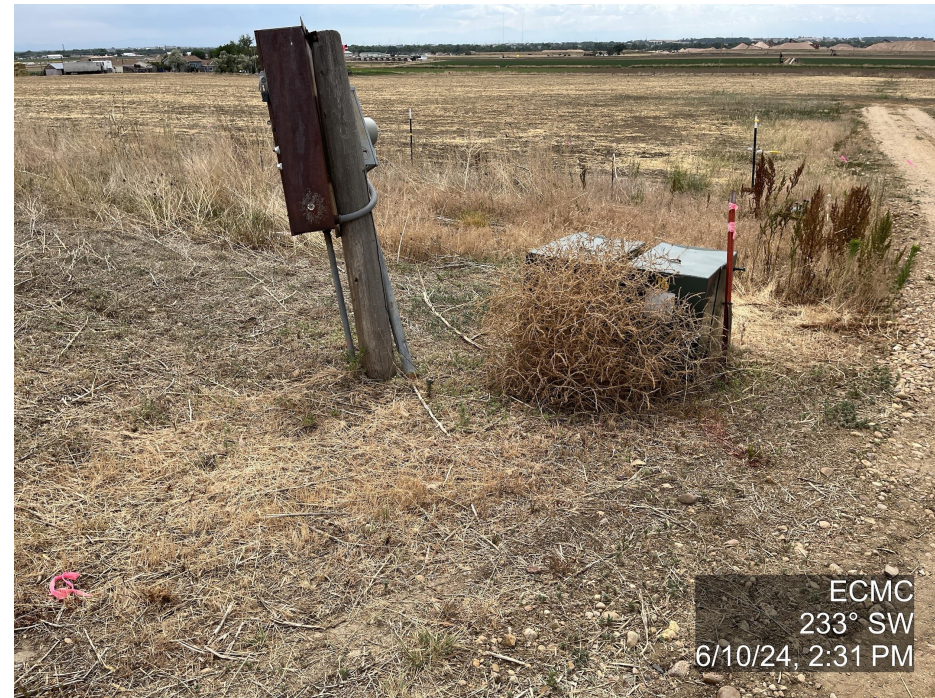
**Photo 5.** The photo was taken at the well location facing South. The photo illustrates are large amount of unmanaged Curly dock growing within the interim area.

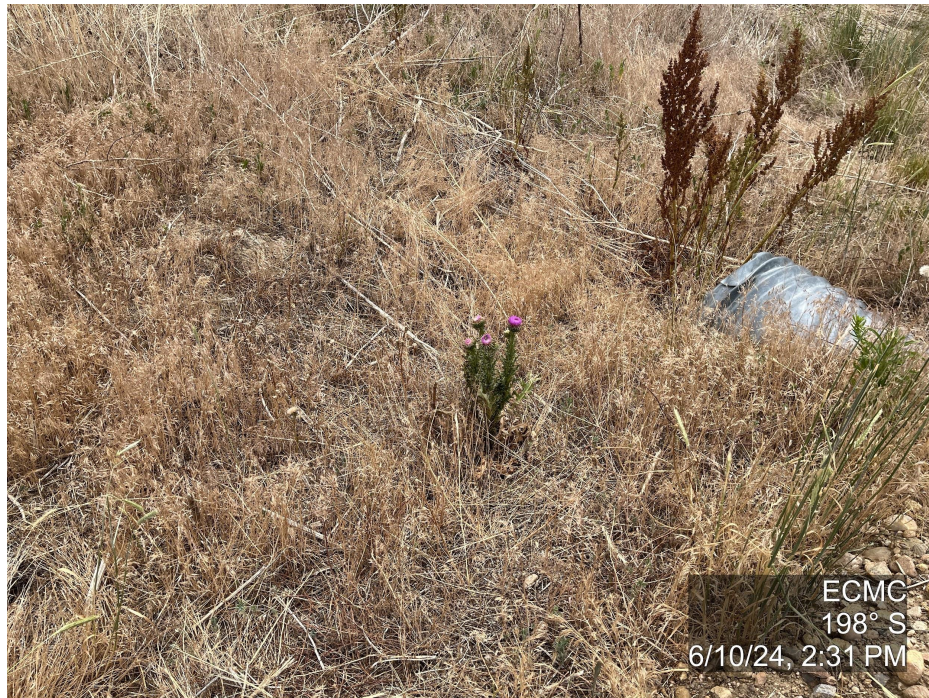
**Photo 6.** The photo was taken at the well location facing Southwest. The photo illustrates unmanaged weed debris and actively growing Curly dock at the location.

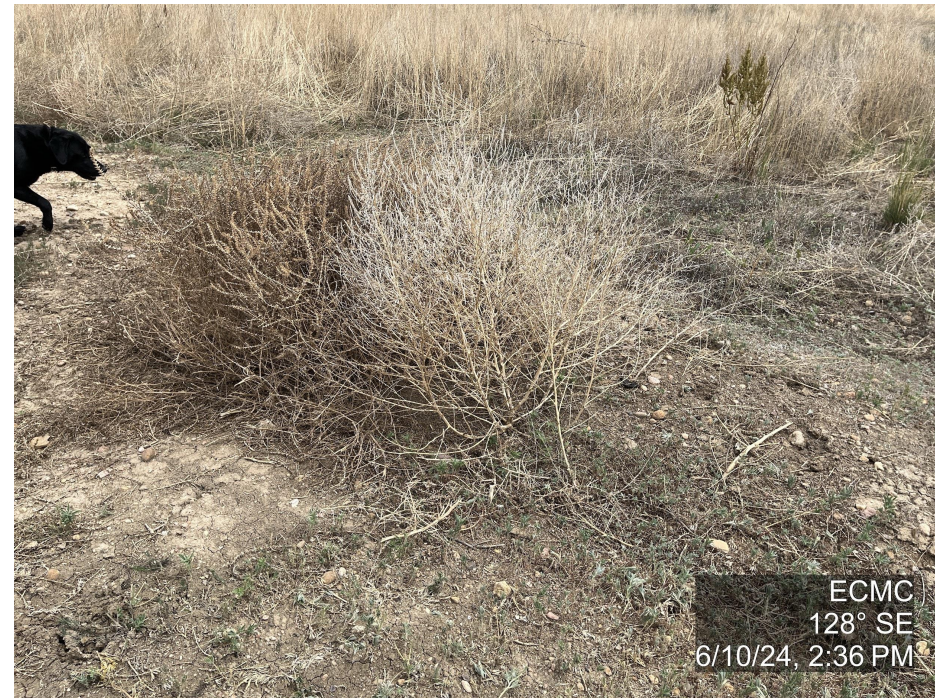
**Photo 7.** The photo was taken at the well location facing South. The photo illustrates an example of a noxious weed, Musk thistle, as well as Curly dock and cheatgrass being unmanaged at the location.

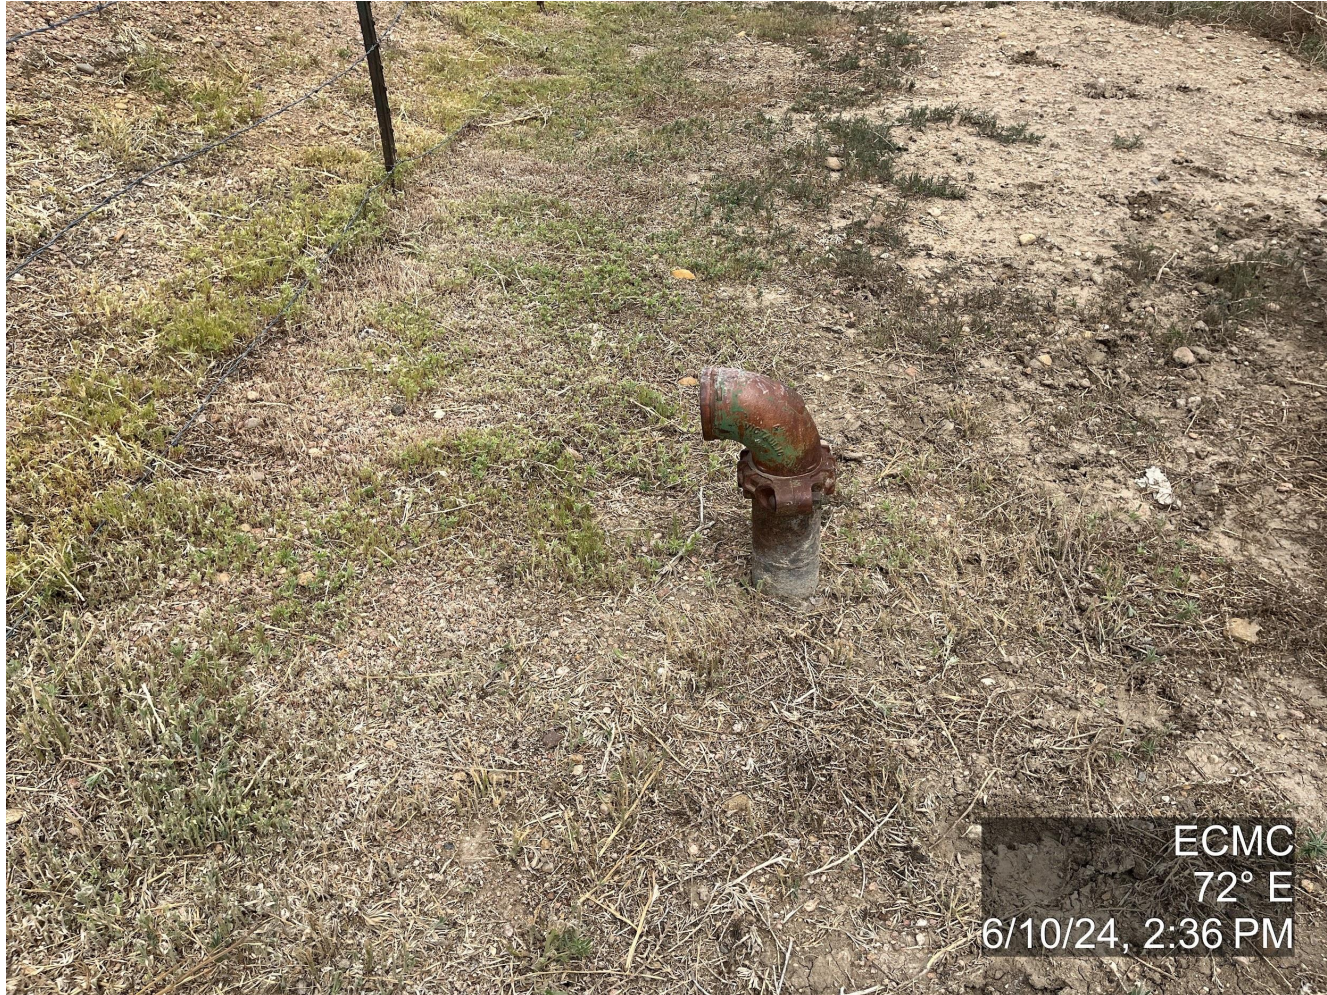
**Photo 8.** The photo was taken at the tank battery location facing Southeast. The photo illustrates unmanaged weed debris on the location.
