Final Reclamation and Stormwater Inspection

Operator: NOBLE ENERGY INC - 100322

Location ID: 322958

Inspection Photos
Location Name: Andre 2-3E
Location ID: 322958

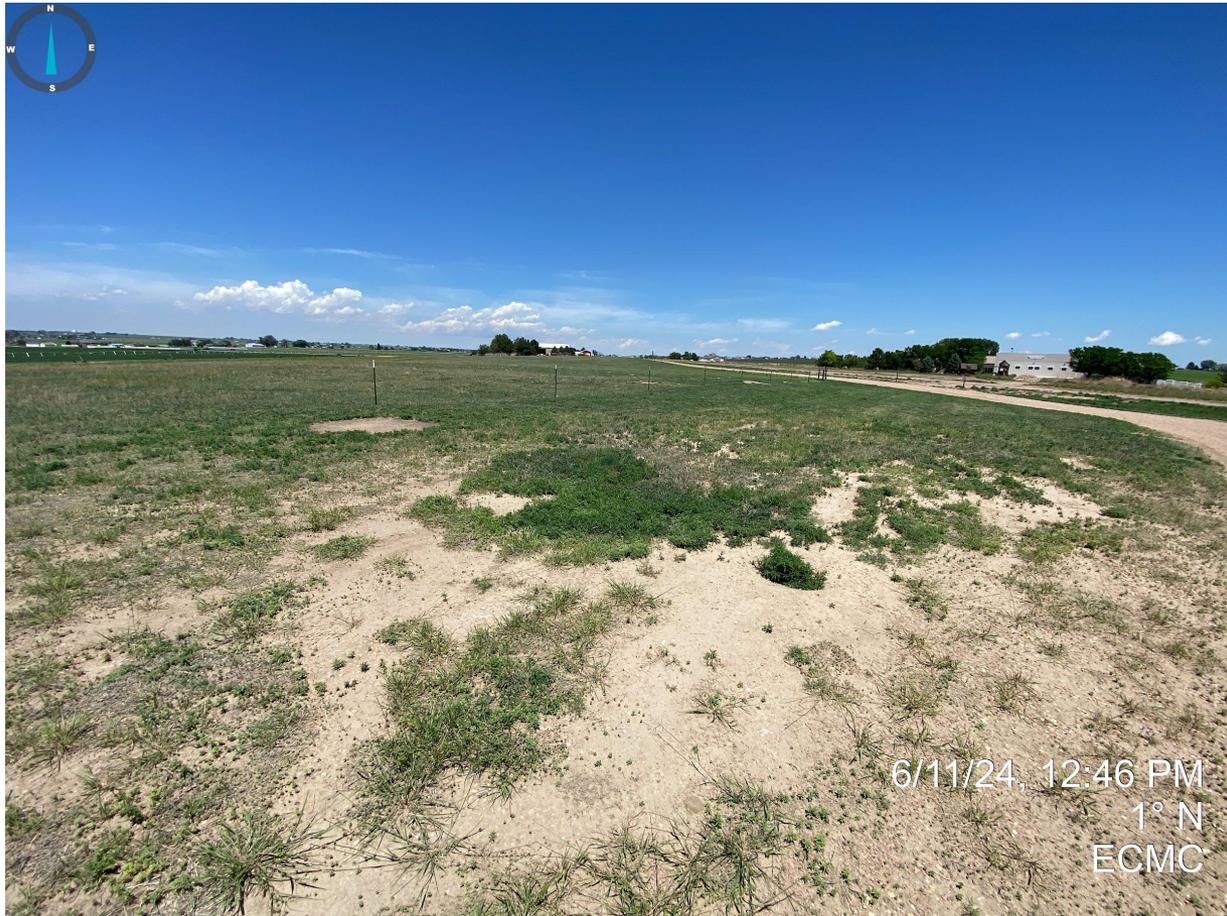
Photo 1. The former well location is not progressing towards Rule 1004 standards and regulations with evidence of undesirable vegetation (kochia) and areas of exposed/bare soil. Additional reclamation activities are required.

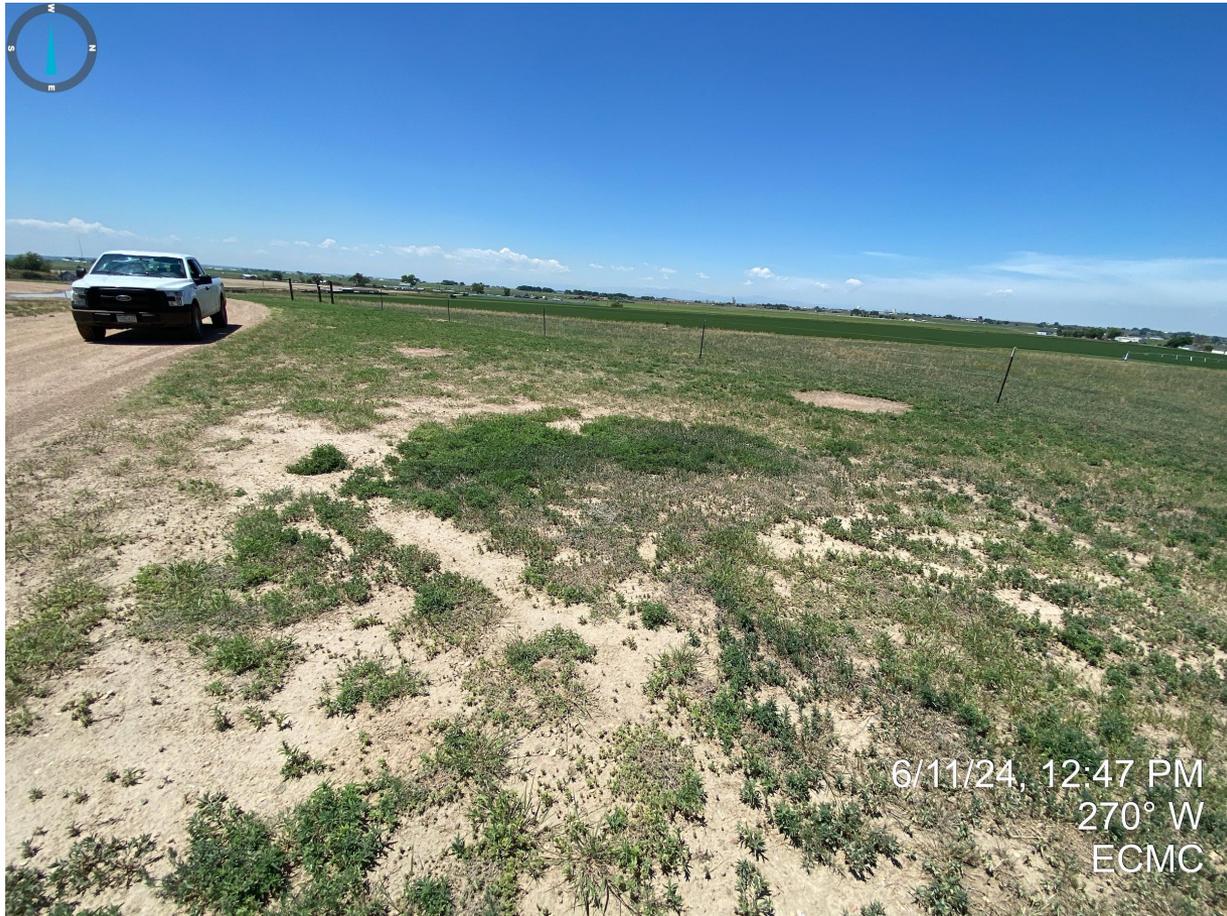
Photo 2. Facing west; see comments in Photo 1.

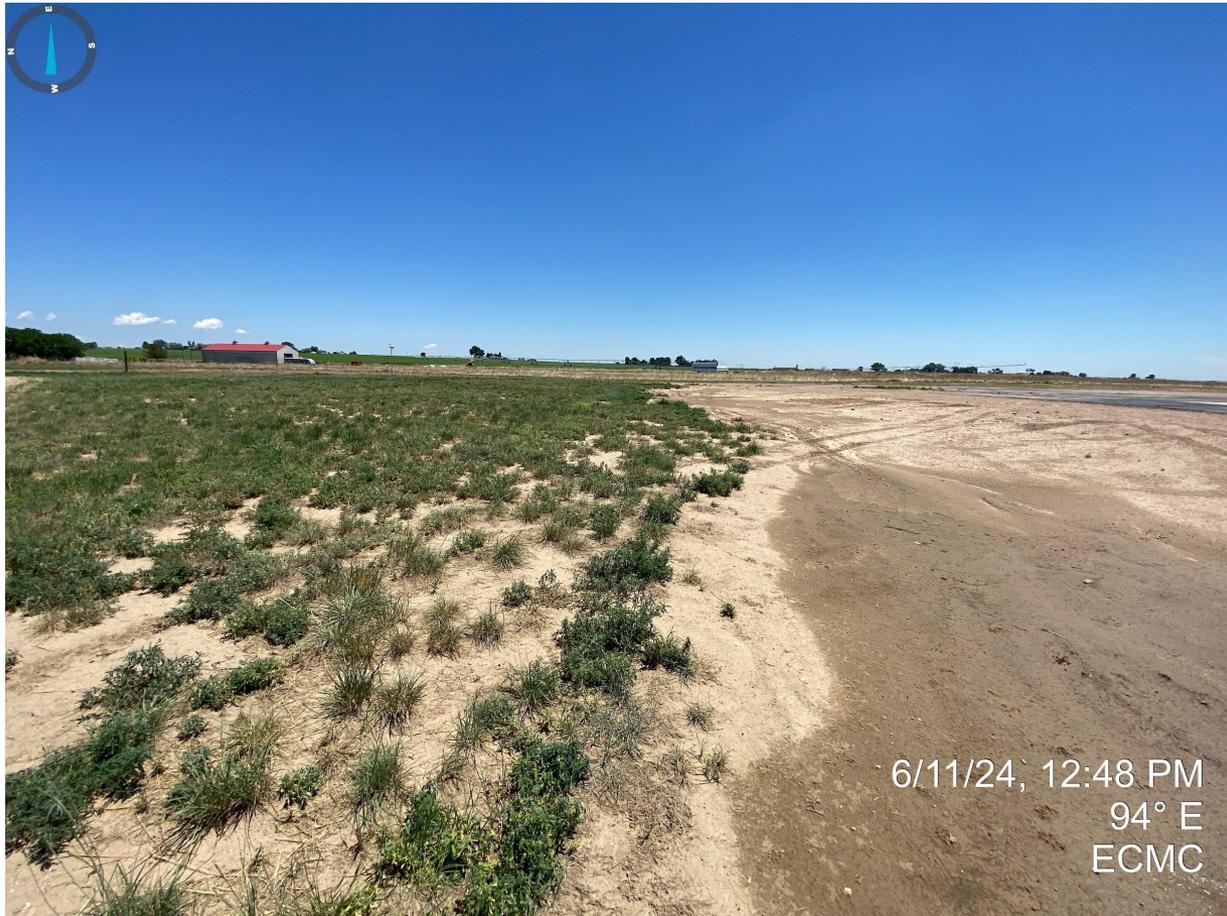
Photo 3. The former tank battery location is predominantly undesirable vegetation (kochia). Some desirable vegetation was observed (sand dropseed, western wheatgrass) though it doesn't appear dense enough to displace the undesirable vegetation.

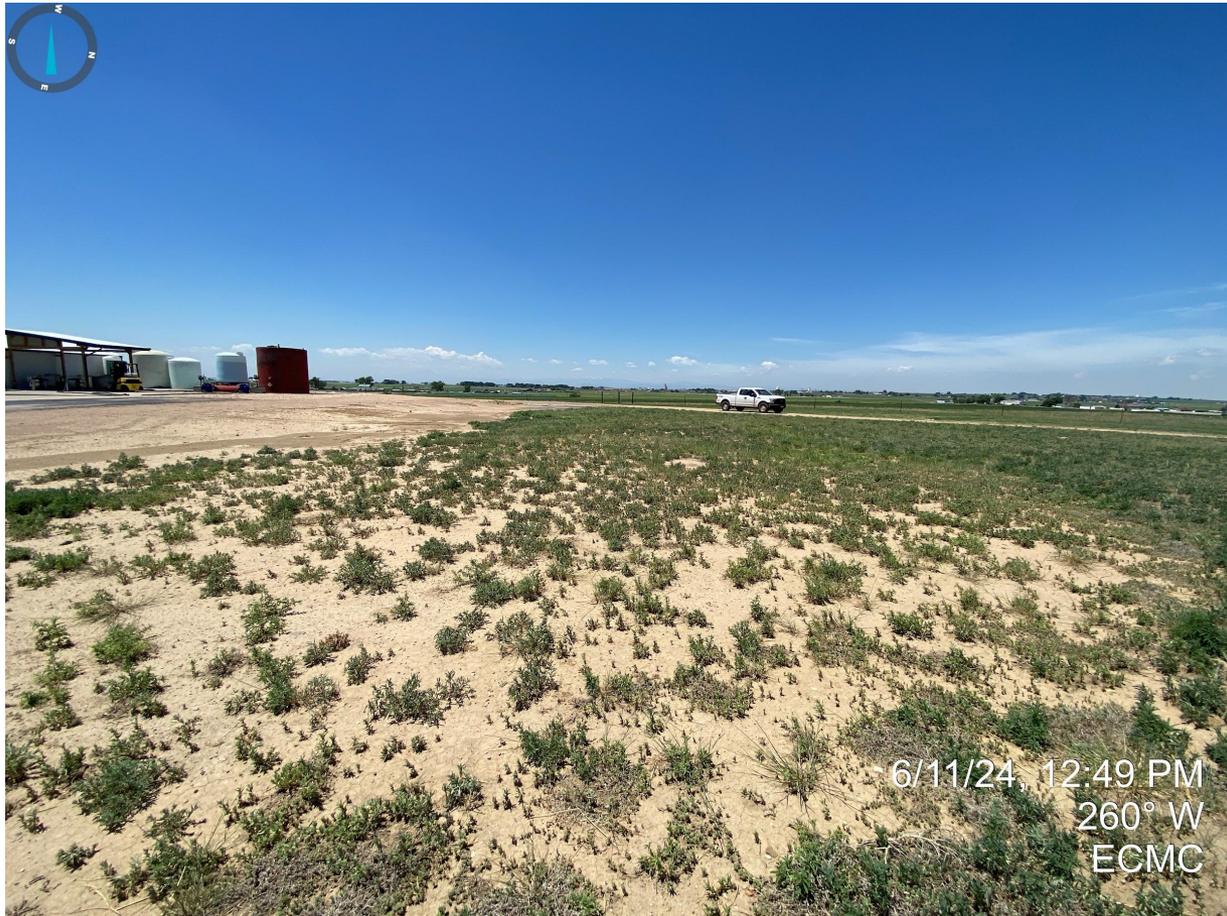
Photo 4. Facing west; see comments in Photo 3.

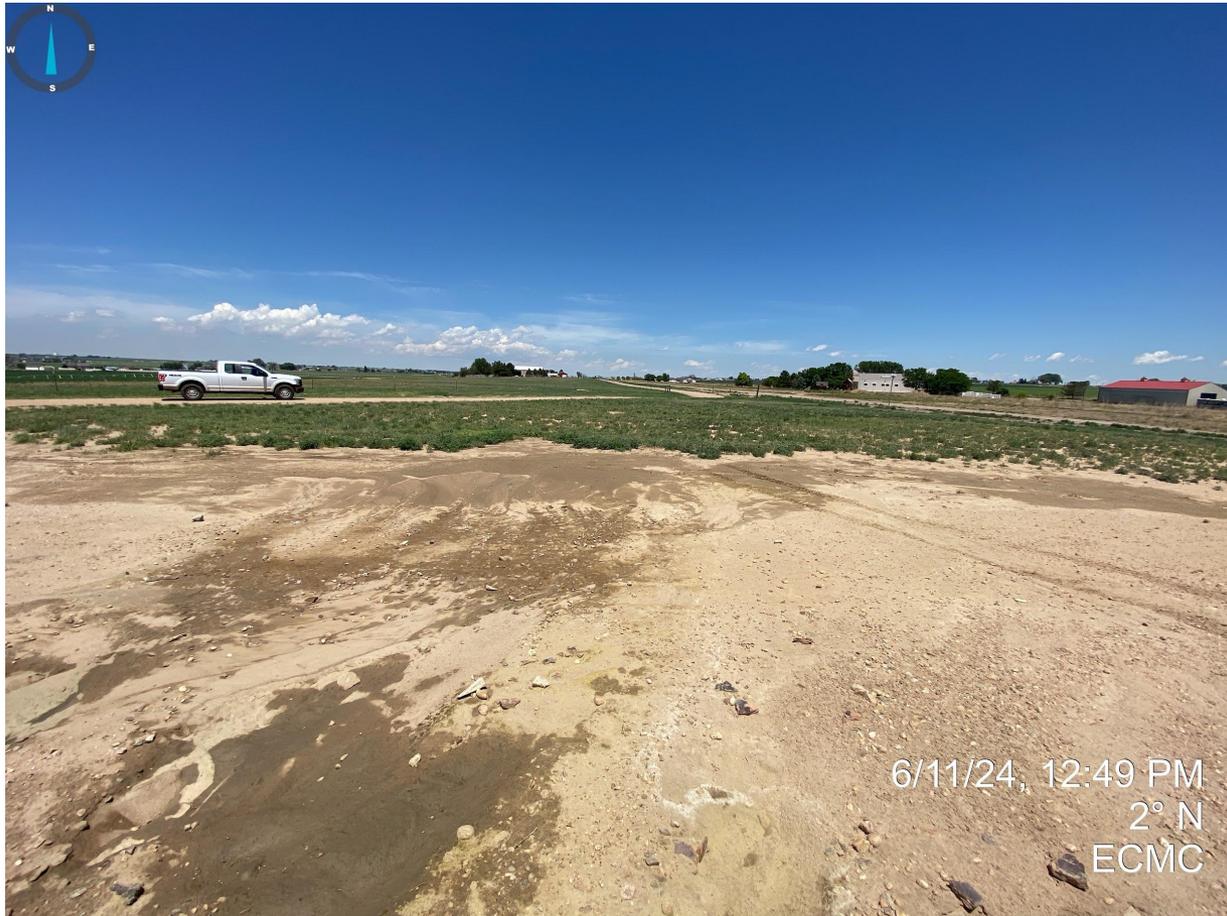
Photo 5. Facing north. It appears that the southern portion of the tank battery reclaim is being used as a herbicide washout.

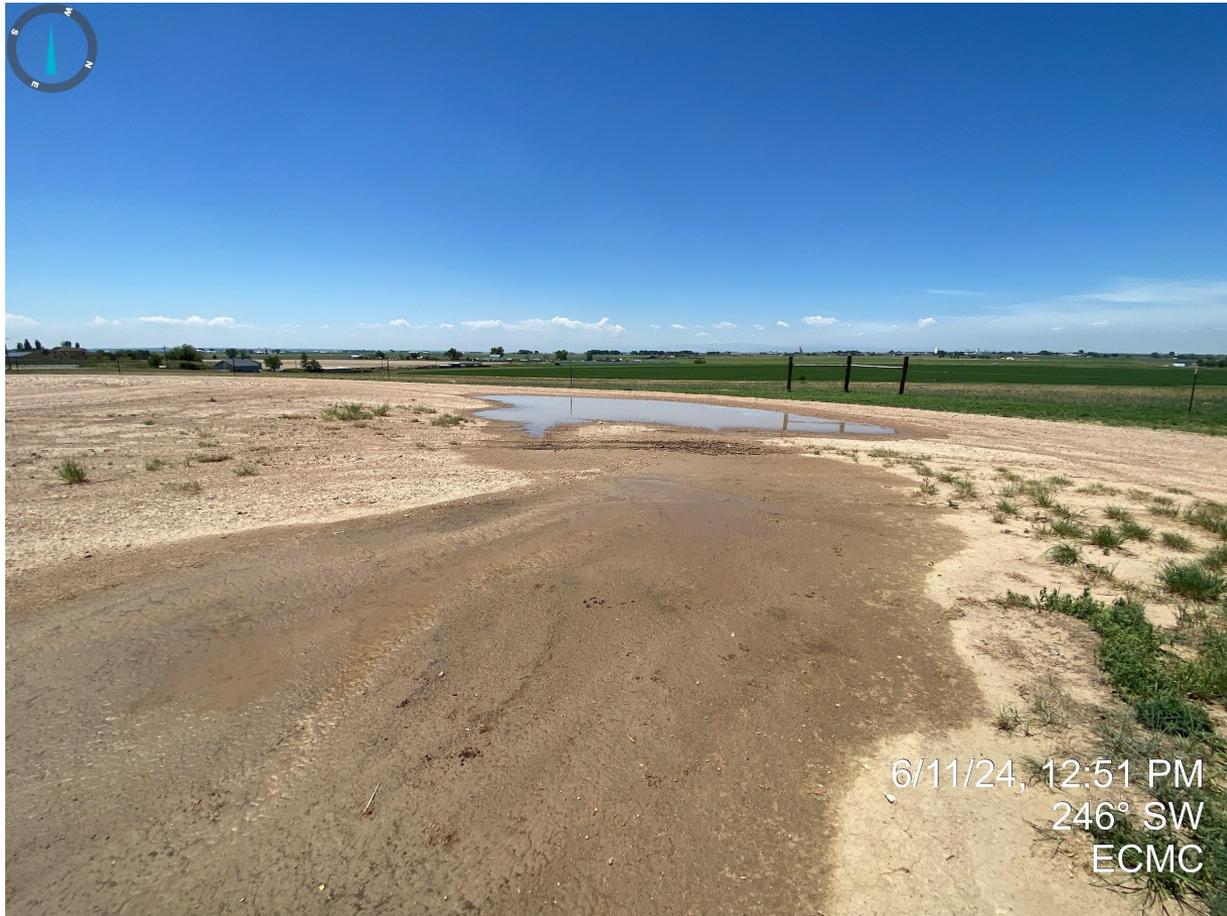
Photo 6. The western portion of the former tank battery location does not appear to have been contoured/graded to prevent the accumulation of stormwater on the access road.

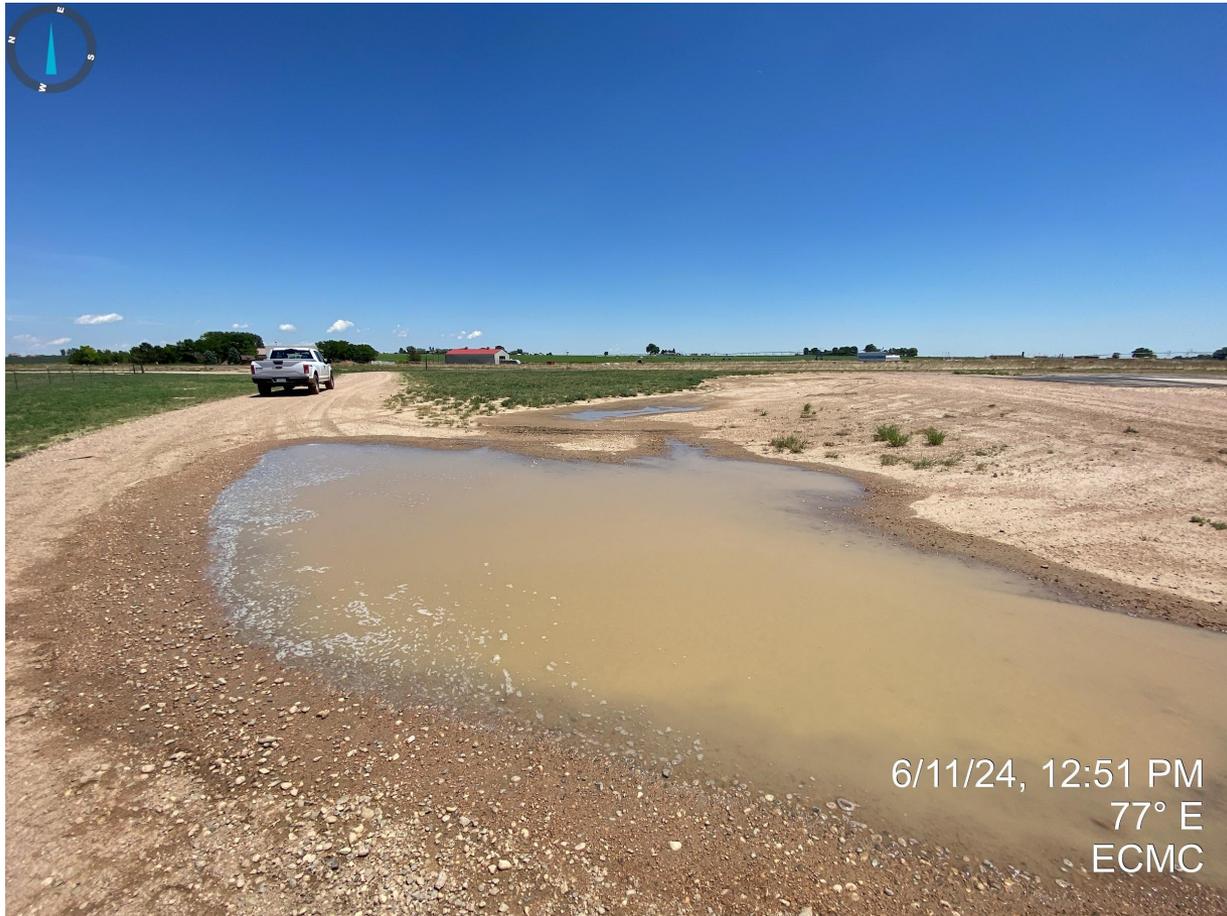
Photo 7. Facing east; see comments in Photo 6.
