# Final Reclamation and Stormwater Inspection

Operator: Crestone Peak Resources Operating LLC -  
10633

Location ID: 333142

Inspection Photos  
Location Name: Seltzer 14-34  
Location ID: 333142

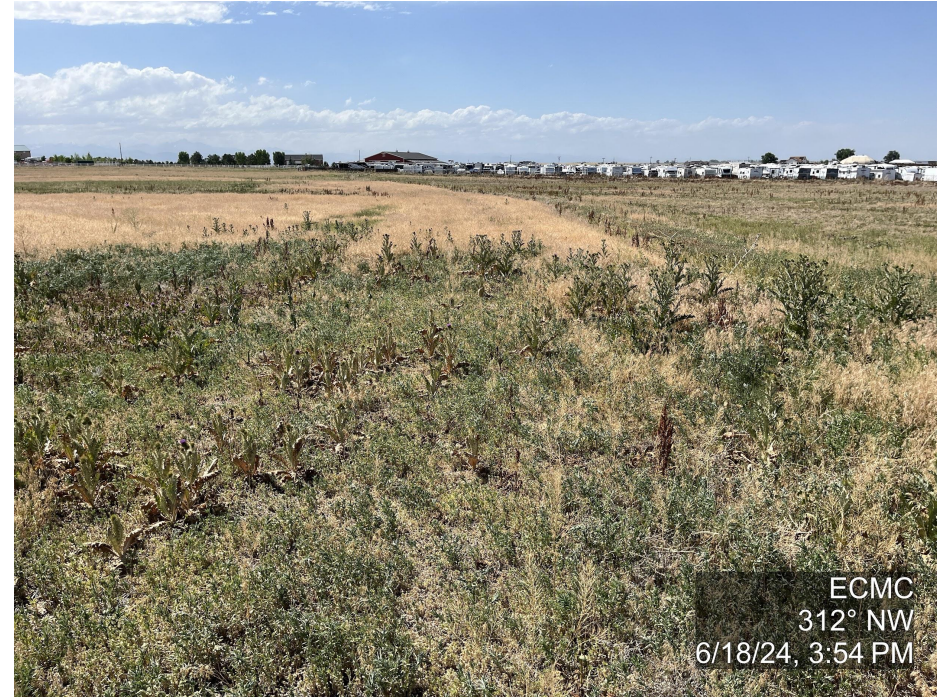
**Photo 1.** The photo was taken at the tank battery location facing Southwest. The photo illustrates the former access road is dominated by Kochia.

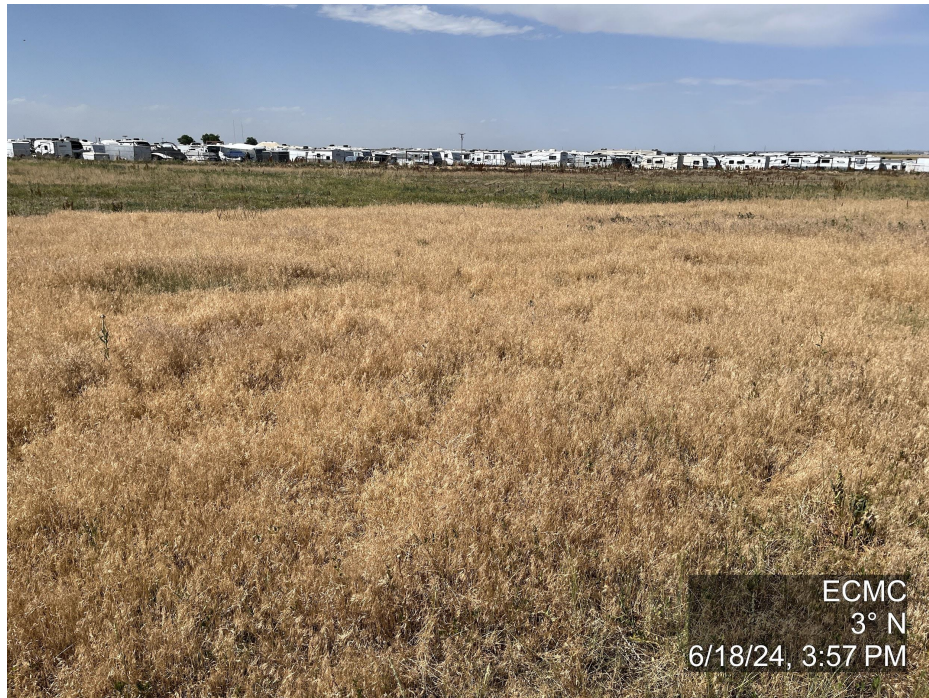
**Photo 2.** The photo was taken along the access road to the well location facing South. Refer to the comment for photo 1.

Note - Areas of the access road are also dominated by Cheatgrass, Scotch thistle and Curly dock.

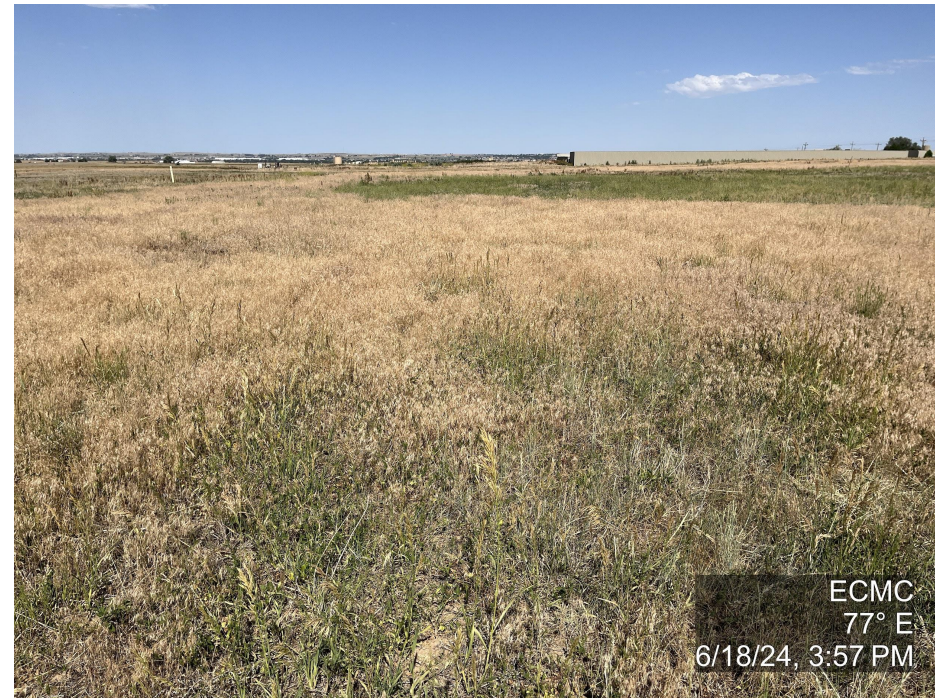
**Photo 3.** The photo was taken at the well location facing North. The photo illustrates the well location is dominated by Cheatgrass.

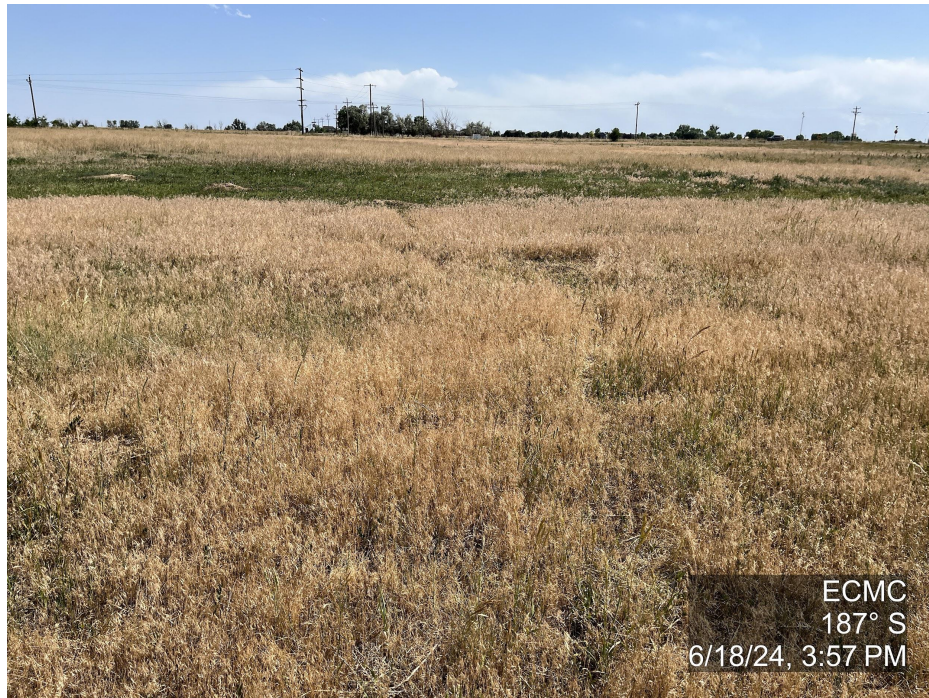
**Photo 4.** The photo was taken at the well location facing East. Refer to the comment for photo 3.

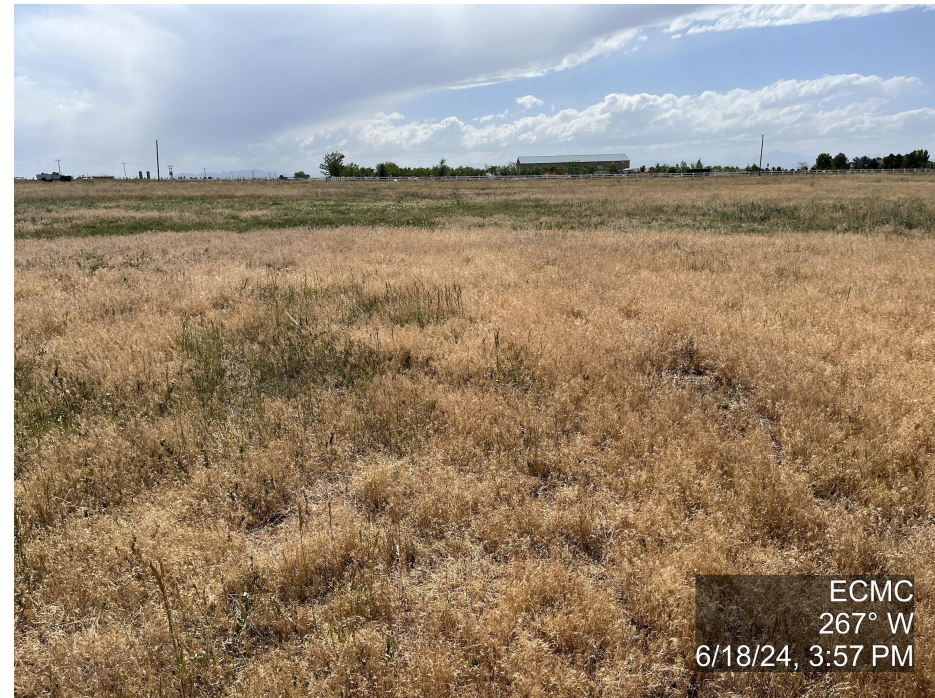
**Photo 5.** The photo was taken at the well location facing South. Refer to the comment for photo 3.

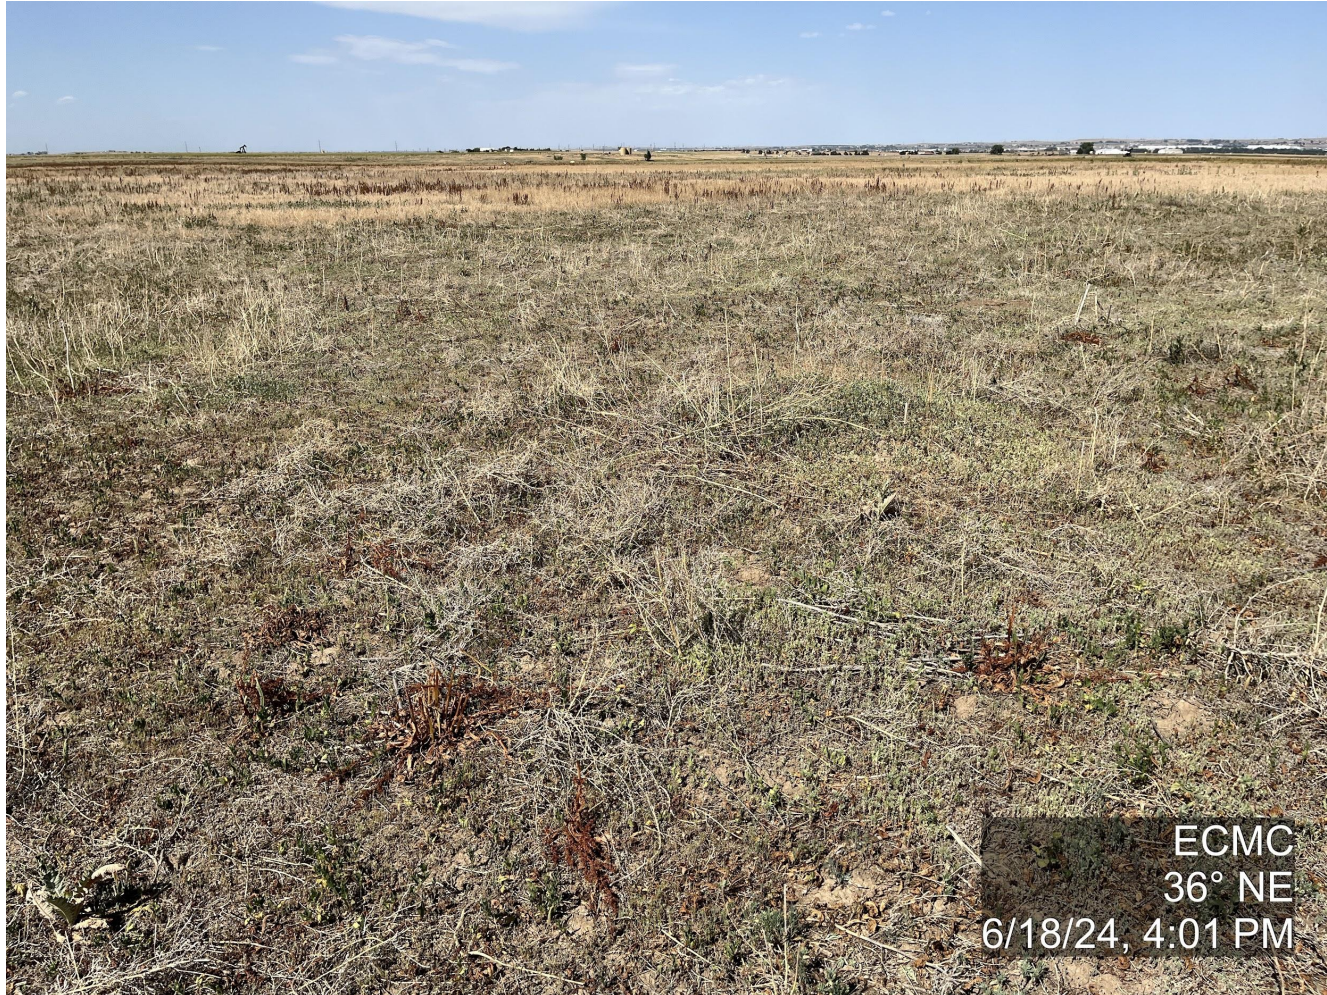
**Photo 6.** The photo was taken at the well location facing West. Refer to the comment for photo 3.

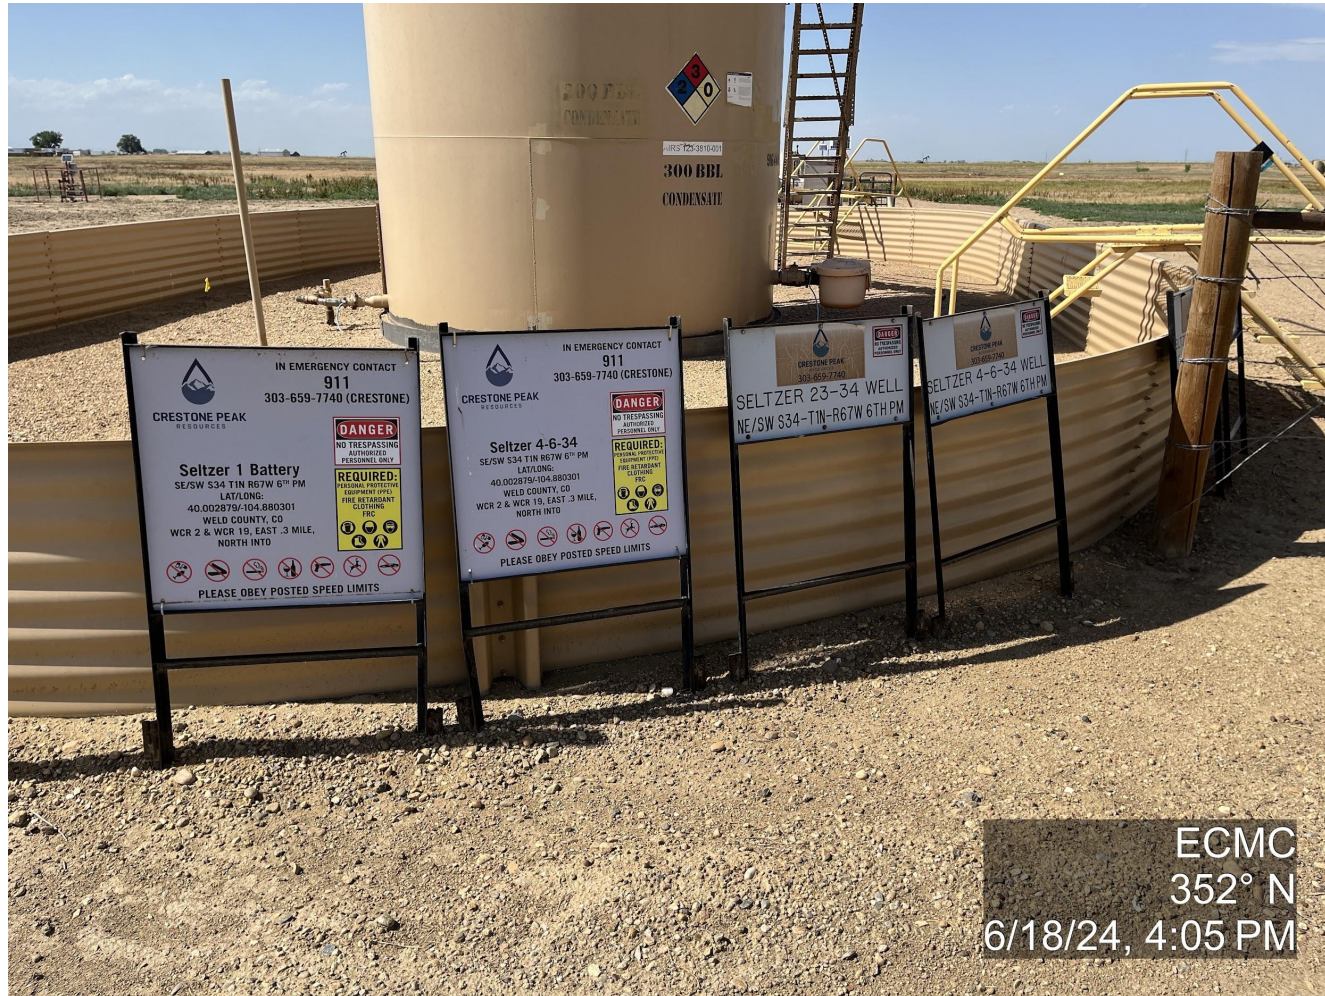
**Photo 8.** The photo was taken at the tank battery location facing North. The photo illustrates the tank battery is in use for other nearby wells.
