Inspection Photos

API: 011-06126

Operator: STRACHAN EXPLORATION INC

Inspection Date: 6/26/2024

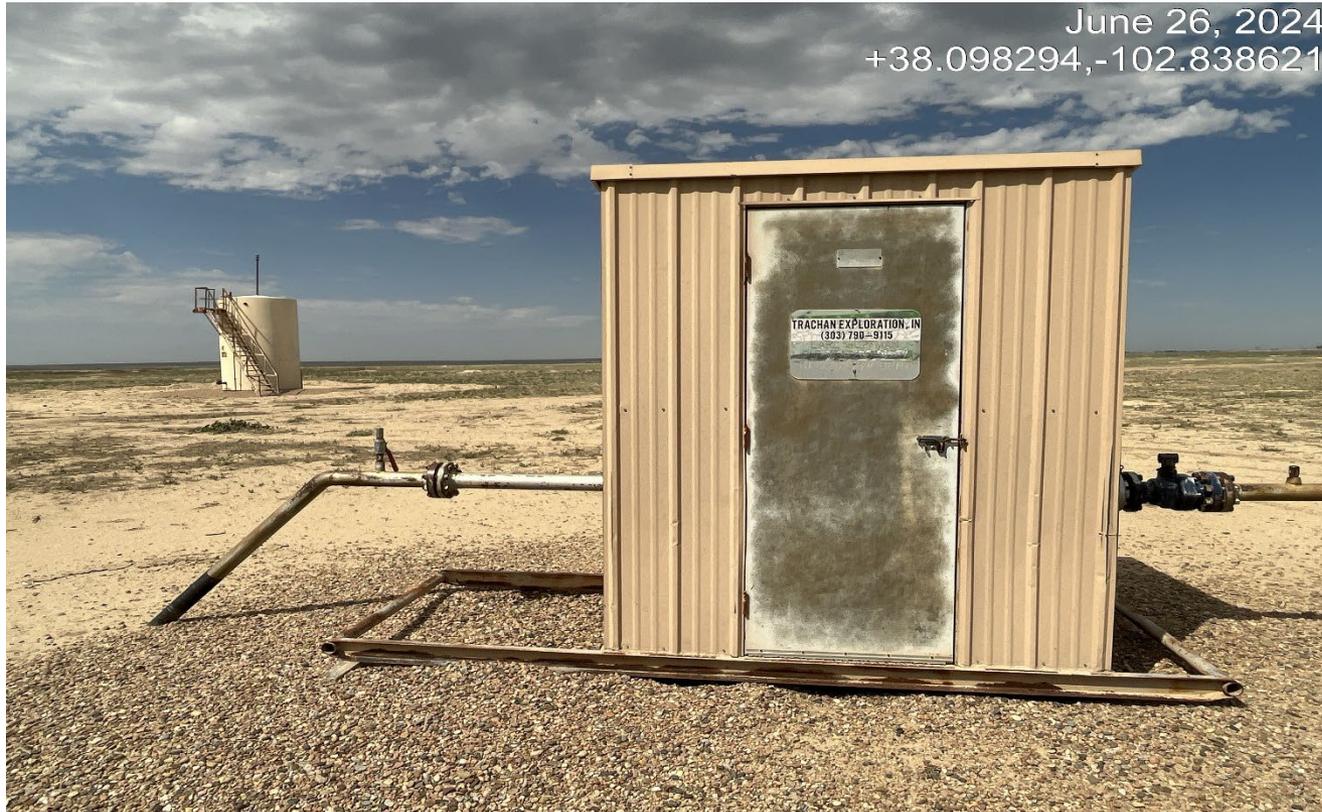
Photo 1. Facing south toward the location. The sign posted at meter shed is faded and not legible. Previous CA was not completed.

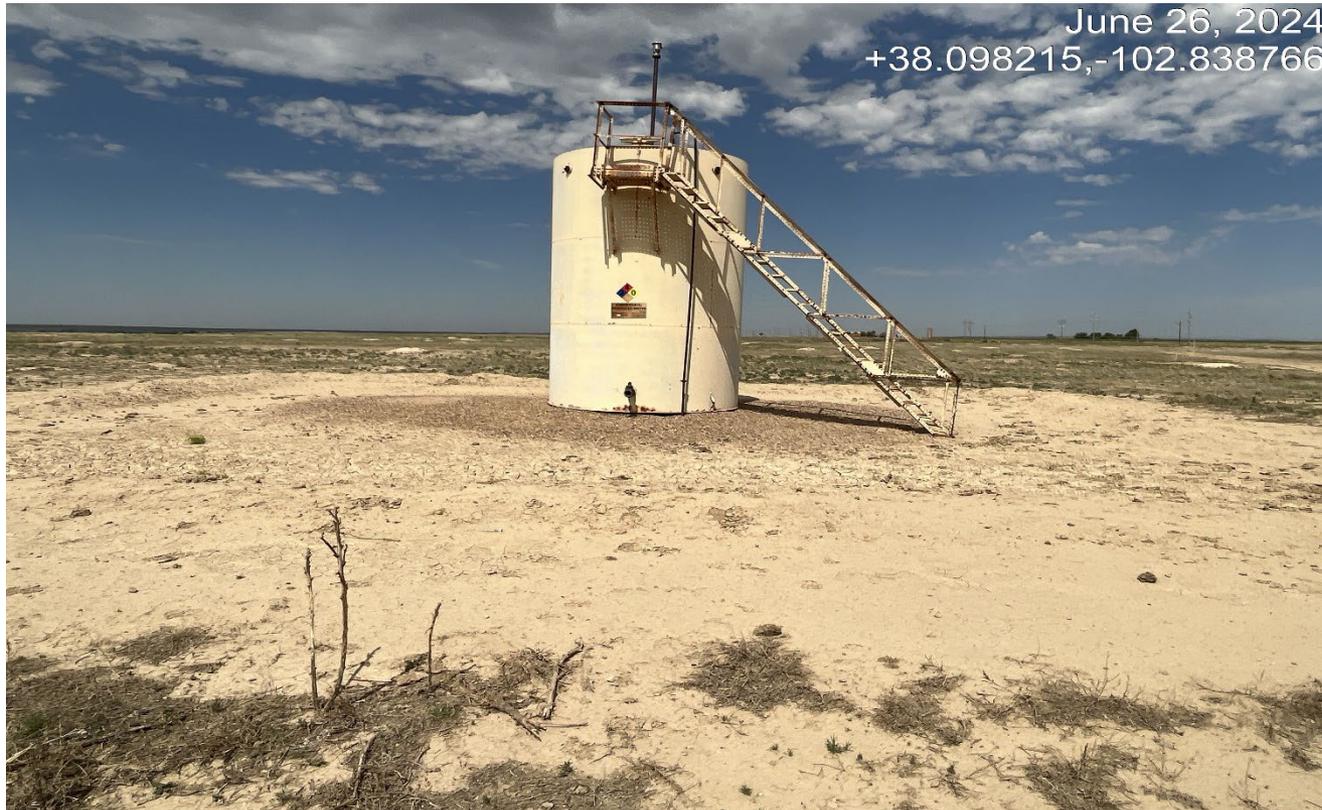
Photo 2. Facing toward the tank battery. There is insufficient secondary containment to contain a spill. Previous CA was not completed.
