Inspection Photos

Operator: Nuevada Resources LLC - 10764

Location ID: 484496

Inspection Document #: 714000911

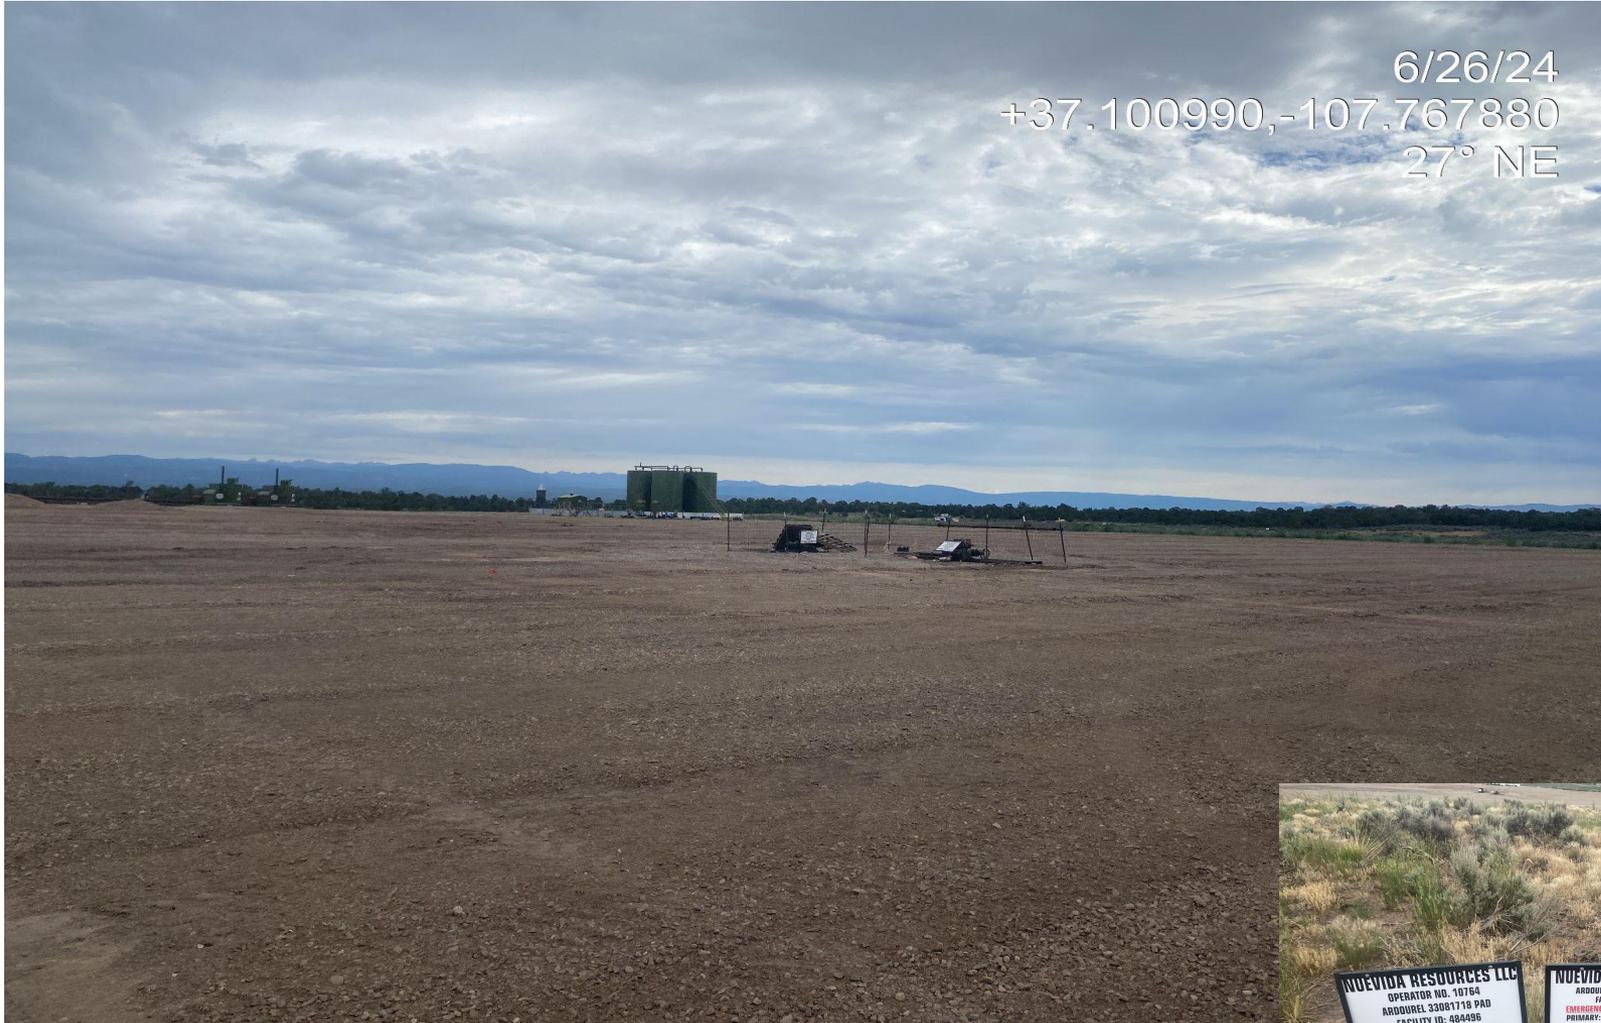
Photo 1. View of the well disturbance taken from the access point facing center.

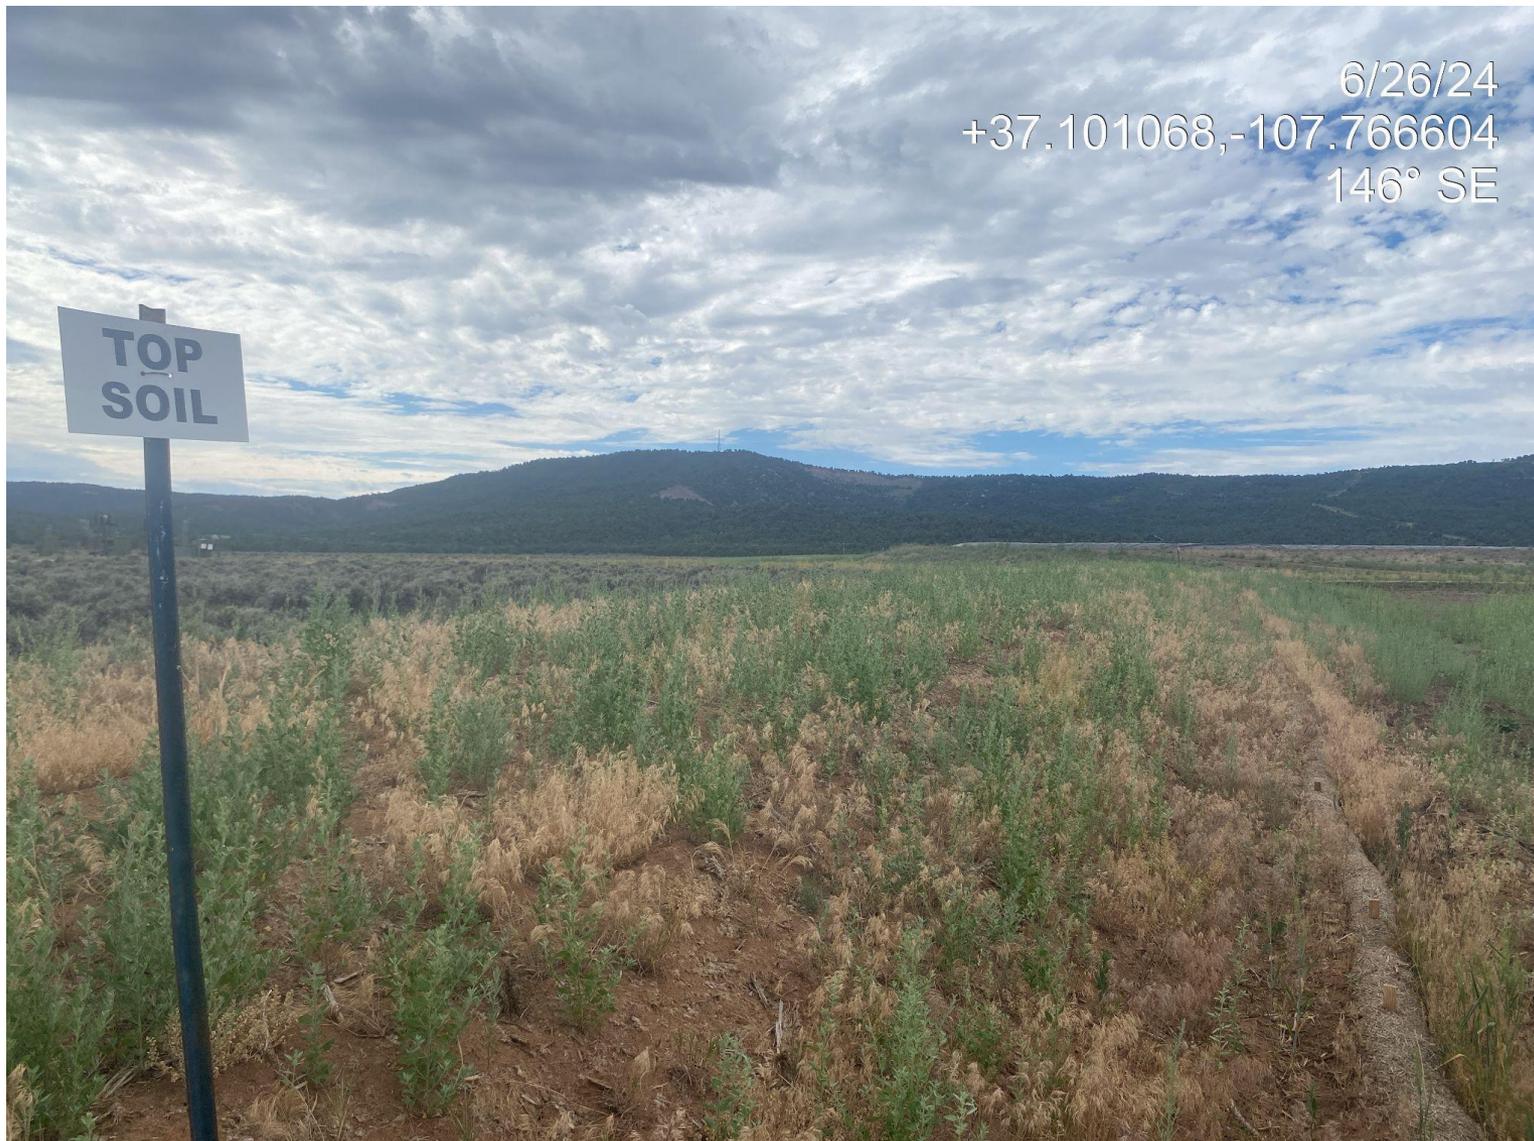
Photo 2. View of top soil pile covered in annual weeds, including but not limited to Cheatgrass and Lambs quarter. Note: All disturbed areas observed on the location were covered in annual weeds.

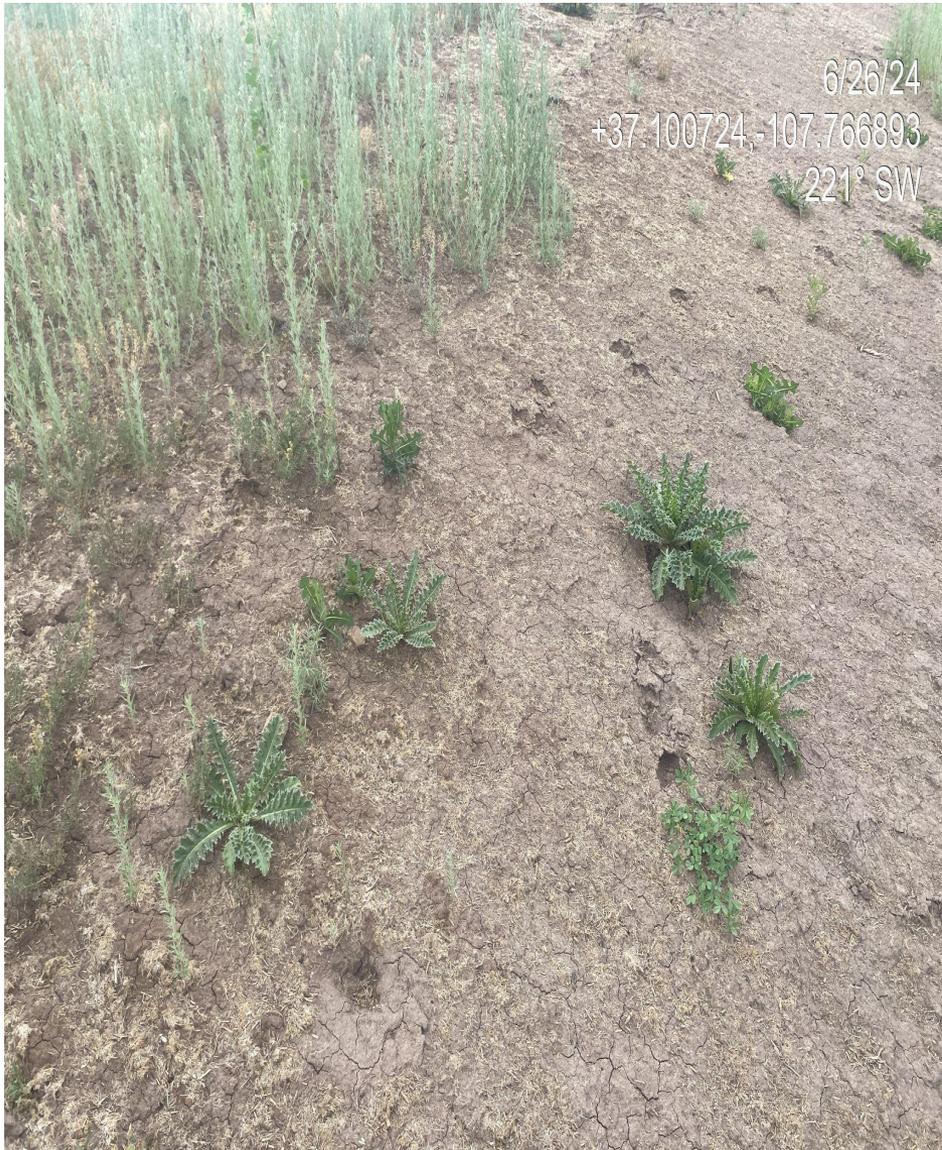
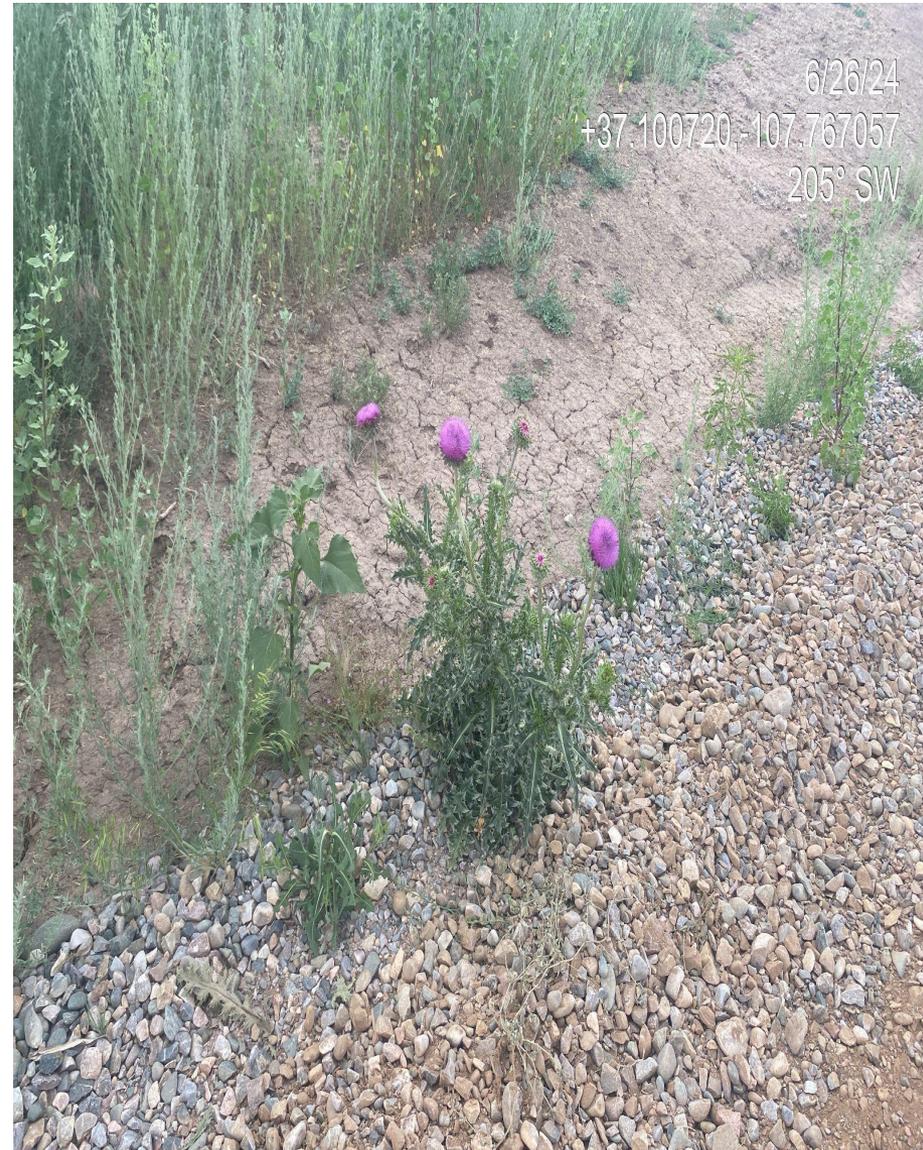
Photo 3. Musk thistle observed in patches around the well pad disturbance.

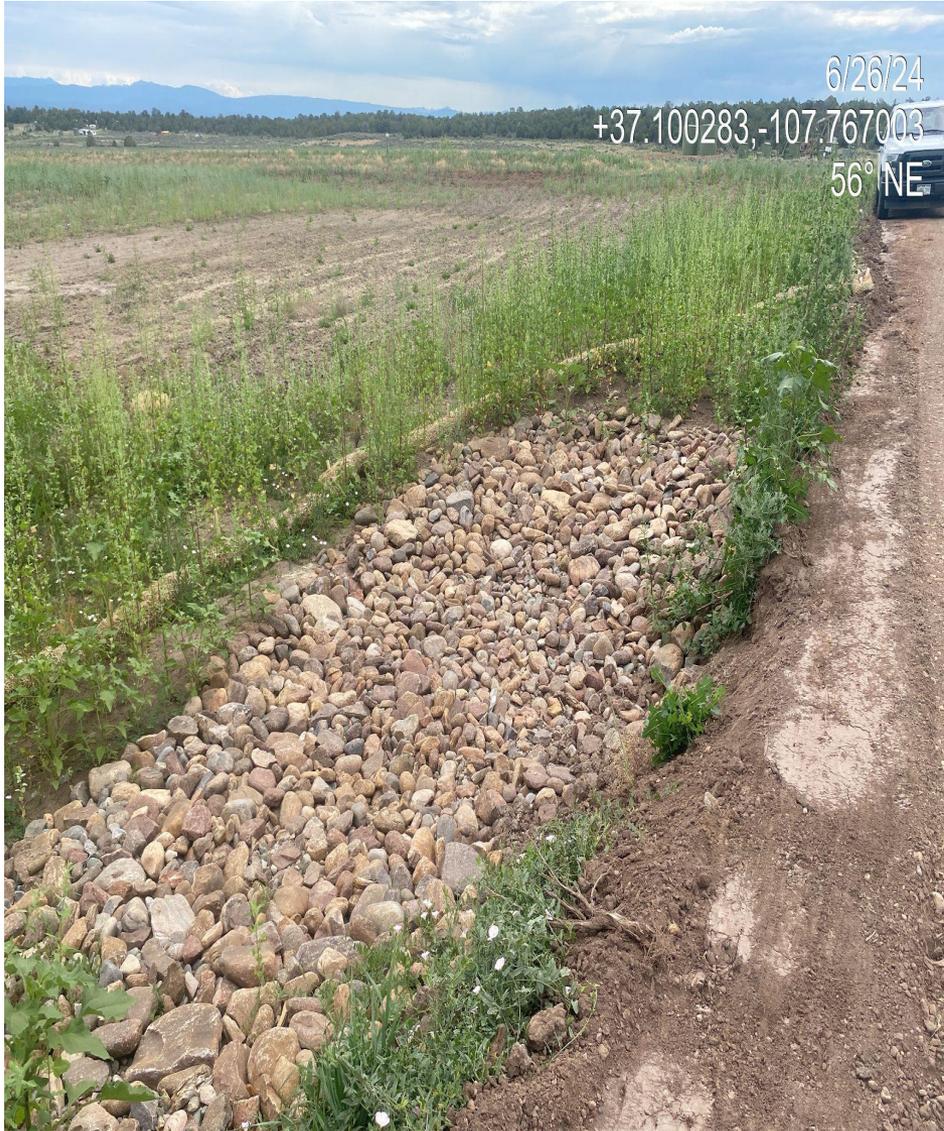
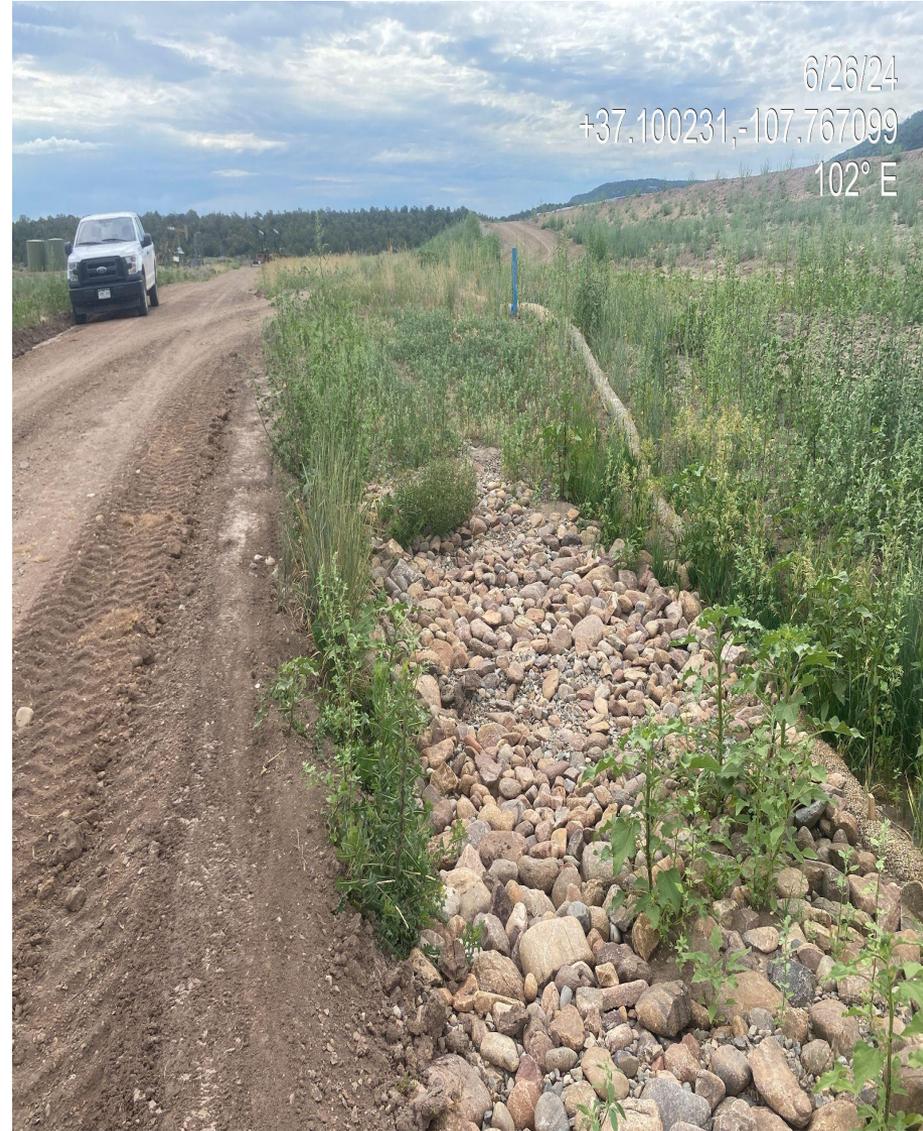
Photo 4. View of functioning and maintained storm water BMPs along existing access road separating the well and tank pads.

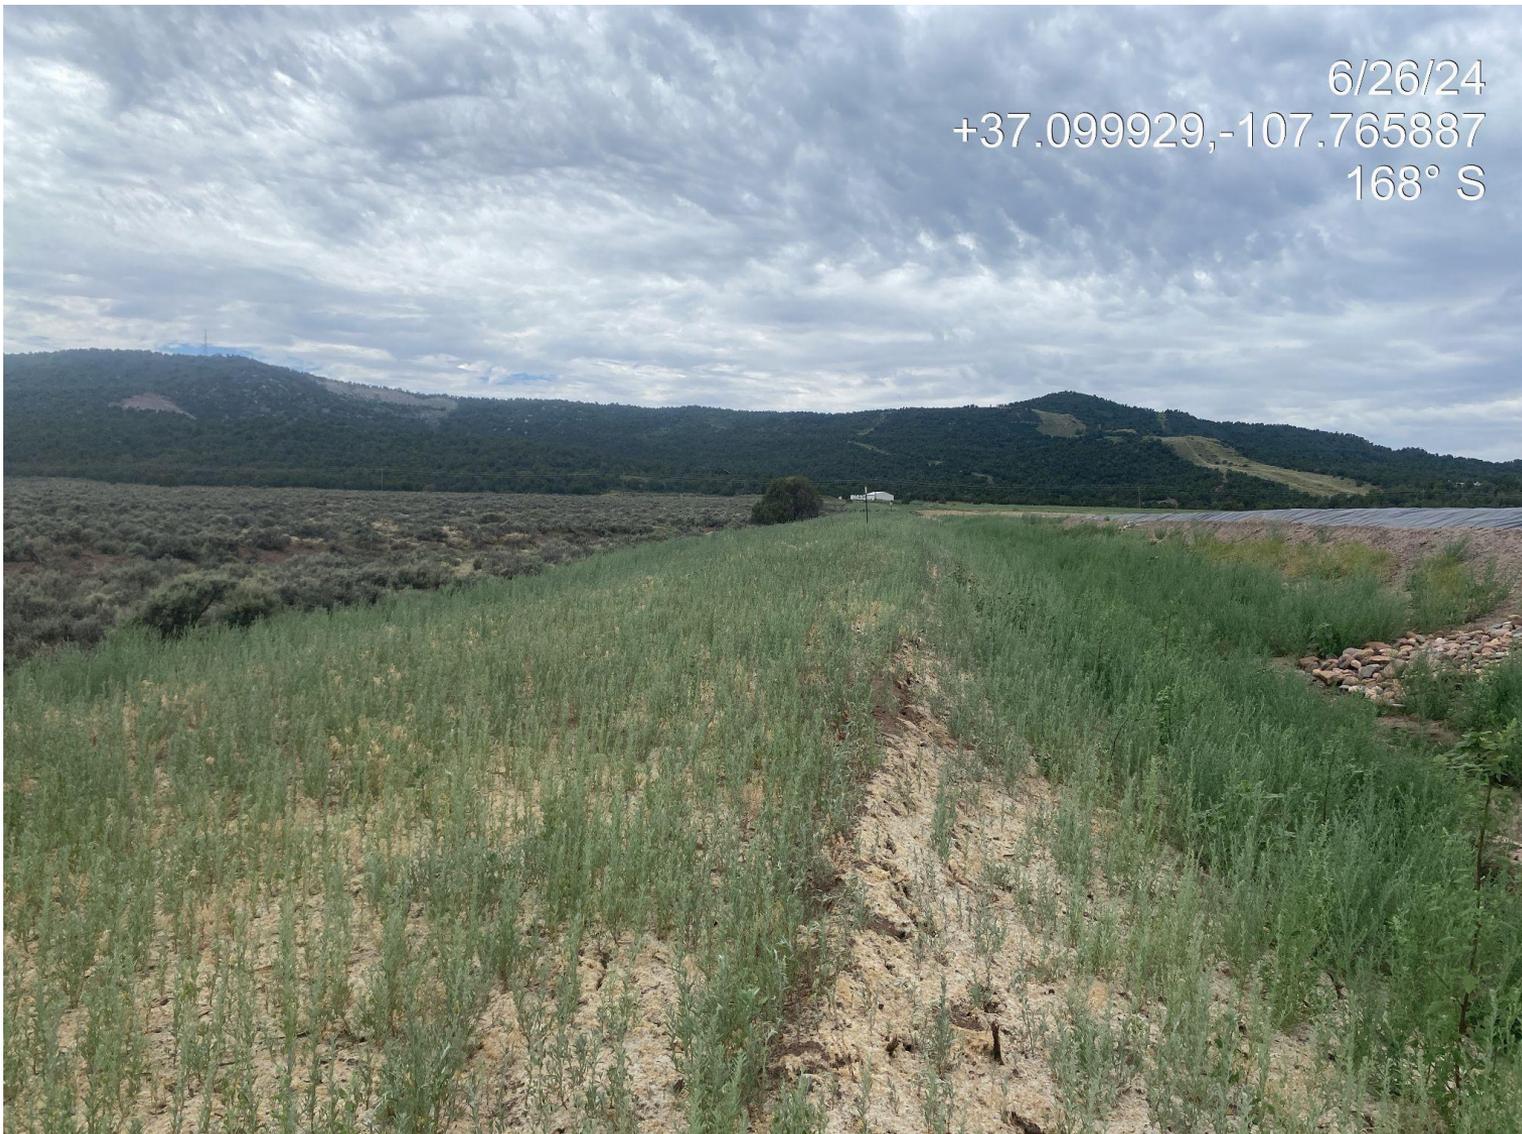
Photo 5. View of tank pad top soil pile that is covered in annual weeds, including but not limited to Cheatgrass and Lambs quarter.

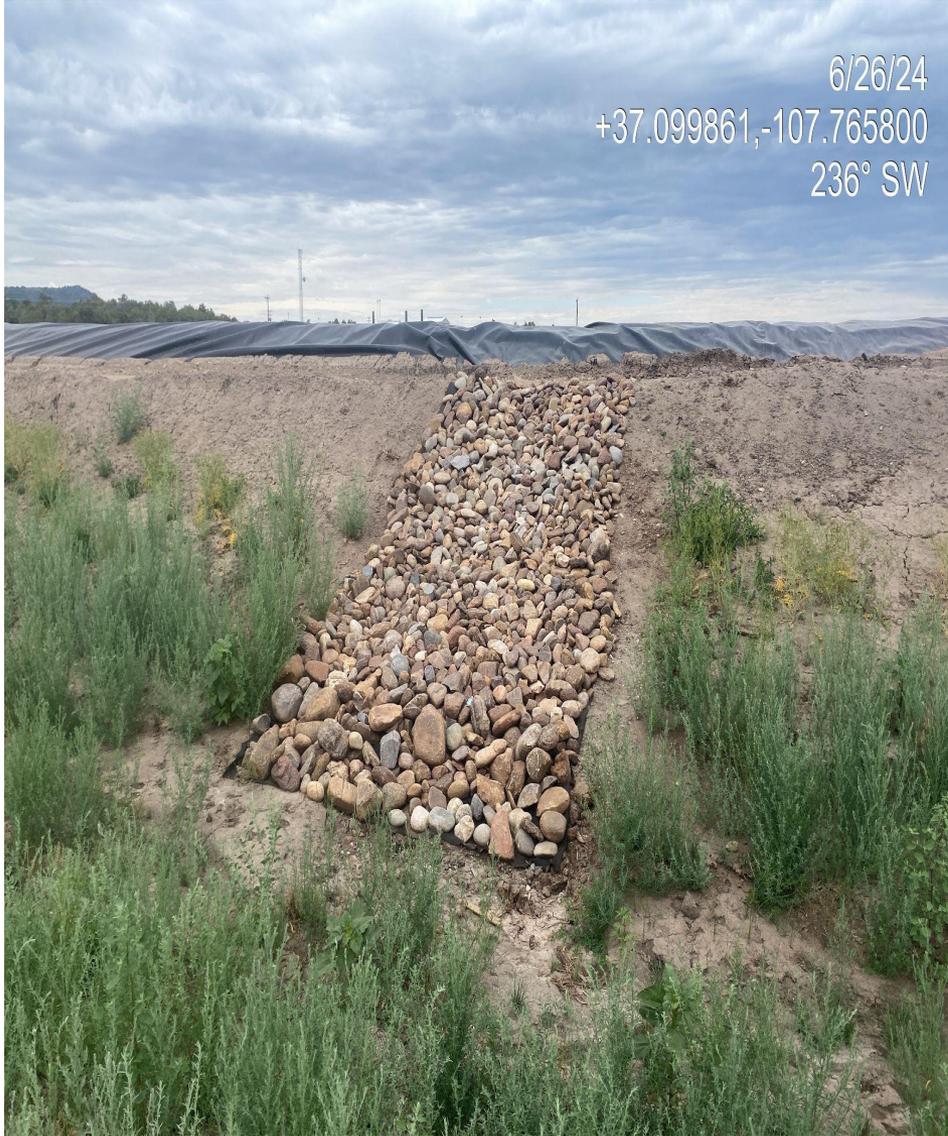
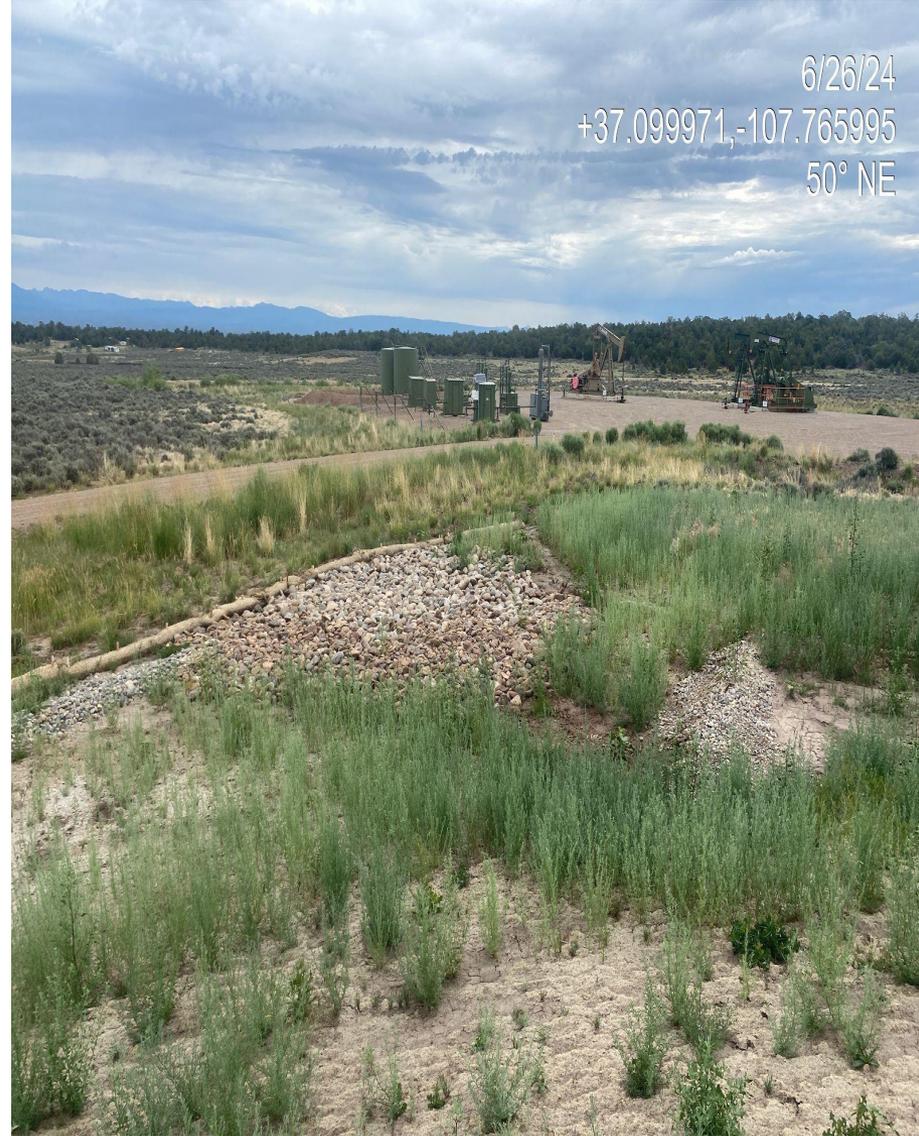
Photo 6. View of functioning and maintained storm water BMPs along the perimeter of the tank pad.

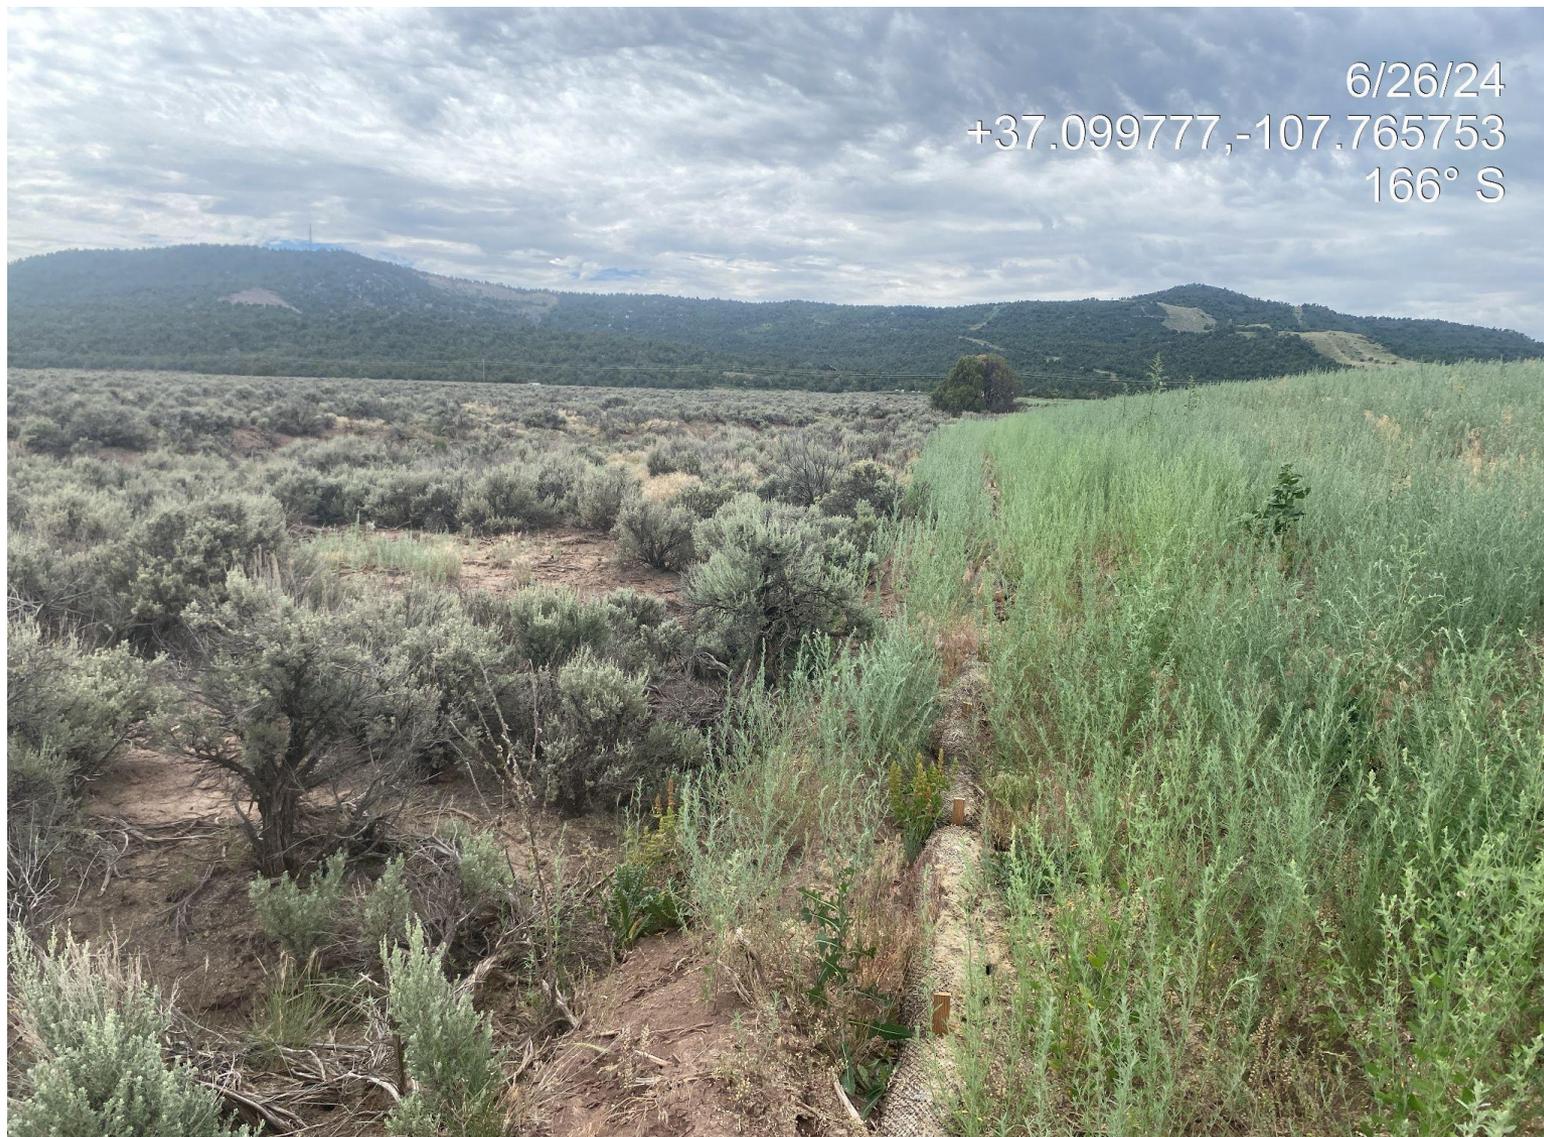
Photo 6. Additional view of delineation between reference area (Left) and disturbed area (right) where annual weeds have moved in and are dominating disturbed areas.

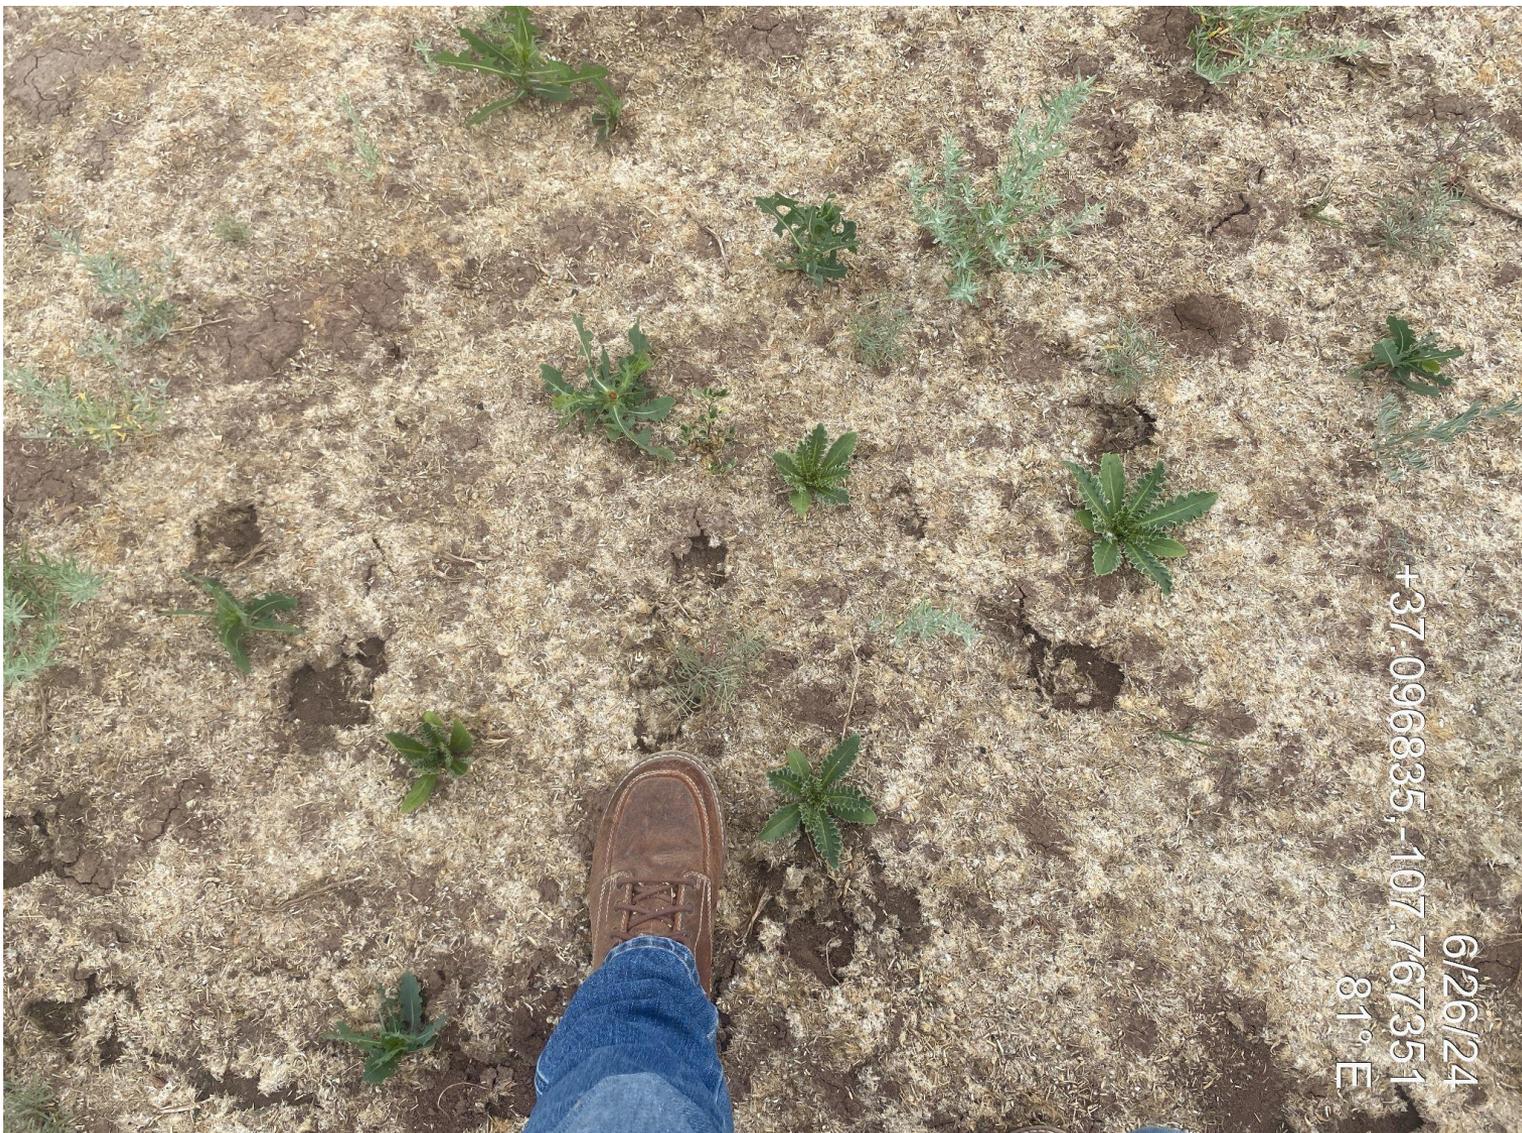
Photo 7. Additional view of musk thistle establishing in the tank pad disturbed areas.
