Final Reclamation and Stormwater Inspection

Operator: Bayswater Exploration & Production LLC -
10261

Location ID: 319523

Inspection Photos
Location Name: Chandler #1
Location ID: 319523

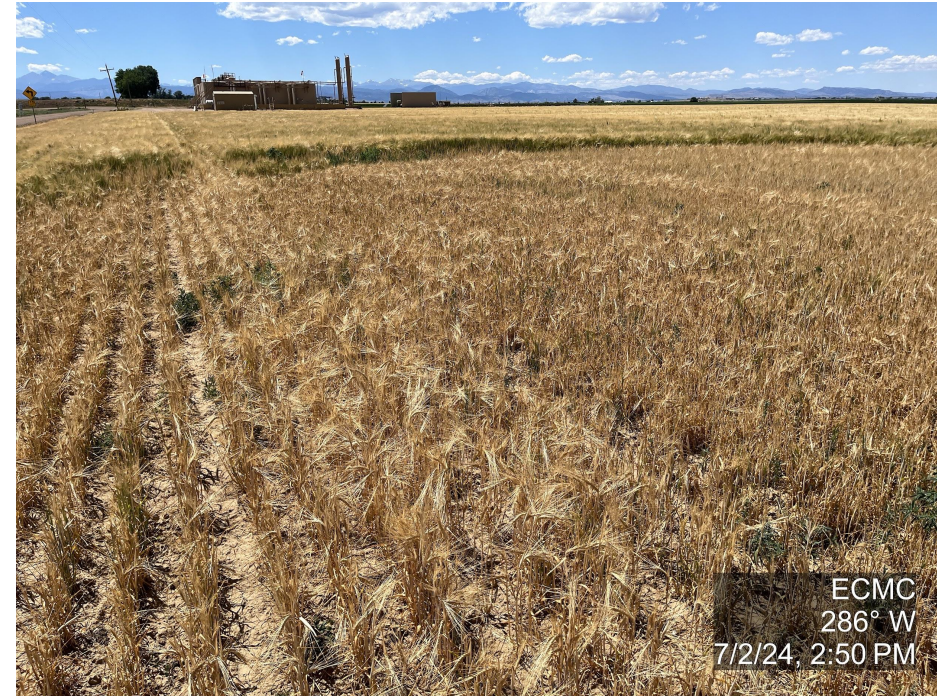
Photo 1. The photo was taken at the tank battery location facing North. The photo illustrates crop in the disturbance (Red) has not yet met reference areas (Blue).

Photo 2. The photo was taken at the tank battery location facing West. The photo illustrates the boundary and discrepancy between the disturbed area and reference in the field.

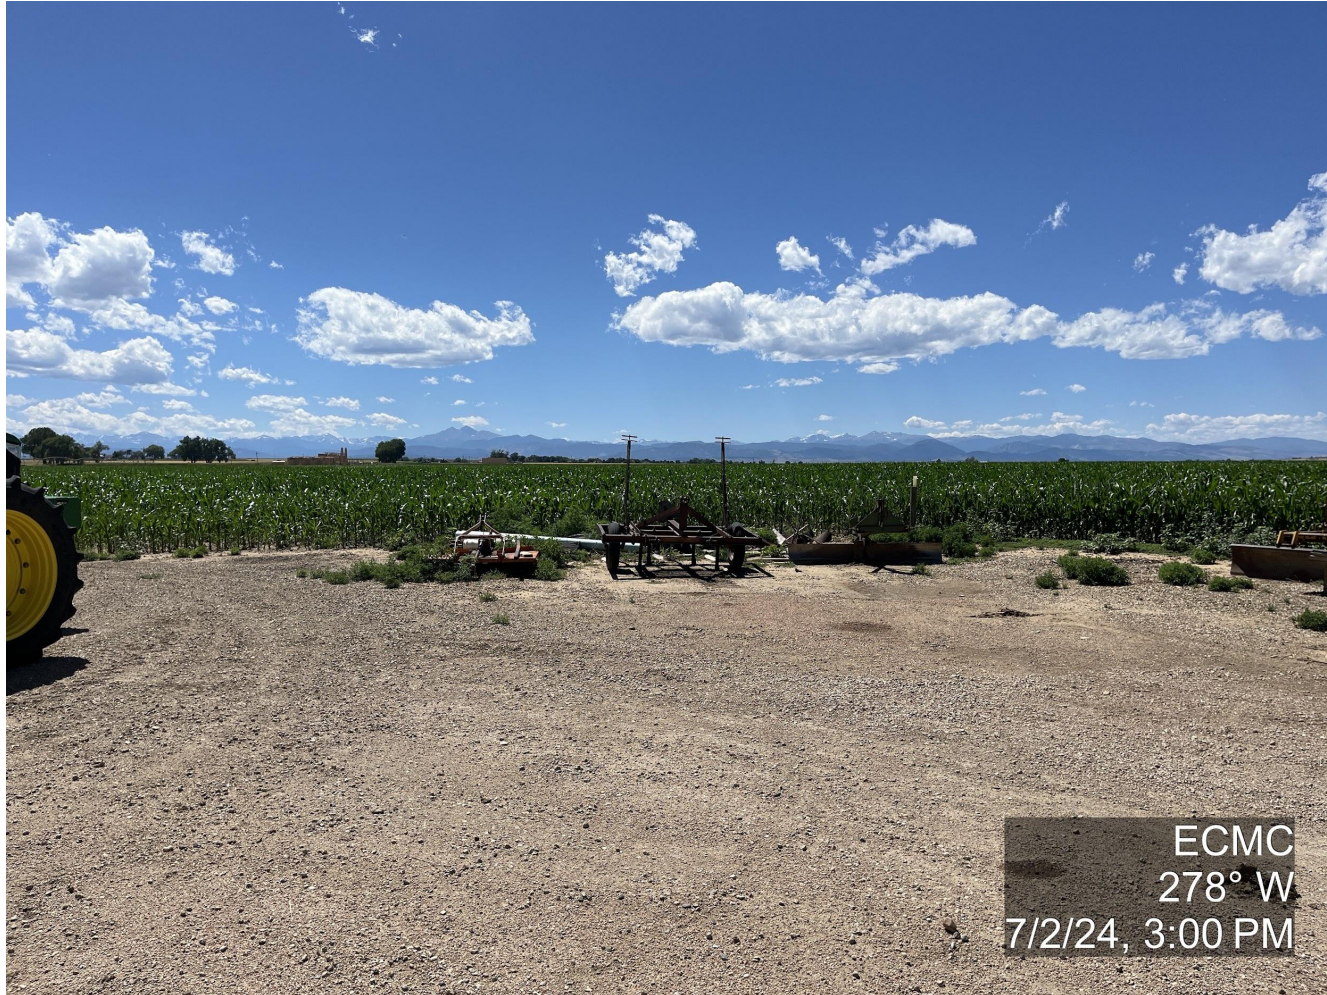
Photo 3. The photo was taken east of the well location facing West. The photo illustrates the well and access road appear to continue to meet Rule 1004 standards.
