**Operator: *CRESTONE PEAK RESOURCES OPERATING LLC***

**Location Name: BRANCH-64N65W 23SWSW**

**Loc ID: 332679**

**Inspection: 714201321**

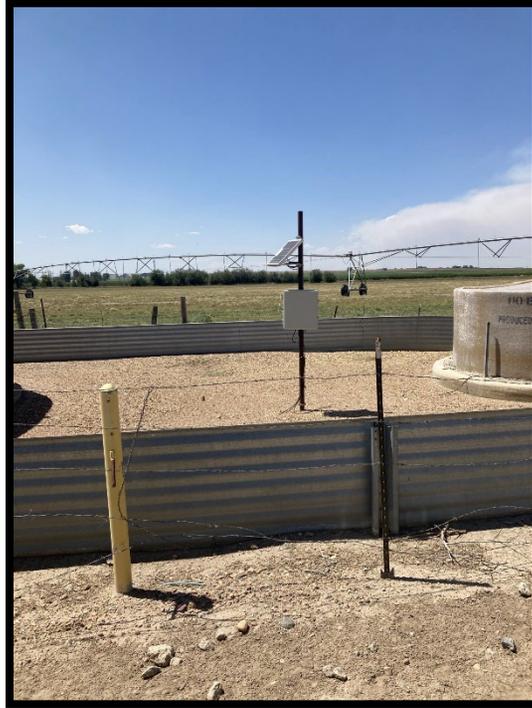
**Exhibit A**

**CA:** Overgrown vegetation inside tank battery berm. See attached photo. Comply with Rule 606.

**CA Resolution:** Weeds have been removed to comply with Rule 606.
