Interim Reclamation and Stormwater Inspection

Operator: O'Brien Energy Resources Corp - 65110

Location ID: 306094

Inspection Photos
Location Name: Lost Creek #31
Location ID: 306094

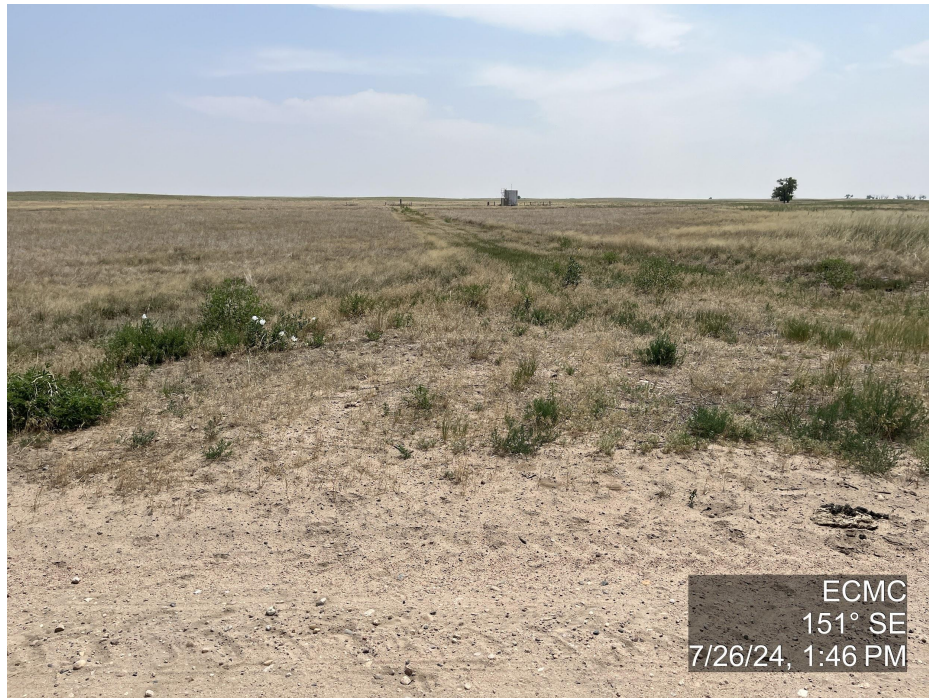
Photo 1. The photo was taken at the entrance to the well location facing Southeast. The photo illustrates the access road is vegetated.

Note - There was no Operator sign posted at the entrance to the well location.

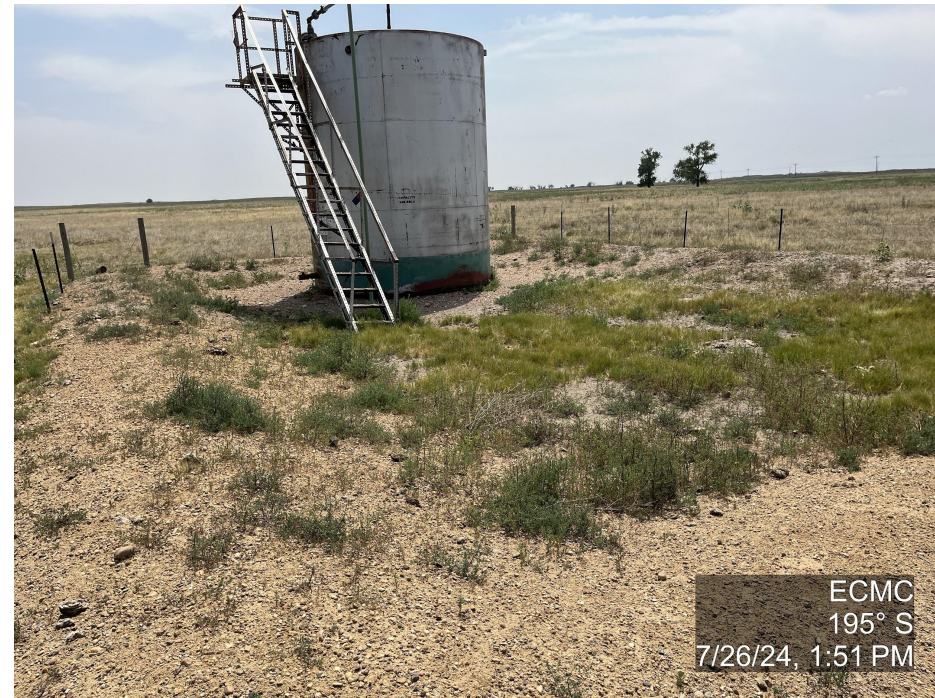
Photo 2. The photo was taken at the well location facing South. The photo illustrates overgrown vegetation within the tank battery containment.

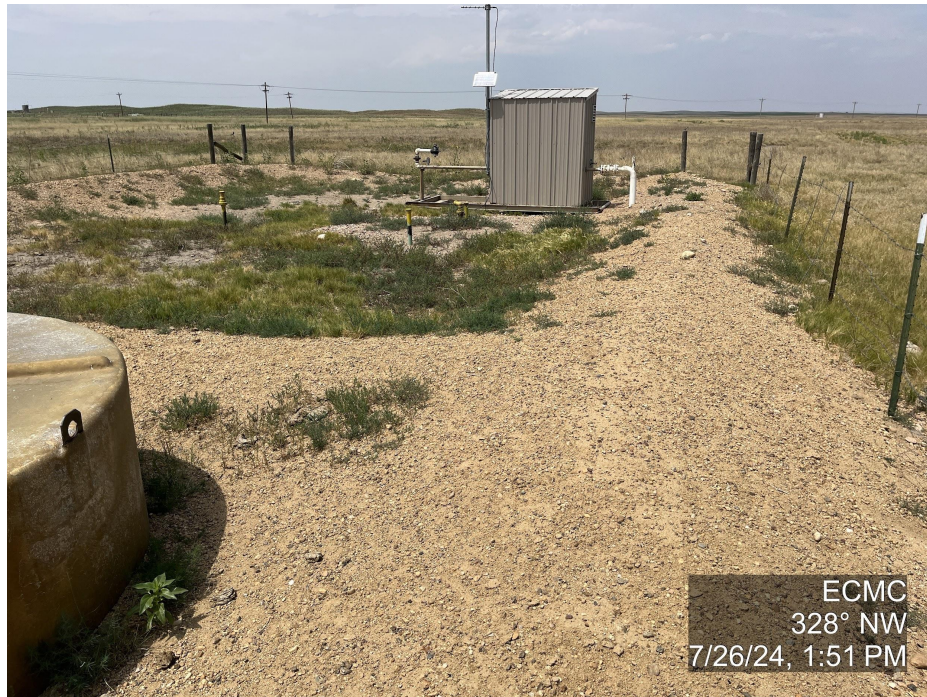
Photo 3. The photo was taken at the well location facing Northwest. Refer to the comment for photo 2.

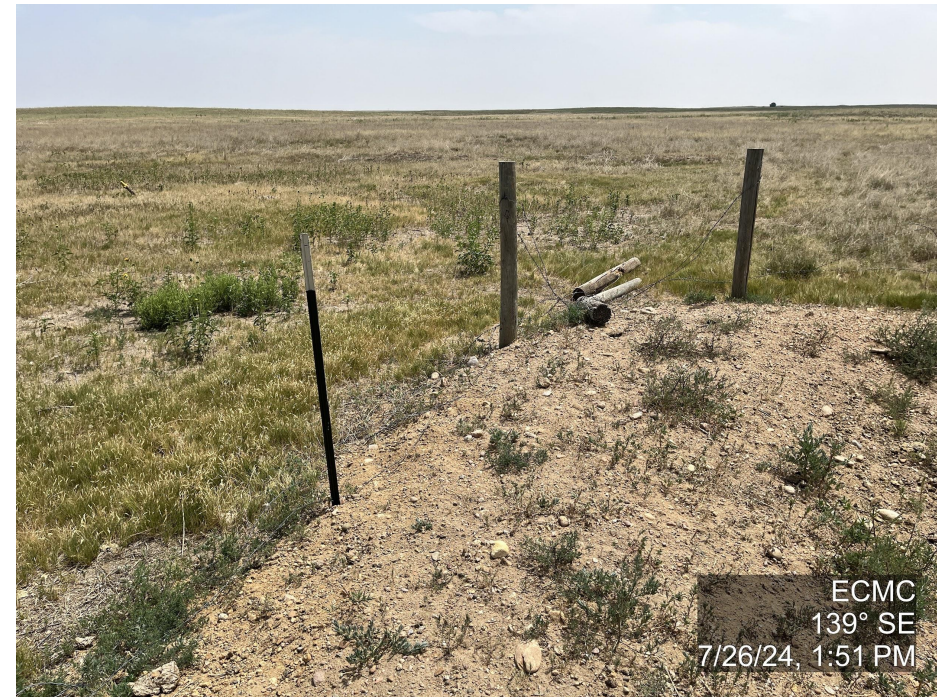
Photo 4. The photo was taken at the well location facing Southeast. The photo illustrates the tank battery fencing is in disrepair.

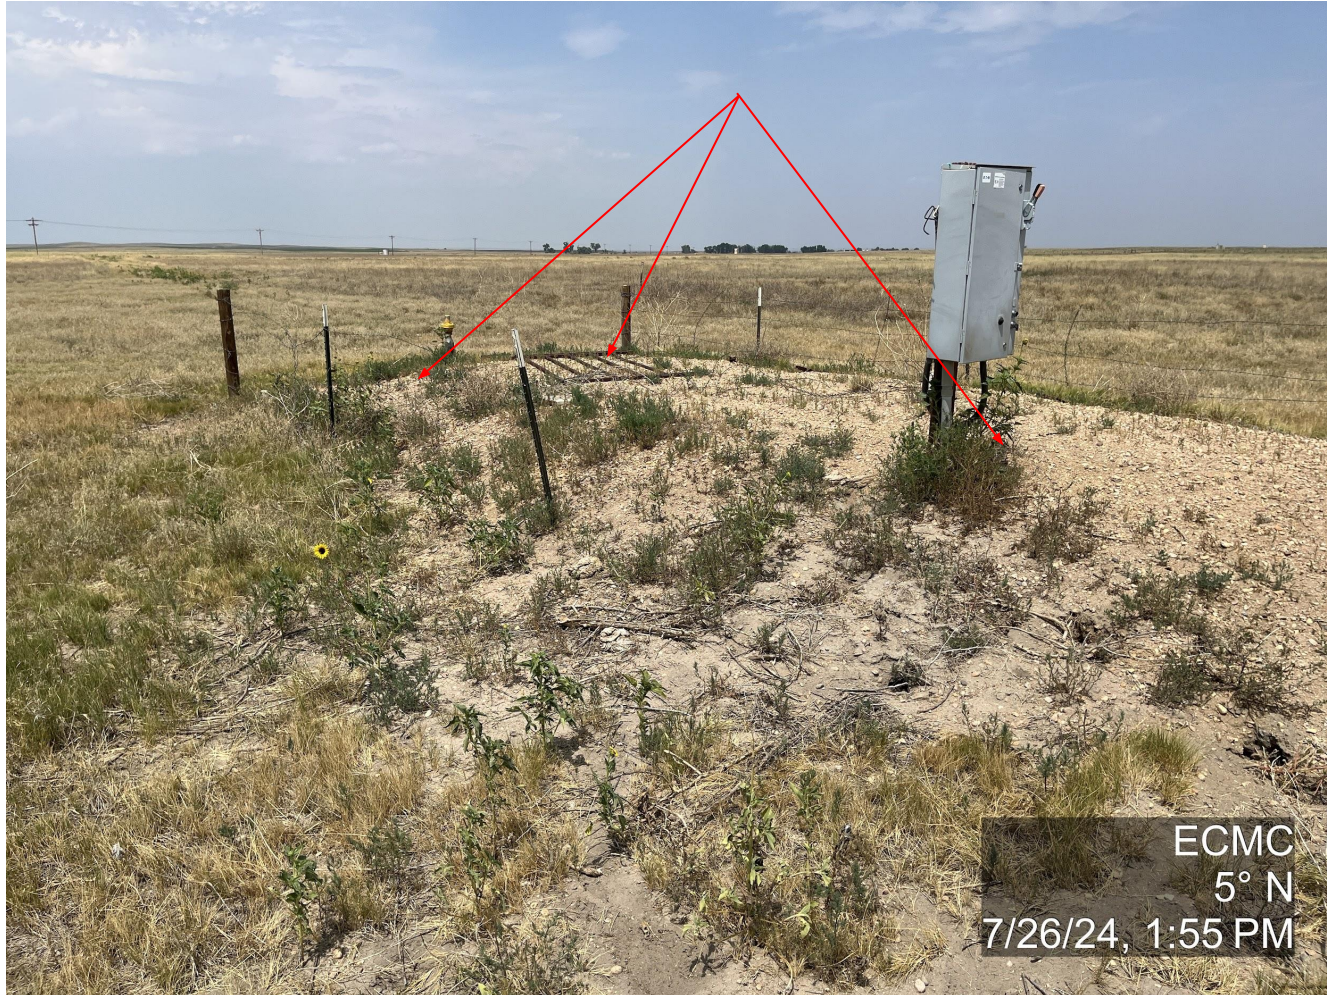
Photo 5. The photo was taken at the well location facing North. The photo illustrates fencing in disrepair, overgrown weeds on the well pad, and debris left throughout the area.
