Interim Reclamation and Stormwater Inspection

Operator: GMT EXPLORATION COMPANY LLC #10243

Location ID: 479191

Inspection Document #: 697505395

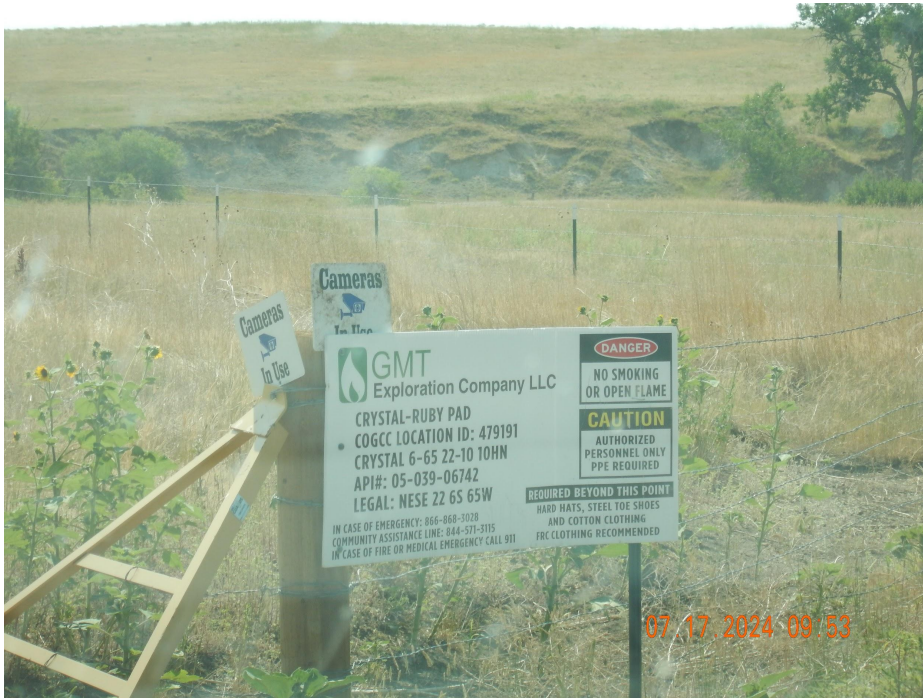
Photo 1. Photo taken from the entrance of location, illustrating the Operator sign.

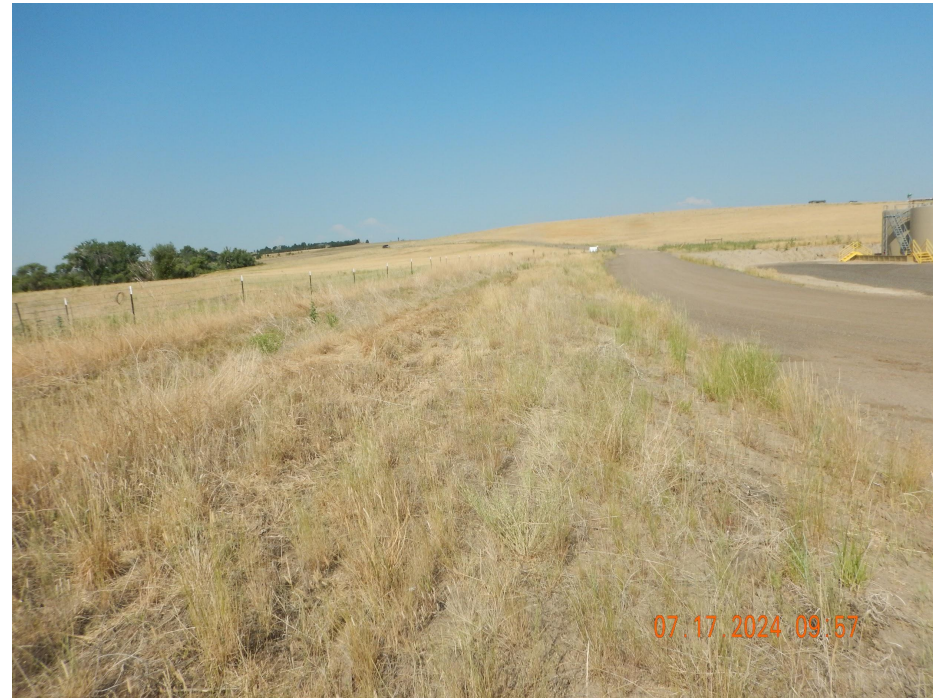
Photo 2. Photo taken along the southeastern perimeter of location, facing West. Photo illustrates the reclamation construction areas are in process of vegetation establishment; however, there appears to be a lack of desirable vegetation.

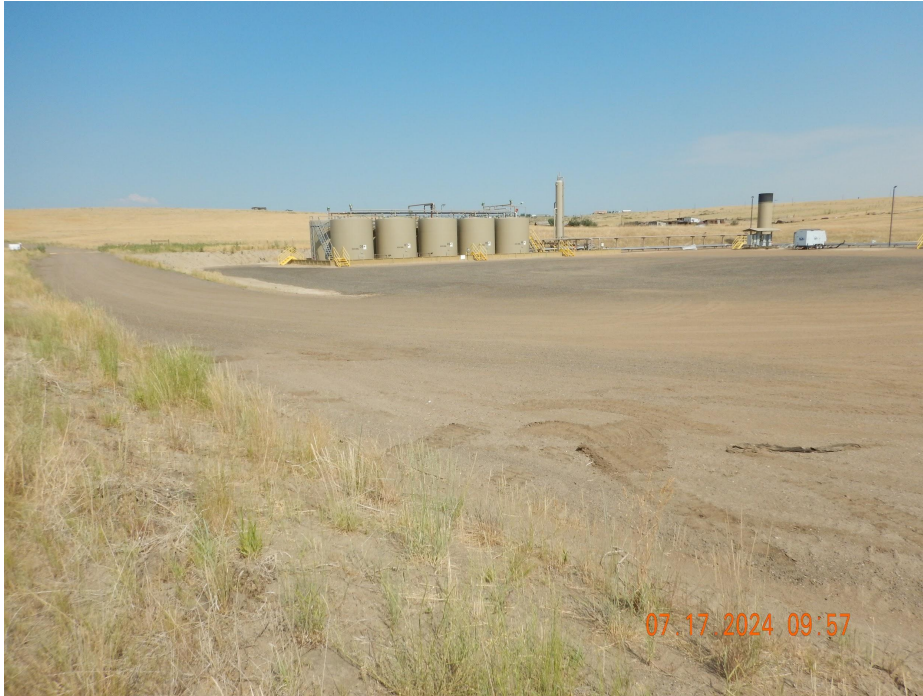
Photo 3. Photo taken along the southeastern perimeter of location, facing Northwest. Photo is an overview of the location.

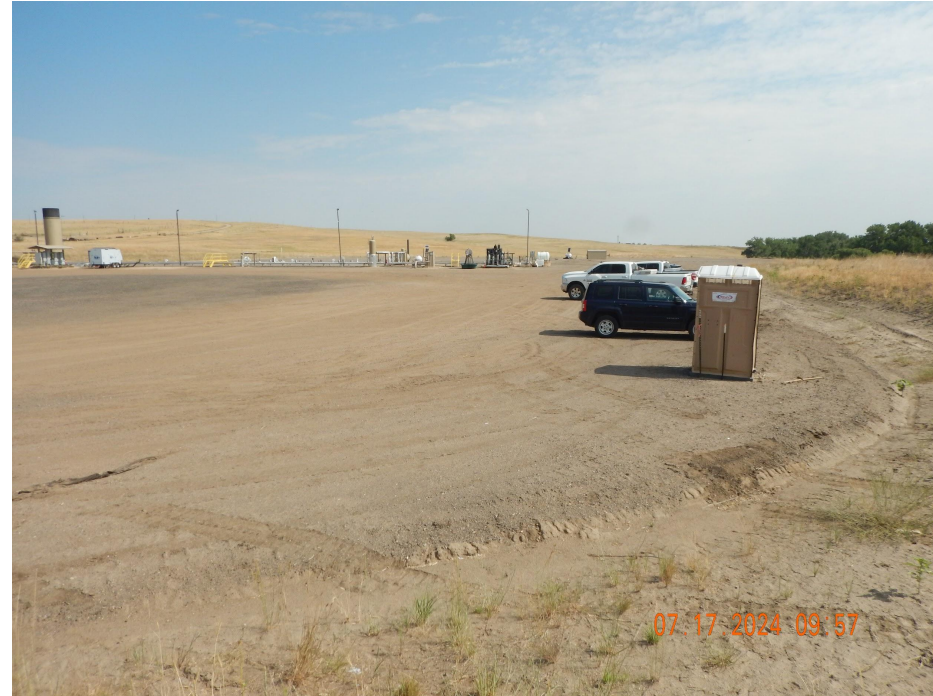
Photo 4. Photo taken along the southeastern perimeter of location, facing North. See comment under Photo 3. Photo illustrates the port-o-let is stabilized.

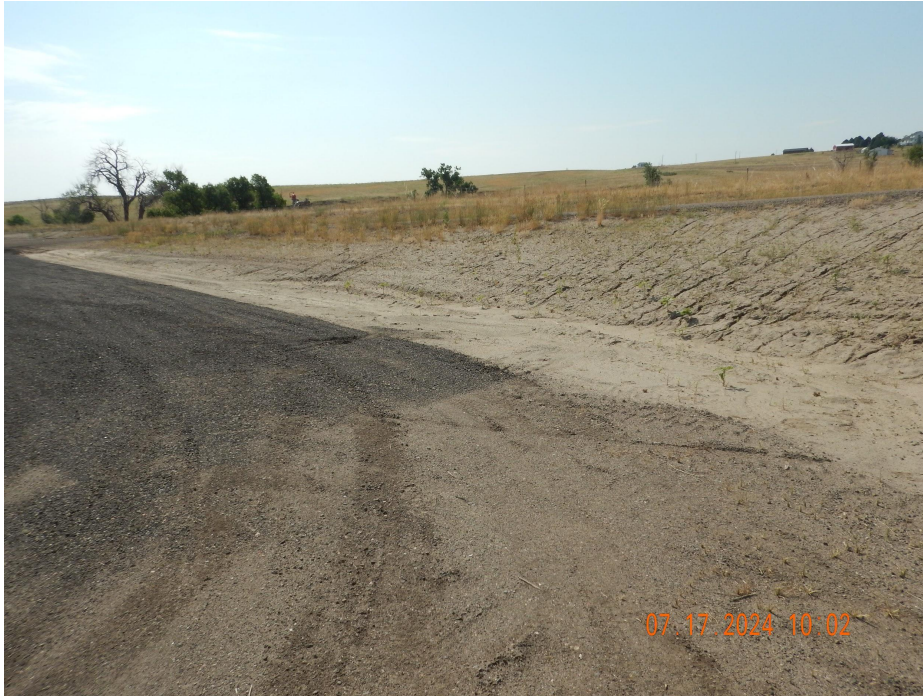
Photo 5. Photo taken along the southwestern working pad surface, facing Southeast. Photo illustrates rill erosion along the cut slope and sediment accumulation along the toe of the slope.

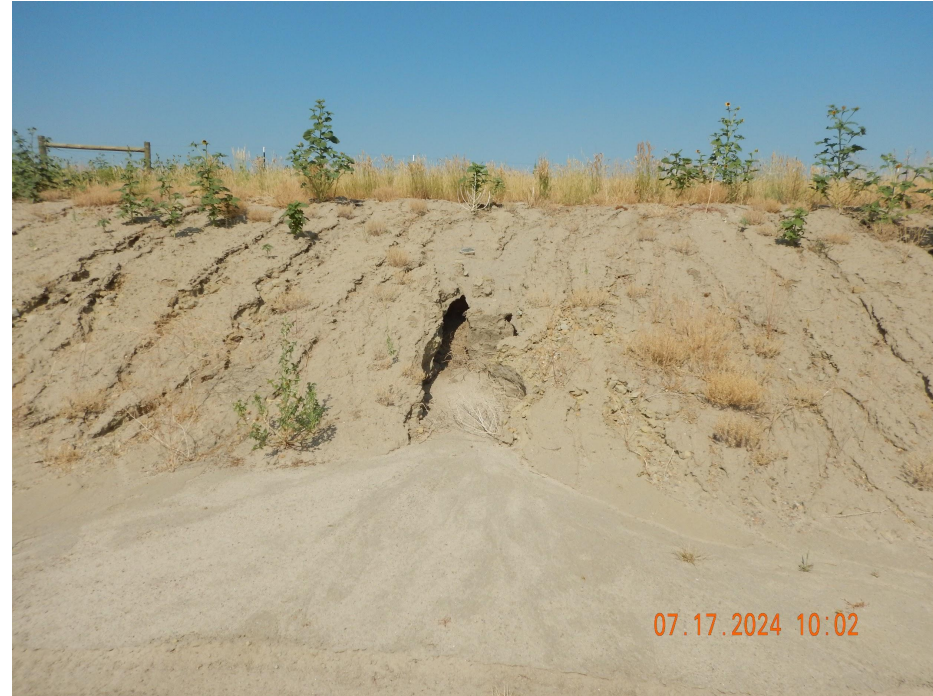
Photo 6. Photo taken along the southwestern working pad surface, facing West. See comments under Photo 5.

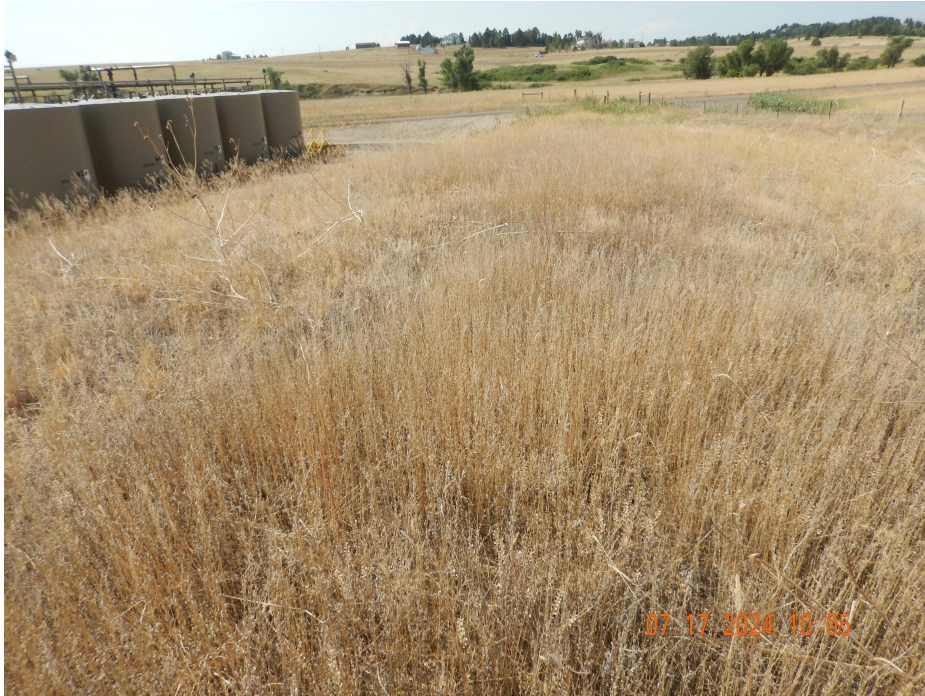
Photo 7. Photo taken from the western topsoil stockpile, facing South. Photo illustrates the stockpile has some establishment of an introduced grass species, Crested wheatgrass, but mostly established with weedy, annual vegetation.

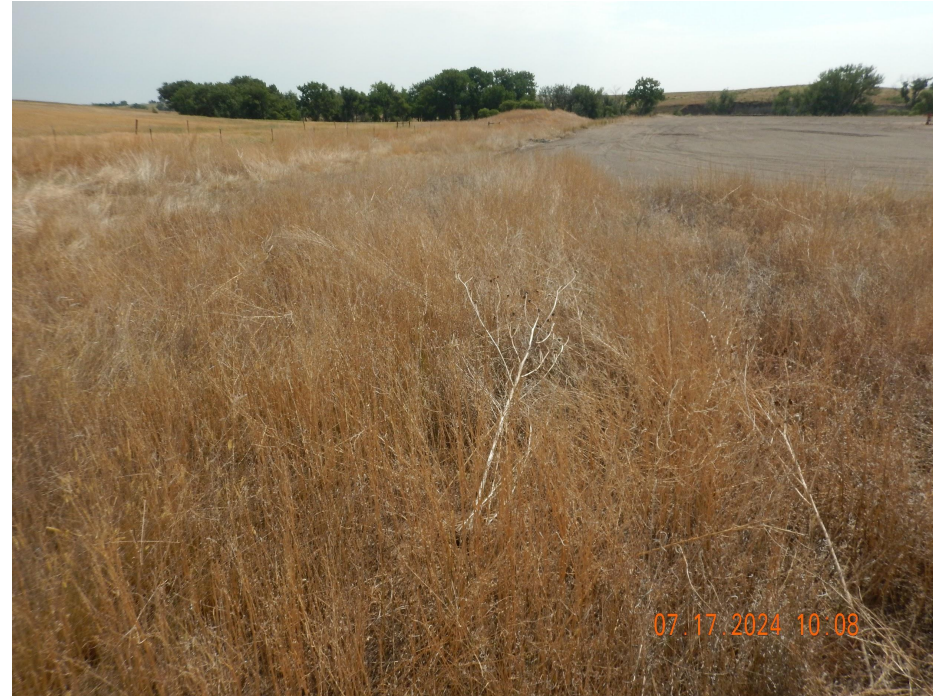
Photo 8. Photo taken along the northwestern perimeter of location, facing East. Photo illustrates weedy, annual vegetation.

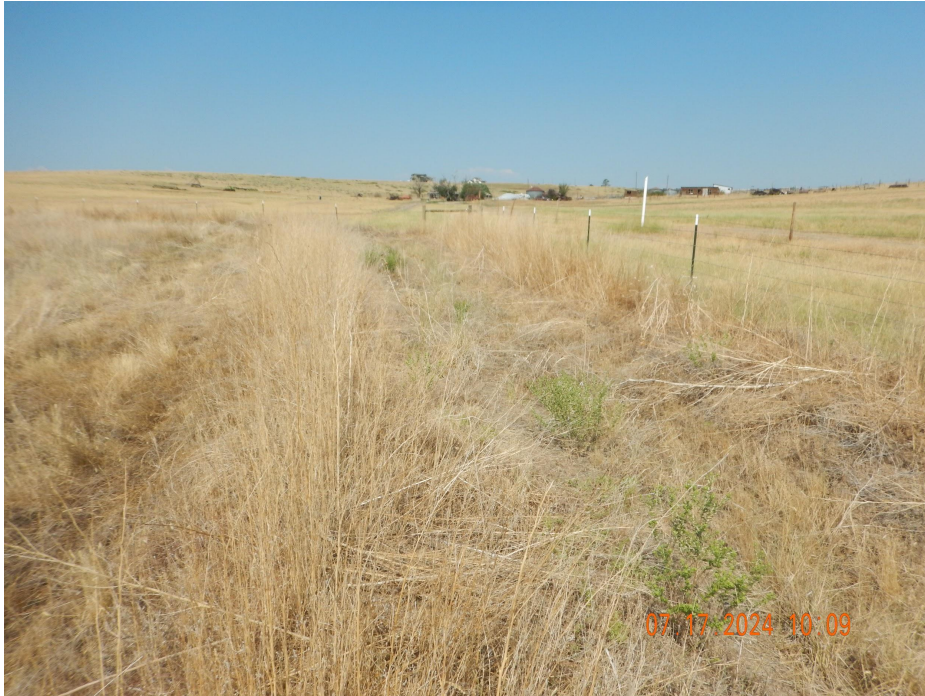
Photo 9. Photo taken along the northern perimeter of location, facing East. Photo illustrates weedy, annual vegetation and a handful of noxious thistles.

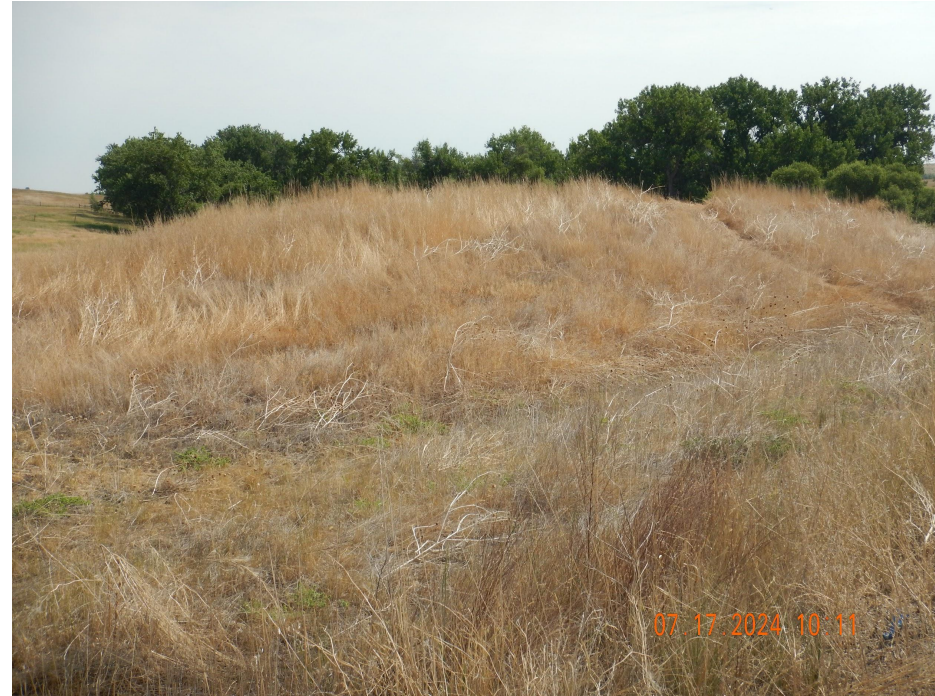
Photo 10. Photo taken of the northern topsoil stockpile, facing Northeast. Photo illustrates weedy, annual vegetation.

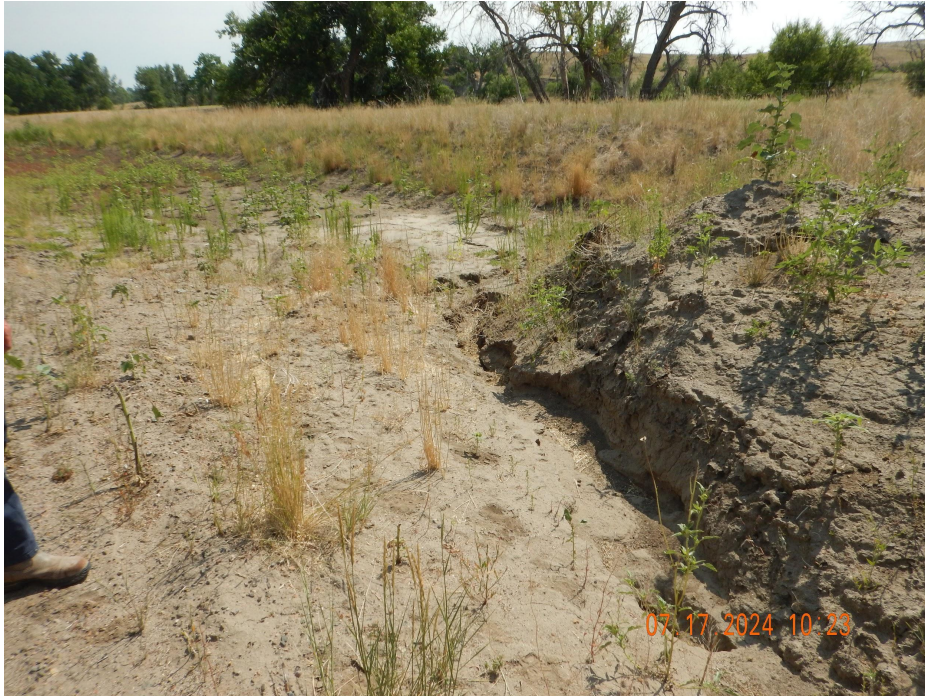
Photo 11. Photo taken from the eastern working pad surface, facing Northeast. Photo illustrates erosion into the retention pond.

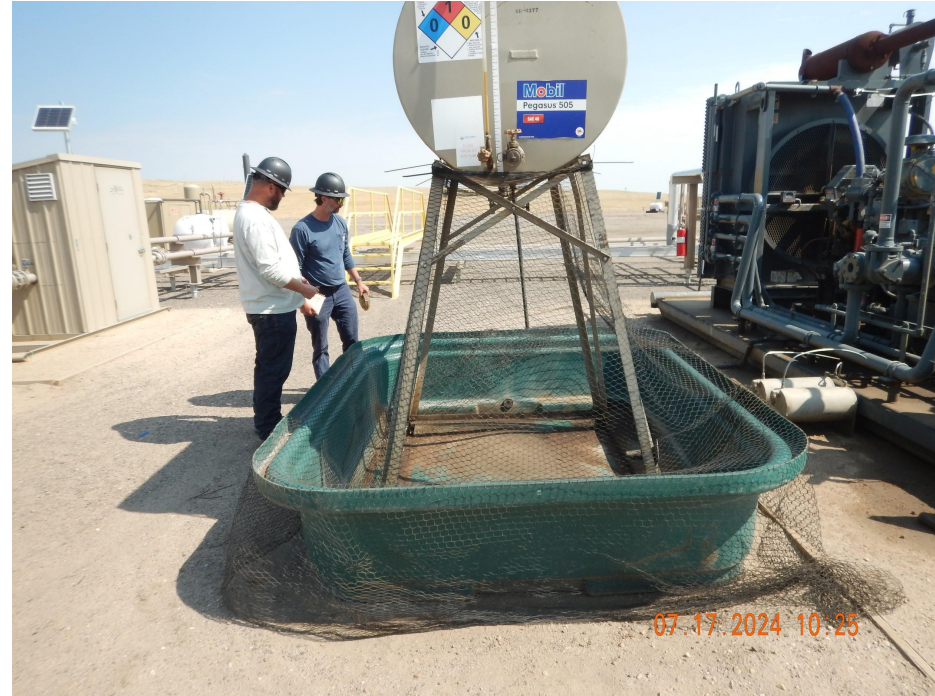
Photo 12. Photo taken from the northern production area illustrating the secondary containment with wildlife protection. Note- netting needs to be better secured to ensure protection.

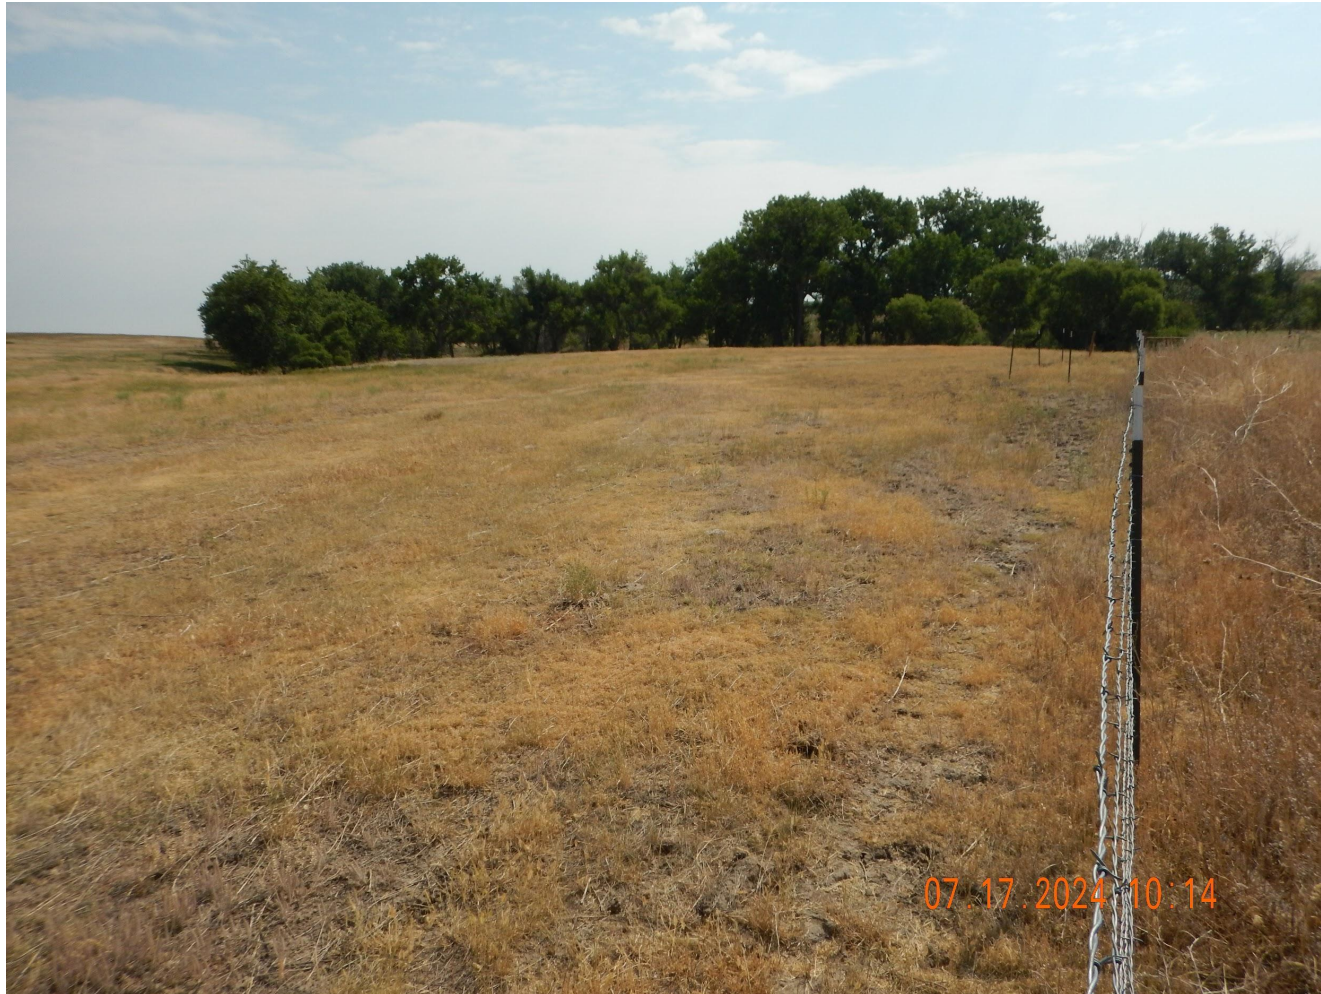
Photo 13. Reference photo taken along the northern perimeter of location, facing East.
Photo illustrates the reference area native shortgrass prairie vegetation.

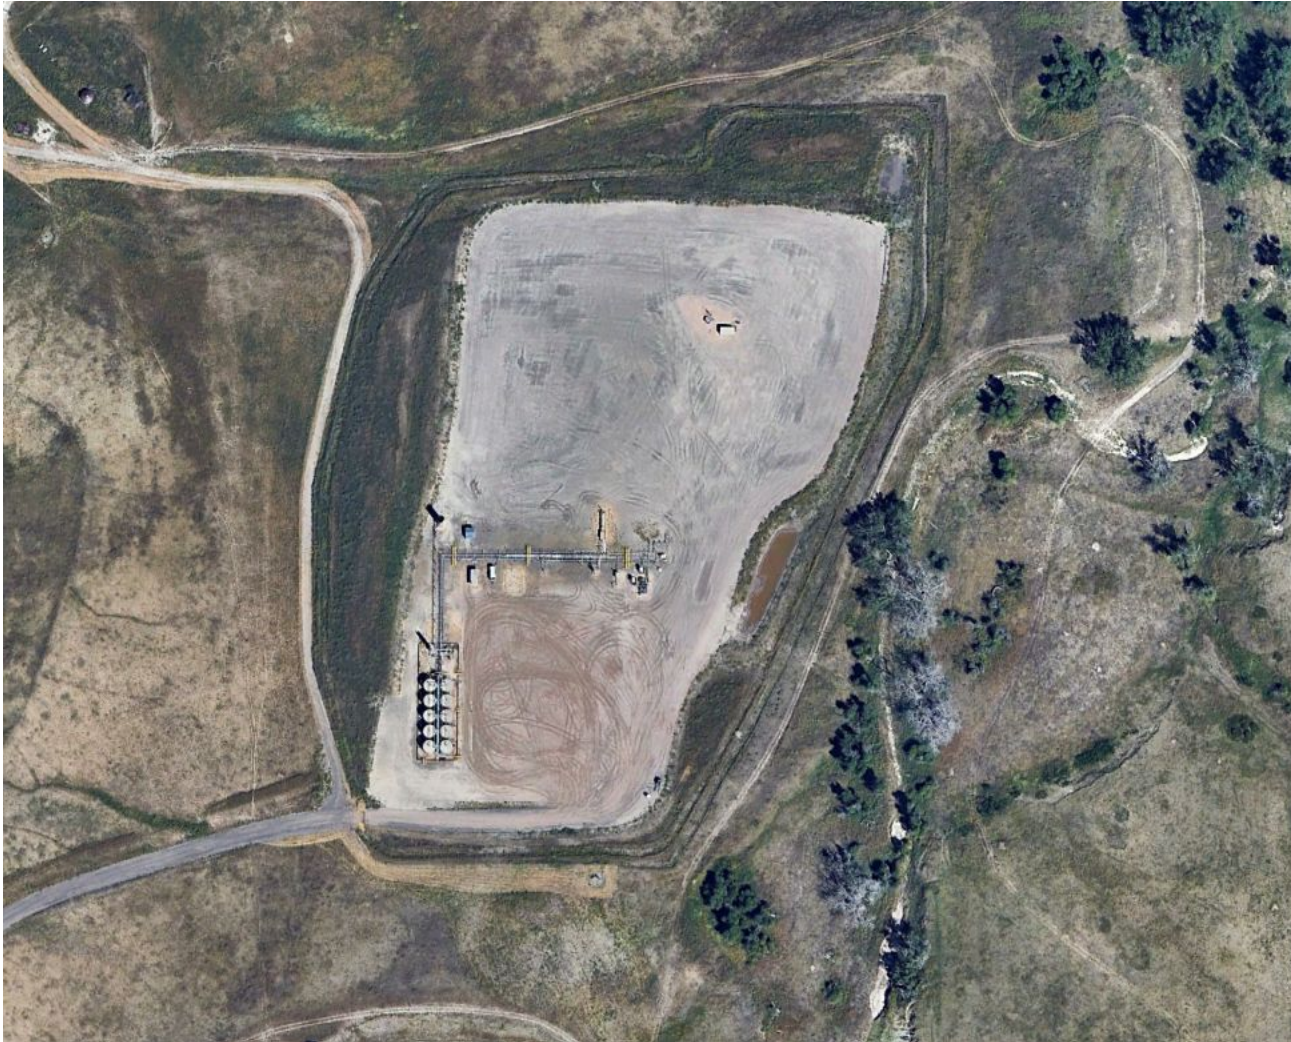
Photo 14. Google Earth aerial imagery from 9/4/2023 illustrates the location and the eastern portion of the access road.
