Inspection Photos

Operator: CAERUS PICEANCE LLC - 10456

Location ID: 323905

Inspection Doc: 696206082

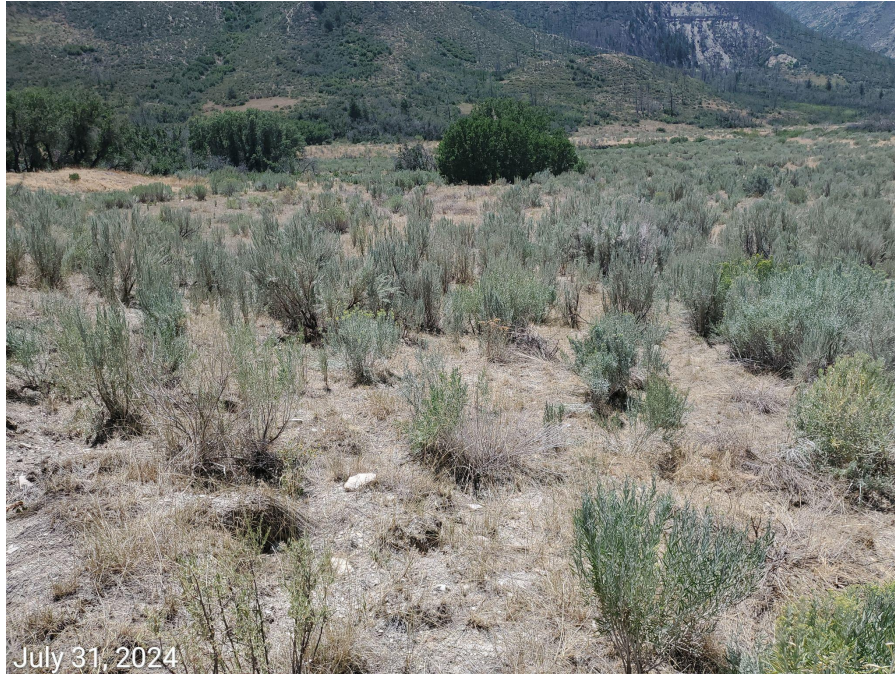
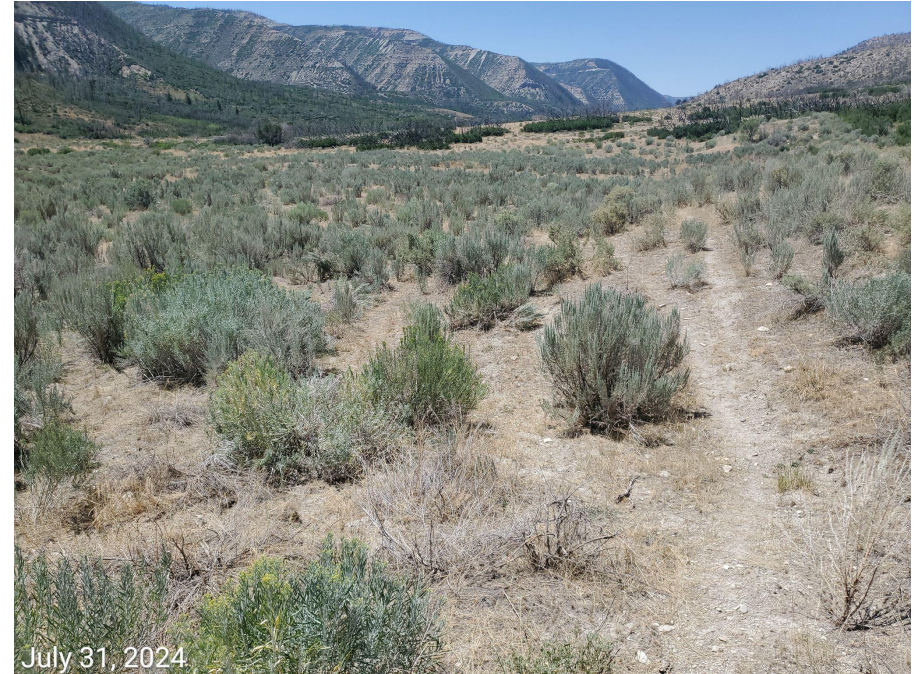
Photo 1: Photos 1-2 taken from the northeast end of the Location, facing southwest and west. The former working pad surface has met ECMC 1004.c revegetation standards.

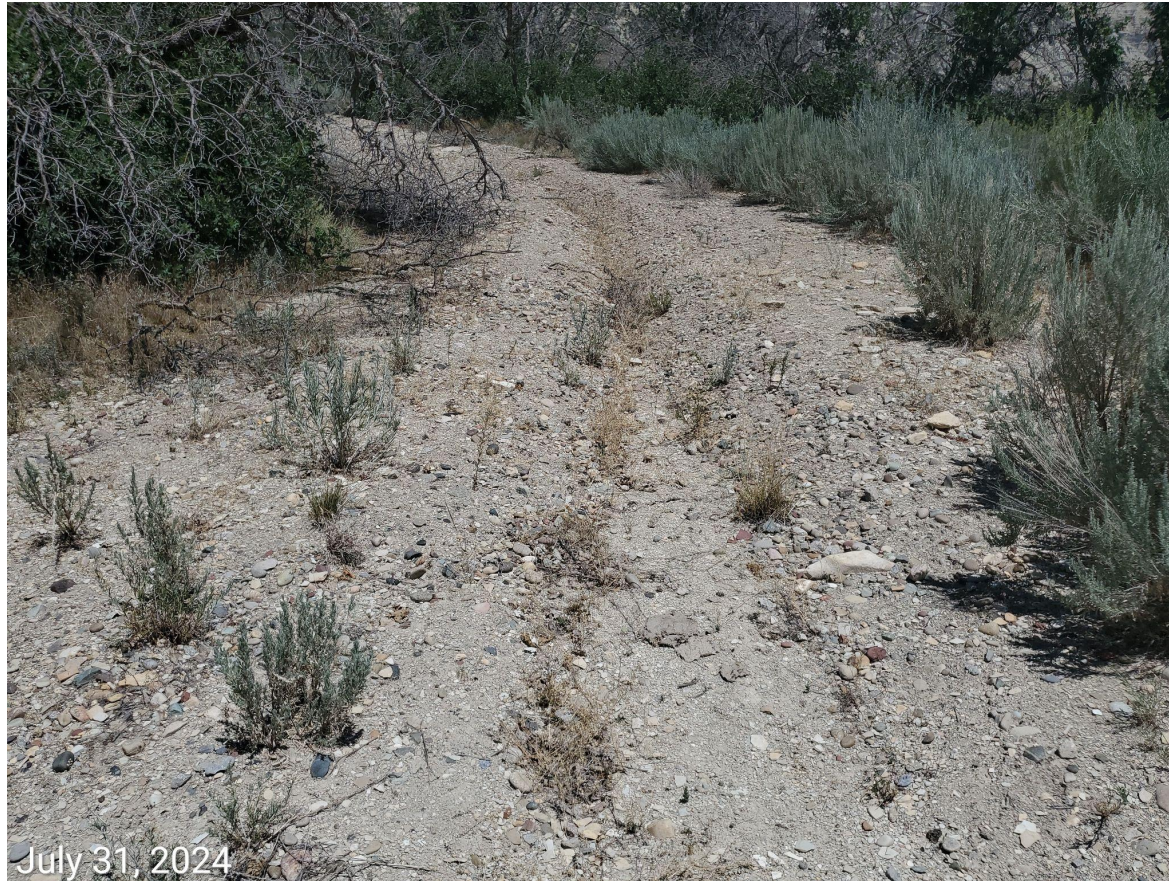
Photo 2: Photos 2-4 examples showing reclamation work including, but not limited to, removal of gravel, compaction alleviation, contouring and reclamation work has not been performed at the access road in accordance with Rule 1004.a

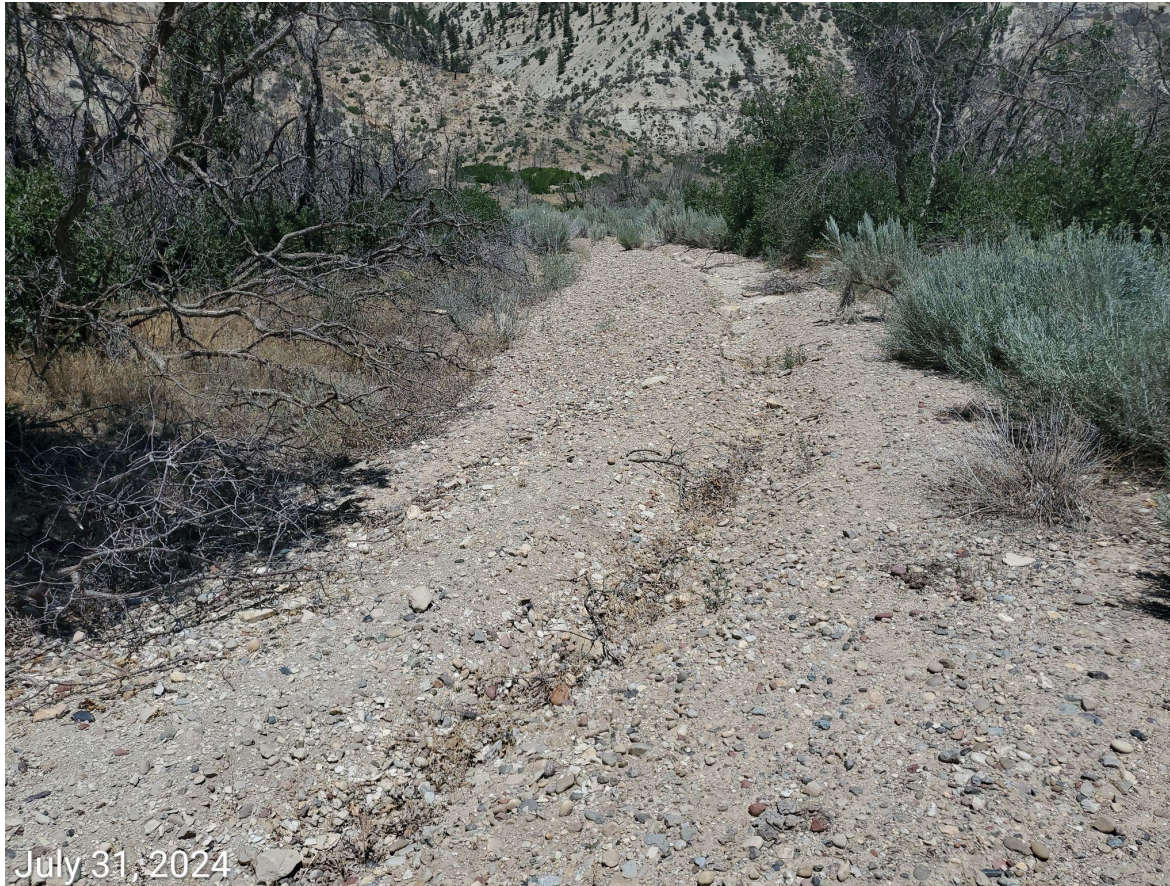
Photo 3: See comments under photo 2.

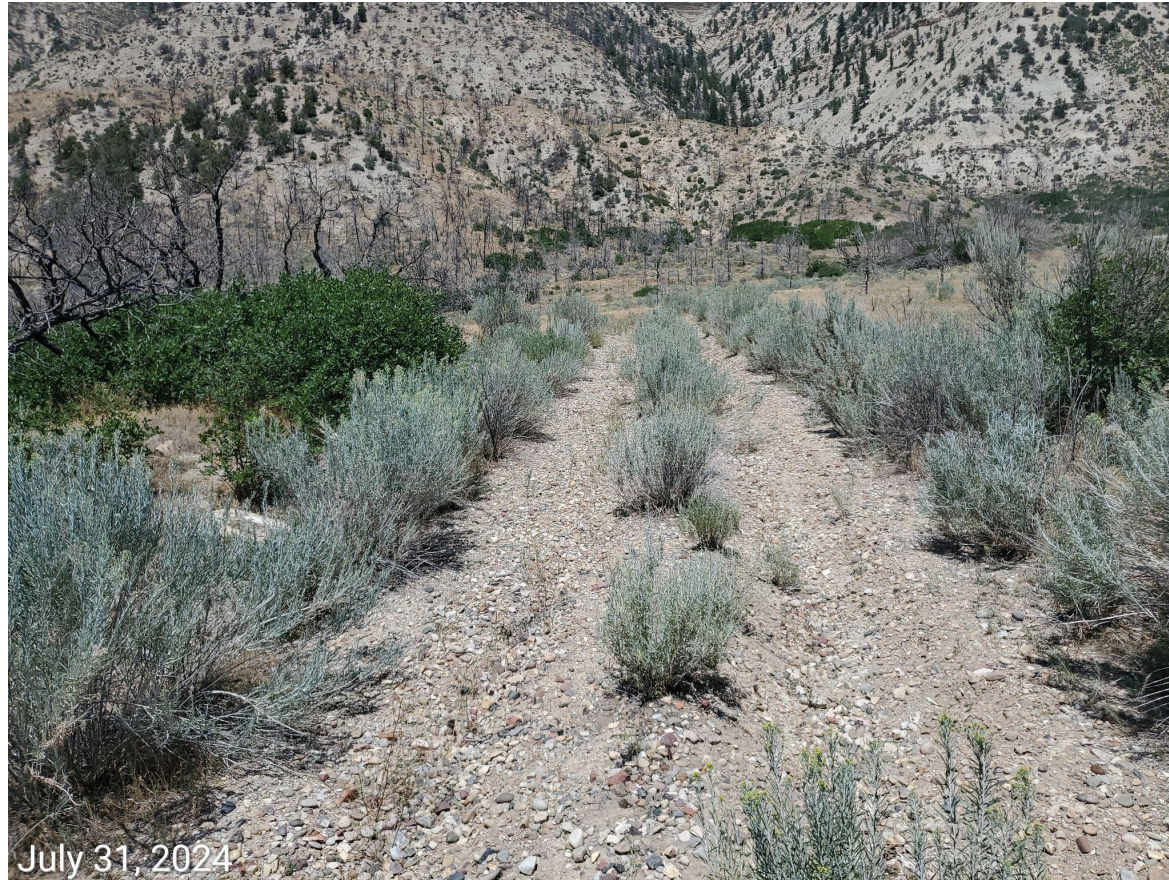
Photo 4: See comments under photo 2.

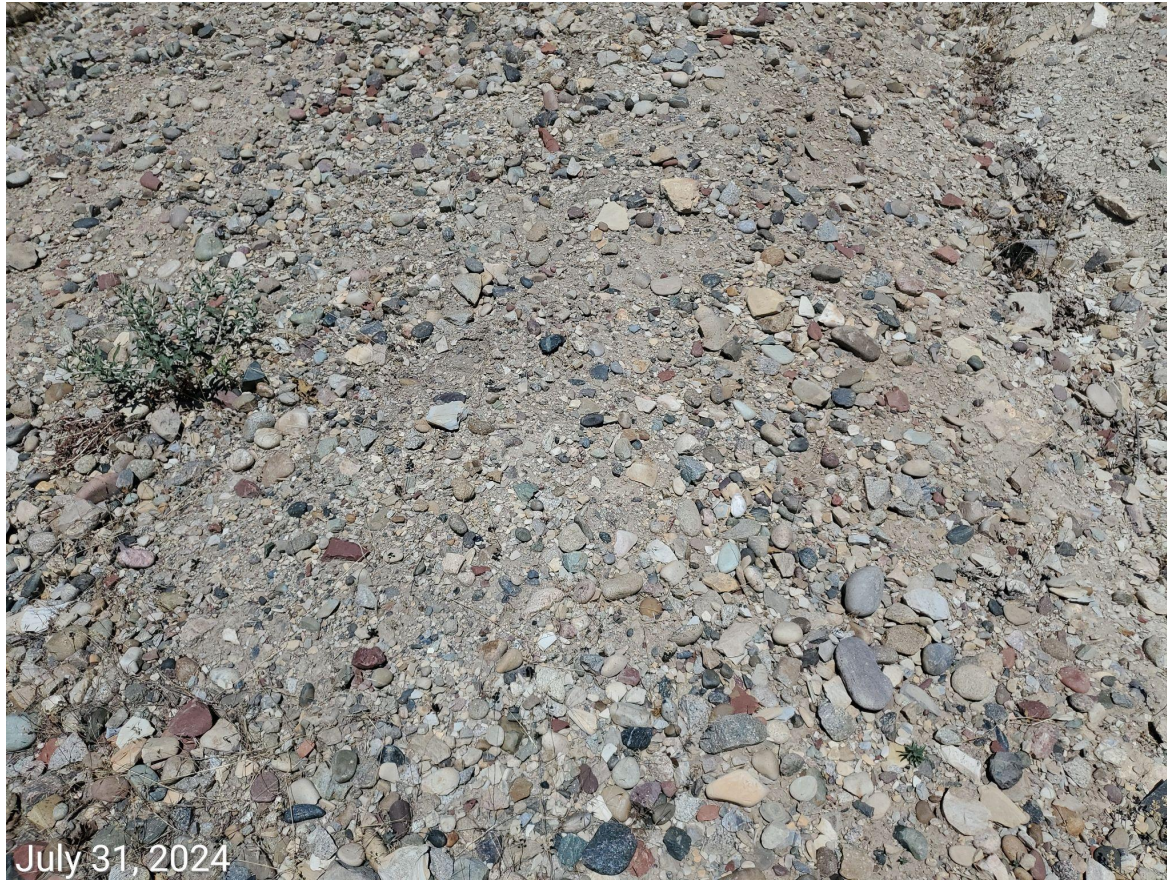
Photo 5: Photo example showing gravel/road base material remaining.

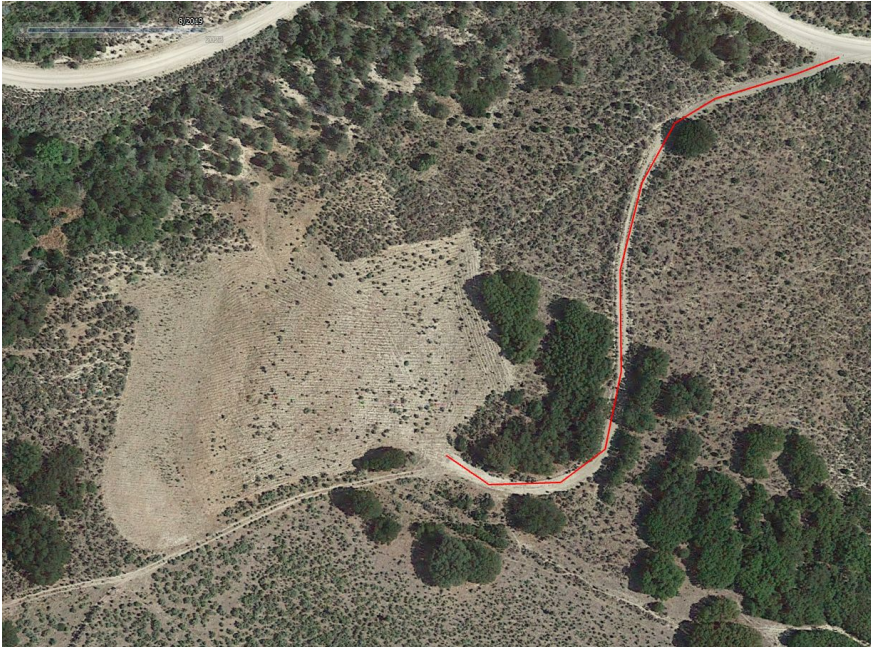
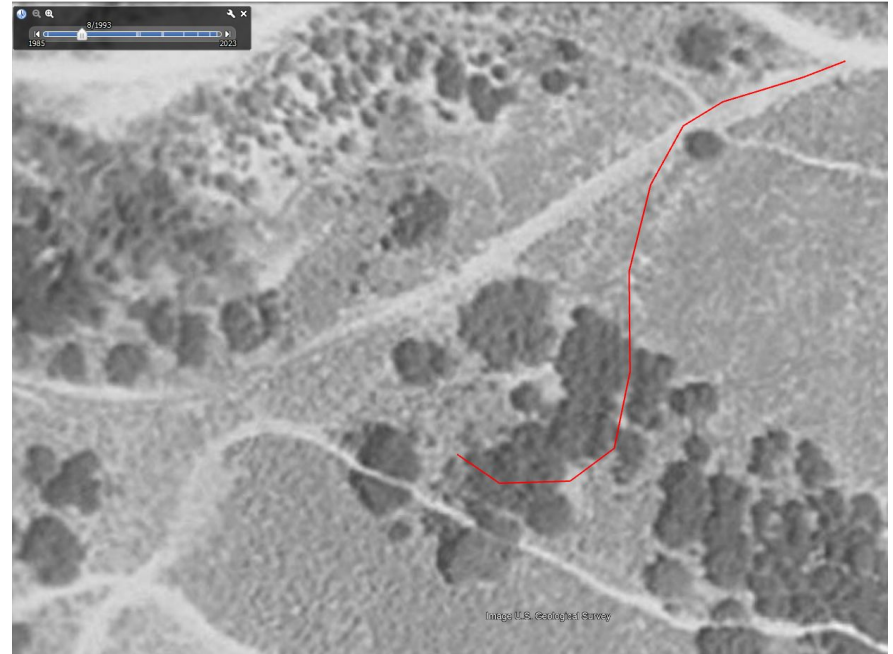
Photo 6: Photo left 2016 Google Earth aerial imagery; Photo right 1993 Google Earth aerial imagery. Records show well was SPUD 7/13/1995. Photos show that the O&G access road (red line) did not pre-exist the O&G Location, and is subject to 1004 reclamation requirements.
