# Inspection Photos

**Operator:** VISION ENERGY LLC - 10770

**Location ID:** 322451

**Inspection Doc:** 696206104

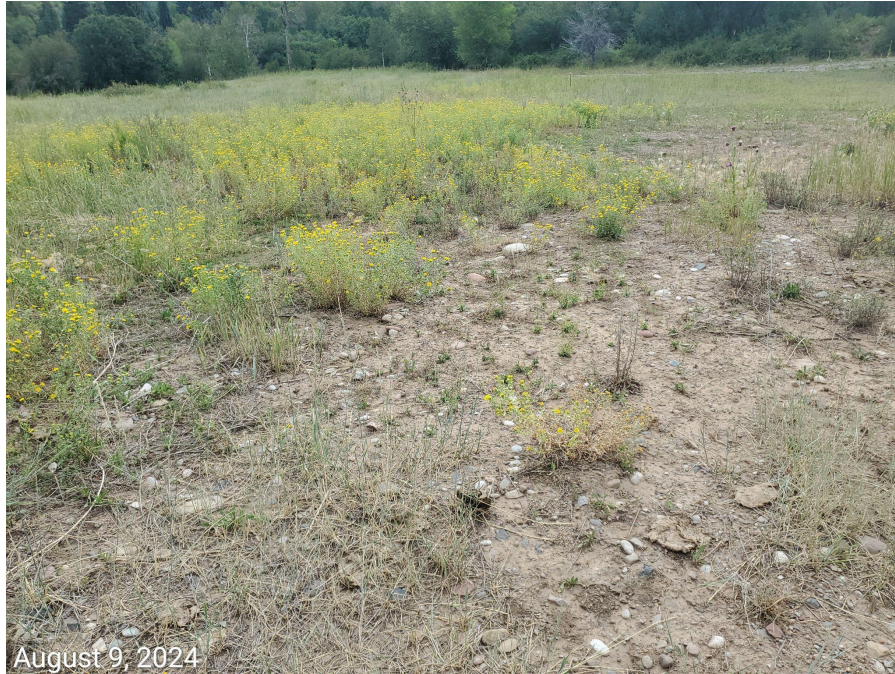
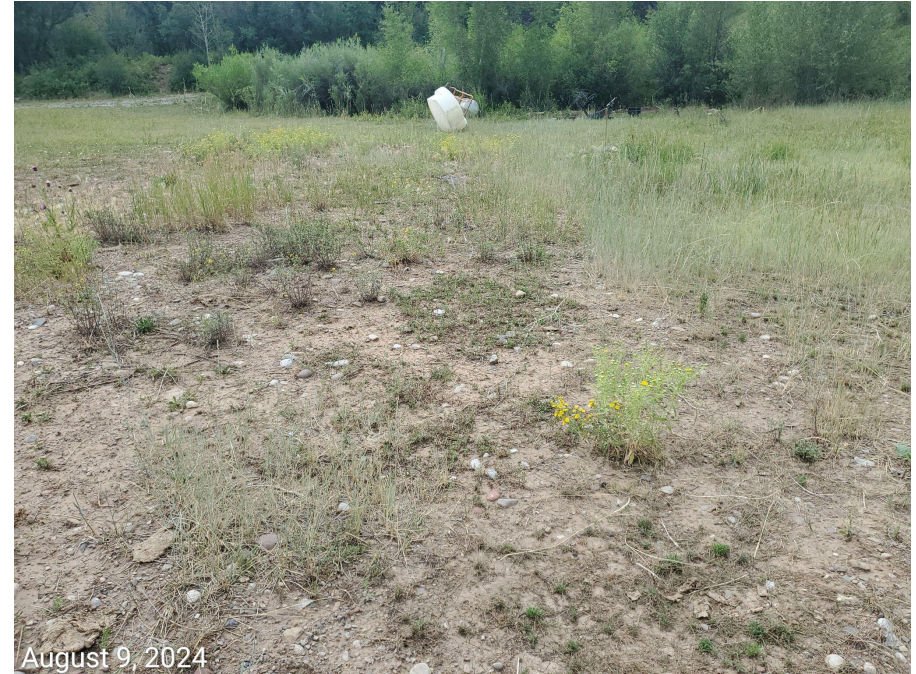
**Photo 1:** Photos taken from the north end of the Location. Photos provide an overview of the Location from southeast to southwest. Unable to find evidence that reclamation and weed management activities have been performed. Various equipment/trash/debris/etc... remains stored on the southwest end of the Location.

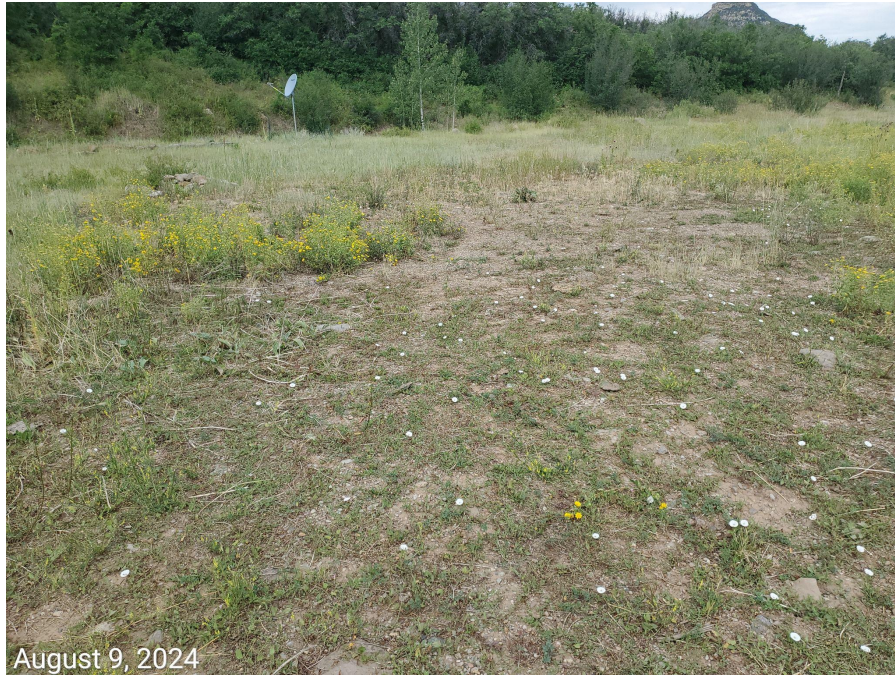
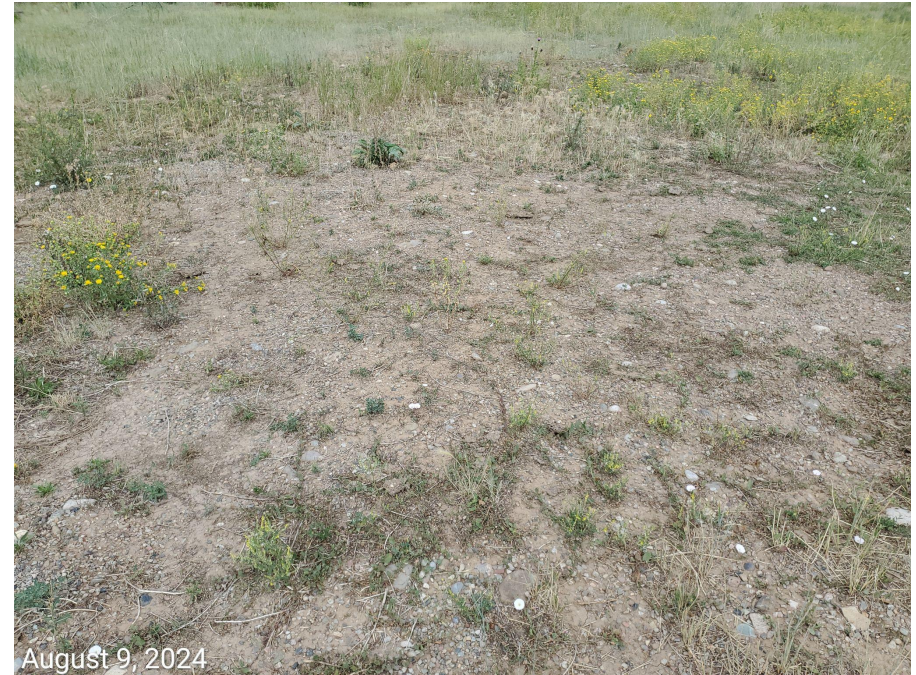
**Photo 2:** Photos examples showing Location is not progressing towards 1004 standards. Vegetation observed is predominantly Undesirable Plant Species. Additional reclamation and weed management efforts have not been performed.

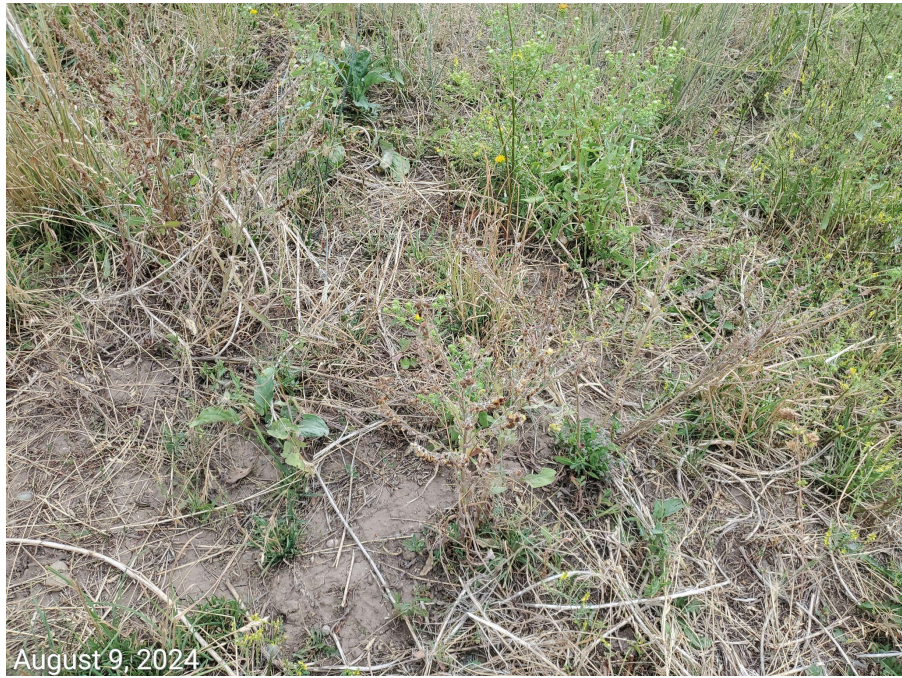
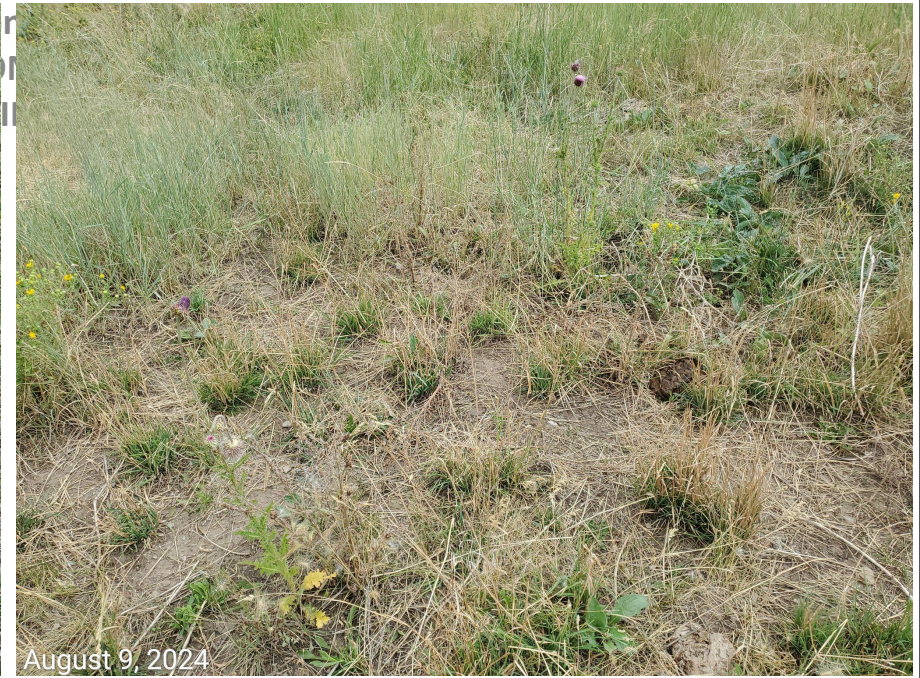
**Photo 3:** Photo example of noxious weeds that have continued to establish and spread on the Location. Weeds include Musk Thistle, Common Mullein, Houndstongue, etc...
