# Inspection Photos

**Operator:** VISION ENERGY LLC - 10770

**Location ID:** 322369

**Inspection Doc:** 696206106

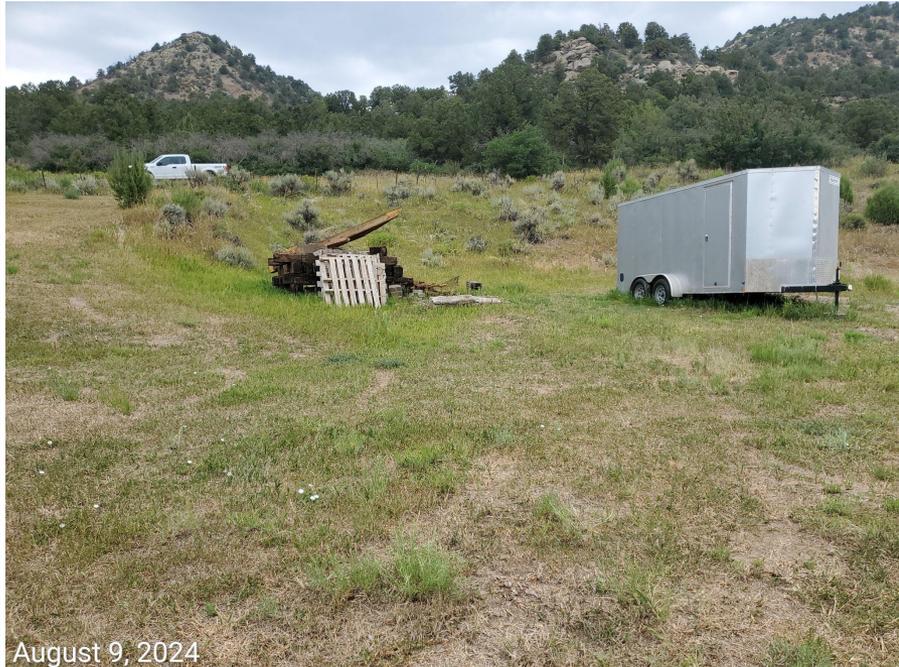
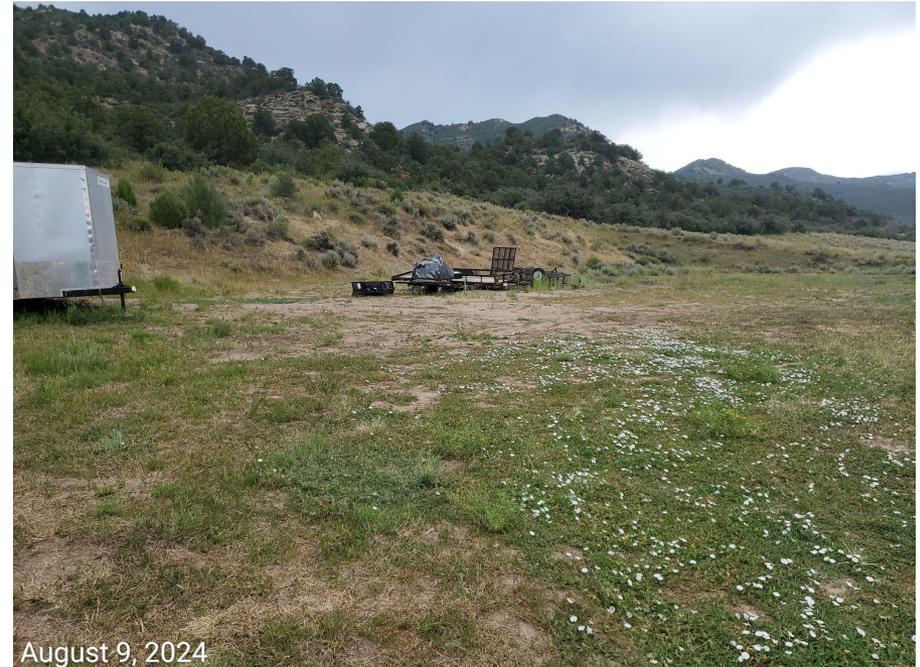
**Photo 1:** Photos 1-2 taken from the west end of the Location. Photos provide an overview of the Location from north, northeast, southeast to south. Various equipment/trailers/debris/etc... remains stored on the Location. 1004.a reclamation work including, but not limited to, compaction alleviation, recontouring/regrading and revegetation activities remain outstanding.

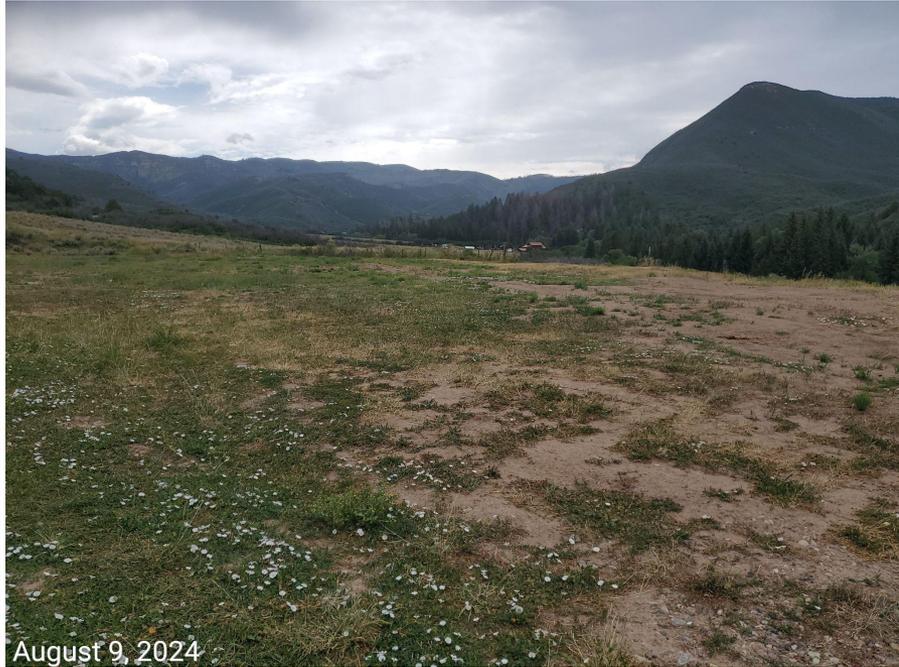
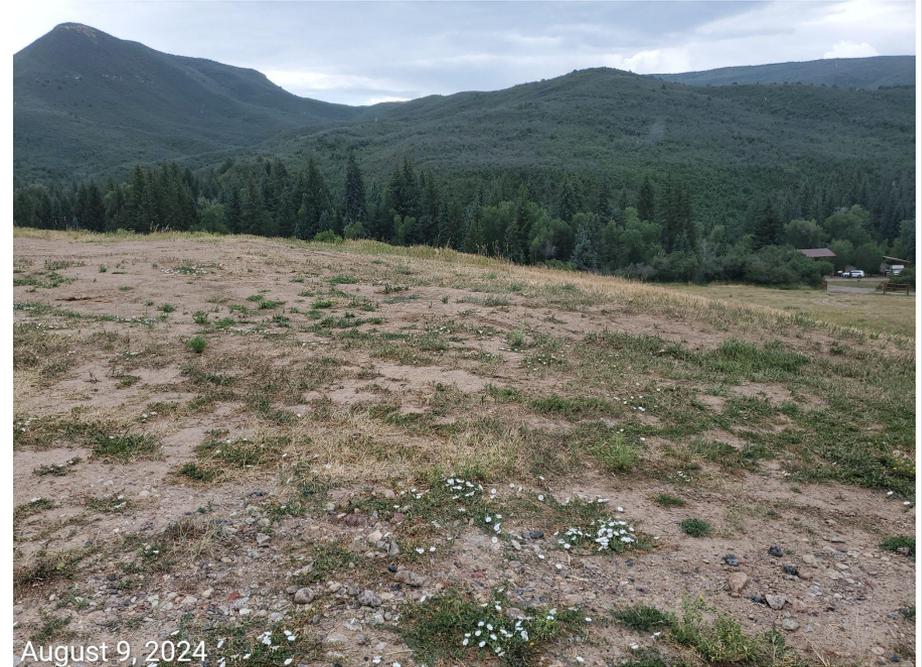
**Photo 2:** See comments under photo 1.

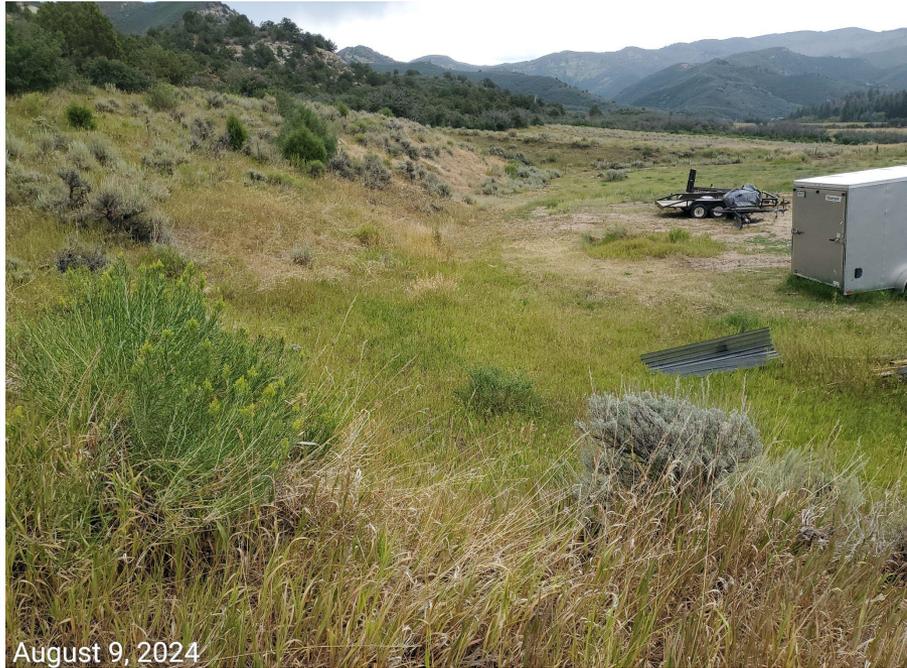
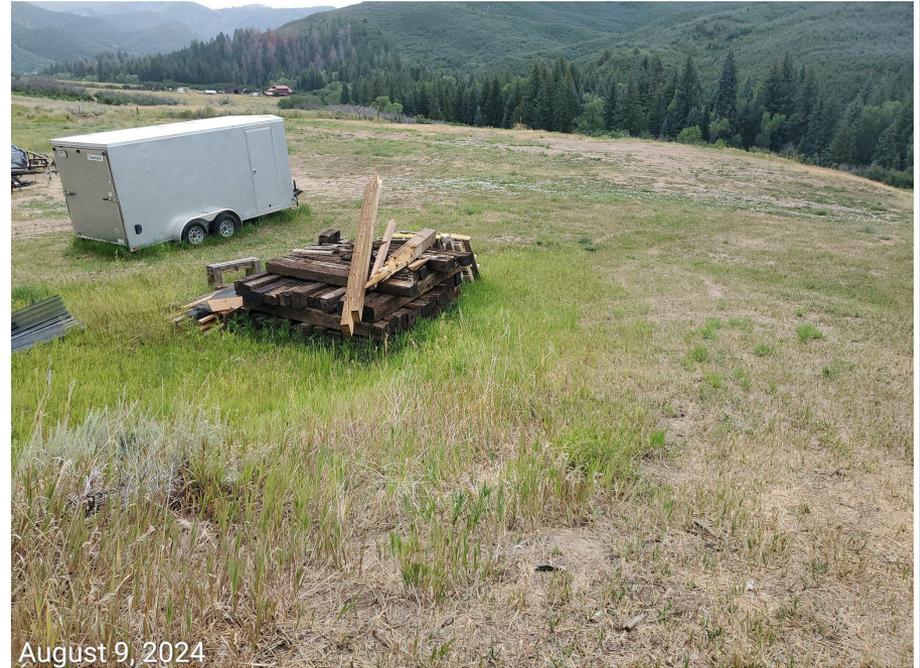
**Photo 3:** Photos taken from the northwest corner of the Location, facing east and south. See comments under photo 1.

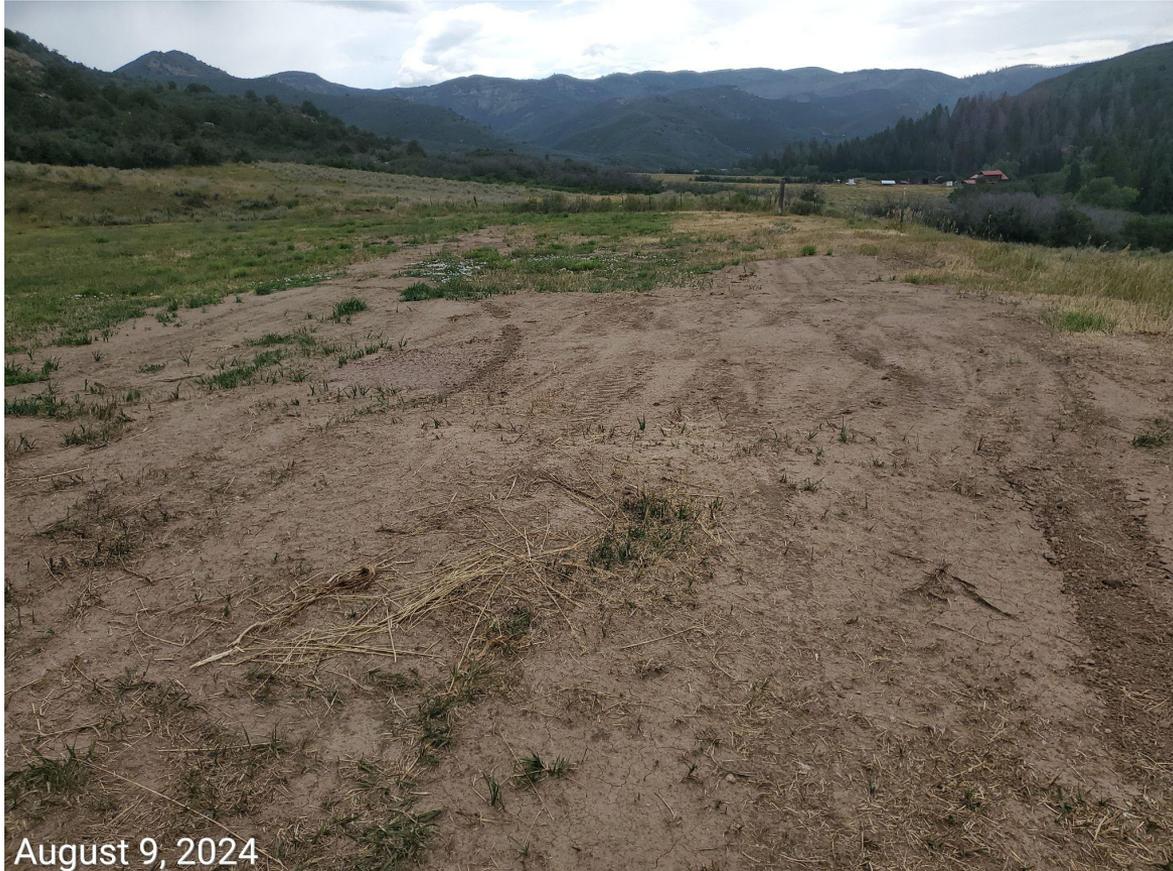
**Photo 4:** Photo taken from the southwest end of the Location, facing east. Photo shows the meter shed has been removed and the flowline excavation has been backfilled. “Monitoring well” previously observed in area also appears to have been removed.

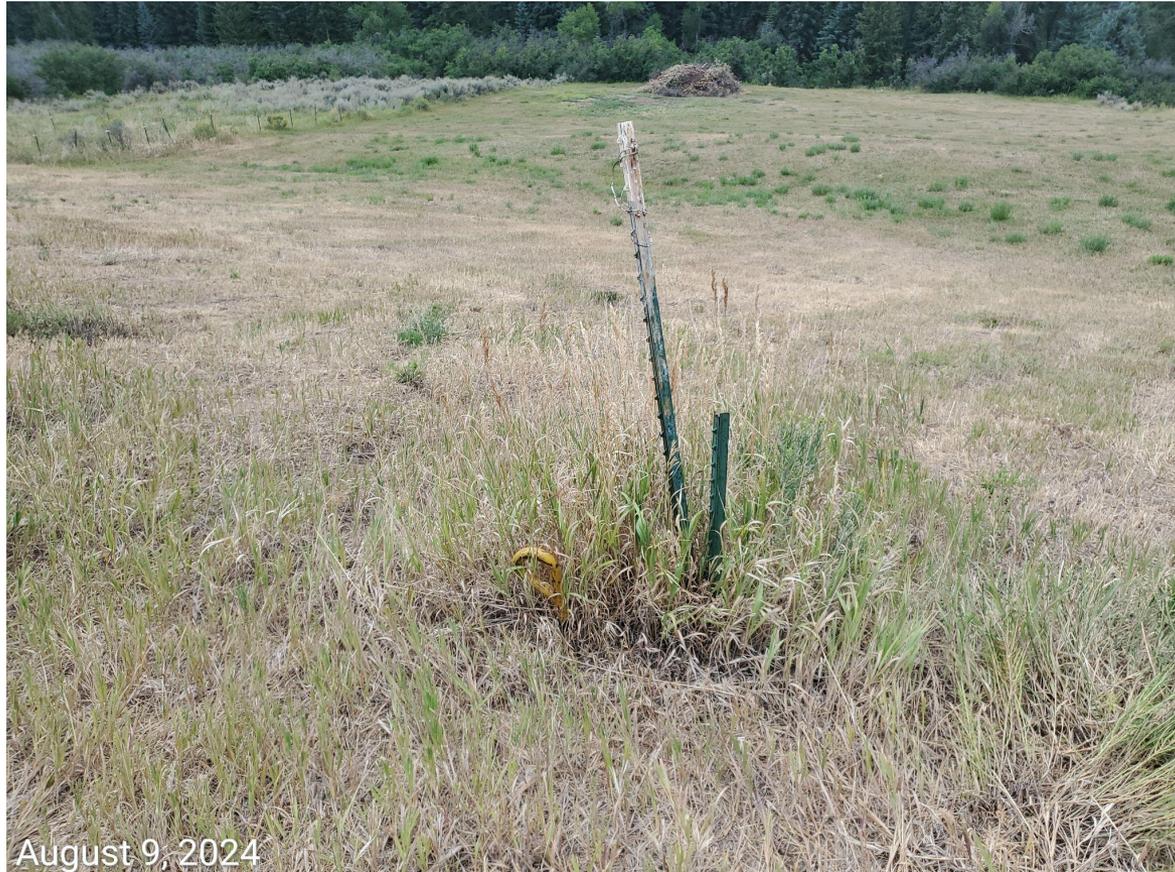
**Photo 5:** Photos shows anchor equipment remaining on the Location.

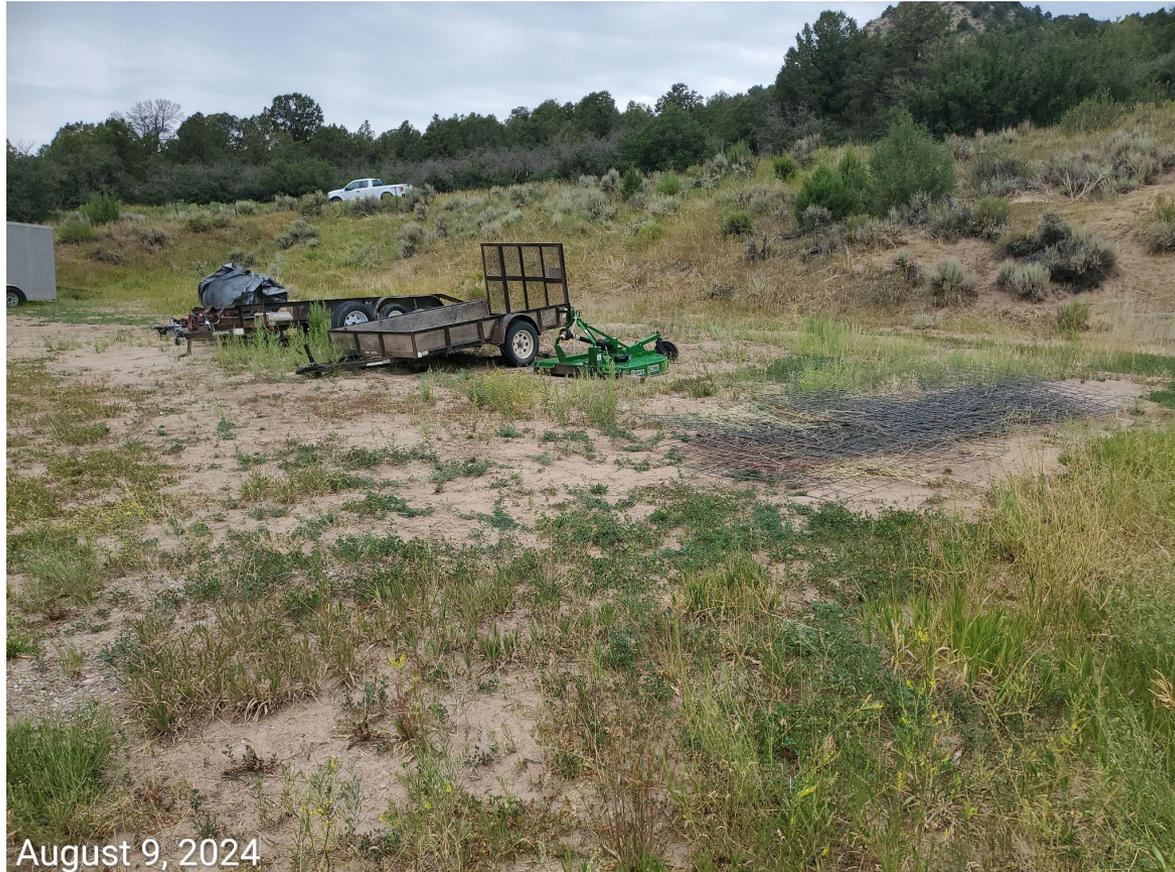
**Photo 6:** Various equipment/trailers/debris/etc... remains stored on the Location.No variance to waive ECMC rules and requirements has been submitted or approved.

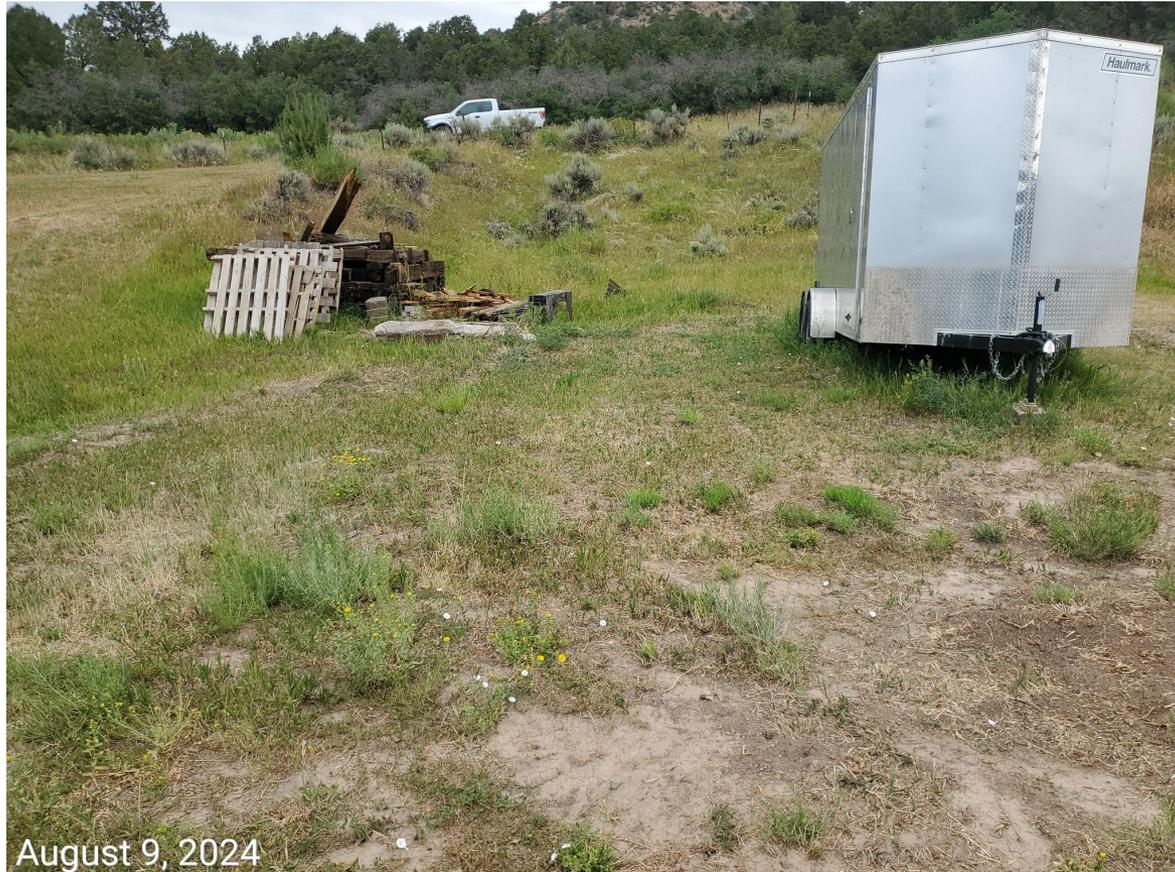
**Photo 7:** Various equipment/trailers/debris/etc... remains stored on the Location. No variance to waive ECMC rules and requirements has been submitted or approved.

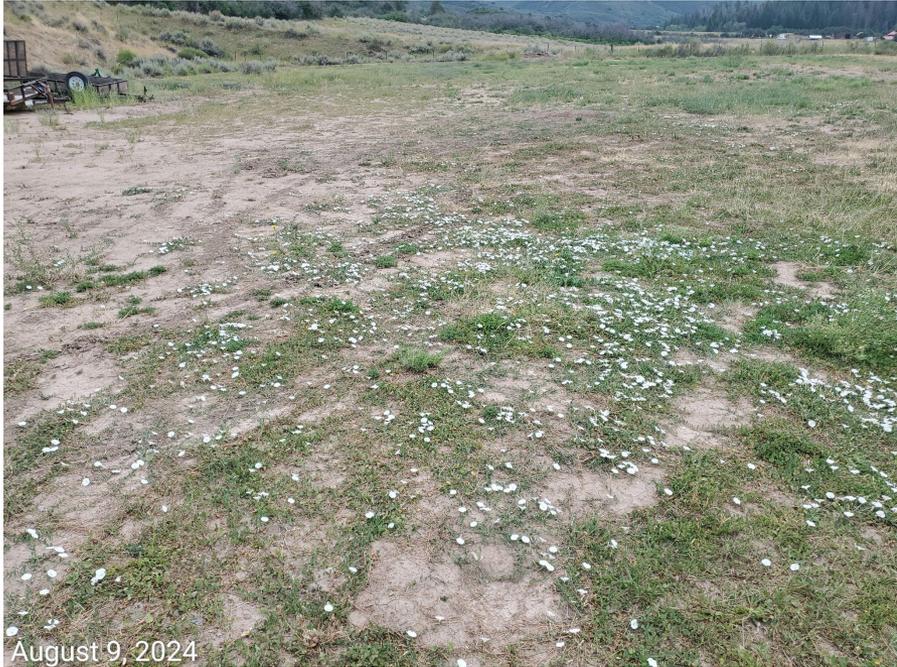
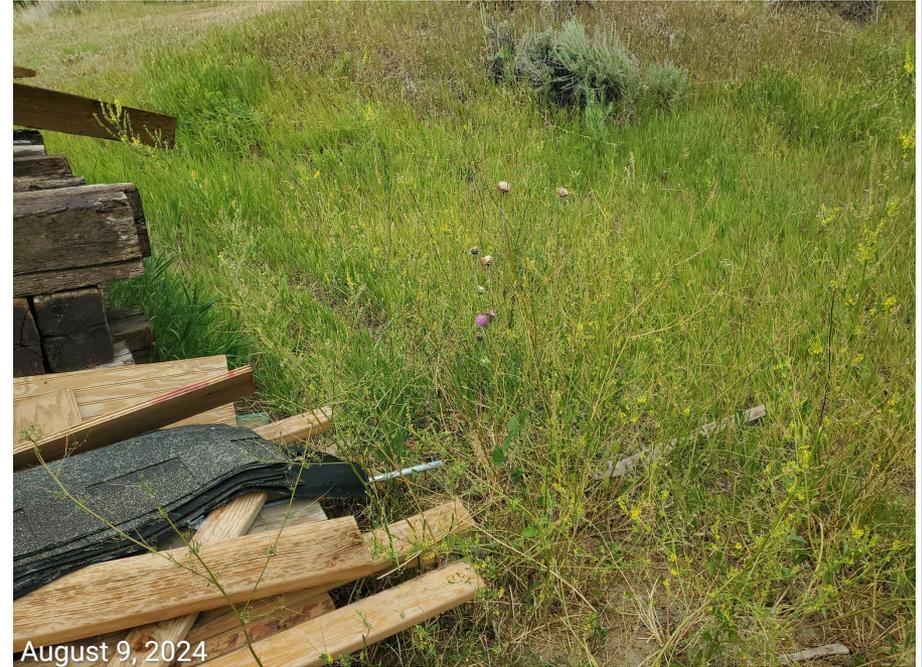
**Photo 8:** Photos examples showing weed establishment on the Location. Weed species observed included Field Bindweed and Musk thistle.
